LAND AT SMITHICK HILL FALMOUTH CORNWALL

Results of Archaeological Monitoring & Recording

Report No.: 110511
Date: 11.05.11
Authors: S. Walls

SWARCH project reference: FSH10
National Grid Reference: SW8079232861
Cornwall County Council Planning Reference: PA02/0188/10/M
OASIS reference: Southwes1-84468
Project Director: Colin Humphreys
Desk-Based Assessment: John Gould; Samuel Walls
Fieldwork: Bryn Morris; Samuel Walls
Post-Excavation Co-ordinator: Samuel Walls
Report: Samuel Walls
Report Editing: Deb Laing-Trengove
Research: Samuel Walls
Graphics: Samuel Walls
OS Map copying Licence No: 100044808

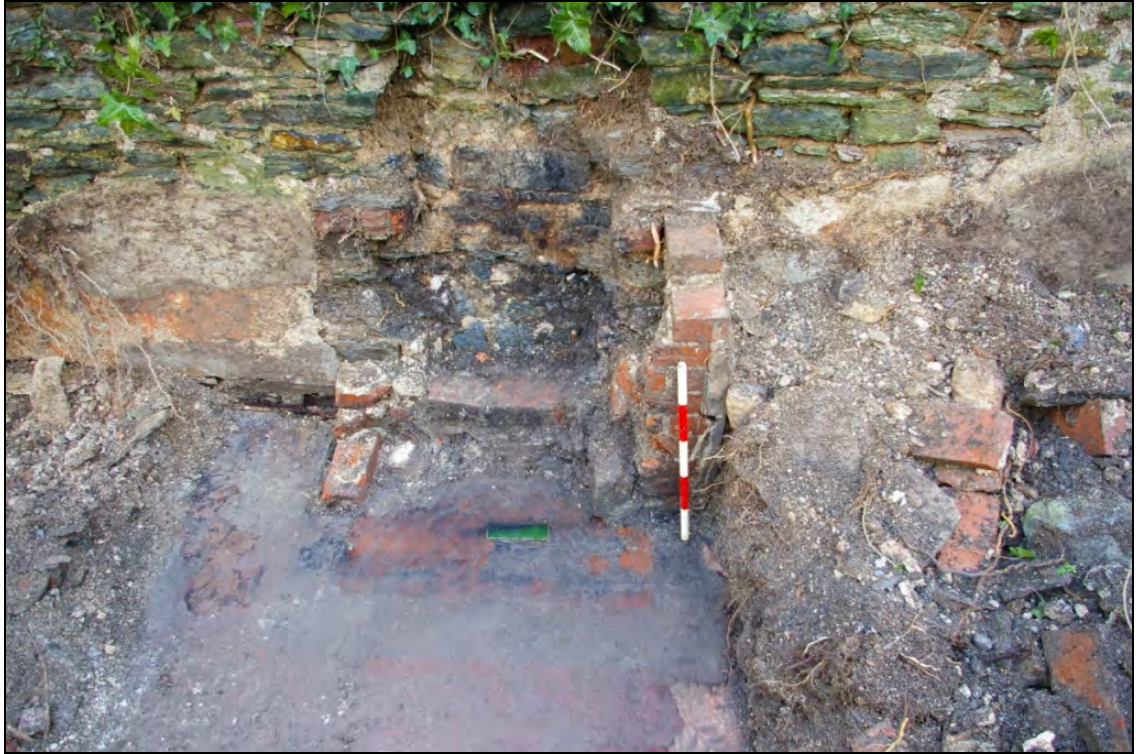
The Edwardian bottle green brick-style tiles lying over the hearth (within the scar of a fender) provide a probable early 20th century date for the insertion of the fireplace, concrete floor and brick rebuilding (see Figure 5).

Figure 5: The fireplace inserted into the southern elevation of Building 2, viewed from the north-east (0.5m scale).

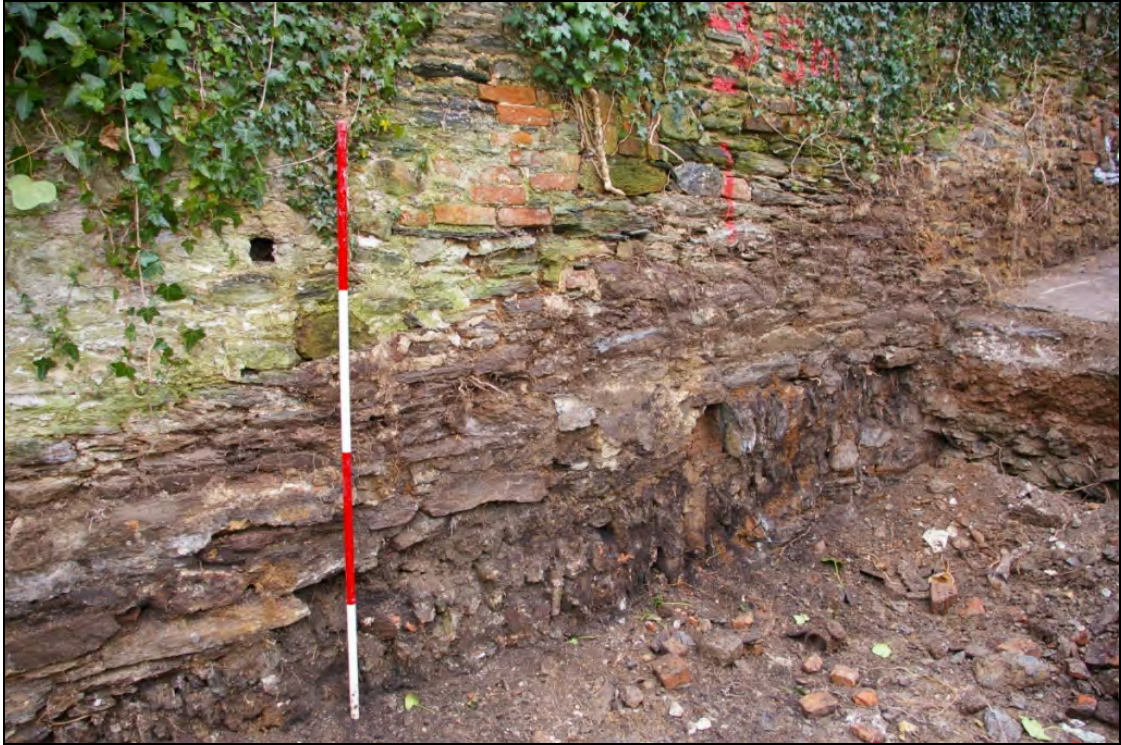
Two fireplaces were also positioned within the north facing elevation, the most easterly of these (for Building 2) was a 1.2m wide brick insert with no surviving lintel and a concrete hearth (Figure 5). The western fireplace (for Building 3) with its iron lintel and stone hearth had been blocked historically with stone rubble with a hard white lime mortar bonding (Figure 6).

Figure 6: The blocked fireplace in the south elevation (Elevation 1) of Building 3, viewed from the north (2m scale).

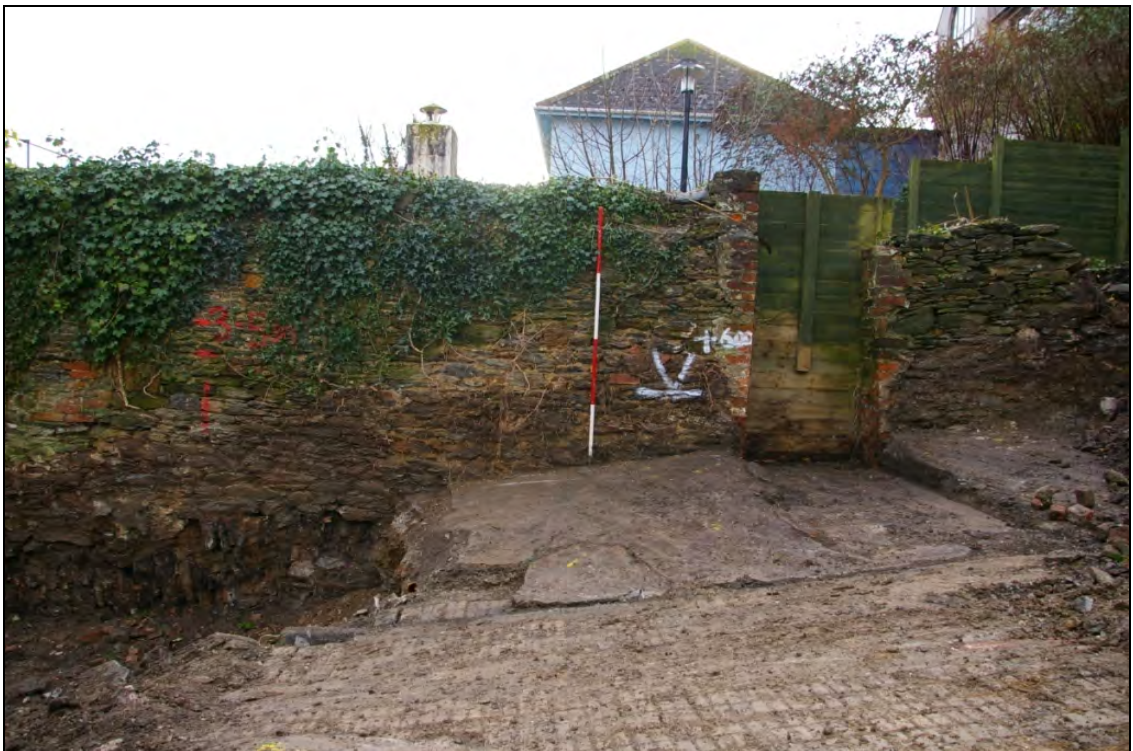
Figure 7: Forced entrance inserted in the south elevation (Elevation 1) of Building 3 leading onto Fountains Ope (formerly Allen's Yard), viewed from the north-west (2m scale).

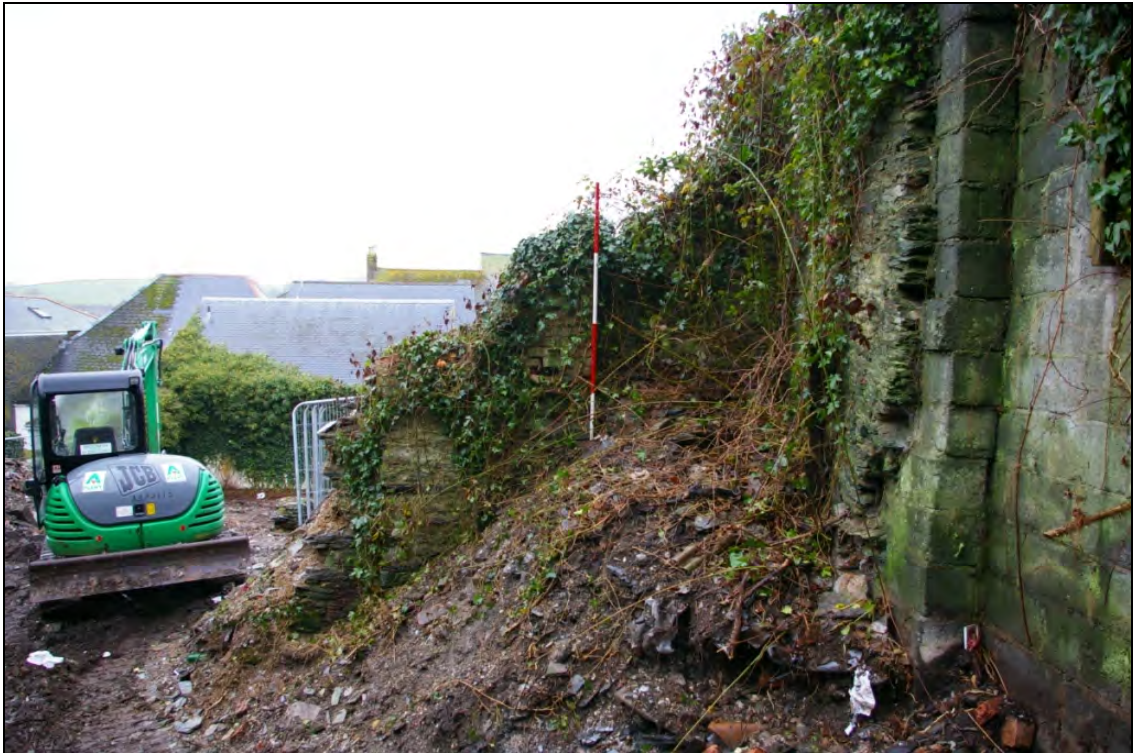
Figure 10: The eastern elevation of Building 5 prior to clearance and collapse (2m scale).

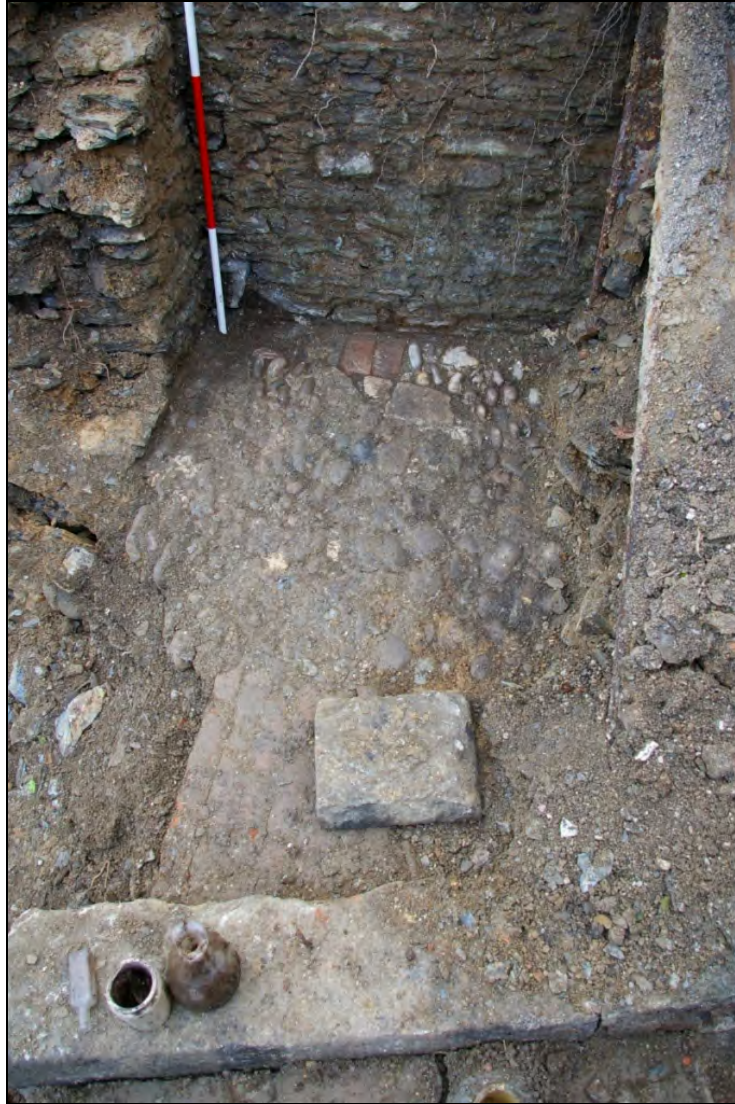
Although not fully exposed during the course of the development, it is of note that a cobble and brick floor surface survived in the south-east portion. No floor was apparent however in the western portion of the building, which may be a result of the rebuilding of the south elevation (Elevation 4).

Figure 11: The surviving cobble and brick floor inside Building 5 (2m scale).

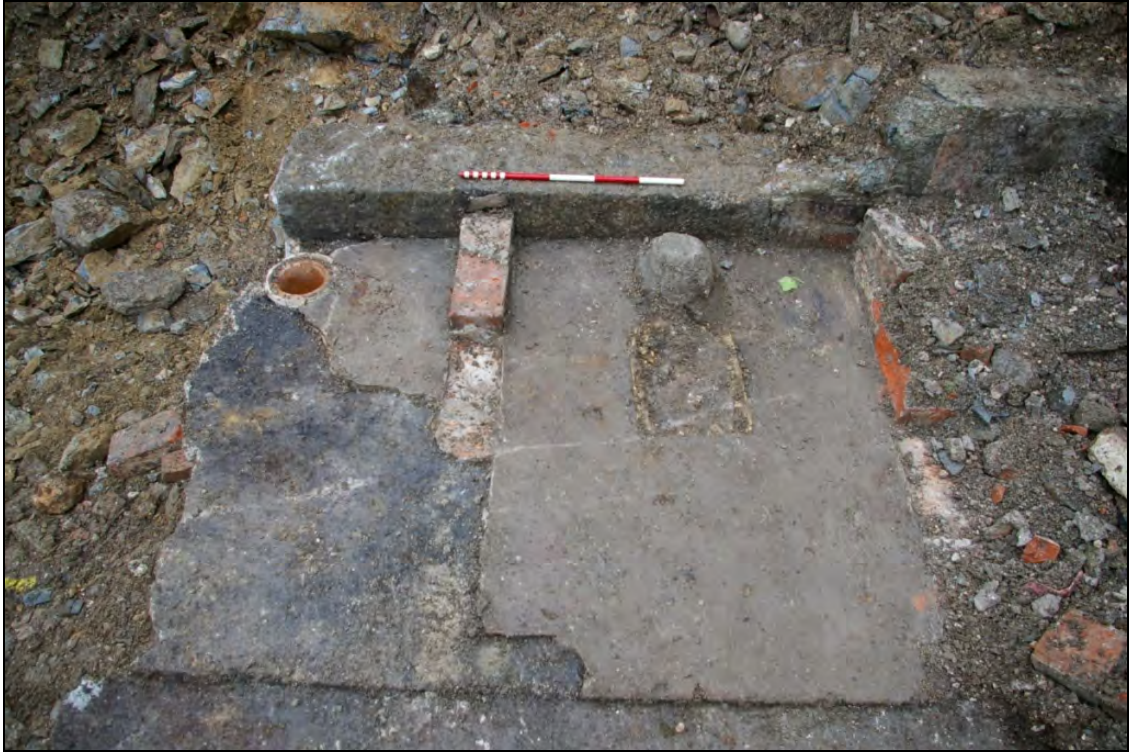
No other elevations survived for Building 12, although two single brick wide partitions divided the remains of the three ceramic toilet pedestals, which had been set in a poured concrete floor.

Figure 12: Building 12, the toilet block, viewed from the north (0.5m scale).

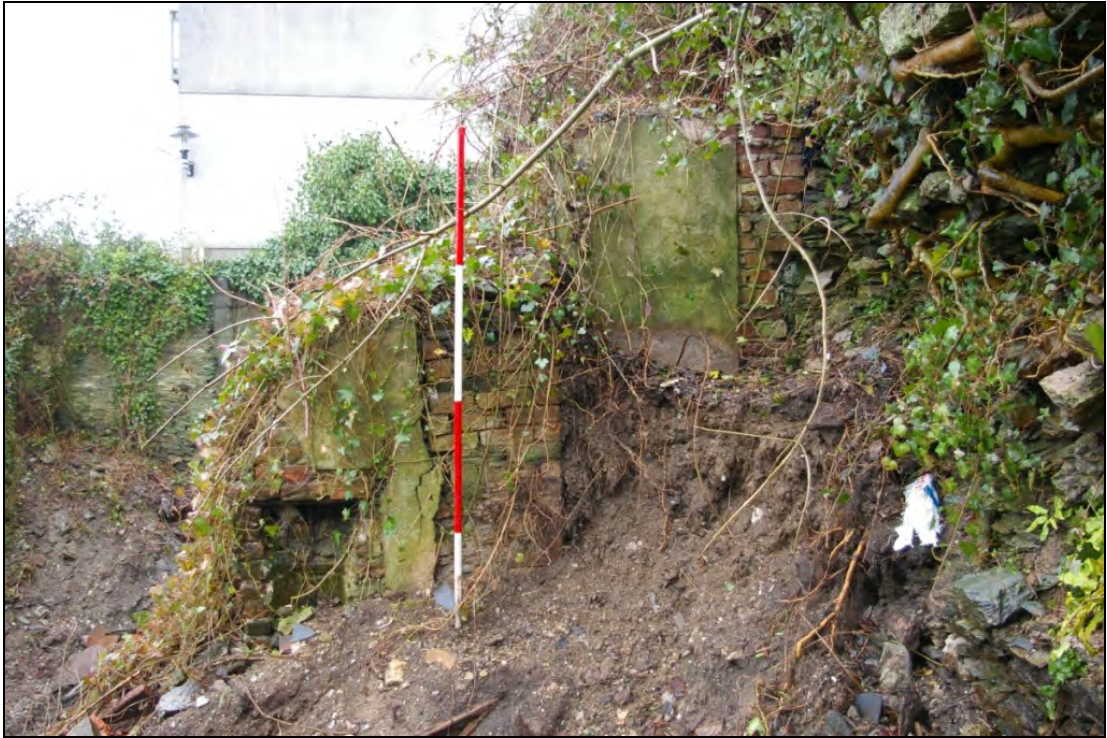
Elevation 6 comprised the north elevation of Building 6 and the south elevation of Building 7 (Figures 15-16) and abutted Elevation 7 to the west. The wall was constructed of roughly coursed platey stone rubble set in a hard cream mortar at ground floor level, with an upper brick-built first floor. Rectangular joist holes were again (as with Elevation 5) located at the junction between the two builds, with a timber lintel located below to the south. There were two brick fireplaces set into each side of the elevation, with both ground floor examples having iron lintels.

Figure 15: North face of Elevation 6, viewed from inside Building 7 (2m scale).

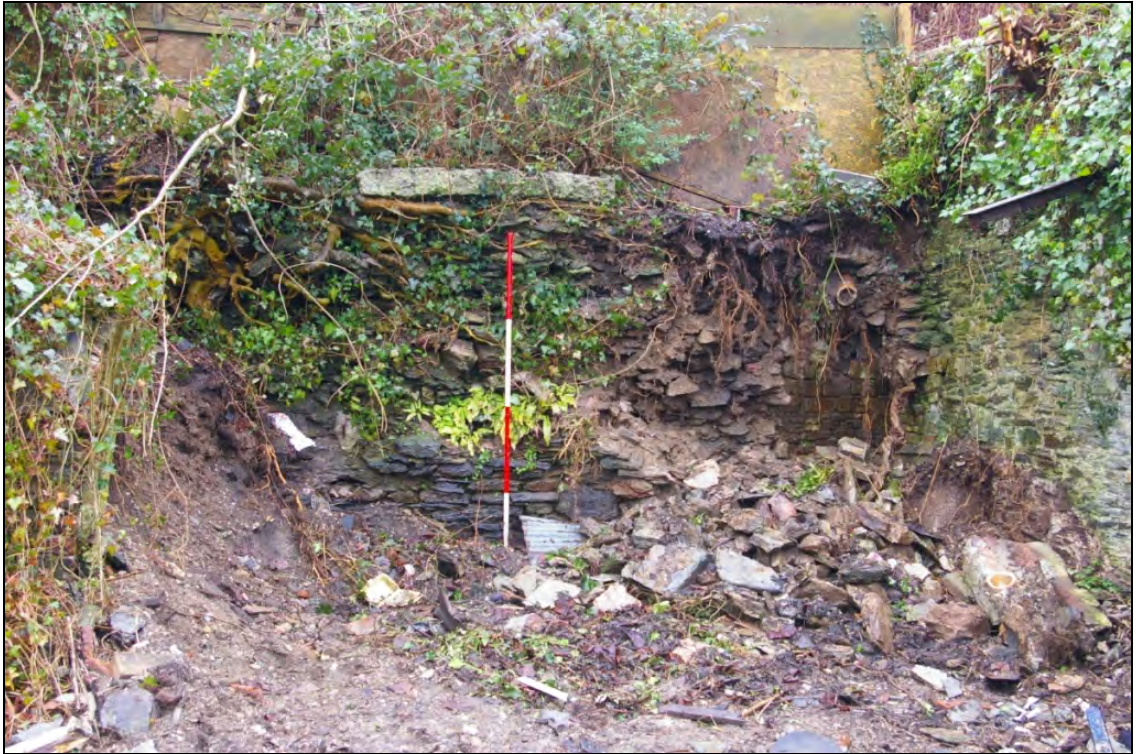
Figure 17: The west elevation of Building 7, viewed from the north-east (2m scale).

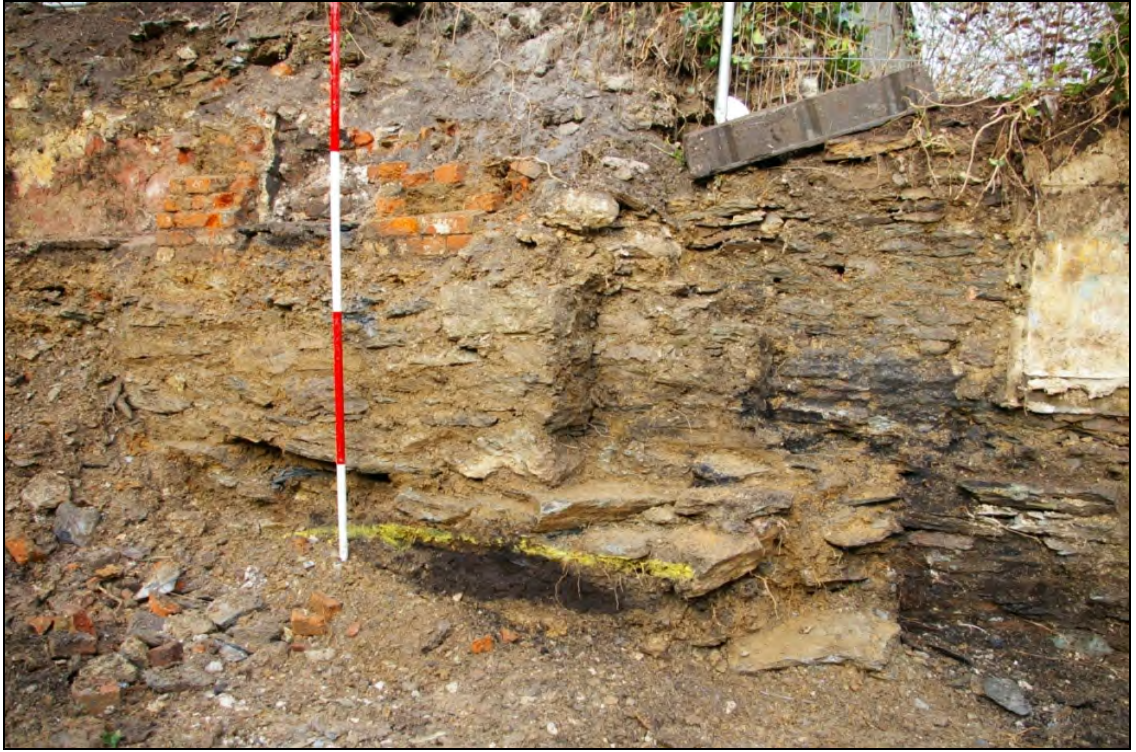
No floors survived and it seems likely that the building formerly had a suspended wooden floor, hence the supporting dwarf wall evident in the north elevation (Figure 20). This is further supported by the much higher amount of roof slate contained within the foundations of this building, forming a layer approximately 0.1m thick immediately above the redeposited natural subsoil that the footings cut into. Also of note was the presence of two glass marbles (found near the entrance step) which had presumably fallen through gaps in the floor boards while the building was occupied.

Figure 20: The dwarf wall in the north-east corner of Building 9, viewed from the east (2m scale).

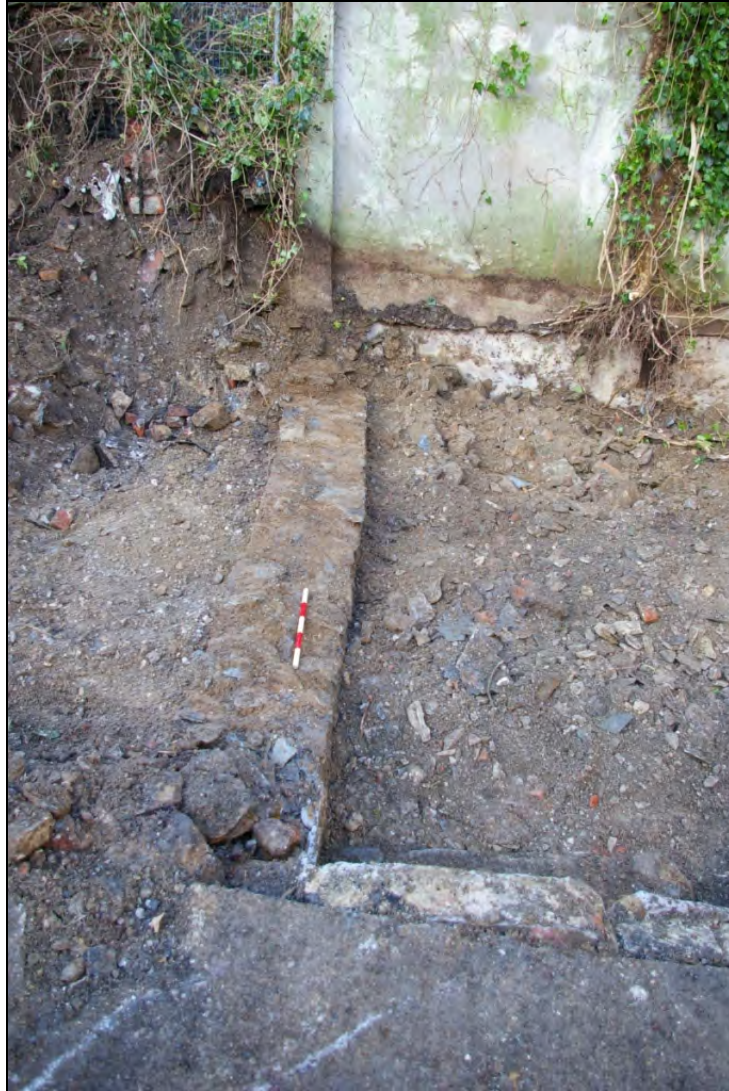
Building 10 was approximately 4m x 3.7m and contained a single brick fireplace in its north elevation. The east elevation survived to a height of 0.3m although this was slightly less to the north end, where it had been truncated by the modern building. The footing of this wall was at a slightly lower level (0.15m) than any of the adjoining walls, although there was no difference in the fabric or build of the wall. The south elevation was of an identical construction, with a single brick width wall on the outer southern edge along the Ope. The west wall was also of the same construction but with occasional patches of plaster surviving.

Figure 21: The east elevation of Building 10, viewed from the south-east with the modern storage building in the background (0.5m scale).

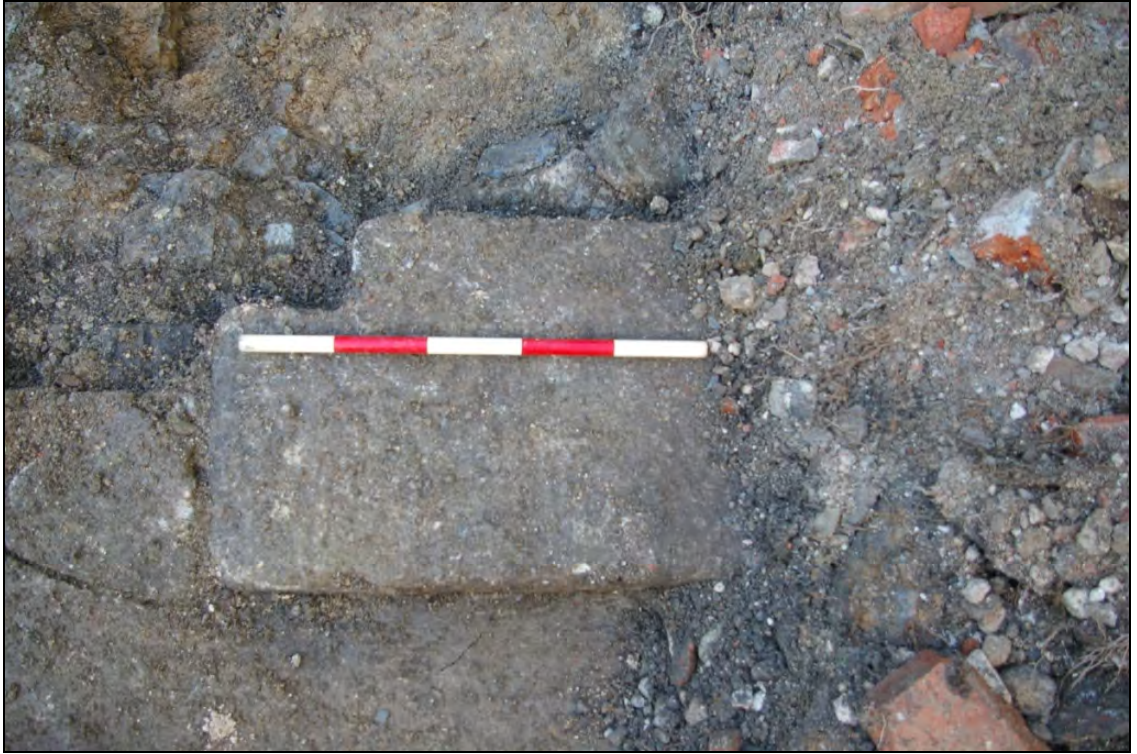
Figure 22: The reused granite lintel utilised for the entrance step into Building 11, viewed from the south-east (0.5m scale).
