ST. MARGARET'S CHURCH STOODLEIGH DEVON

Results of a Desk-Based Assessment
&
Bell Frame Recording

Report No.: 101013
Date: 13.10.10
Author: B. Morris

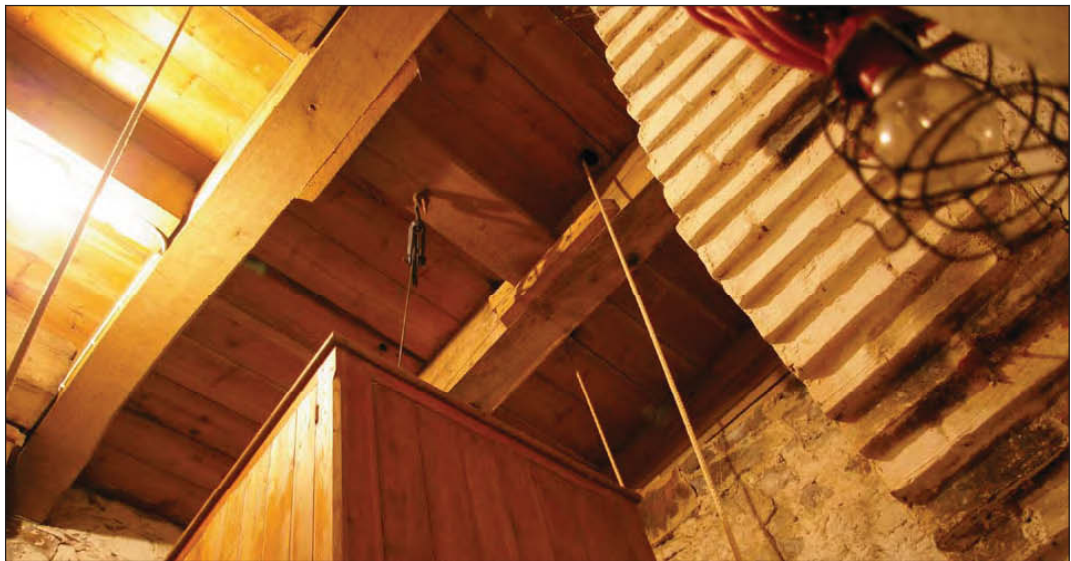
Figure 7: The floor of the belfry, viewed from below and the north-east.

The bell frame sits on four horizontal beams orientated north to south. The ends of the two central beams sit on a ledge/offset in the walls of the tower. The east and west beams rest entirely on the ledge/offset. Only the western face of the eastern beam is visible, and the western beam is entirely hidden and/or replaced by recent/modern timber. All of the original beams are oak, and c.0.25×0.2m thick. One of the beams has been shaped to slip past the brick chimney abutting the north wall. On the eastern side, four transverse oak beams of similar dimension run east to west, secured by unpegged mortise and tenon joints. The bases of the draw bolts running through the bell frame above are visible, and can be observed to have twisted in their sockets; two of them have been reset.

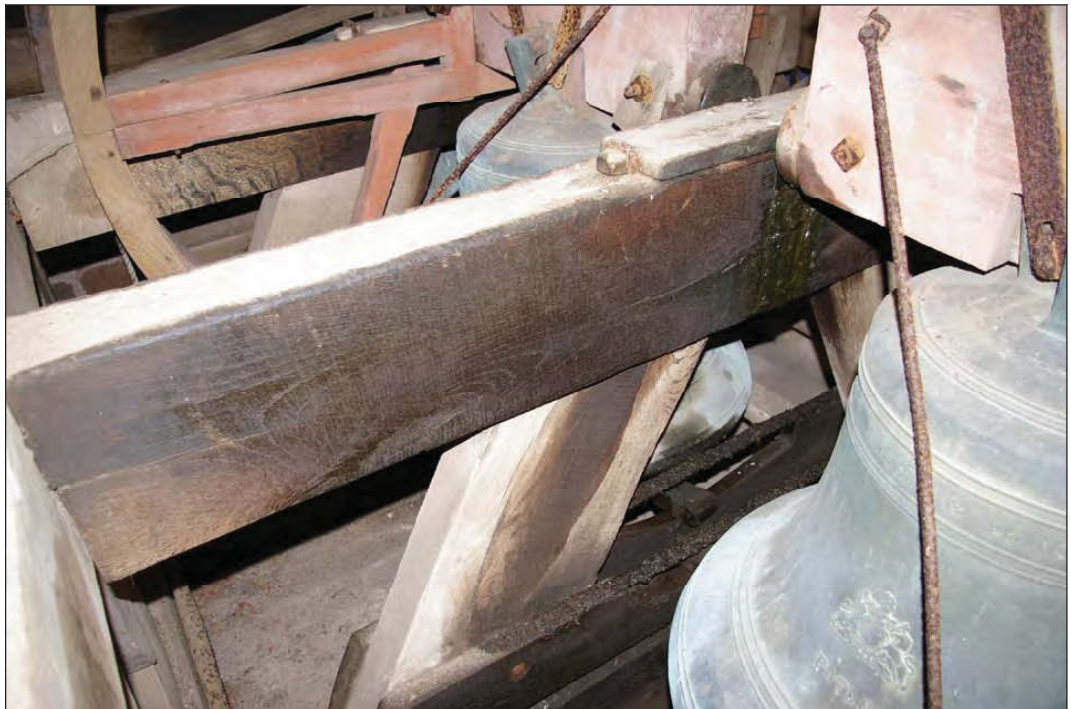
Figure 8: Detail of the truss on the north side of bellpit 3.

The cable from the clock rises in bell pit 3 and is connected to a section of iron shafting attached to the central north-south truss. On the hour, the clock striker hits the Tenor.

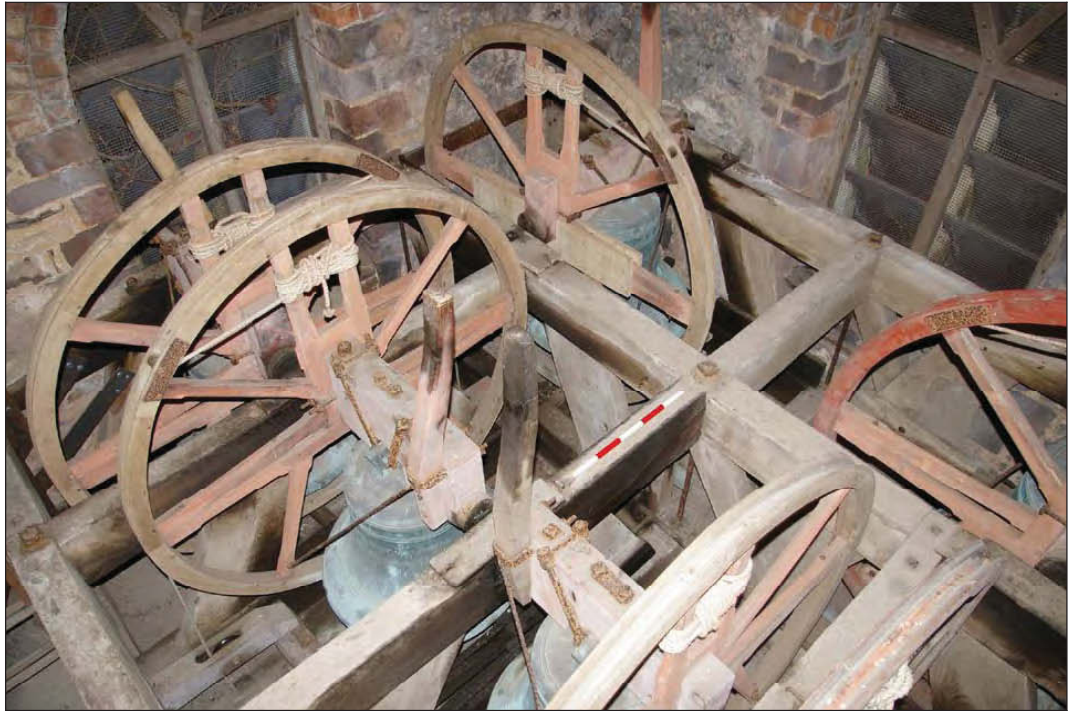
Figure 13: The bell frame, viewed from the north-east (scale 0.5m).

In the south-east corner a steel corner post has been inserted to support a cracked framehead. Not all the iron draw bolts are still straight. The cross-braced eastern truss looks like it has racked to the south, and some of these draw bolts have been reset. This truss also features additional bolts in the head beam, inserted to prevent it cracking. The trusses in bell pits 1-4 have been strengthened by the addition of lateral timbers below the level of the bell. The frame in the south-west corner has rotted and been repaired with additional timber, and the frame and floorboards along the west wall has clearly suffered from water damage. At the time of the survey, the Fifth was supported on wooden blocks and the principal spokes of the wheel crudely tied together with plywood.

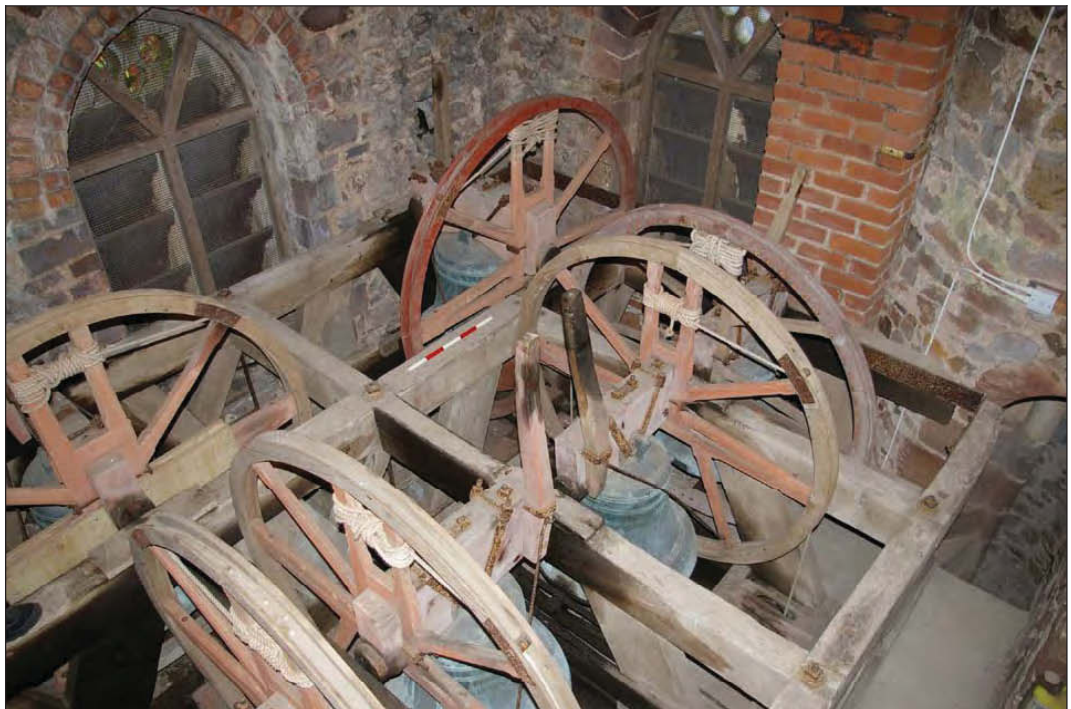
Figure 14: The bell frame, viewed from the south-east (scale 0.5m).
