THE CIDER BARN, BATSON HALL COTTAGE SALCOMBE DEVON

Results of a Desk-Based Assessment
with Historic Building Recording

Report No.: 101201
Date: 01.12.10
Author: B. Morris

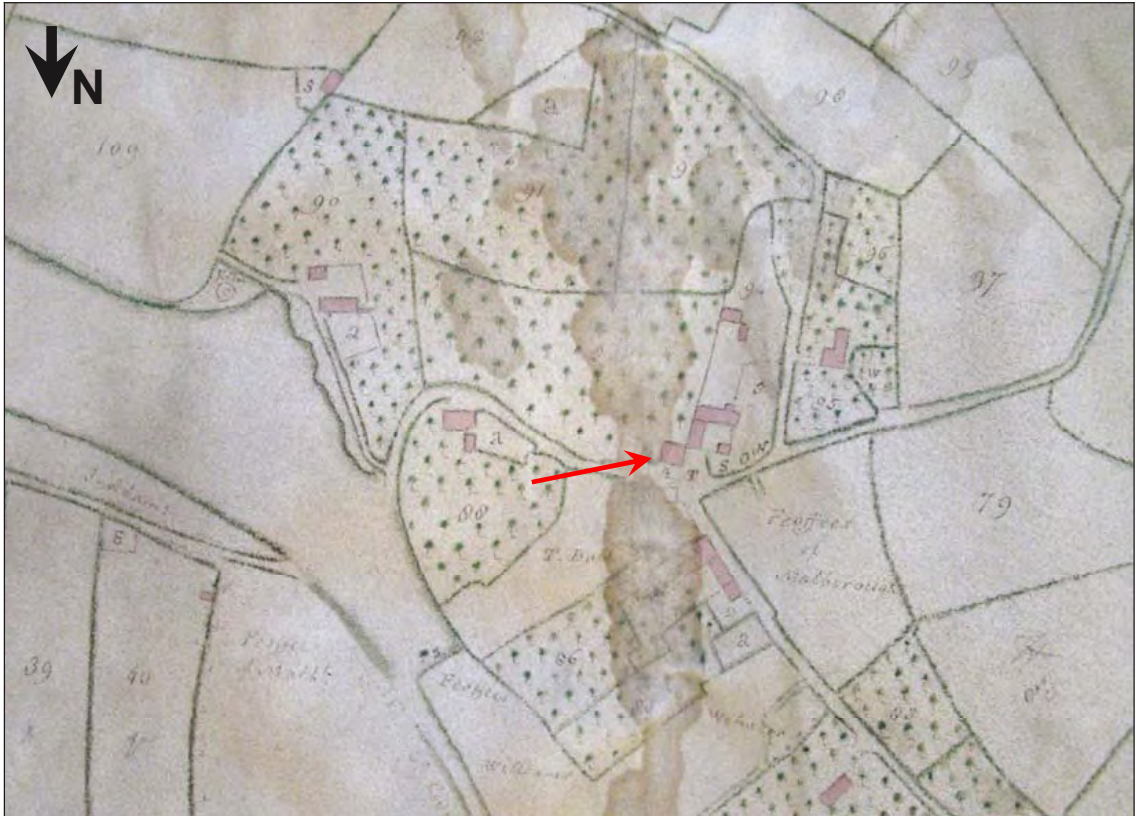
Figure 3: Extract from the 1821 estate map compiled on behalf of the Pollexfen-Bastard family. Note the extensive surrounding orchards. The cider barn is indicated (DRO).

The first detailed map of the area is a 1821 estate map of the lands of the Pollexfen-Bastard family in Marlborough and adjoining parishes (Figure 3). This clearly shows the cider barn and the adjoining house and buildings, in a pattern to be repeated in all succeeding cartographic sources. In the accompanying schedule, the surrounding fields and closes are all listed and named as orchards. Field number 89 (adjoining the cider barn to the east) is listed as the *Great Orchard*.

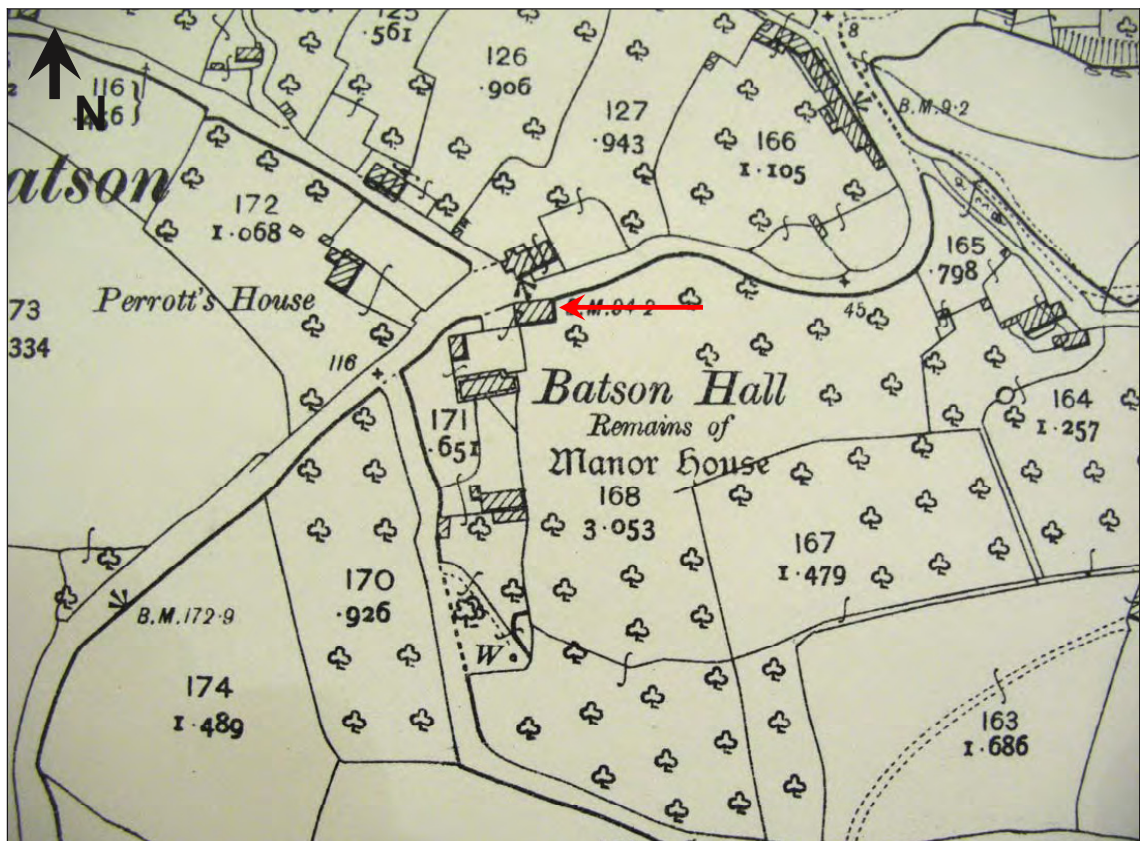
Figure 6: The Ordnance Survey 2nd edition 1:2500 scale map of Batson, published 1906. Devonshire sheet 136.11 (DRO).

By 1886 (Figure 5), there appears to have been some rationalisation of field boundaries (e.g. the hedge separating fields 227 and 231 on the tithe map has disappeared). In addition, one of the buildings at Batson Hall Farm – and the structure most likely to have been the ‘*Manor house*’ marked on the Ordnance Survey maps – has fallen out of use. The garden walls of Batson Hall Cottage contain a fireplace and several blocked openings, which clearly belonged to that structure. By 1906 (Figure 6), that building is no longer shown, but little further change is evident.

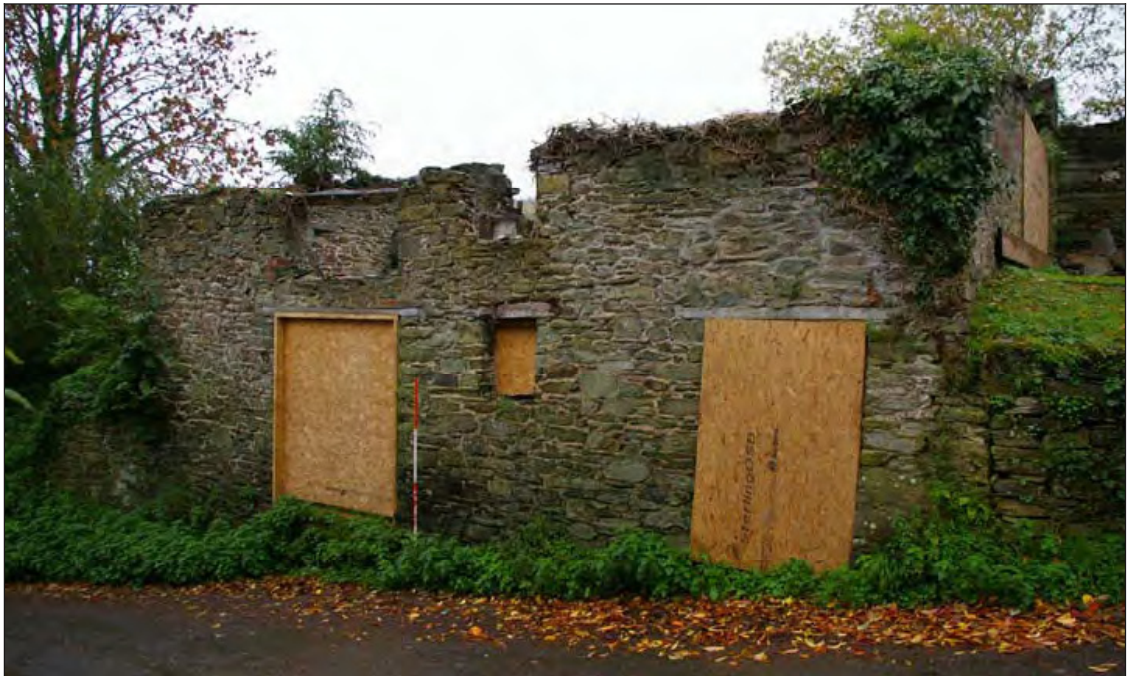
Figure 7: The northern external elevation of the cider barn, facing onto Shadycombe Lane. Viewed from the north-west (scale 2m).

A single-celled structure of two storeys set back into the southern side of the deeply-sunken Shadycombe Lane (Figure 7). The ground floor is accessed from the lane; the exterior ground surface is level with the first floor on the east, west and south sides. The structure is in a partly-ruinous state, having no roof and no surviving internal floors. The eastern end of the south wall has collapsed. The current structure had a mono-pitch roof, sloping from south to north, but was probably originally a hipped double-pitch roof. The photographic evidence suggests the mono-pitch roof was of corrugated asbestos sheets supported by 6×3” rafters with widely spaced purlins.

The north (front) wall contains five openings, with two doors and three windows (Figure 7). On the ground floor, the lintel of the door (D1) at the west end has failed and a thin concrete lintel substituted, with an area of rebuild above (in stone externally, in concrete block internally). The second door (D2), towards the eastern end, is a wider cart entrance, with two tall (*c.*2m) stone

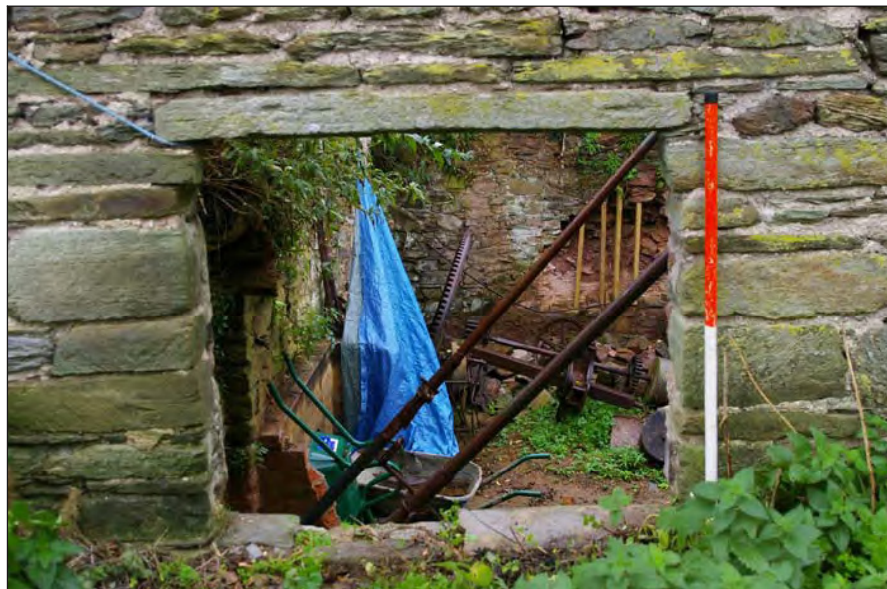
Figure 8: The window (W4) in the external east elevation, viewed from the east. Note the dressed stonework around the jambs and lintel (scale 1m).

The east (gable) wall contains a single opening, a splayed two-level window opening (W4), the upper part of which is level with the ground surface outside. This opening is crudely cut into the lower Phase 1 wall and integral to the Phase 2 wall above, with reused dressed stones forming the jambs and external lintel (Figure 8). The internal lintel is a reused oak timber with a central line of peg holes, probably from a hay rack. In addition, there is a small shallow asymmetric socket set in the middle of the interior face of this wall.

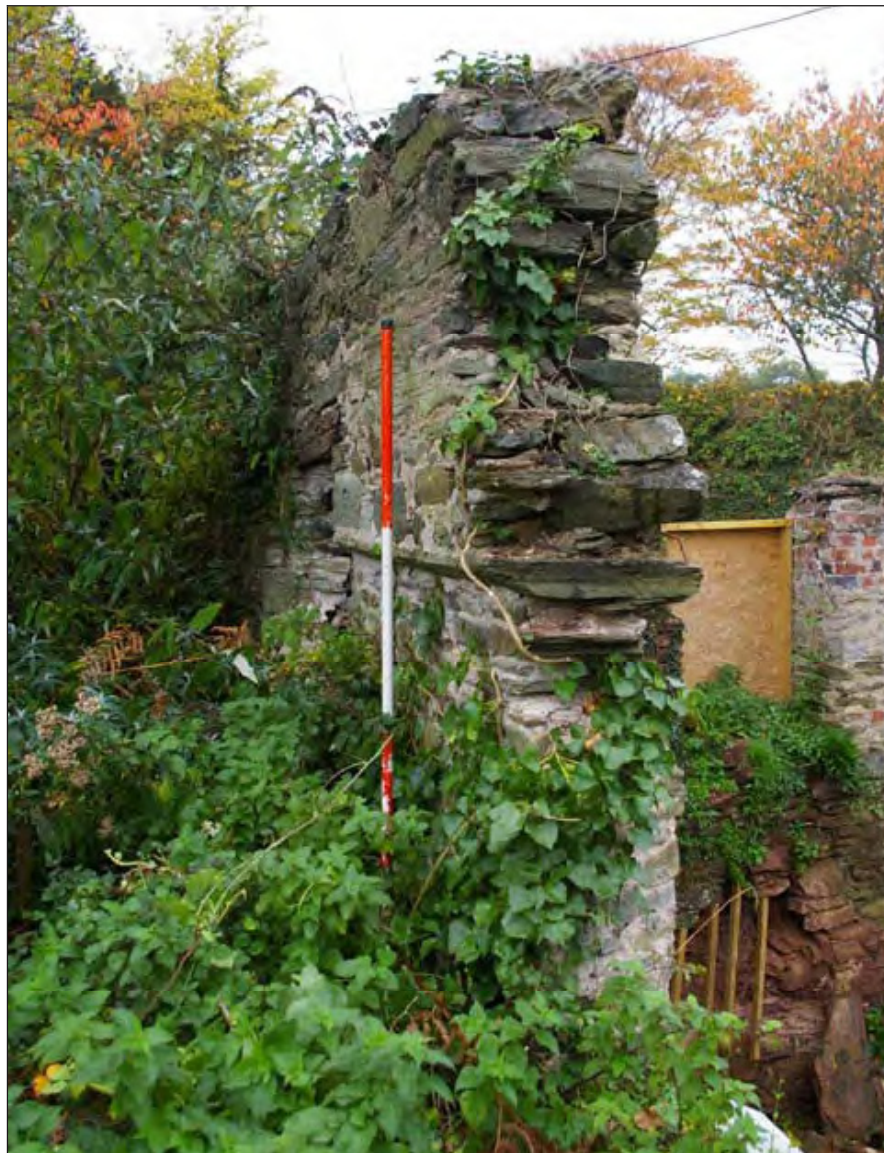
Figure 9: Surviving splay of window (W5) and projecting chamfered string course, viewed from the east (scale 2m).

The south wall is partly ruinous, a significant part of the eastern length of the first-floor wall having collapsed. The surviving length contains one side of a splayed window opening (W5)

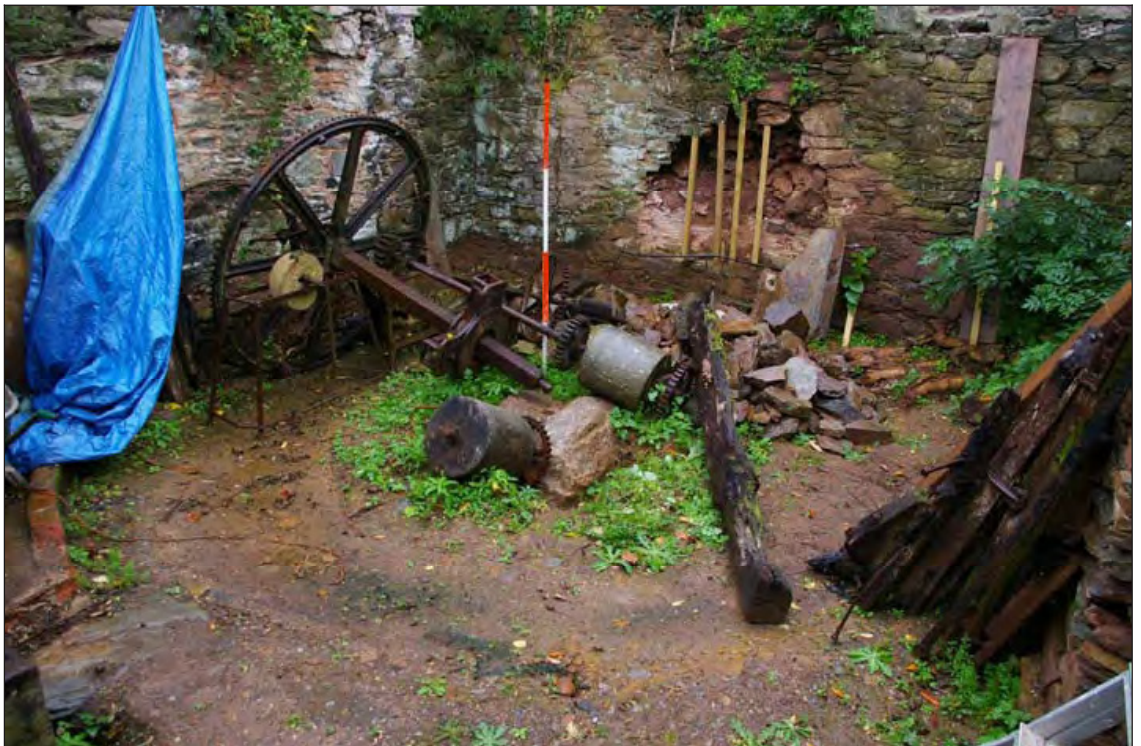
Figure 11: The western half of the interior, viewed from the north-east. The groove worn into the floor around the horse engine is clearly visible (scale 2m).

The horse engine sits in the middle of the ground floor, offset to the east and slightly to the south (Figure 11). The engine is encircled by a wide groove in the floor, created by the horse/pony as it turned the engine. Located in the eastern third of the building are the cider press, two brick-built and internally rendered tanks, and a raised area in the south-east corner (Figure 10). Tank 1 (T1) is 1.8×0.95m by 0.7m deep (internally), and is located immediately to the west of the press. At the northern end it has an integral brick-built mounting bay for a large cylindrical roller. Tank 2 (T2) is less regular: it measures 2.0×2.1m by 1.1m deep (internally), but has a curving western side to allow the horse/pony to pass as it turned the engine. In the south-west corner, and immediately to the west of T2, iron pintles are set into large flat stones.

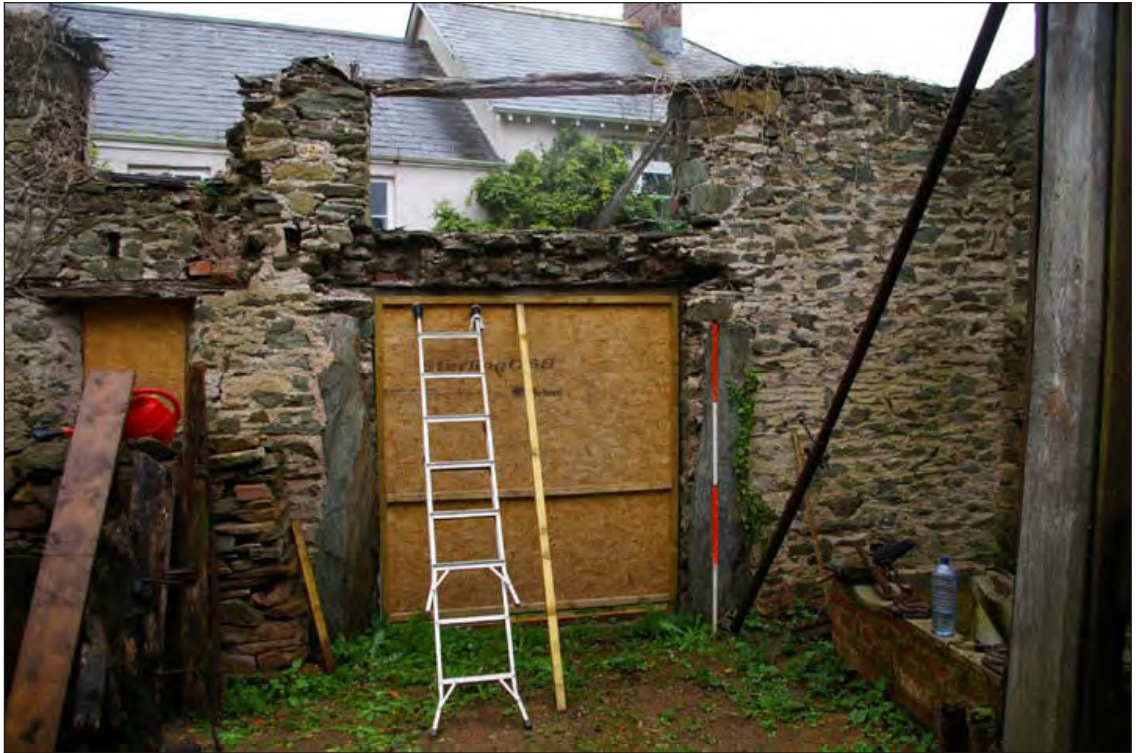
Figure 12: The internal elevation of the north wall, showing the two orthostats flanking the door (D2). Viewed from the south (scale 2m).

orthostats flanking the doorway on the interior, possibly to protect the corners of the entrance from damage (Figure 12, and see below). The lintel for this door has also failed and been replaced by a narrow concrete beam with an area of rebuild above. Between the two doorways, there is a small splayed window (W1) with a weathered oak lintel. On the first floor, there is a small splayed window (W2) directly above the one on the ground floor, and a wide window (W3) opening above the cart entrance, subsequently widened on the eastern side to match the width of the cart entrance.

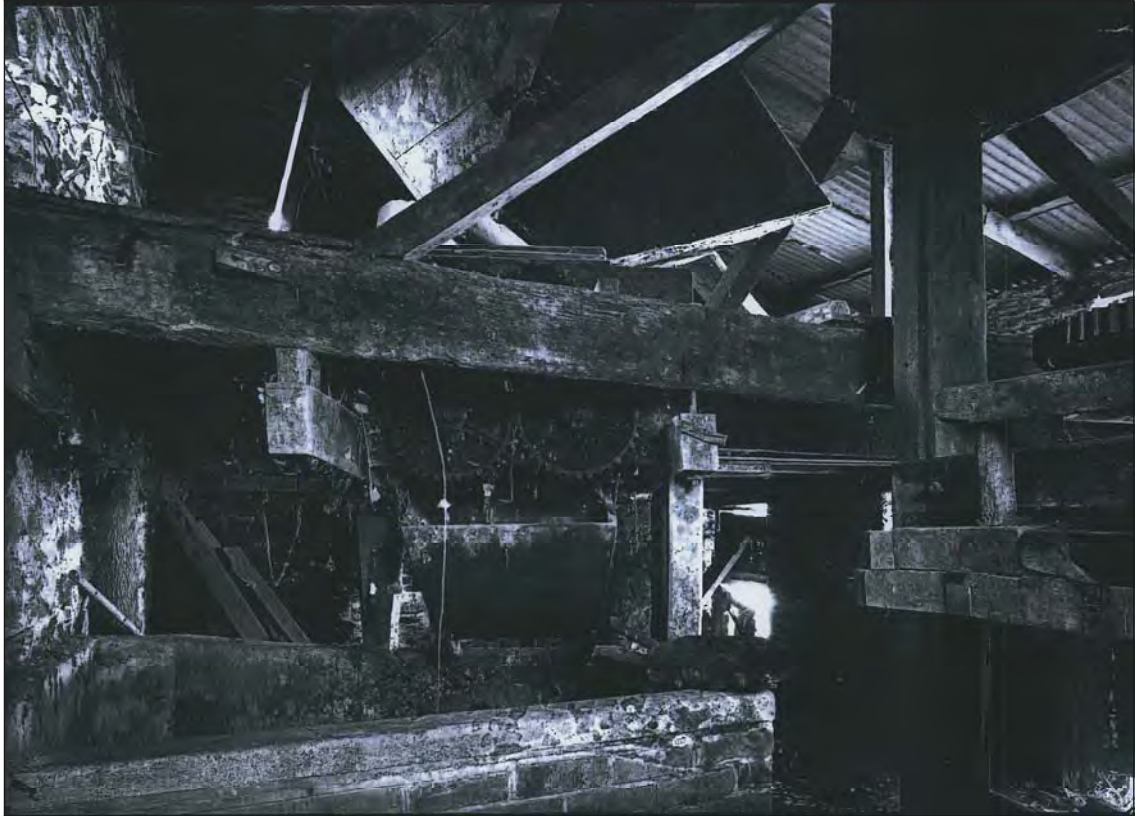
Figure 14: The Cider Barn. The apple roller-crusher, viewed from the east.

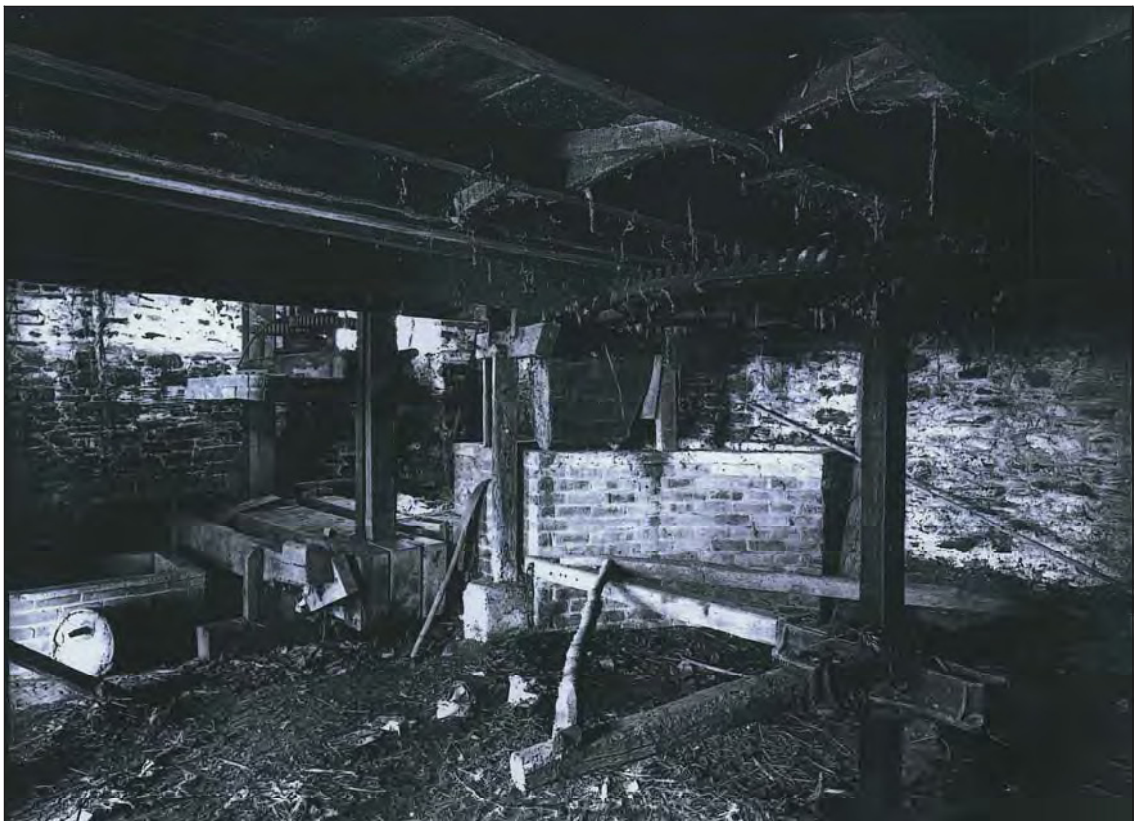
Figure 15: The Cider Barn. The horse engine, with the roller-crusher and cider press in the background, viewed from the north-west.

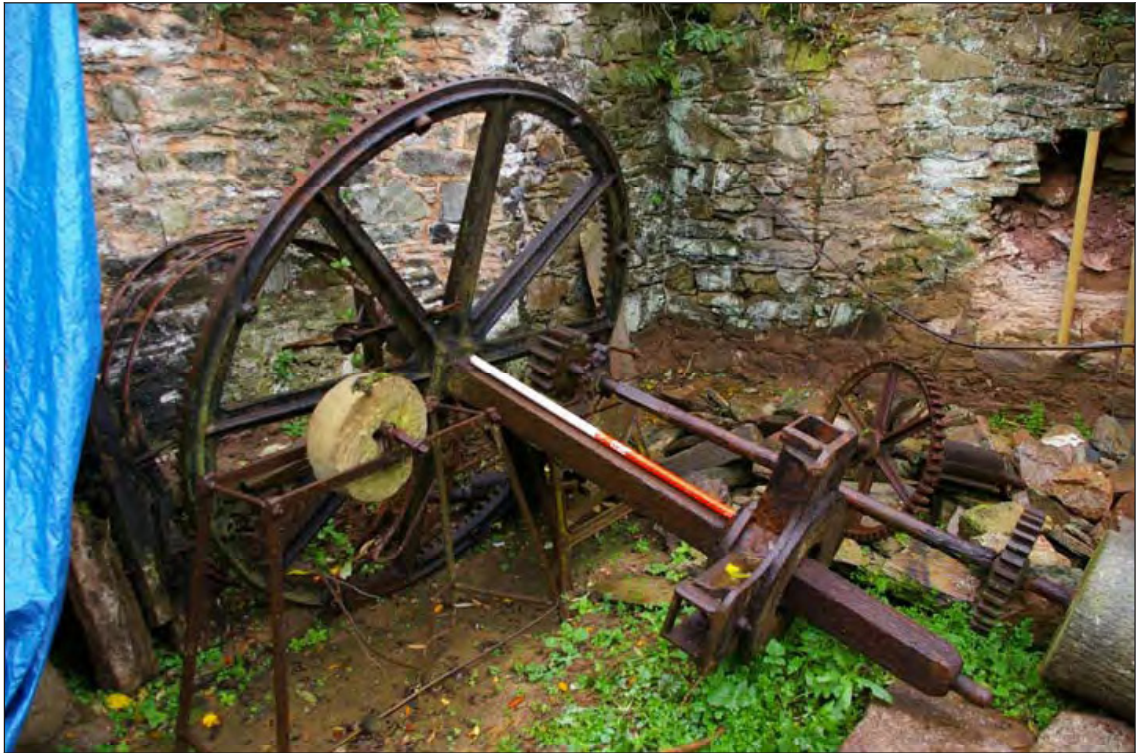
Figure 20: The horse engine (not *in situ*), viewed from the north-west (scale 1m).

The horse engine is based on a single heavy cast iron rectangular post, the lower end tapering sharply to an iron pin, originally set in a shallow hole in a large granite block buried in the floor. This block is clearly reused, and appears to be the base and foundation of a circular pillar c.1.0m in diameter. The upper part of the post is held in a cast iron bearing housing, originally bolted to one of the joists.

The spur gear is cast as one piece and held in place with iron wedges. It is 1.82m in diameter and has 8 radiating spokes. 0.5m up from the base of the shaft is a cast iron tiller housing with four large sockets for timber tillers. In the historic photographs, only one tiller is shown, and

this is braced to timbers in the two adjoining sockets by cross-braces. The tiller projected beyond the diameter of the ring gear.

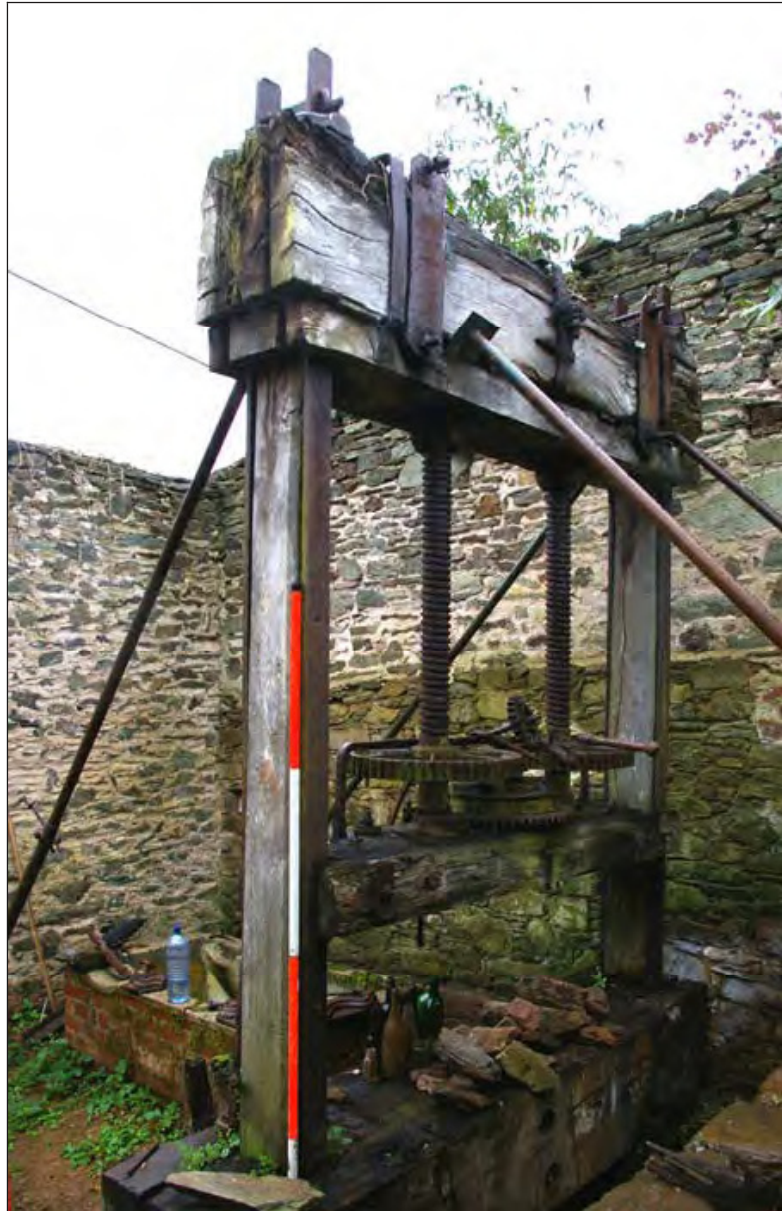
Figure 21: The cider press, viewed from the south-west (scale 2m).

The bottom beam is supported on two transverse sleeper beams that rest on four concrete pads. These have rotted, allowing the press to sink into the cavity beneath; a rusty mechanical iron jack has been wedged into the cavity on the south-east side. The sleeper beams originally supported the press deck via four short posts that carried two axial joists notched into the tops of these posts. The press deck would have been square, but is missing even in the historic

The top beam is of two parts. The lower member is square-cut and only 0.14m thick, and is strapped by four bolted iron plates to a larger, upper member 0.36m thick. This upper beam is strengthened by the addition of three narrow iron straps, and the gaps between the upper and lower member filled with thin wooden wedges. This upper beam appears much older, and may have come from an earlier press.

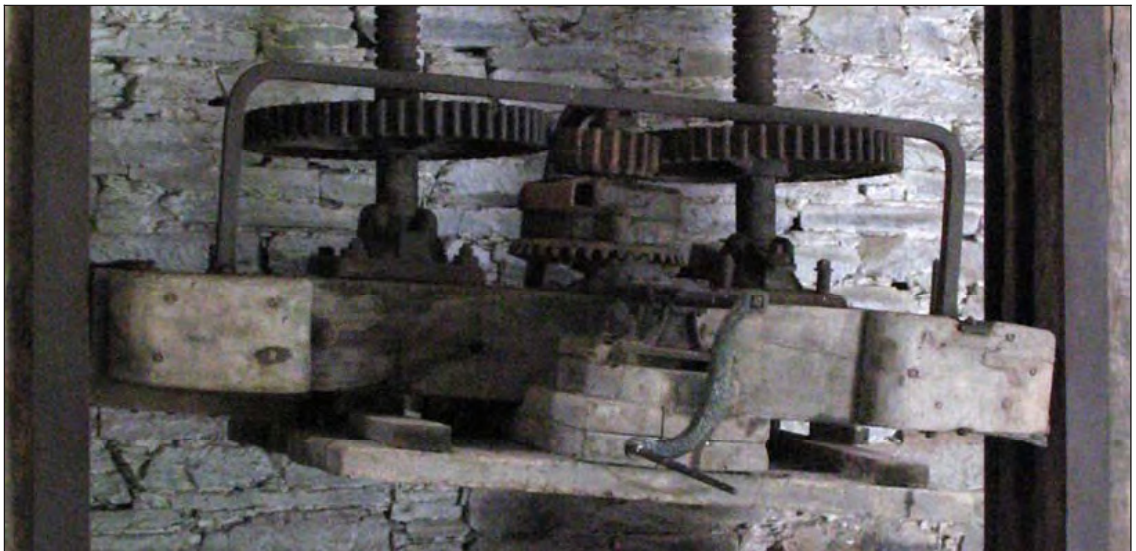
Figure 22: An example of a similar cider press mechanism (crown wheel and pinion) from a press at Buckland Abbey (photo: B. Morris).
