BUILDINGS TO THE REAR OF THE LONDON INN OKEHAMPTON

Results of a Desk-Based Assessment
&
Historic Building Recording

Report No.: 290711
Date: 20/06/11
Author: D. Laing-
Tregrove

Location: Buildings to the rear of the London Inn, 22 West Street
Parish: Okehampton
District: West Devon
County: Devon

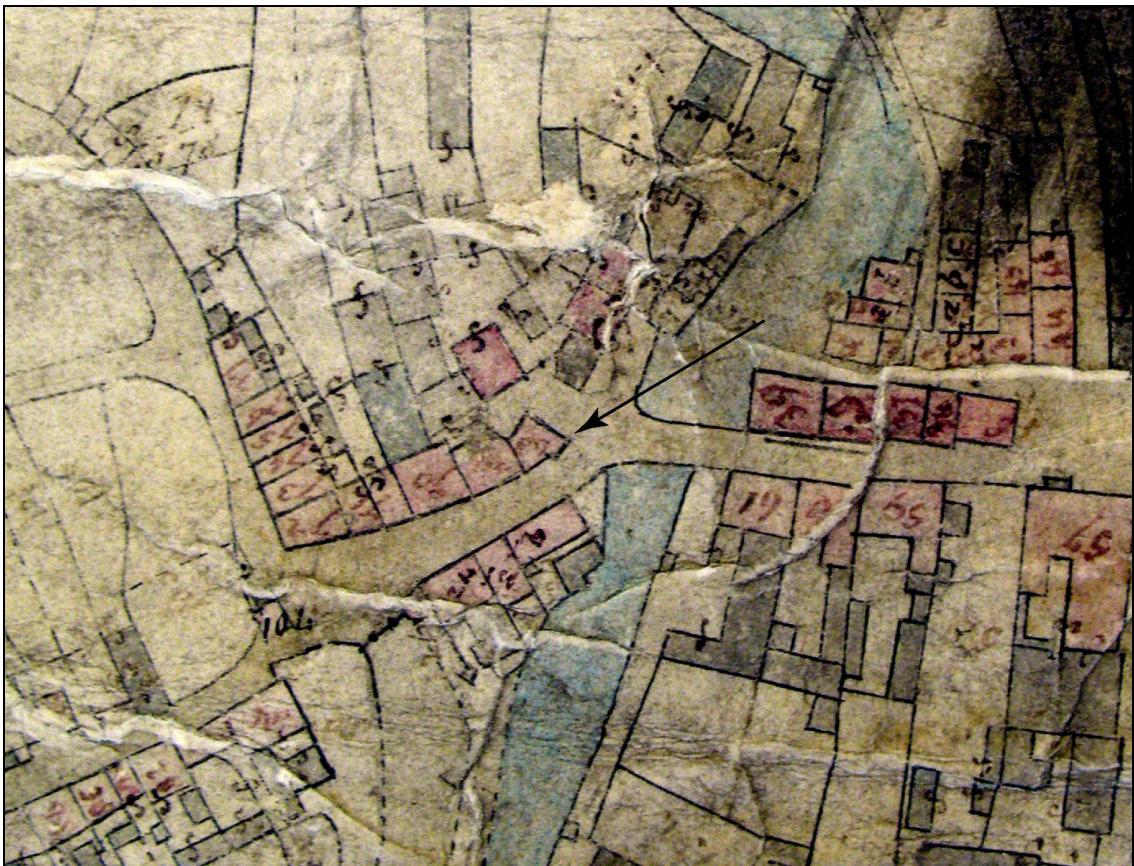
The Okehampton tithe map (Figure 3) although in rather a poor state of repair appears to show an irregular shaped domestic (coloured pink) building fronting onto West Street (numbered 68) roughly in the current position of the London Inn. The apportionment states that number 68 is a house owned by the ‘Mayor & Burgesses’ and was rented by William Aggitt, and that number 69 (the adjacent pink building to the west) was the London Inn, owned and lived in by William Bond.

The unclear numbering system means that it is difficult to say for certain whether the domestic building across a yard to the north-west is at this time part of the same property. However, what is clear is that this building is ligatured to the various non-domestic (coloured grey) buildings situated to either side of the plot to the rear (north) showing them to be all parts of a single holding, and it would appear that the building identified in the apportionment as the London Inn is also ligatured to this group of buildings. The outbuildings to the east appear to be quite large and they extend into the plot to the west, straddling the boundary visible on the map to the north, defining a former medieval burgage plot and forming the rear wall line of the northernmost building on this side of the yard.

Figure 3: Extract from the Okehampton Tithe map, 1841 (DRO). The site London Inn is arrowed.

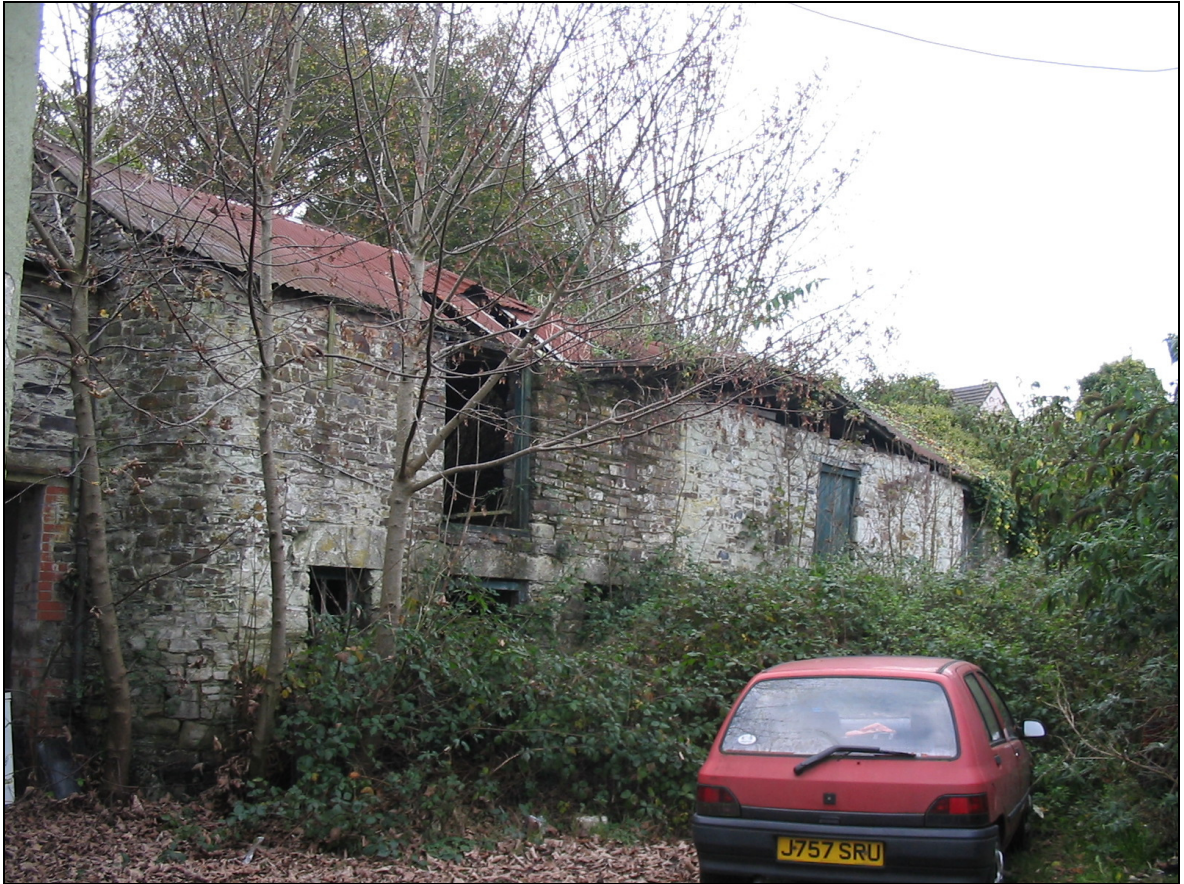
Figure 6: The buildings formerly in the centre of the range (B3 & B4), prior to collapse, viewed from the south-east. (Courtesy of Bill Walton)

From the evidence of earlier photographs (see Figures 6 & 7) Buildings B3, B4 and B5 appear to be two storied and of a continuous build, possibly with a shared first floor loft and with a number of openings on the ground floor and a loading door apparently central in the first floor of each under a corrugated sheet metal roof.

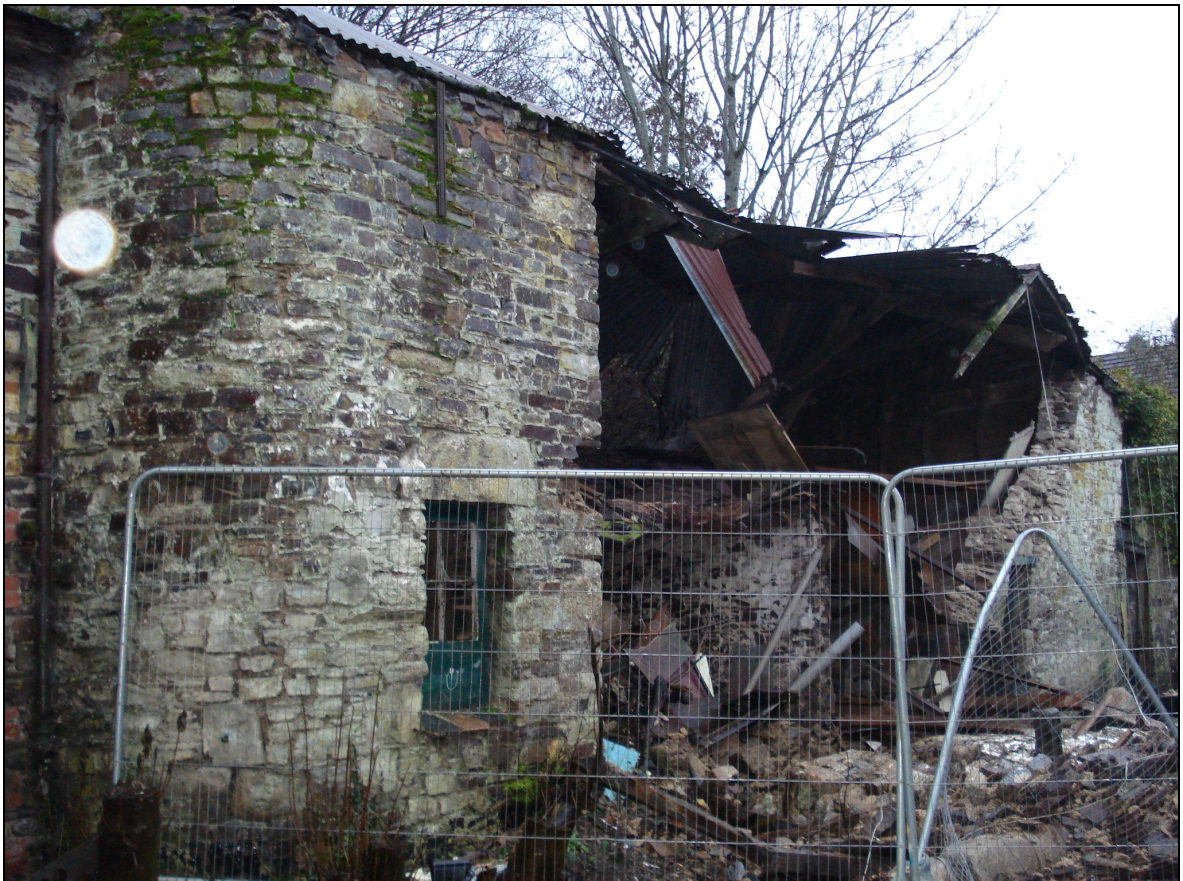
Figure 7: The buildings formerly in the centre of the range (B3 & B4), partially collapsed, viewed from the south-east. (Courtesy Bill Walton)

The eastern exterior corner of the building is rounded, allowing horse and cart access around the building (see Figures 6 & 7). This perhaps suggests that this wall may be a fragment of an earlier building, extant prior to the construction of the stable (B2) when cart access was required rather than access primarily for horses to the northern stable entrance. This section of wall is constructed of fairly regular sized stone, which is fairly well coursed, elsewhere the remaining walls are constructed of more random size and shape stone, including some larger, rounded former river stone, and are semi coursed. At ground floor level in the remaining north-east elevation is a single window opening with a granite lintel and wooden frame, boarded below and with 2x2 panes above and with a terracotta tile and slate sill. From photographs of the building before collapse there were three regularly spaced openings at ground floor level on this elevation of the building; a central door flanked by windows, each with granite lintels (see Figure 6). The remaining section of wall terminates at the eastern jamb of the formerly central door opening which formerly had a loading door above. The dividing wall between B3 and B4 is of the same construction as elsewhere and it abuts the rear wall which has a line of former joist holes at first floor level. The walls were all formerly whitewashed inside and out and the floor cobbled. Small sections of the floor survive in the corners and alongside the remaining walls of the building, where the stones used are square and blocky rather than worn river stone. Where the floors have been removed a layer of silty river sand survives, former bedding for the cobbled floor.

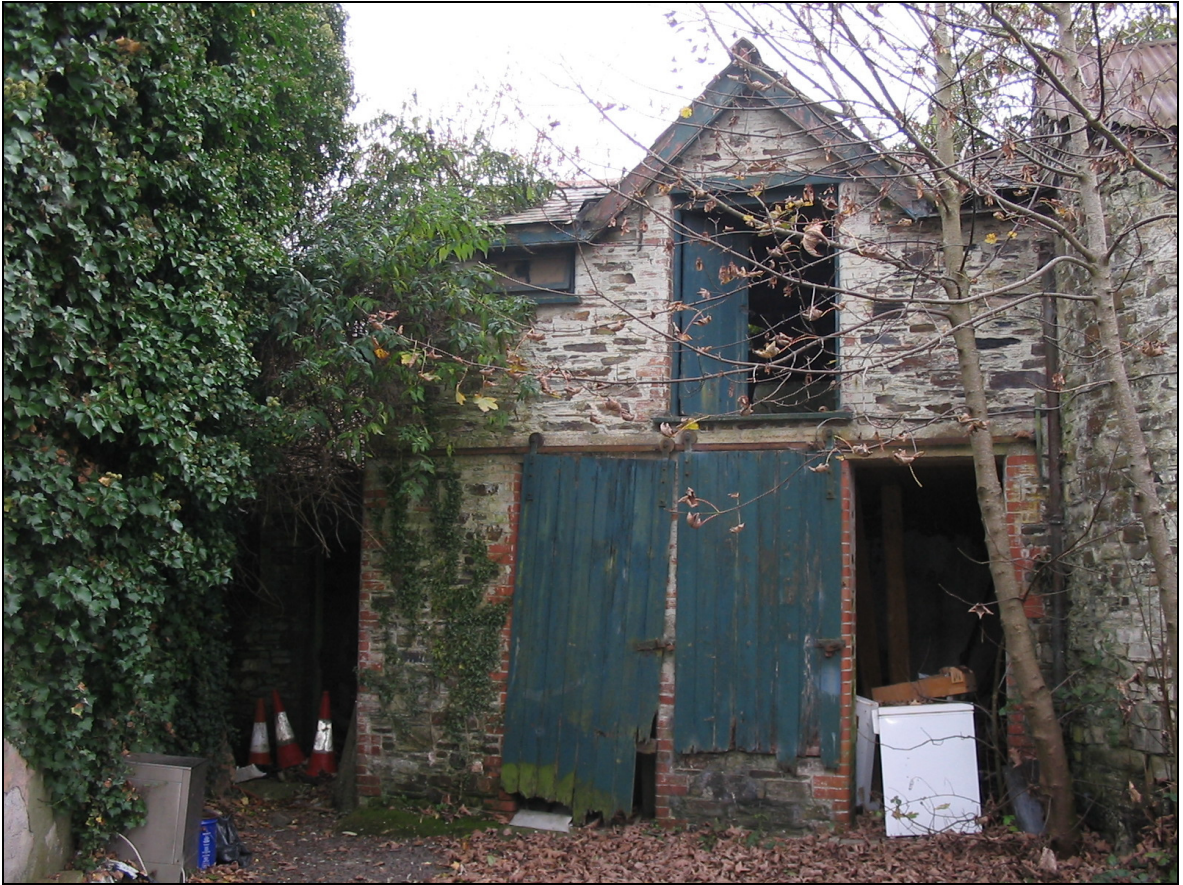
The most complete of the buildings on site (Figure 8). A one and half storey building with uncoursed rubble stone elevations, formerly whitewashed, with brick to the window and door openings, with a pitched slate roof with terracotta ridge tiles, beaded wooden barge boards to north-east and south-east and a dormer just to the north-west of centre in the north-east (front) pitch. Any guttering has now gone but there is a cast iron downpipe at the north end of the north-east wall and a partial section hanging diagonally from the eastern corner on the south-east elevation.

Figure 8: The Former stable at the south-east of the range (B2), viewed from the east. (Courtesy Bill Walton)

The first floor tallet and feed store floor has failed to the rear (south-west) and was not accessed for safety reasons, but it was viewed through the exterior loading door from a ladder. The timber roof structure is comprised of two heavy purlins to each pitch with a central ridge pole, all set into the gable end walls to the north-west and south-east, with the slight rafters set into the purlins with the battens nailed to the backs of the rafters. The gabled dormer roof timbers are notched into and supported on the central ridgepole. The walls are plastered and the floor is planked with thick boards. There were a number of old-fashioned hessian grain or oat sacks in this upper floor which suggests that this was used primarily as a feed store for the horses below.

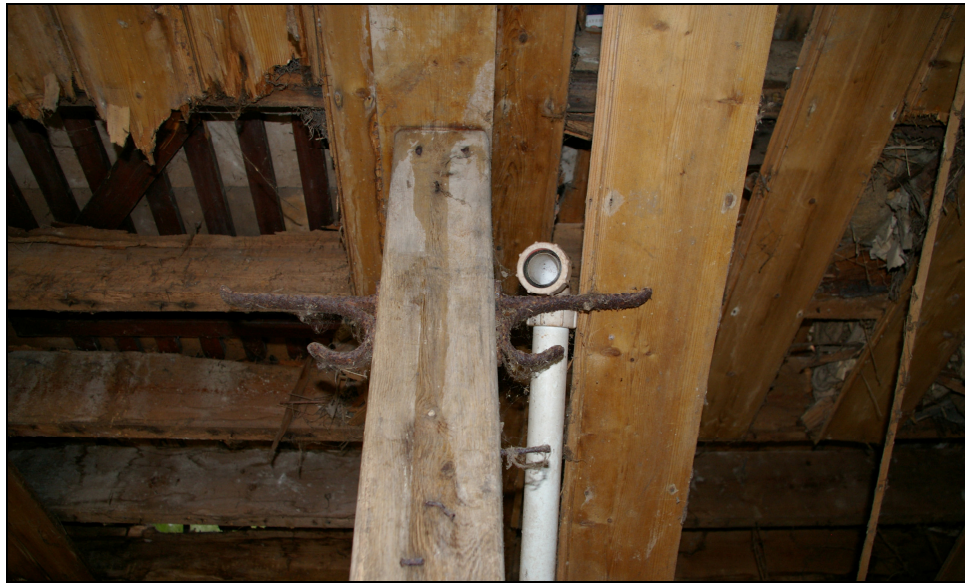
The interior of B2 is divided into two compartments by a framed wooden plank partition, open to the upper portion with inset iron bars and forming two horse stalls. There would have been a brick-built corner trough to the inner corners of both stalls (missing from the northernmost compartment) and an iron ring tether to each stall on the rear (south-west) wall. There are large hooks to the planked partition to the front, presumably for hanging tack or harness on (Figure 9). A wooden chute or trunking appears attached to the front wall in the eastern corner adjacent to a window and seems to be associated with the tallet above, probably formerly supplying grain or oats to a trough

Figure 9: The hooks to the front of the dividing partition within B2.

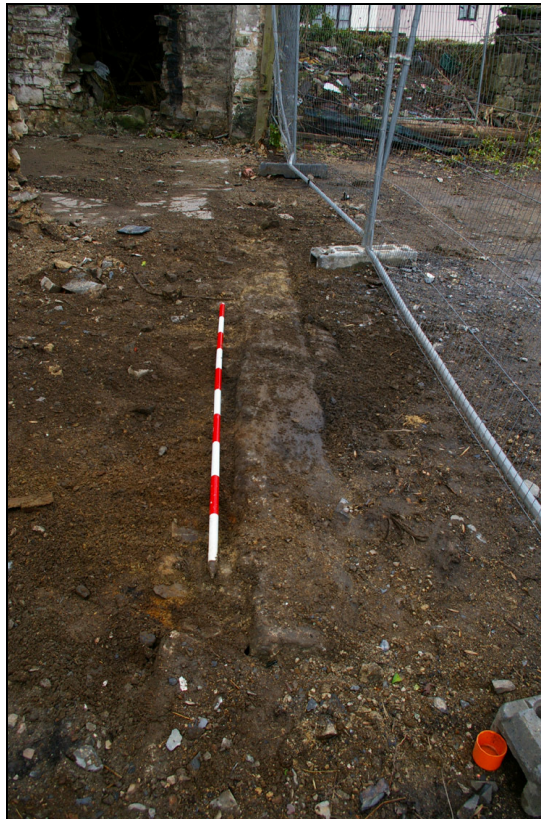
Unfortunately very little of B4 now remains (see Figure 11), the rear south-west wall and small sections of the south-east and north-west walls, none of which reach first floor height and all of which are of the same construction as B3. The rear wall is leaning to the north-east, but the positioning of the abutting wall to the north-west suggests that this was happening before this dividing wall was set against it. The floor was formerly cobbled as B3 but there is also a line of large, flattish, possibly granite, stones set in the ground in the line of the former front north-east wall (Figure 10).

Figure 10: The footings of the former north-east wall of B4, viewed from the south-west (2m scale).

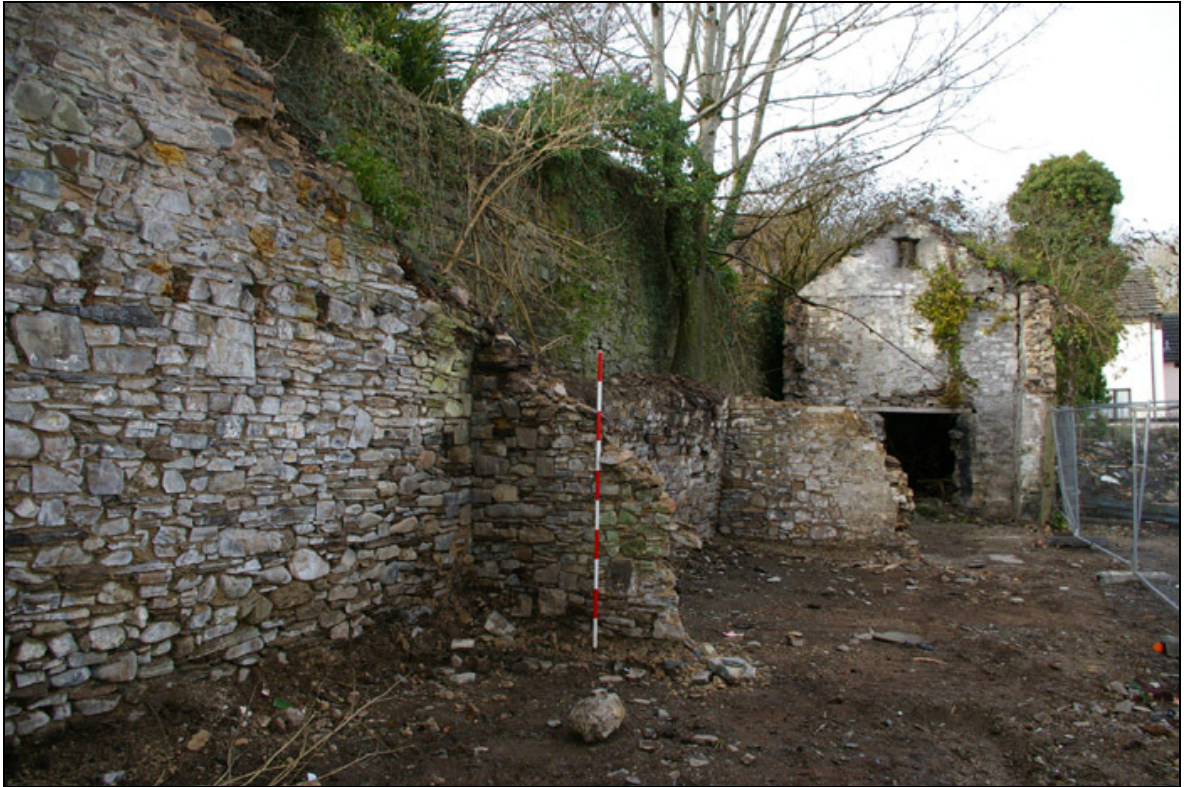
The leaning continuous (south-west) rear wall within B5 has almost entirely collapsed but at the base where it does survive the stones are very large and blocky. The gable wall to the south-east survives and the ragged remains of the west end of the south-west wall project from it and are clearly part of the same build, with large blocky quoins. The wall has a small unglazed window high up in the gable, with splayed reveals and possibly a stone lintel, possibly an owl hole suggestive of fodder storage, and there is a large forced opening with an inserted wooden lintel at ground floor level roughly central in the elevation. To the north the north-east wall appears partially tied into the gable on the interior but on the exterior this wall projects from the face of the northern, quoined end of the gable and appears to be a later rebuild. This wall terminates approximately 1.0m to the east at a former door jamb that has large blocky quoins at the base. This northern part of the building has been more heavily whitewashed than the other remaining standing walls. The floor is modern cement.

This building has partially collapsed and the surviving walls are difficult to access. The north-east and south-west walls of this building abut the surviving mixed rubble stone north-west gable of B5. Although also of mixed rubble stone the build of these two walls is dissimilar to the gable in that they are uncoursed, the gable is coursed and has large quoins to the east and south ends. There is a small opening with modern brick quoins in the north-east wall and to the north-west are a pair of large double doors filling the entire elevation. The roof has now collapsed but was formerly pitched with slate and terracotta ridge tiles, now the central bolted A-frame truss has inverted and now hangs down into the building. A ridge tile lying within the building is stamped 'COLTHURST AND SYMONS BRIDGEWATER'.

Figure 11: The remaining masonry of the rear (south-west) walls & dividing walls of B3, B4 & B5, with the north-west gable of B6 viewed from the east (2m scale).
