# TRESKILLING FARM CLAY DRY LUXULYAN CORNWALL

Results of a Photographic Survey

Report No.: 110322  
Date: 22.03.11  
Authors: L. Bray

**SWARCH project reference:** LCD10  
**National Grid Reference:** SX0460058200  
**Cornwall County Council Planning Reference:** PA10/04824  
**OASIS reference:** southwes1-96961  
**Project Director:** Colin Humphreys  
**Desk-Based Assessment:** Lee Bray  
**Fieldwork:** Lee Bray  
**Report:** Lee Bray  
**Report Editing:** Samuel Walls, Deb Laing-Trengove  
**Graphics:** Lee Bray

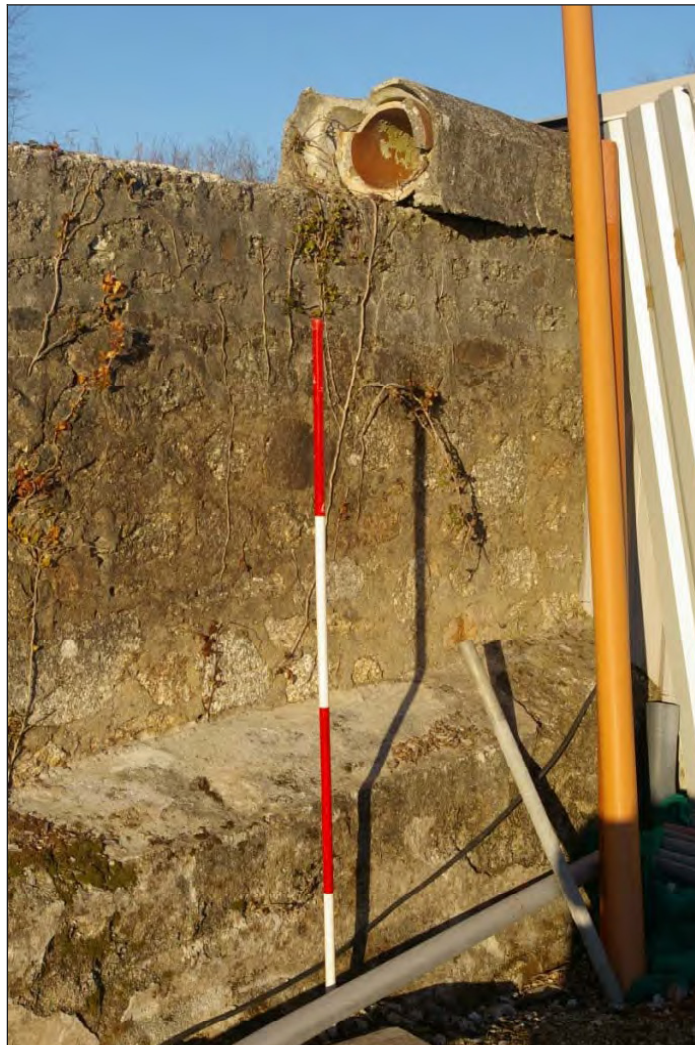
The pipe which fed the clay slurry into the tanks was still visible running along the wall between tanks 6 and 7, although the change in the style of wall construction from semi-coursed to more regular coursed work, suggested the pipe had been added after the initial building of the settling tank, but before the phase 2 extension (Figure 3 and see below). Each tank had at least one exit, two in the case of tanks 5 and 6, on the south-western side which were well preserved. They consisted of a gap (Figure 4), 1.2m wide on either side of which was a 0.1m wide vertical slot which would have held horizontal planking (2.2) when the tank was in use. Running along the exterior of the southern side of the row of settling tanks, across each entrance, was a 0.6m wide dwarf wall standing *c.*0.3m above the probable level of the drying pan floor (see below). This wall carried a deep, 0.2m wide channel (Figure 5) intended to carry waste water from the settling tanks as it was released. From here the water was fed into culverts running under the rest of the building (see below) and into a leat which still survives (Figure 6) to the south-west.

Figure 3: Clay slurry pipe on the wall between settling tanks 6 and 7 (see Fig. 2), viewed from the south-east (Scale: 2m).

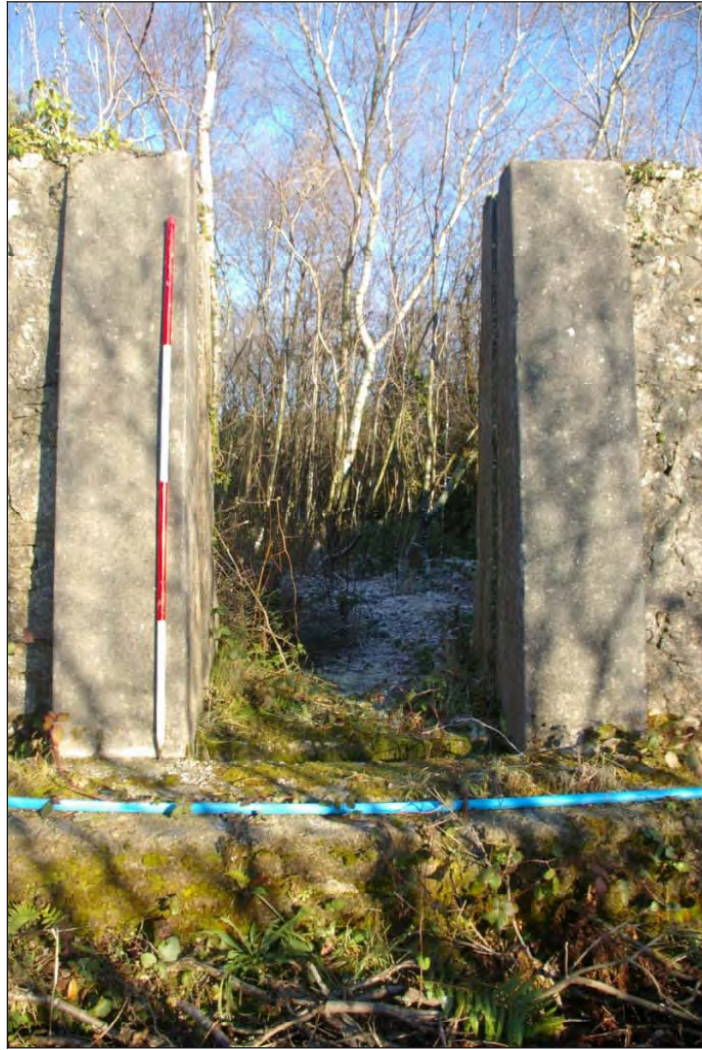
Figure 4: Entrance to settling tank 3 (see Fig. 2), viewed from the south-west (Scale: 2m).

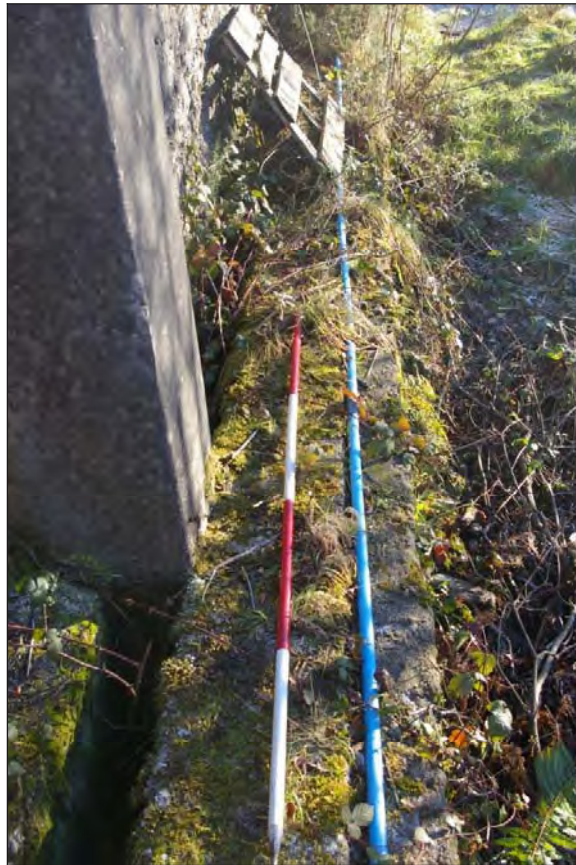
Figure 5: Dwarf wall in front of the entrance to settling tank 3 (see Fig. 2) carrying the waste water channel, viewed from the north-west (Scale: 2m).

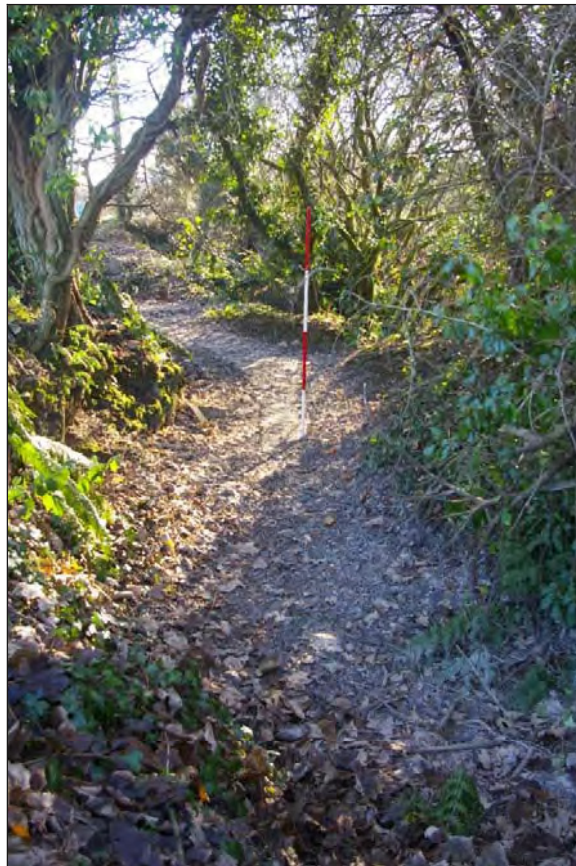
Figure 6: Leat for waste water, viewed from the north-west (Scale: 2m).

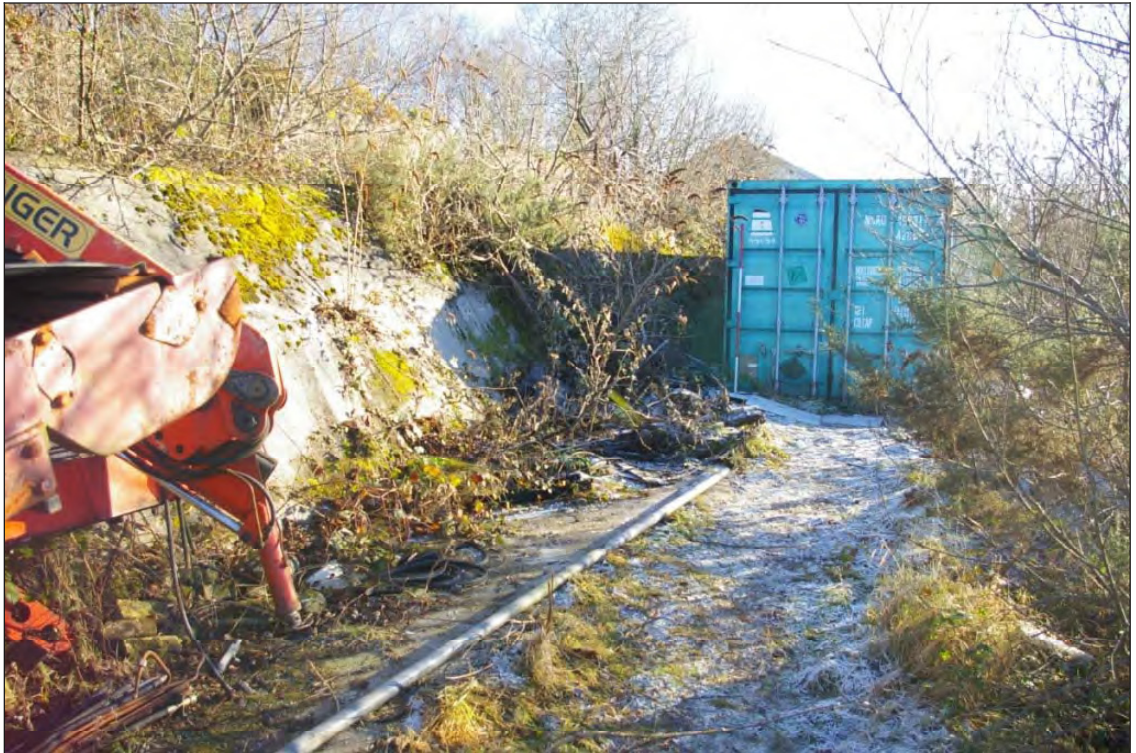
The contemporary linhay was situated adjacent to the drying pan to the south-west and running parallel to it, though much of it was inaccessible at the time of the survey due to the presence of several cargo containers and scrap heavy machinery. The wall dividing the linhay from the drying pan was 0.6m wide at the top but with a pronounced batter that doubled its thickness at the level (Figure 7) of the linhay floor which was *c.*1.75m lower than that of the drying pan. The floor of the linhay was *c.*0.8m higher than the modern ground level to the south-west and was bounded on this side by a wall of concrete blocks (Figure 8).

Figure 7: Phase 1 linhay, viewed from the north-west (Scale 2m).

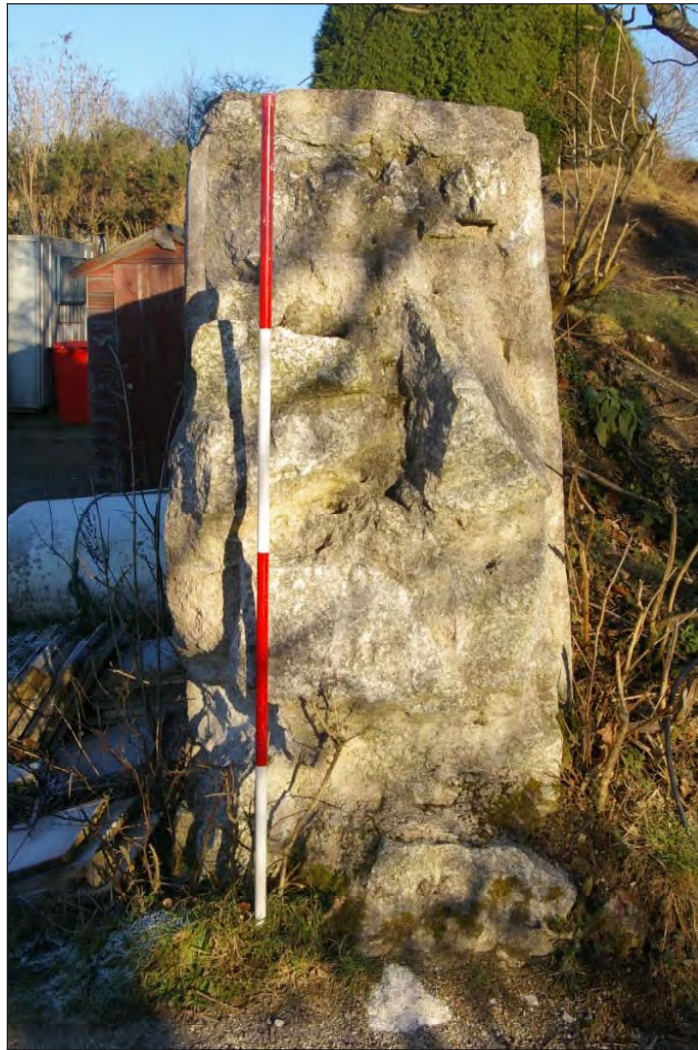
Two new settling tanks (Figure 2, tanks 7-8) were added to the south-eastern end of the Phase 1 row, each 14m wide, 30m long and *c.*2.0m deep, and each with two exits. Subsequent alteration has removed or obscured the channel for the removal of waste water.

Figure 9: Section through the south-eastern wall of settling tank 8 (see Figure 2) showing the shuttered concrete and granite rubble construction (Scale 2m).

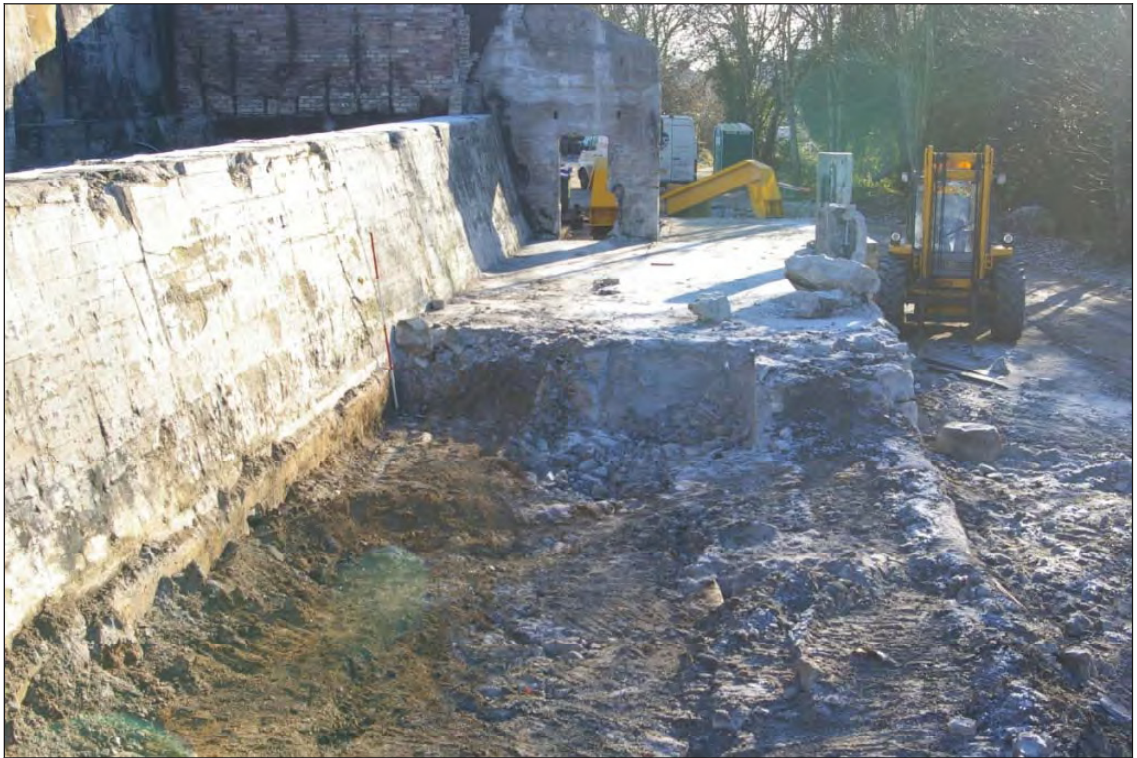
At the time of the survey, part of the Phase 2 linhay had been removed during reconstruction work so that only the south-eastern end survived (Figures 10 and 11). However, this was sufficient to show the new linhay had been 5.7m wide, slightly wider than that of Phase 1, and its roof had been supported by a row of pillars along its south-western side constructed of 'home-made' reinforced concrete in which the pillar had been formed around old railway rails (Figure 12). A loading bay was present at the south-eastern end, adjacent to the furnace house. Demolition work has revealed the structure of the linhay, the floor of which was constructed on three compartments running parallel to its long axis (Figure 10). Each of these had been filled using a different material; that to the north-east containing soil, that in the centre containing sand, while that to the south-west contained a mixture of soil, sand and cinder, presumably derived from the furnace. Removal of the north-western part of the Phase 2 linhay had also revealed culverts running beneath it which carried waste water from the settling tanks (Figure 13). During the final stage of Phase 2, clay drying methods changed and clay slurry was then transported in railway tankers. To enable this a pipe was laid under the floor of the new linhay which was uncovered during demolition (Figure 14). The way in which this arrangement worked is unknown as no evidence was apparent to explain how slurry was fed into it or where it went after leaving the Dry.

Figure 10: Phase 2 linhay, viewed from the north west, the three compartment construction is clearly visible (Scale: 2m).

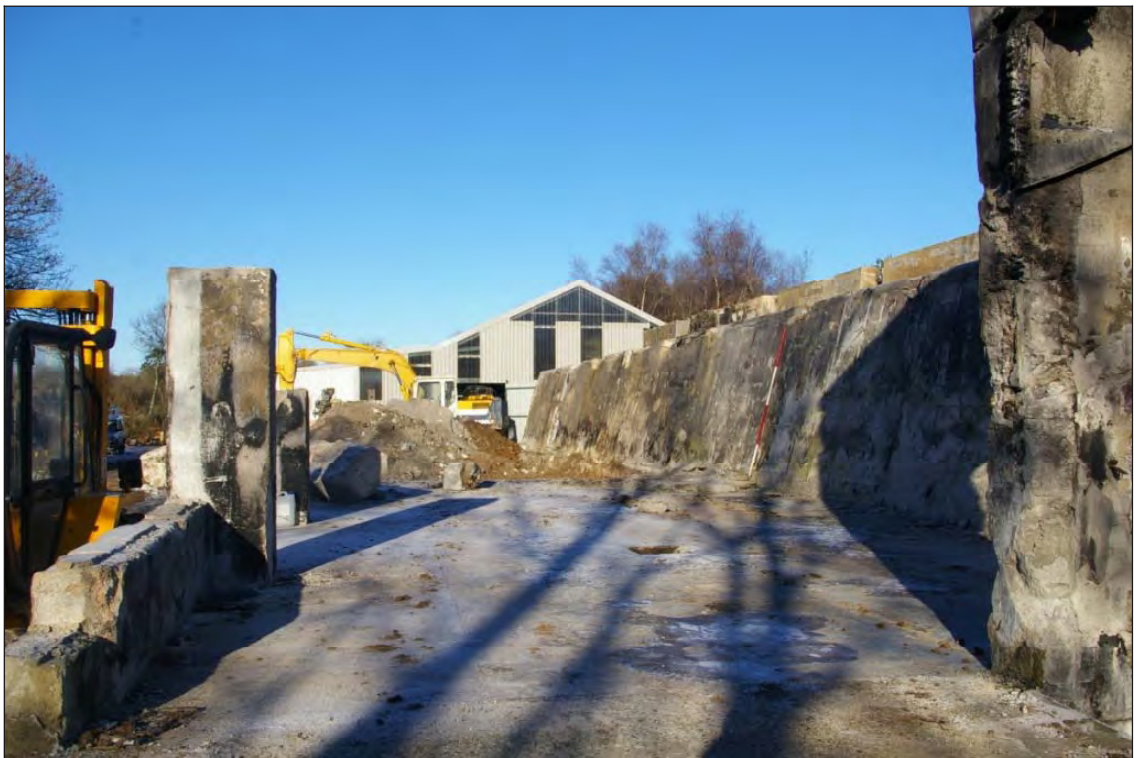
Figure 11: Phase 2 linhay, viewed from the south-east (Scale: 2m).

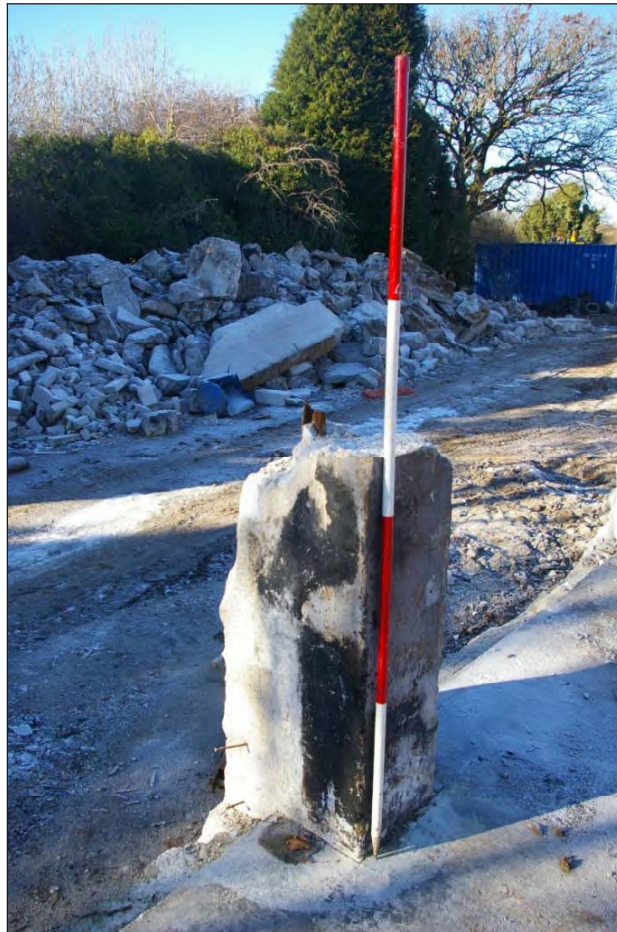
Figure 12: Concrete pillar on the south-western side of Phase 2 linhay, viewed from the south-east (Scale: 2m).

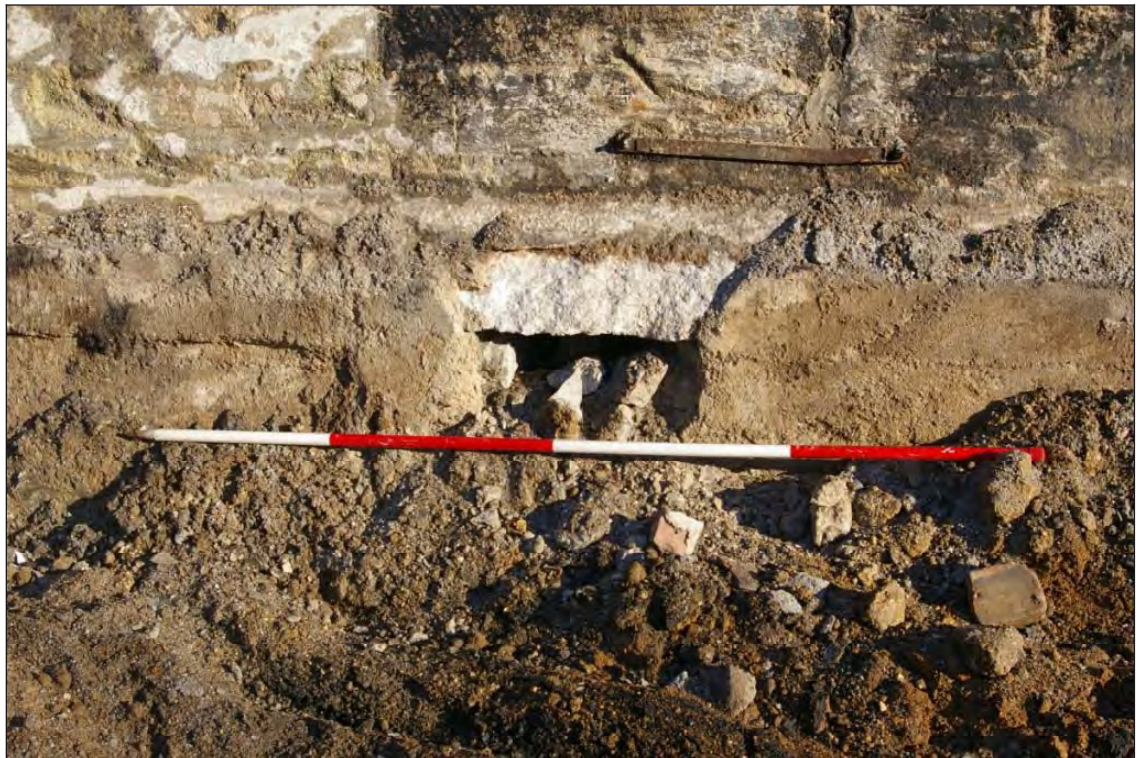
Figure 13: Culvert for carrying the waste water from the settling tanks under the linhay and drying pan, viewed from the south-west (Scale: 2m).

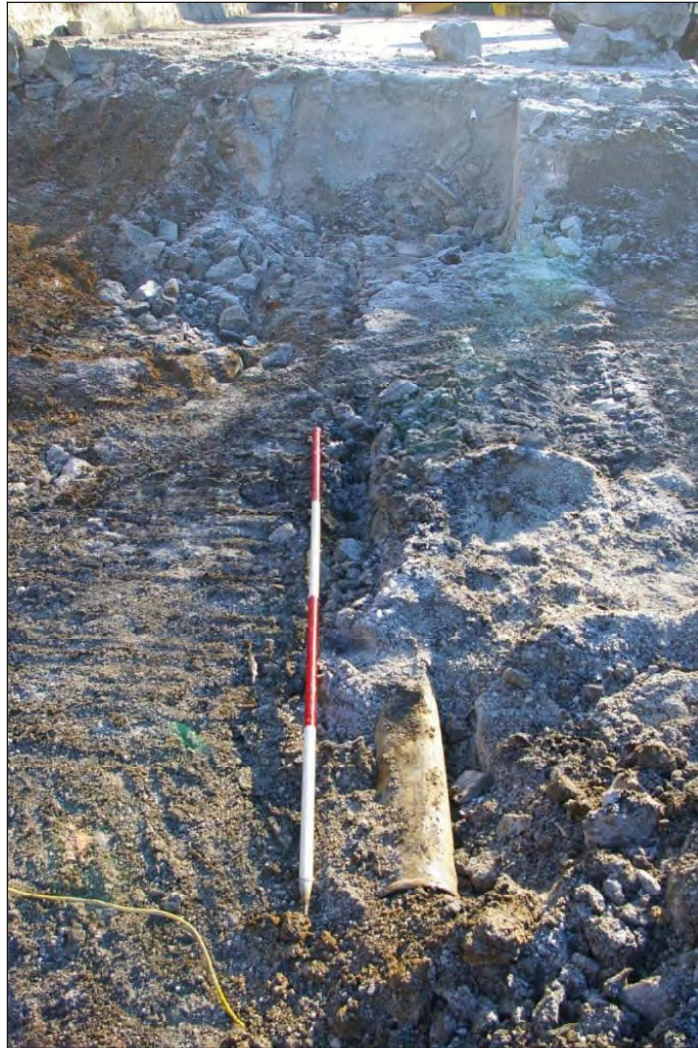
Figure 14: Clay slurry pipe under the Phase 2 linhay, viewed from the north-west (Scale: 2m).

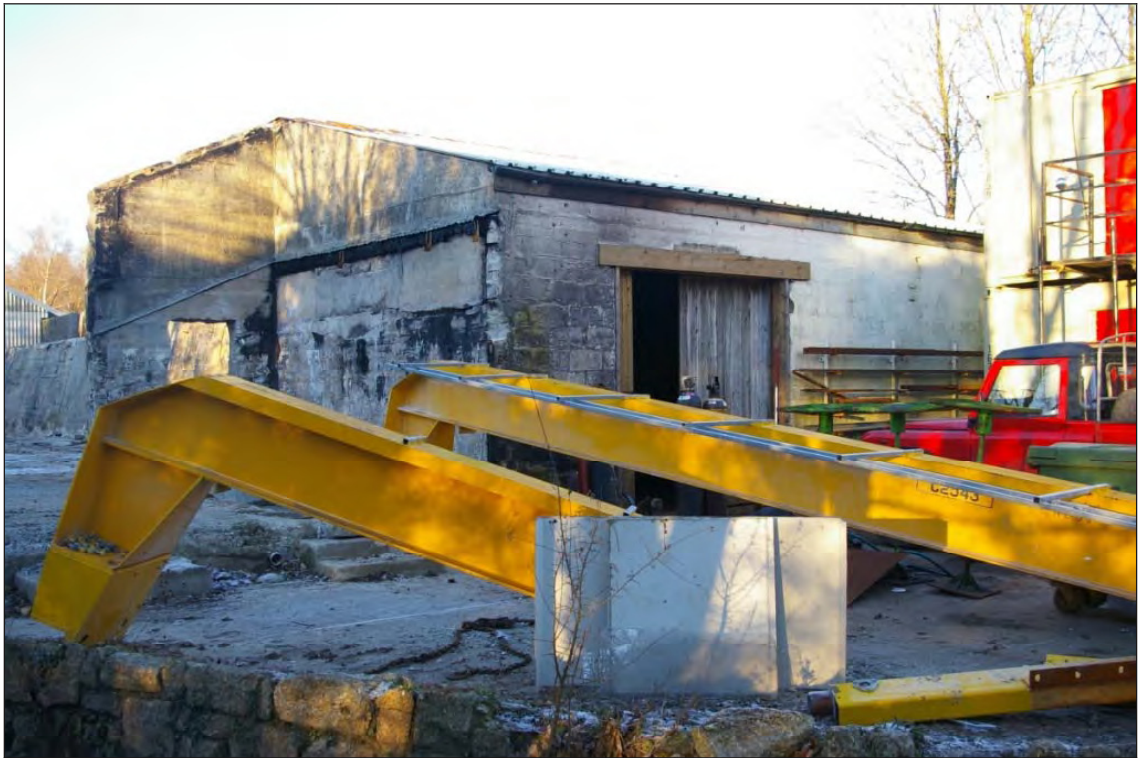
The furnace house which is currently used as a workshop, was situated at the south-eastern end of the Phase 2 drying pan, measured 9.75m by 6.4m and was constructed of concrete blocks with a mono pitch roof sloping to the south-east (Figure 15). It had a door opening 2m wide on the south-eastern side which appeared to be original and 2 blocked openings in the north-east and south-west walls which may have been to supply fuel to the furnace. In the interior a broad arch was visible in the north-western wall which presumably originally connected the furnace to the flues under the drying pan floor (Figure 16).

Figure 15: Phase 2 furnace house, viewed from the south (Scale: 2m).

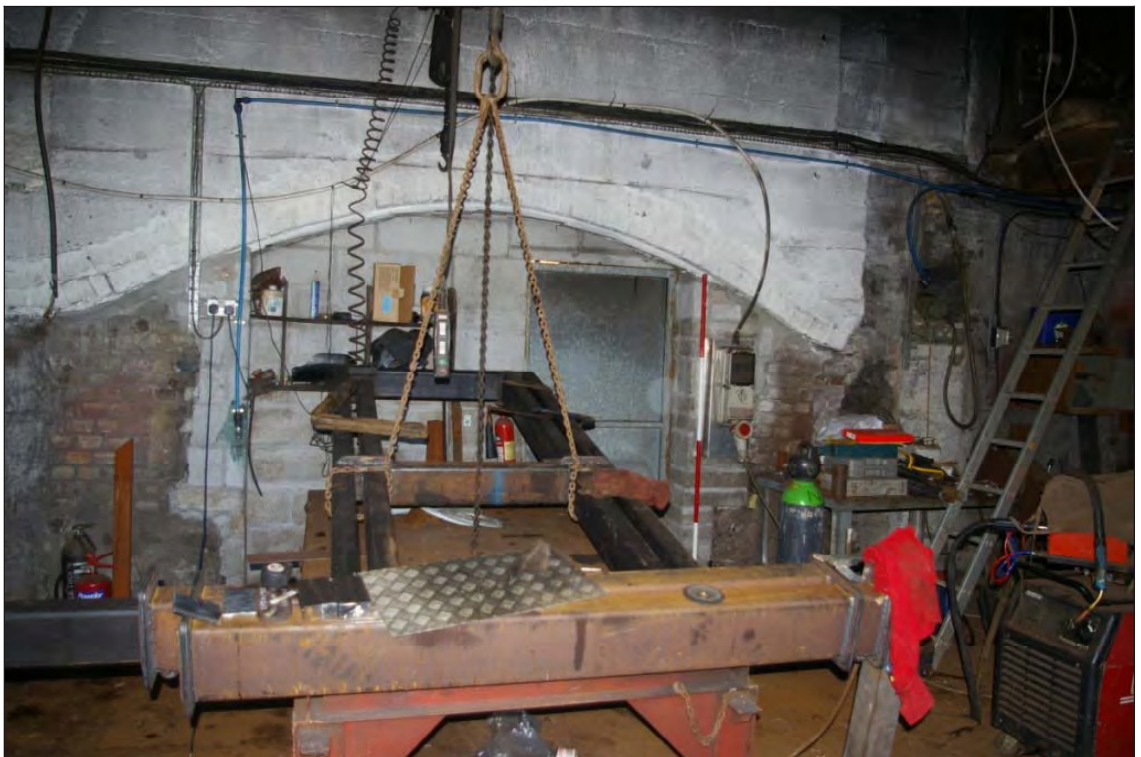
Figure 16: Archway through the north-western wall of the furnace house, viewed from the south (Scale:2m).

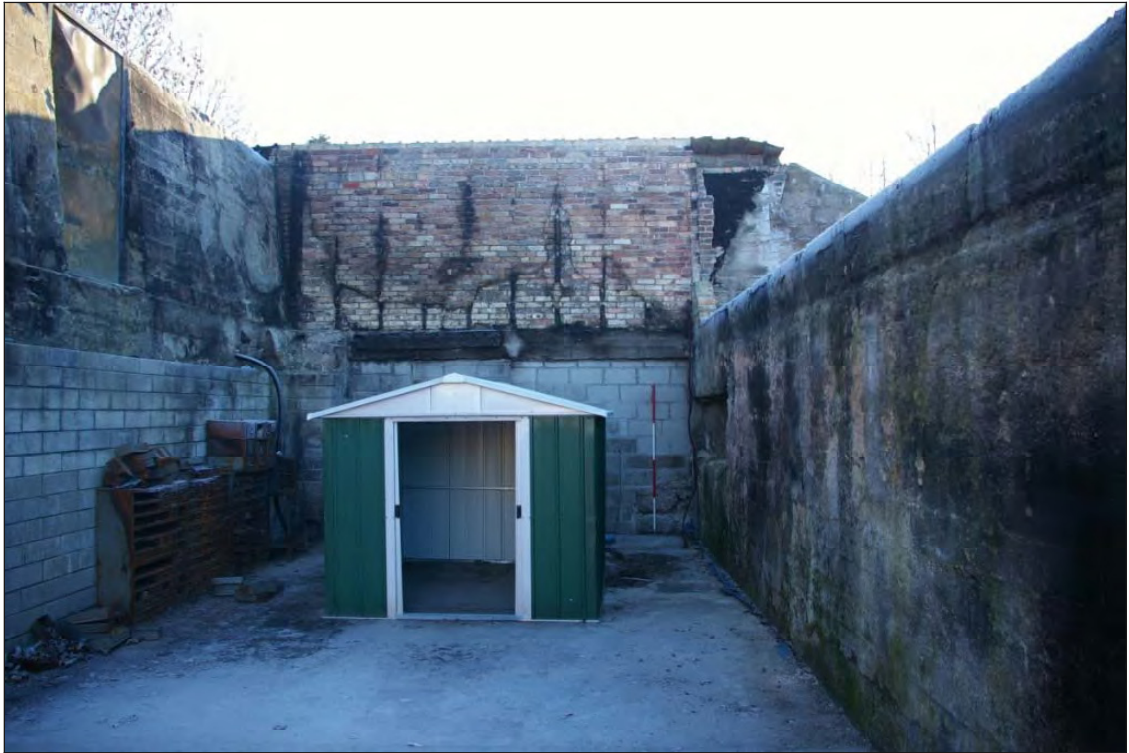
Phase 3 consists of the alterations to the building undertaken as part of its conversion to a workshop which was centred on the Phase 2 drying pan and linhay. This work involved the removal of the floor and underlying flues from the drying pan and the reconstruction of the upper part of the north-western wall of the furnace house in brick (Figure 17).

Figure 17: North-western exterior wall of the furnace house, viewed from the north-west (Scale: 2m).

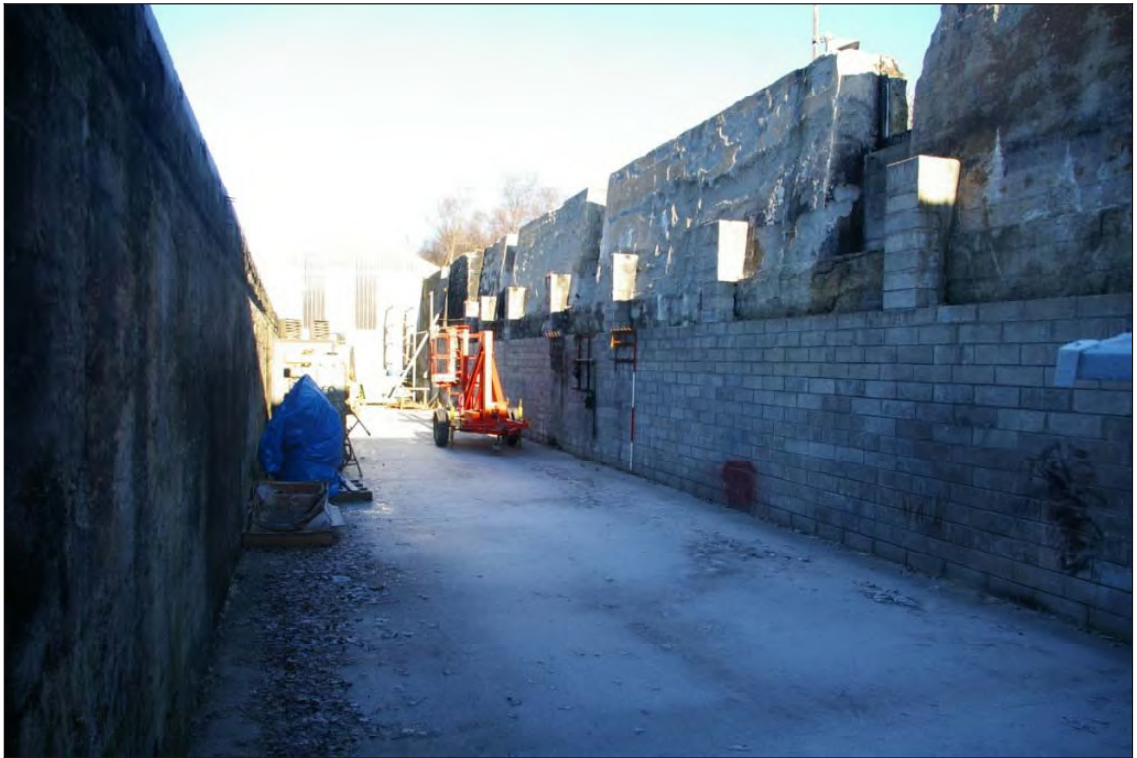
Phase 4 consists of the reconstruction work, in progress at the time of the survey, following the fire in 2010. It is likely that the concrete blockwork lining the north-eastern wall of the Phase 2 linhay and Phase 3 workshop (Figure 18) belongs to this phase as it appears new and relatively unmarked by scorching. The same seems to be the case with the concrete blockwork filling the archway in the north-western wall of the furnace house into which a door has been inserted. Additional work includes the construction of a steel framed shed, currently housing the workshop, at the eastern end of the Phase 1 drying floor and linhay (Figure 2). It is not known whether the construction of this building involved the removal of any of the clay dry's fabric. Further work will involve the removal of the Phase 3 linhay and the wall separating it from the drying pan, while work to date has destroyed the junction between the Phase 1 and Phase 2 parts of the building except in the case of the settling tanks where the contrasting styles of construction remain easily visible (Figure 19).

Figure 18: Junction between the Phase 1 and Phase 2 settling tanks, viewed from the south (Scale 2m).

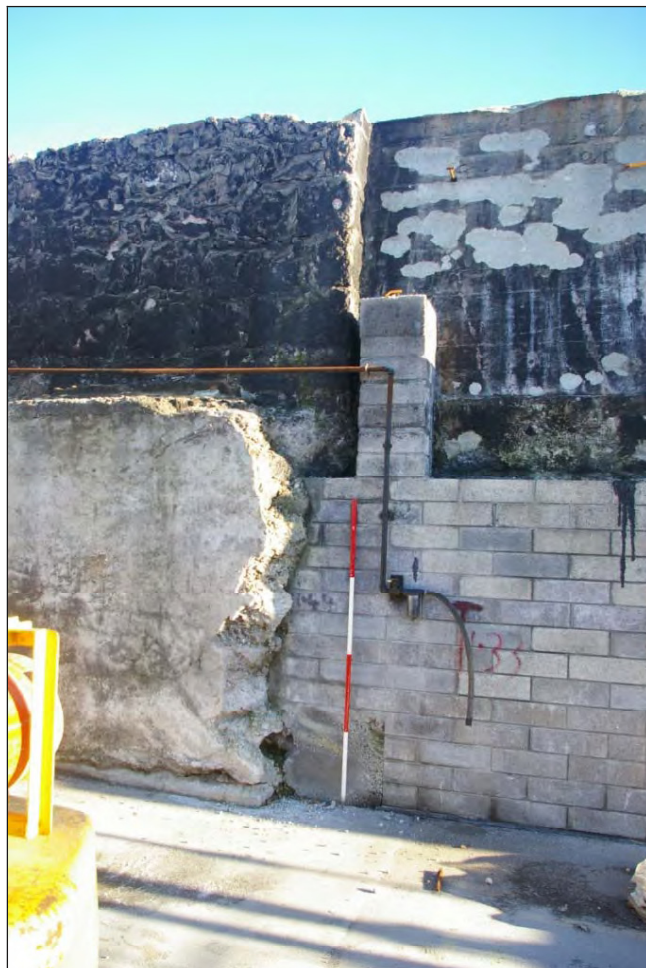
Figure 19: Phase 2 drying pan, the site of the Phase 3 workshop (Scale 2m).
