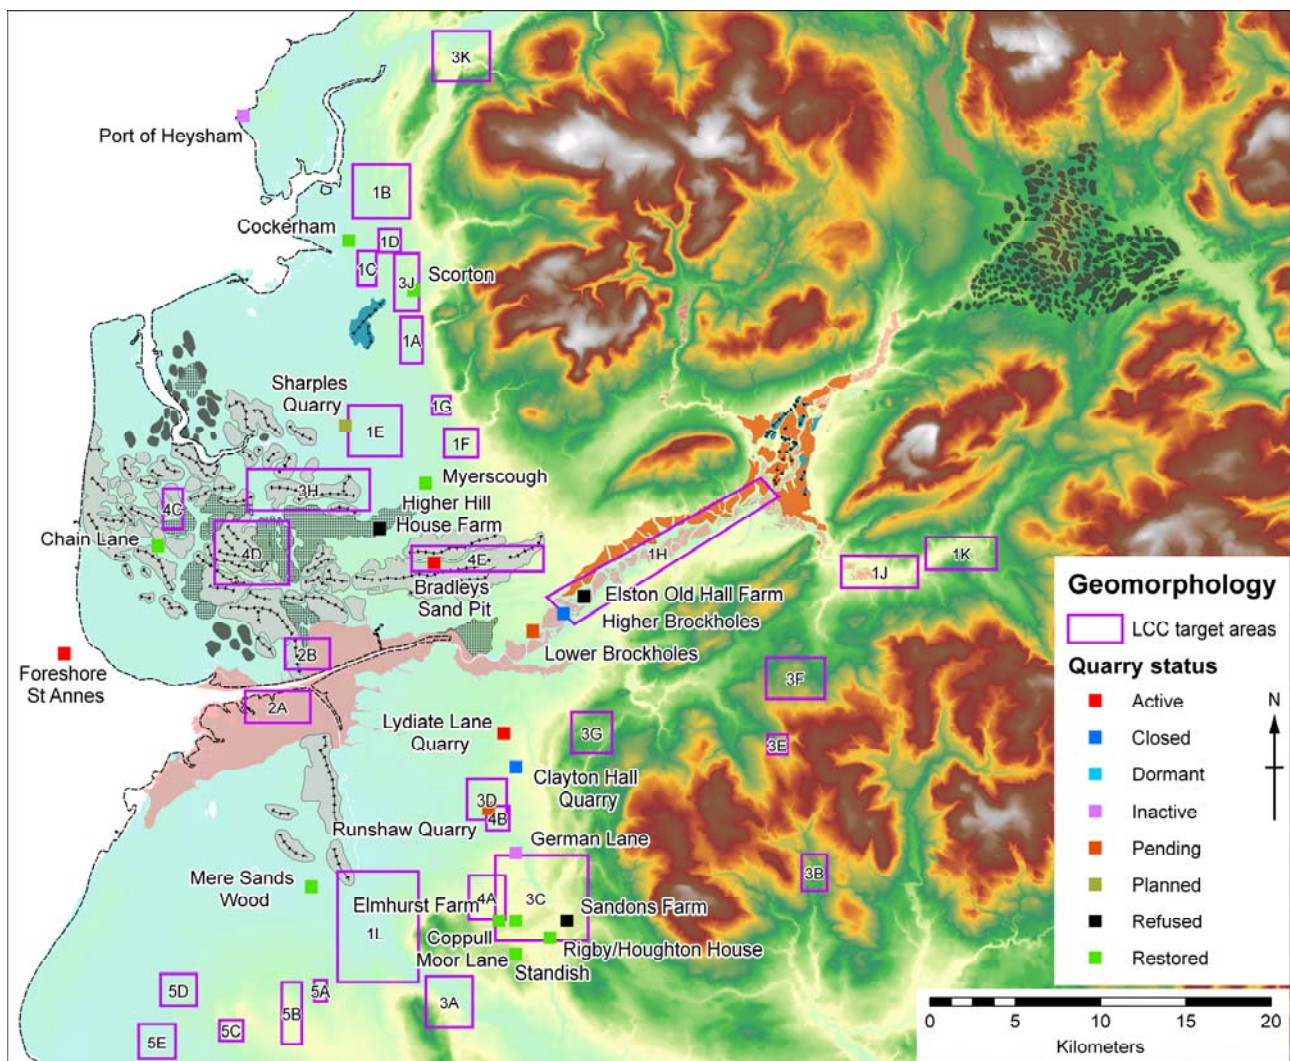
Figure 144: Distribution of active and inactive sand and gravel workings in Lancashire, overlain by the Resource Blocks addressed by LCC in the Entec UK Ltd and Geoplan Ltd reports

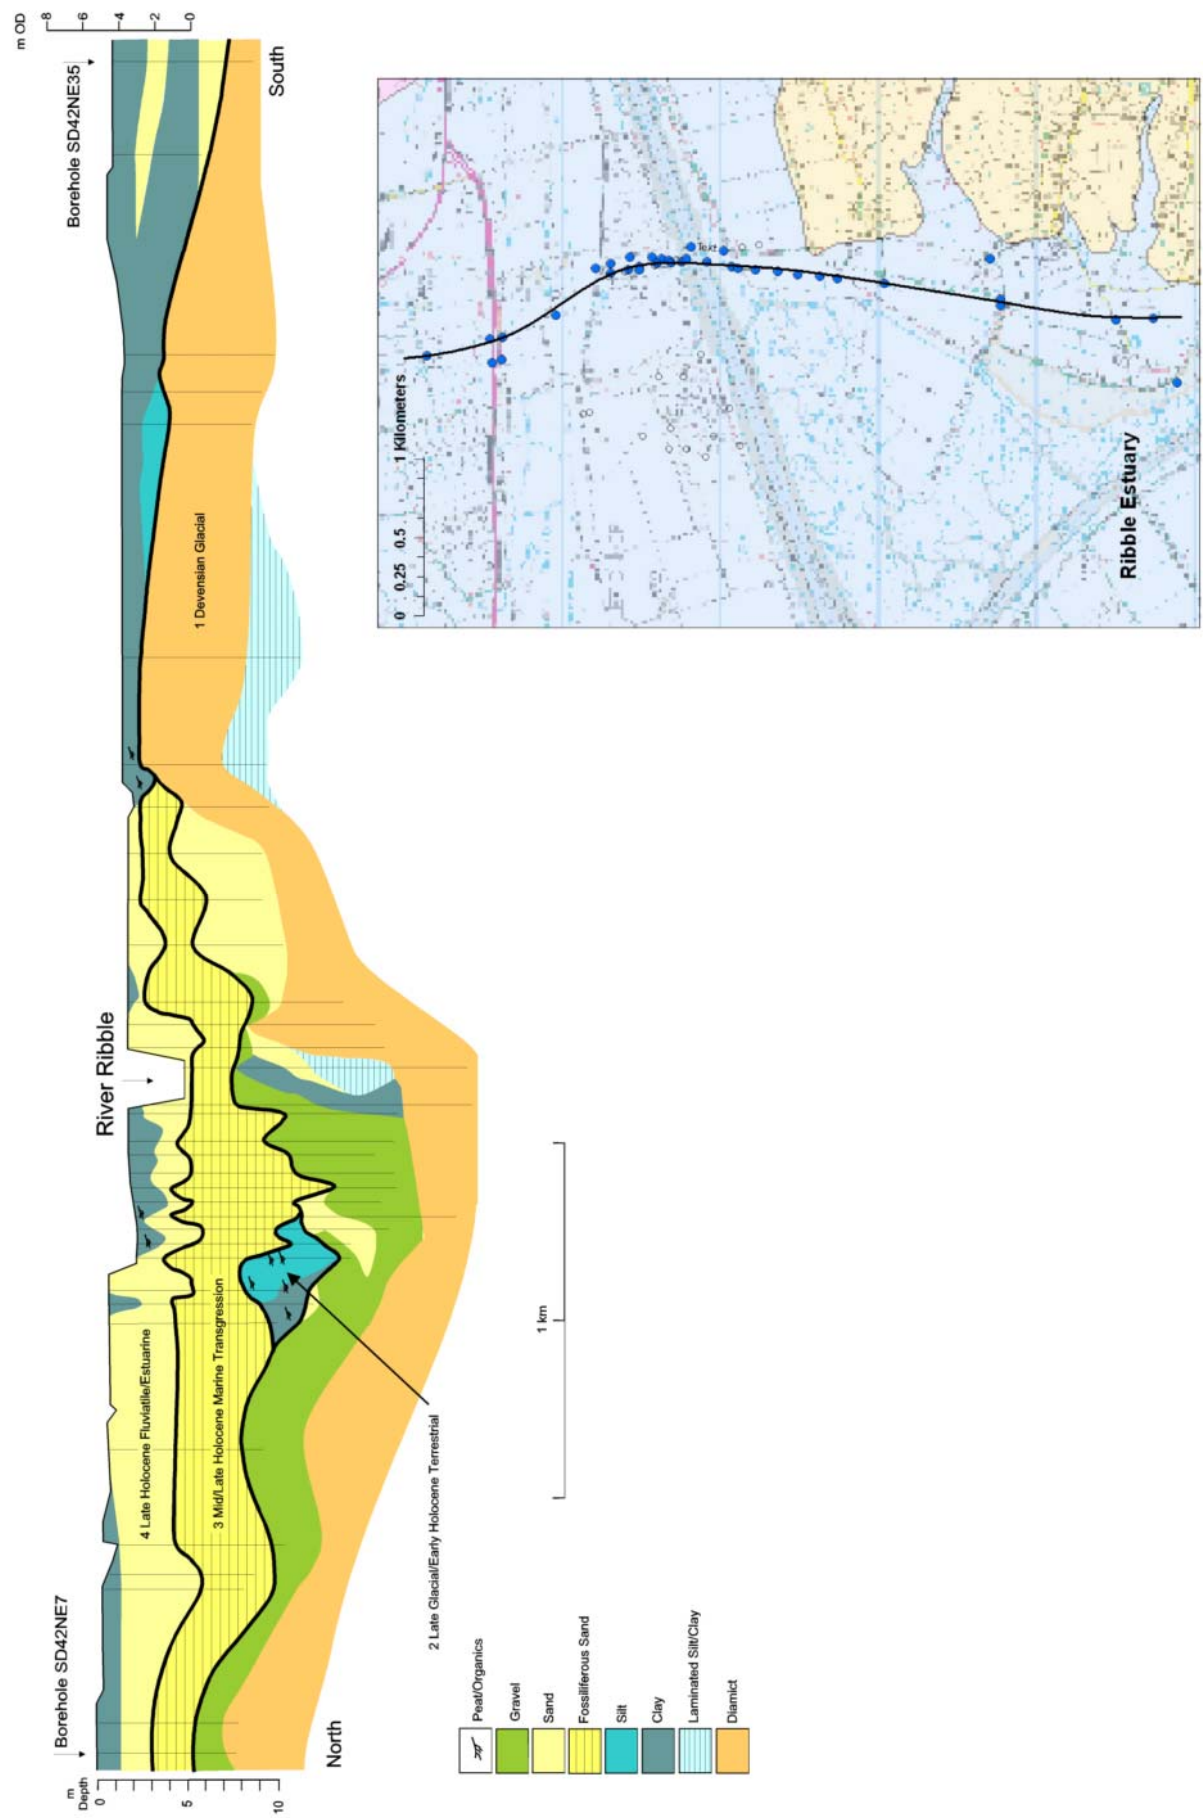
Figure 147: Borehole evidence for the stratigraphy across the inner Ribble estuary
