ARCHAEOLOGICAL MONITORING AND RECORDING AT OLD CHURCH COTTAGE, HARMSTON ROAD, AUBOURN, LINCOLNSHIRE (AOCC 12)

Work Undertaken For M.J. Green (Navenby) Limited

December 2012

APS Report No. 109/12

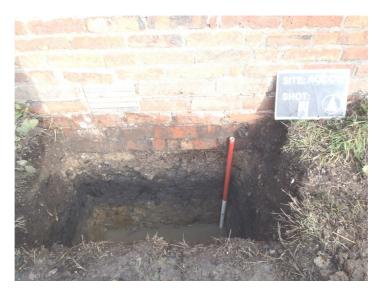
Plate 2 – Pit 1, Section 1, south facing, looking north

Overlying the natural within this trench was a layer of bluish grey silty clay with coal/charcoal and industrial residues (005). Identified as a former topsoil, this measured 0.15m thick (Fig. 4, Section 1; Plate 2) and contained $16^{th} - 17^{th}$ century pottery and medieval roof tile. This was in turn sealed by a 70mm thick layer of grey sandy clay (004), also a former topsoil, which also produced medieval roofing tile.

Cut into this layer was a presumably rectangular foundation feature (007). This was 0.15m deep and contained a fill of yellowish brown sandy clay (003) upon which was constructed wall (002).

Topsoil, comprising grey silty sand (001), sealed the above deposits.

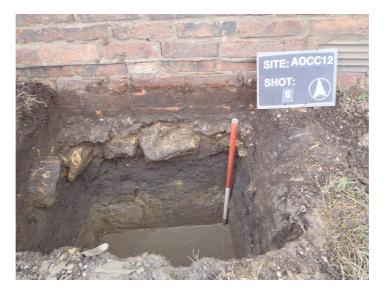
Plate 3 – Pit 2, Section 3, south facing, looking north

Developed over the natural (006) was a buried soil of bluish grey silty clay (023) which measured 0.47m thick (Fig. 4, Section 3; Plates 3 and 4). This was in turn sealed by former topsoil (022) comprising sandy brownish grey clay and incorporating a number of limestone blocks acting as a foundation course along with post-medieval roof tile. This was 0.2m thick and was overlain by yellowish brown sandy clay (021) upon which wall (018) had been constructed.

The wall had been underpinned, although the cut (020) for the concrete (019) was only 60mm deep.

Sealing all deposits was the topsoil of grey silty sand (017), measuring 0.18m thick.

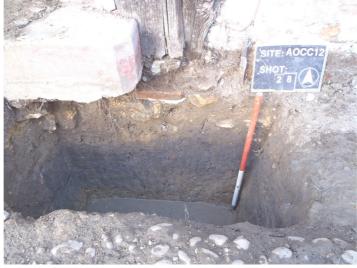
Plate 5 – Pit 3, Section 6, looking north

Three layers of former topsoil were recorded within this pit overlying the natural. The earliest was mottled greyish brown and brownish grey sandy clay (047), which was succeeded by grey sandy clay (046) and brownish grey clayey sand (045) with limestone blocks towards its upper horizon. These had a combined thickness of 0.9m (Fig. 4, Section 6; Plate 5).

Constructed upon this and the limestone blocks was the wall of the cottage (043).

Abutting this and overlying (045) was the topsoil of brownish grey clayey sand (044).

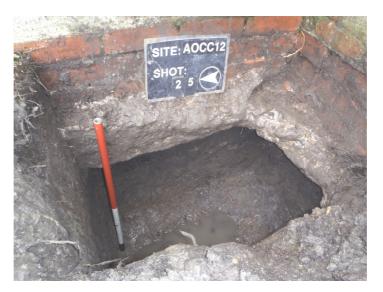
Plate 6 – Pit 4, Section 5, looking southeast

Sealing the natural (006) were former topsoil layers of mottled greyish brown and brownish grey sandy clay (042), measuring 0.3m thick, and grey sandy clay (041) that was 0.4m thick (Fig. 4, Section 5; Plate 6). Animal bone was retrieved from both these layers. A final buried soil of greyish brown sandy clay (040) was also recorded that was 0.5m thick.

Cut into the uppermost buried soil was a foundation trench (039) that was 0.25m deep containing concrete (038). Upon the concrete, recent walls (036) and (037) had been constructed. Sealing the foundation cut and butting against the walls was the topsoil of grey silty sand (035).

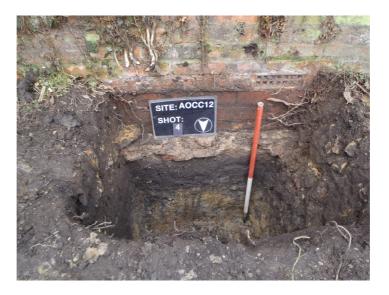
Plate 7 – Pit 5, Section 2, looking south

Above the natural was a former topsoil of bluish grey silty clay (016) measuring 0.17m thick which contained a fragment of lead sheeting. This was sealed by a second former topsoil layer of grey sandy clay (015) that measured 0.3m thick (Fig. 4, Section 2; Plate 7). Pottery of late 16th to 17th century date was recovered from this deposit along with medieval roof tile.

The former topsoil (015) had been truncated by the insertion of a foundation trench (014) in which was a fill of yellowish brown sandy clay (013). This supported the brick wall (009).

This foundation trench was in turn cut by a 0.15m deep trench (011) in which was concrete underpinning (010). The trench had been backfilled with grey sandy clay (012).

Sealing the underpinning trench was a topsoil of grey silty sand (008) that was 0.24m thick.

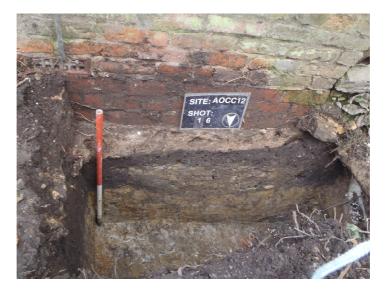
Plate 8 – Pit 6, Section 4, looking south

A buried soil comprising a 0.2m thick layer of bluish grey sandy clay (032) overlay the natural.

Cut into the buried soil was a pit or ditch terminus (030). Measuring 1.15m wide by 0.5m deep (Fig. 4, Section 4; Plate 8) it contained a single fill of mottled greenish brown, greenish grey and bluish grey mixed sand, clay and sandy clay (031). A single animal bone and three burnt stones were retrieved from the pit fill.

Sealing the pit was another former topsoil layer also of bluish grey silty clay (029) that was 0.25m thick. This had subsequently been sealed by a dumped deposit of grey sandy clay (028) measuring 0.3m thick that contained 18th century pottery.

Cut into the dumped deposit was a foundation trench (027) containing concrete underpinning (026) and backfilled with grey silty clay (033). Recent brick wall (025) was constructed upon this.

Topsoil comprised grey silty sand (024) measuring 0.25m thick.

Also pre-dating the construction of the cottage is a small pit of uncertain function located in Pit 6.
