**ARCHAEOLOGICAL MONITORING AND  
RECORDING AT THE PORT OF BOSTON,  
BOSTON,  
LINCOLNSHIRE  
(BOPO 14)**

**Work Undertaken For  
WYG Environment**

December 2014

APS Report No. **132/14**

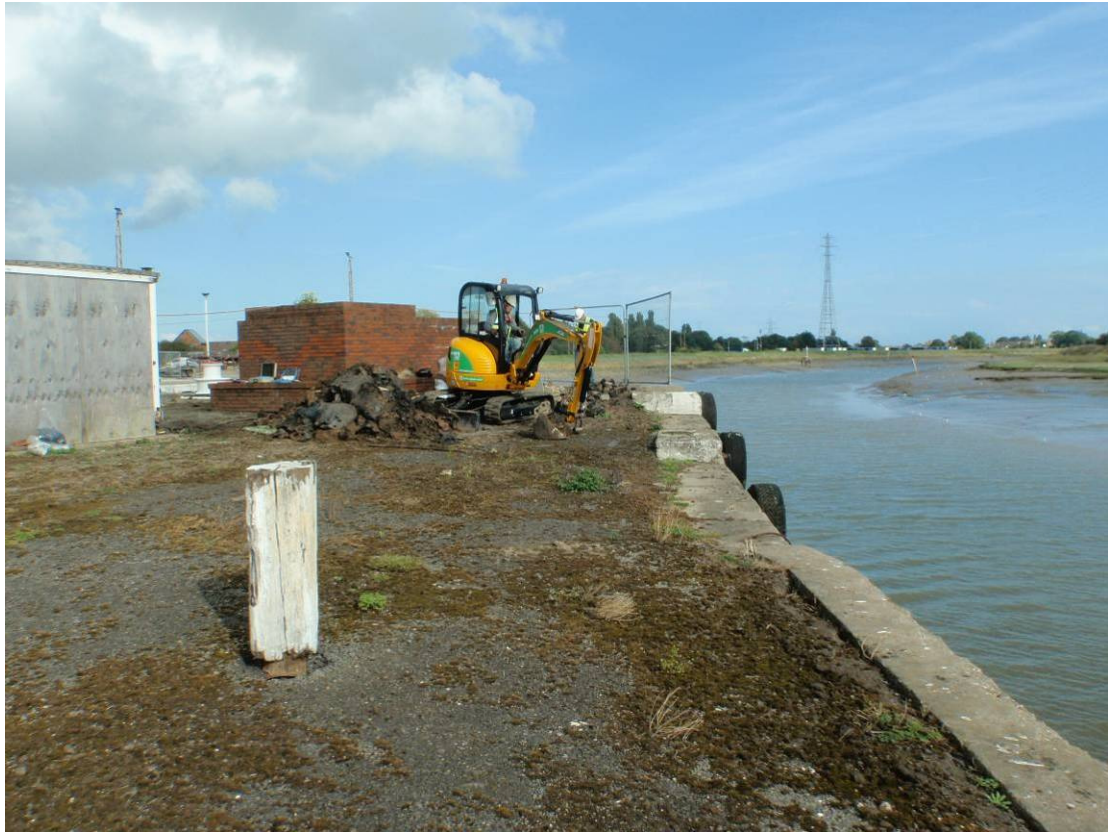
Plate 1. Excavating trial pit 03KKTP02 looking east along River Witham

In this trial pit, at the east end of the quay, the stone inner face of the quay wall [028] was revealed. This was overlain by an at least 2m thick dumped deposit of mid greyish brown silt with timber fragments (027). Above this was a 0.5m thickness of dark grey silt, gravel and cinders (026). A 0.5m thick layer of grey rubble (025) supported the current tarmac surface (024).

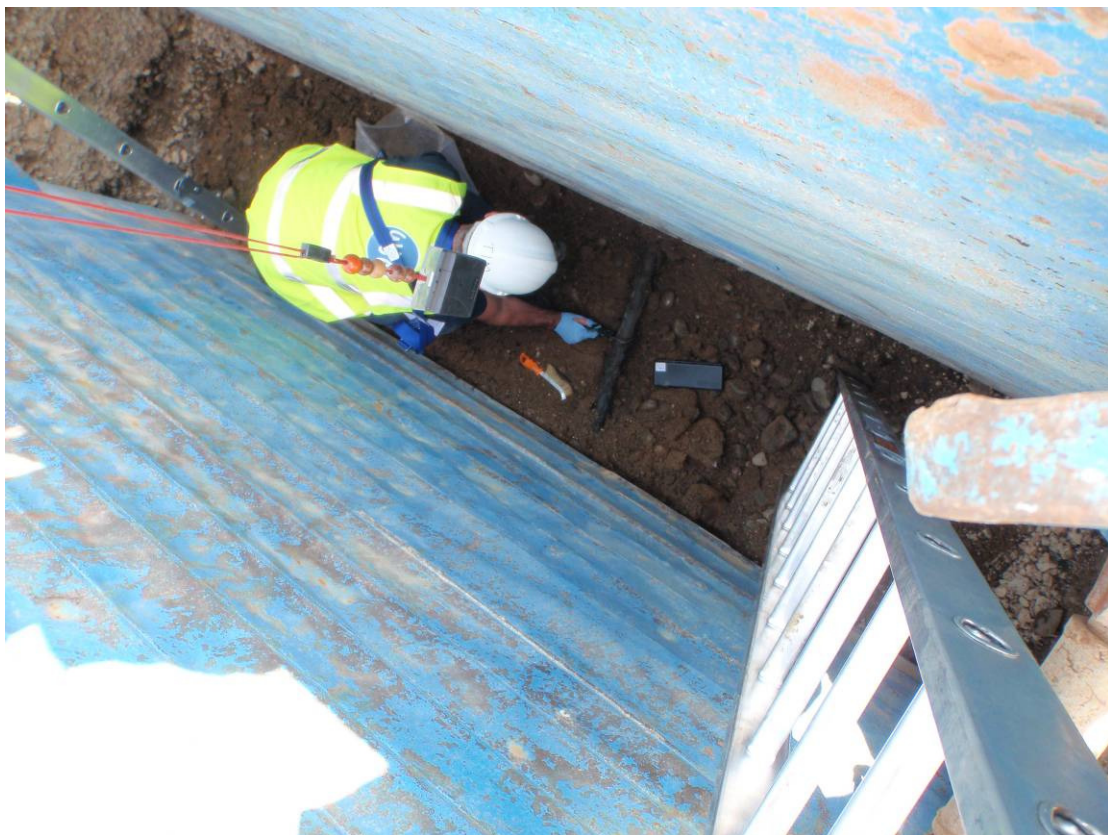
Plate 2. Exposing iron tie rod (011) in shored trial pit 03MFTT04

The deposits in this trial pit were similar to the above with an at least 0.26m thickness of (008) at the base. This contained a further iron tie rod (011) (Plate 2), at a depth of 1.52m. Above the sandy silt and cobbles was 0.9m thick crushed limestone (007) which was topped by 0.44m thick tarmac (006).

In the trial pits themselves, there was a great depth of modern overburden, comprising made ground for the docks. Several of the trial pits were excavated to establish the position of the iron tie rods between the dock walls (Plate 2). Only a

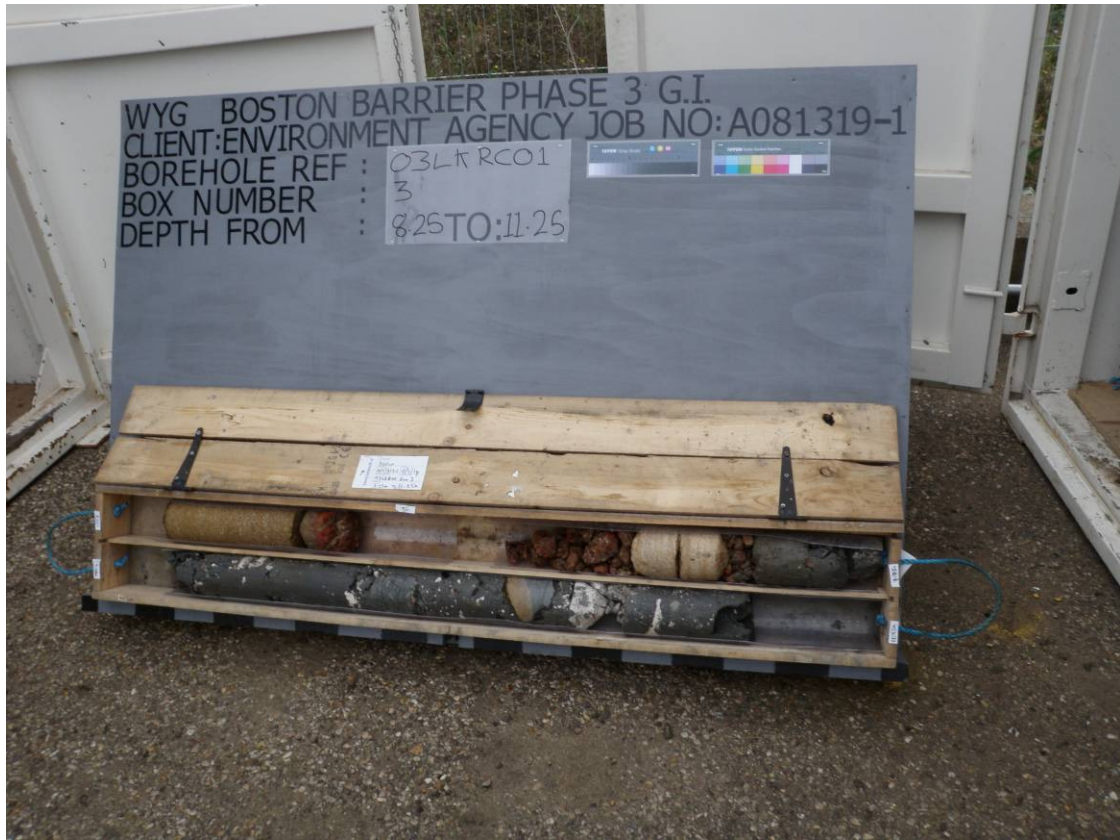
Plate 3. 03LKRC01 core showing transition from dock wall to boulder clay at 9.5m

This borehole lay close to the entrance lock for the dock. The cores were laid out for examination. The borehole extended to a depth of 15.26m. Stiff mid grey clay (038) with frequent chalk fragments and flints comprised the deposits below 9.5m depth. Above this, the material appeared to be the quay wall (037) being composed of brick and concrete, with some cracking apparent (Plate 3).

The earliest deposit observed during the monitoring was a mid to dark grey clay with frequent chalk fragments and flints, at a depth of 9.5m, below the dock wall, in rotary cores LKRC01 and 03. This is natural boulder clay.

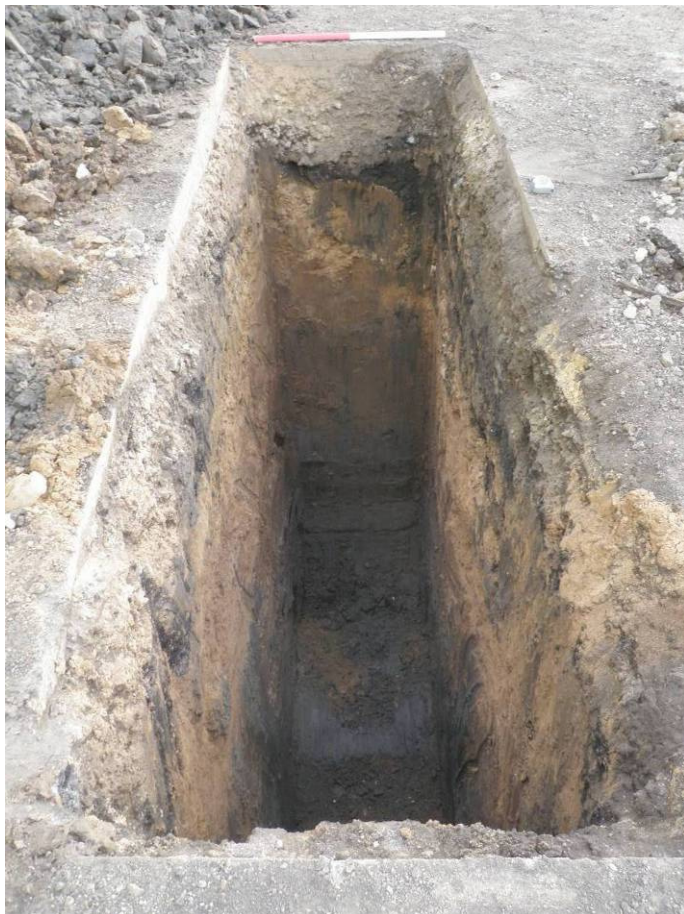
Plate 4. Trial pit 03FWTP02, Section 14, looking east

Iron tie rod (064) was included within at least 1.4m thick mid grey sandy silt dumped deposit (063) at a depth of 3.92m. This was overlain by 0.6m thick brown/grey clayey silt (062), above which was mid brown clayey silt (061). Overlying this was brownish grey silt (059) at the top of which was another iron tie rod (060) at a depth of 0.8m and was sealed by 0.18m thick grey/black grit and ash (058). Above this, 0.42m thick mid grey stone (057) was overlain by limestone fragments (056) providing the base for 0.1m thick tarmac surface (055).

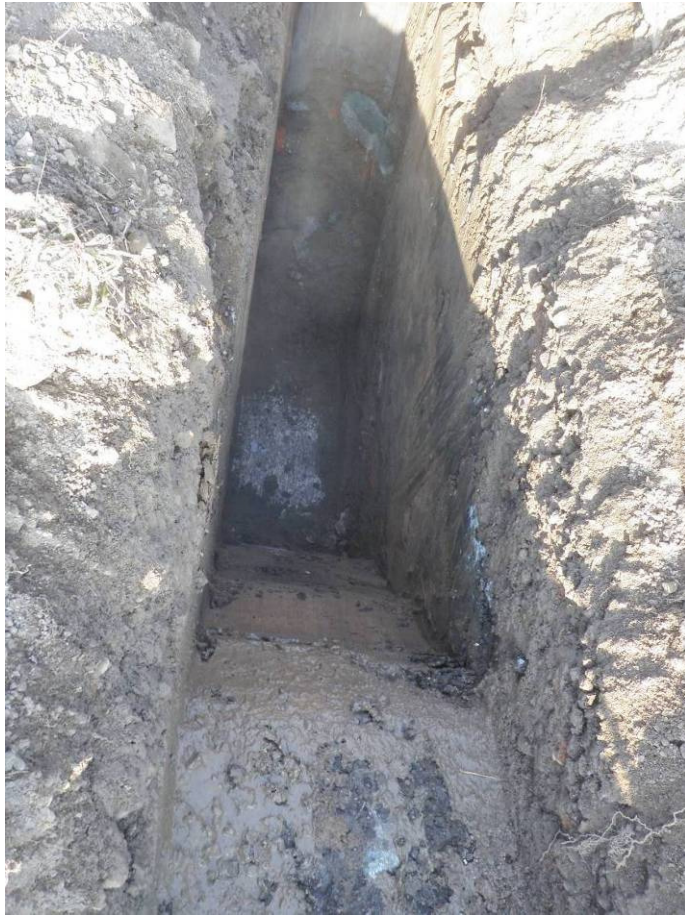
Plate 5. Trial pit 03DRTP02, Section 17, showing hard surface (077) at base, looking east

In several pits along the line of the proposed dock road, 03DRTP02-06, a hard yellow limestone surface halted machining at a depth of between 2.5 and 3.1m. This was remembered as an area of sunken workshops by a docks vehicle mechanic. Certainly the rubble backfill was of very recent date and the surface may have been a road or yard associated with the workshops.

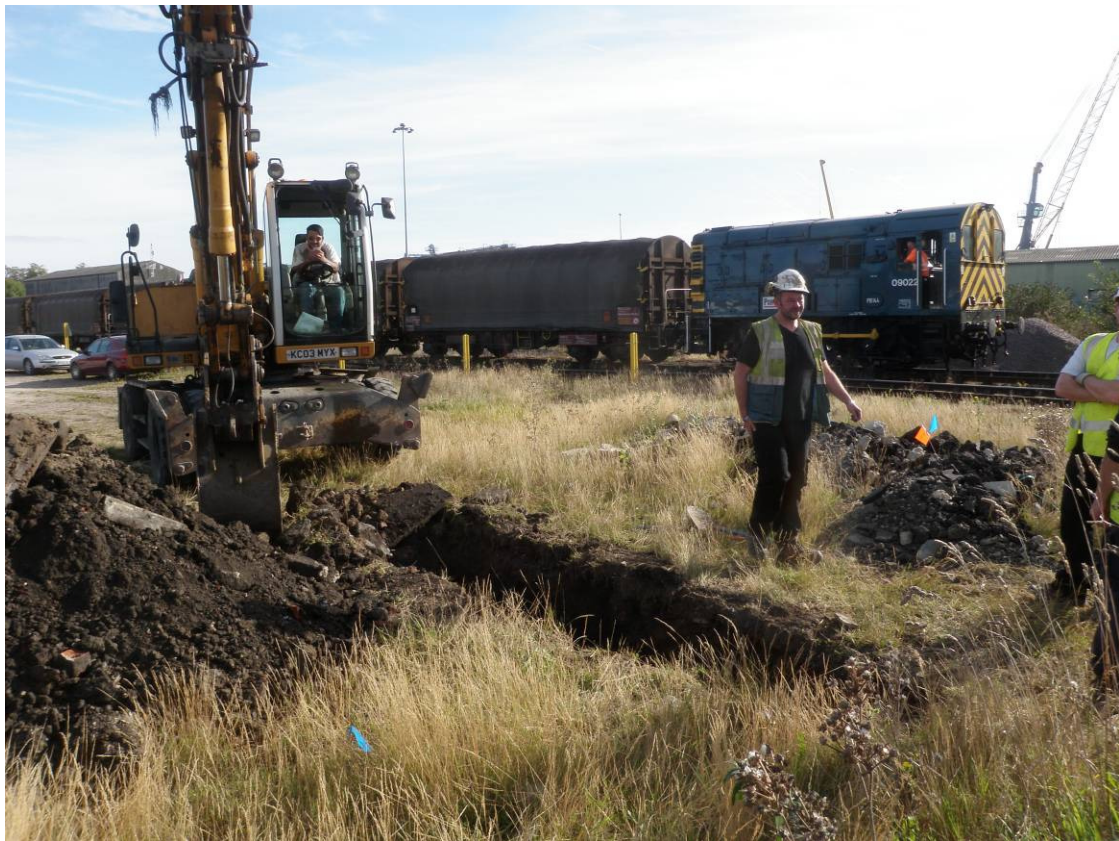
Plate 6. Excavating trial pit 03DRTP04 on line of proposed new road, looking northeast

The same compacted limestone surface (077) was reached at a depth of 2.59m. This was overlain by 1.1m thick dark brown clay with concrete fragments (080) above which was 1.16m thick mottled yellow and grey clay (075). This was topped by 0.34m thick grey clayey silt (079).
