**ARCHAEOLOGICAL WATCHING BRIEF  
AT ALL SAINTS' CHURCH,  
WALSOKEN,  
NORFOLK  
(NHER 2209)**

**Work Undertaken For  
Birdsall, Swash and Blackman LLP  
Chartered Architects and Diocesan Surveyors  
On behalf of  
Walsoken Parochial Church Council**

May 2010

APS Report No. **35/10**

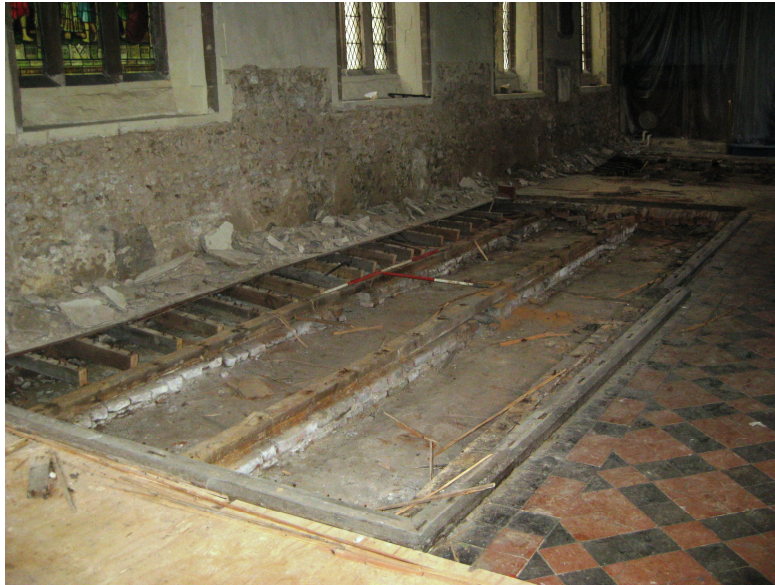
Plate 1 – General view of the area of works, looking northeast

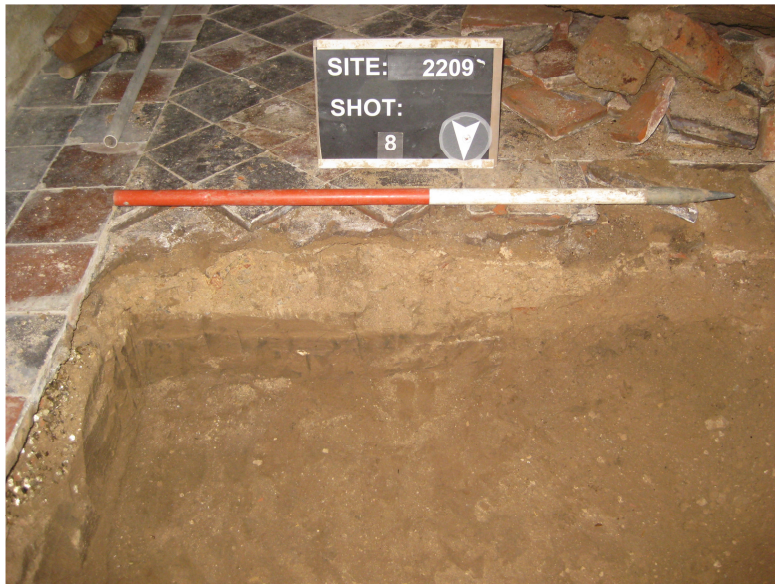
The earliest deposit encountered at the base of the stripped area within the north aisle was a layer of brown sandy silt (006). Interpreted as a possible subsoil, this measured in excess of 0.14m thick (Fig. 4, Section 1).

Plate 2 – Section 1 showing the general sequence of deposits encountered, looking south

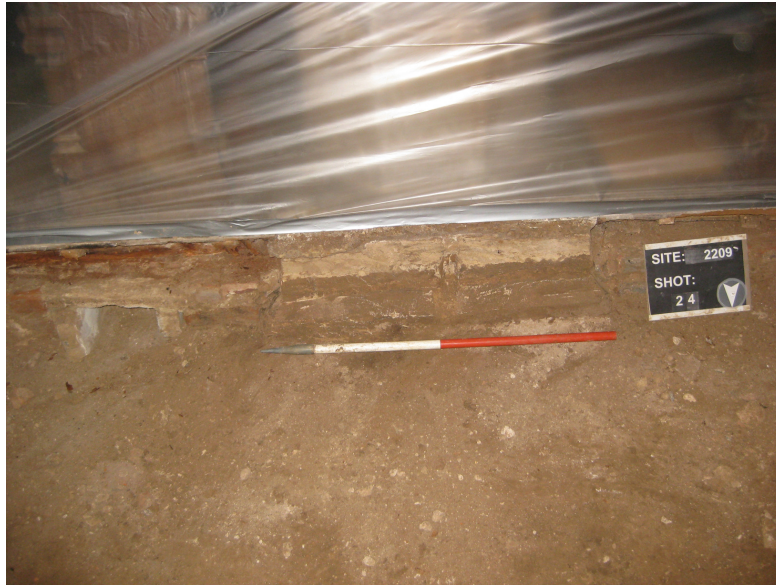
Inserted into this deposit was a limestone plinth of the easternmost pier of the arcade between the north aisle and nave (015). This was a 1m wide plain chamfered base with a small moulded decoration on its side and corners (Fig. 4, Section 2; Plate 2). No other pier bases were affected by the works.

Plate 3 – Section 2 showing the exposed pier base, looking south

pre-date the construction of the north aisle. Alternatively, it may be a dumped deposit and mask earlier levels associated with the 14<sup>th</sup> century aisle or an earlier 12<sup>th</sup> century predecessor. A medieval pier plinth was partly exposed inserted into this layer.

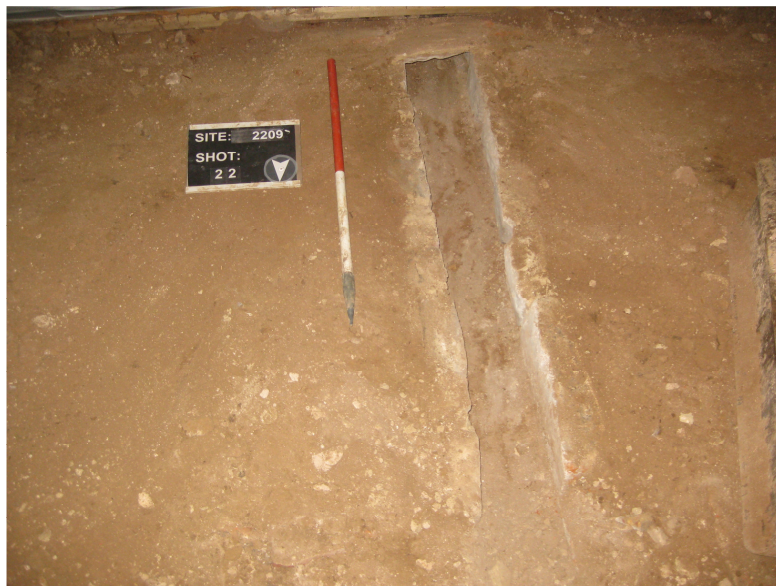
Cutting (006) were two north-south trenches (011) and (012). Within these were low brick or stone walls either side of a channel which had then been capped by stone slabs forming an air duct (Plate 4).

Plate 4 – View of the air duct (012), looking south

Air ducts and pew supports were found and are likely to be of later post-medieval date. Above this was the tiled floor with its associated contexts which are broadly contemporary.

012	Brick (220mm x 110mm x 60mm) and stone (460mm x 180mm x 100mm) structure, 2 courses of brick to east, 1 of stone to west, 1.85m long by 0.38m wide by 0.22m high	Air vent beneath floor
013	Linear feature, aligned north-south, 1.85m long by 0.38m wide by 0.22m high, vertical sides and flat base	Foundation trench for (012)
014	Unstratified finds retrieval	
015	Limestone structure, pier plinth exposed by works, 1m wide	Pier plinth
