**ARCHAEOLOGICAL MONITORING AND  
RECORDING AT  
BELTON STREET,  
STAMFORD,  
LINCOLNSHIRE  
(STBS 11)**

**Work Undertaken For  
Hallam Contracts**

APS Report No. **90/11**

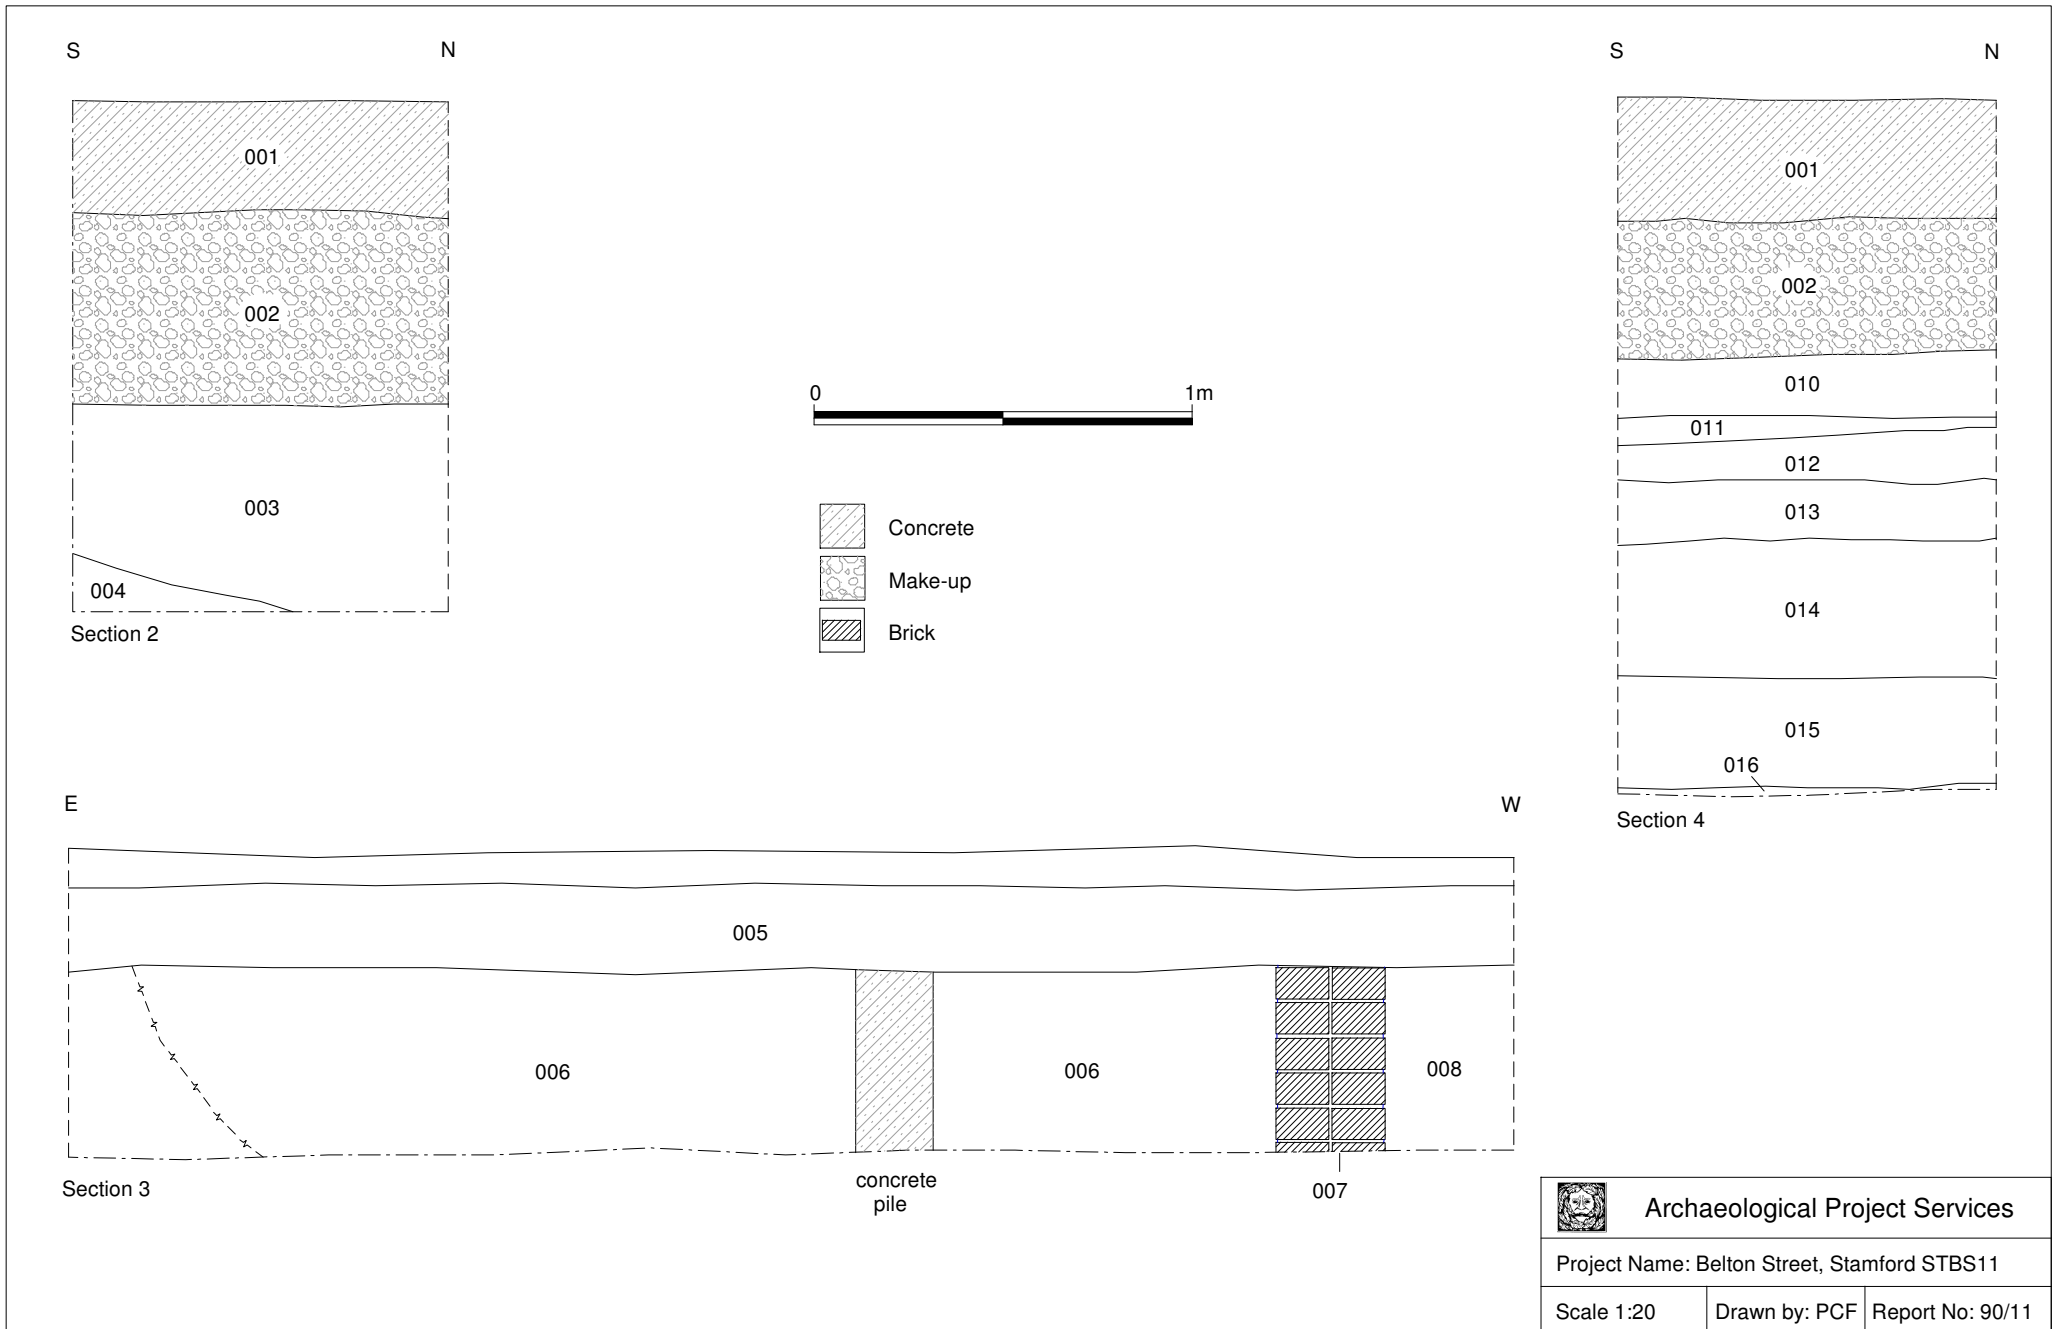
Figure 4 - Sections 2, 3 and 4

20mm thick (Fig. 4, Section 4; Plate 4). Sealing this was a layer of grey silt (015), perhaps also a levelling deposit, which was 0.28m thick.

Towards the east of the site, overlying the possible levelling deposit (015) was a layer of yellowish brown silty clay (004) that measured in excess of 0.15m thick (Fig. 4, Section 2; Plate 3). This was sealed by a dumped deposit of brownish grey silty clay with coal fragments (003).

Perhaps representing the same deposit as (004) was a layer of brown silty sand (008). This measured over 0.5m thick. Inserted into this was a rectangular brick wall (007) that defined an area measuring 2.5m long by over 1.1m wide. The wall was 2 courses thick and was 0.3m wide (Fig. 4, Section 3). Contained within the walls was a deposit of brown silty sand with brick and coal fragments (006).

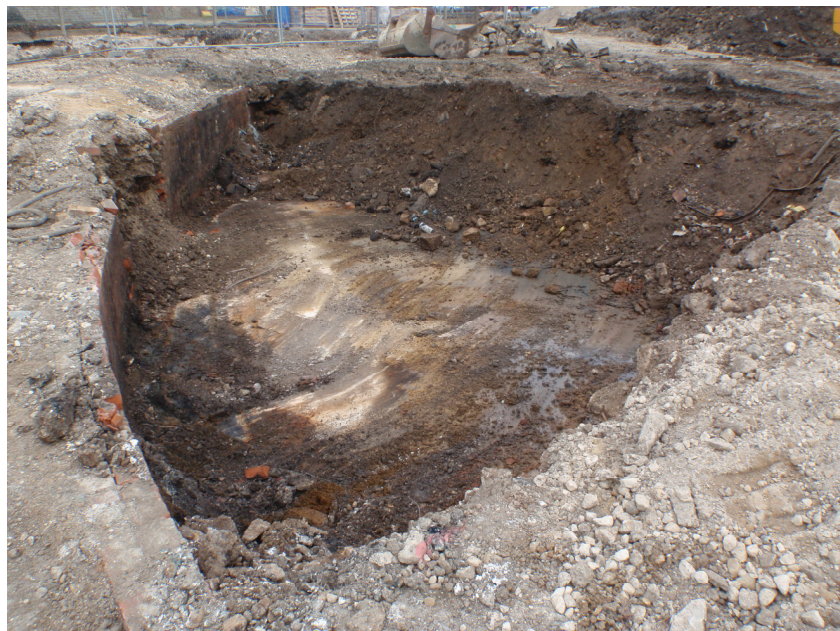
The levelling deposits and a topsoil layer appear to immediately pre-date the construction of the gas works at the site. The use of the site as a gas works is evidenced by a number of deposits that contain coal fragments, as well as the gasometer walls. Additionally, a brick cellar wall was recorded which may relate to the ancillary buildings of the works.

Plate 2 – View showing the brick foundations of the gasometer

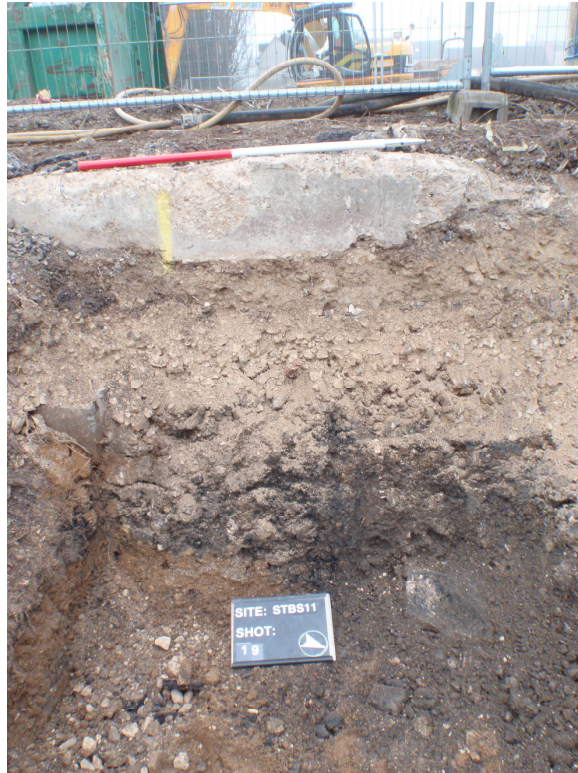
Plate 3 – Section 2 showing the general sequence of deposits, looking southwest

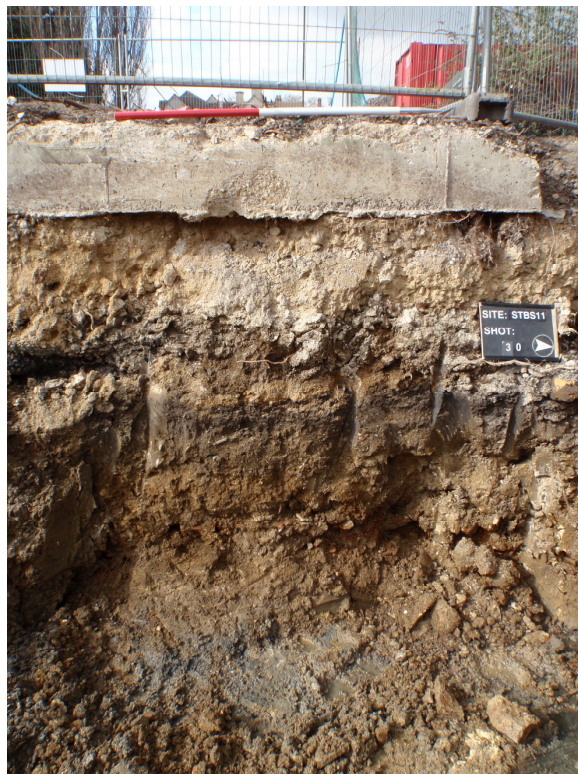
The earliest deposit encountered in the base of the stripped area towards the north of the site was a layer of mixed grey silty sand (016). Identified as a possible levelling deposit, it measured in excess of

Plate 4 - Section 4, looking southwest
