**ARCHAEOLOGICAL MONITORING
AT 36 LYNDON ROAD,
MANTON,
RUTLAND
(MLYR11)**

Work Undertaken For
Thomas Wilson Architects
on behalf of
Mr P Harrison

A.P.S. Report No. **81/11**

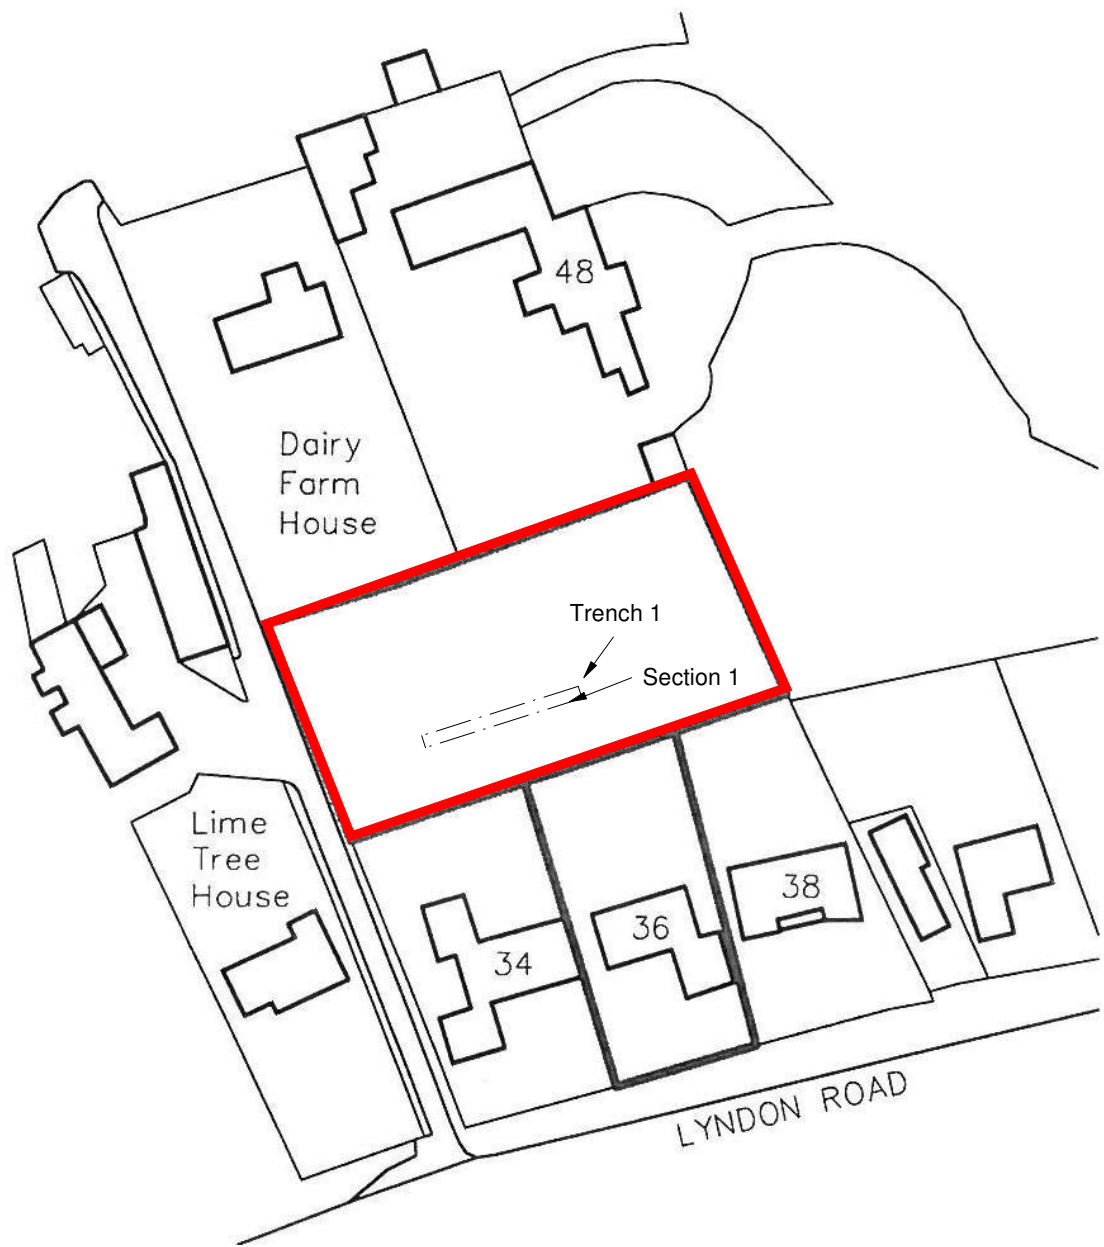
Figure 3 Detailed site plan

In advance of the main ground reduction, a single trench was excavated along the length of the footprint of the building in order to determine the location, depth and extent of archaeological remains at the site (Fig 3, Plate 1).

The initial trench (Fig 3, Plate 2) was excavated to a depth that revealed both archaeological features and the natural geology of the site.

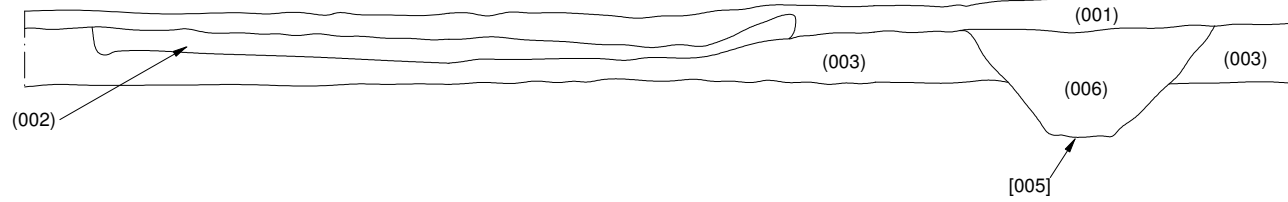
Figure 4 - Section of Trench 1

Partially sealing the subsoil was a compact, angular stone rubble, metalled surface (002) up to 0.2m in depth (Fig 4, Plate 3). It had patches of brick repair in the surface, suggesting it may have been a well used hard-standing or track. Surface finds were dated to the 19th century suggesting this was the date that it went out of use.

A friable, mid brown, silty-sand topsoil has formed over metalled surface (002) and this contained 19th century finds (Fig 4).

Deposit (009) within
indistinct feature
[008]

North-facing section of trial trench 1

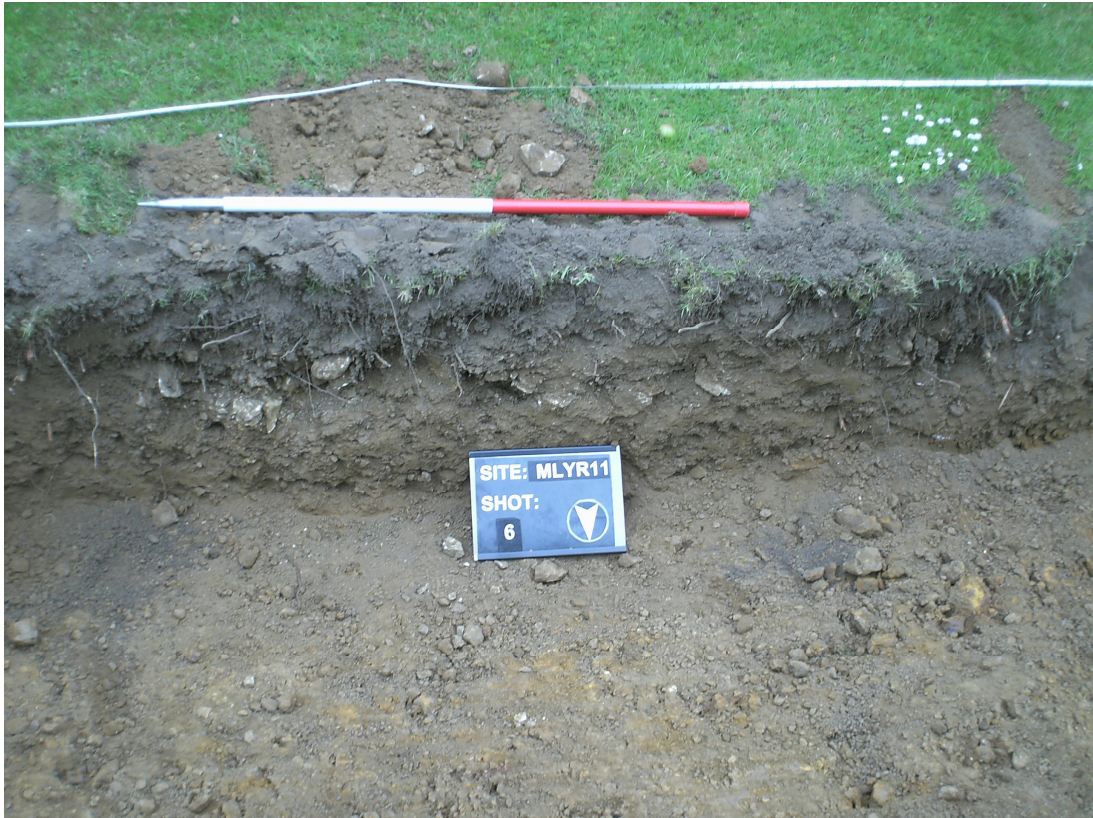
Plate 3: Stone surface (002) evident in the section of the trench

Across a large area of the site the subsoil was sealed by a metalled surface of limestone rubble, (002). This is probably related to the farm located directly to the north and may represent a hard standing or track, although cartographic evidence shows no evidence of either.

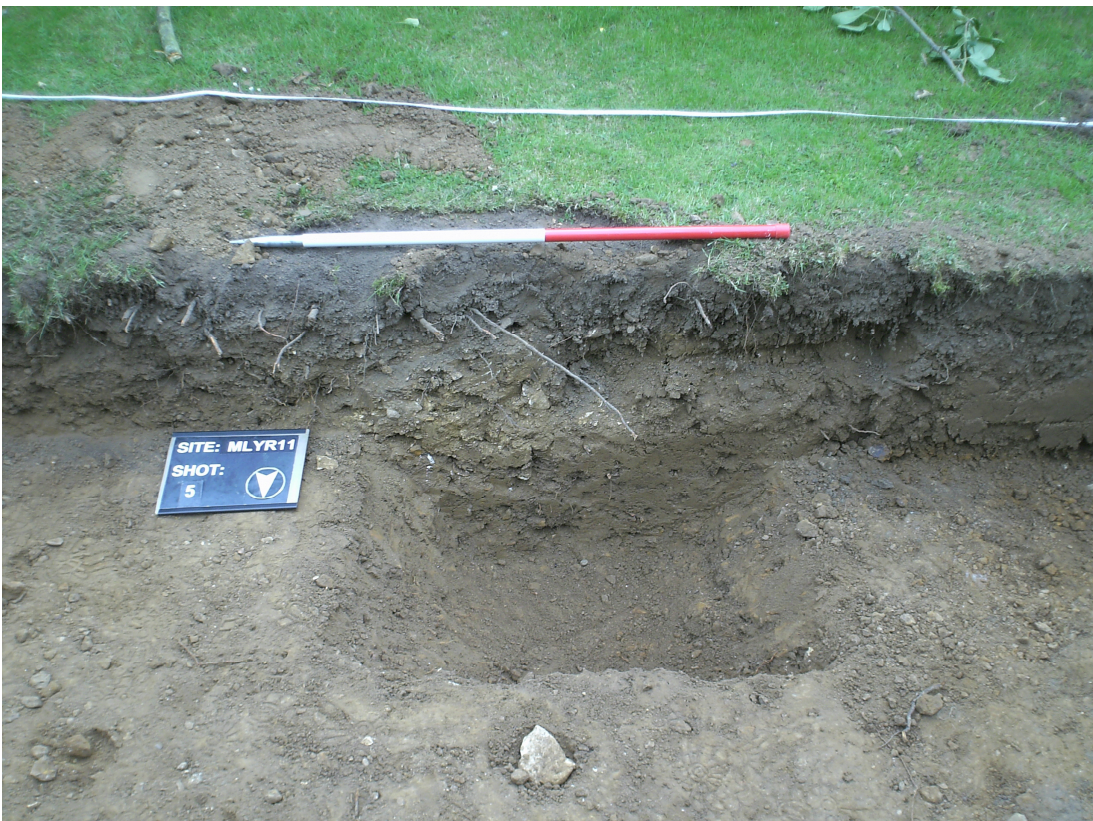
Plate 4: Ditch [005] in Trench 1

Cutting through the stone surface (002) and subsoil (003) and into the natural deposit below (004) was a linear ditch [005], 1.4m in width x 0.5 m deep, with relatively steep sides (Fig 4, Plate 4). It has a singular fill (006) of mid yellowish brown, sandy silt. Frequent stone rubble in

the upper sections of the fill suggests that the ditch was cut through the stone surface. The ditch contained large amounts of bone and ceramic fragments, the latter dating the fill as 18th – 19th century.

The ditch observed running north-south through the site, [005], contained large amounts of domestic waste. The feature cuts stone surface (002) but the stone in the upper fill may suggest that the surface

had been loosely re-instated and the ditch may be for drainage purposes.

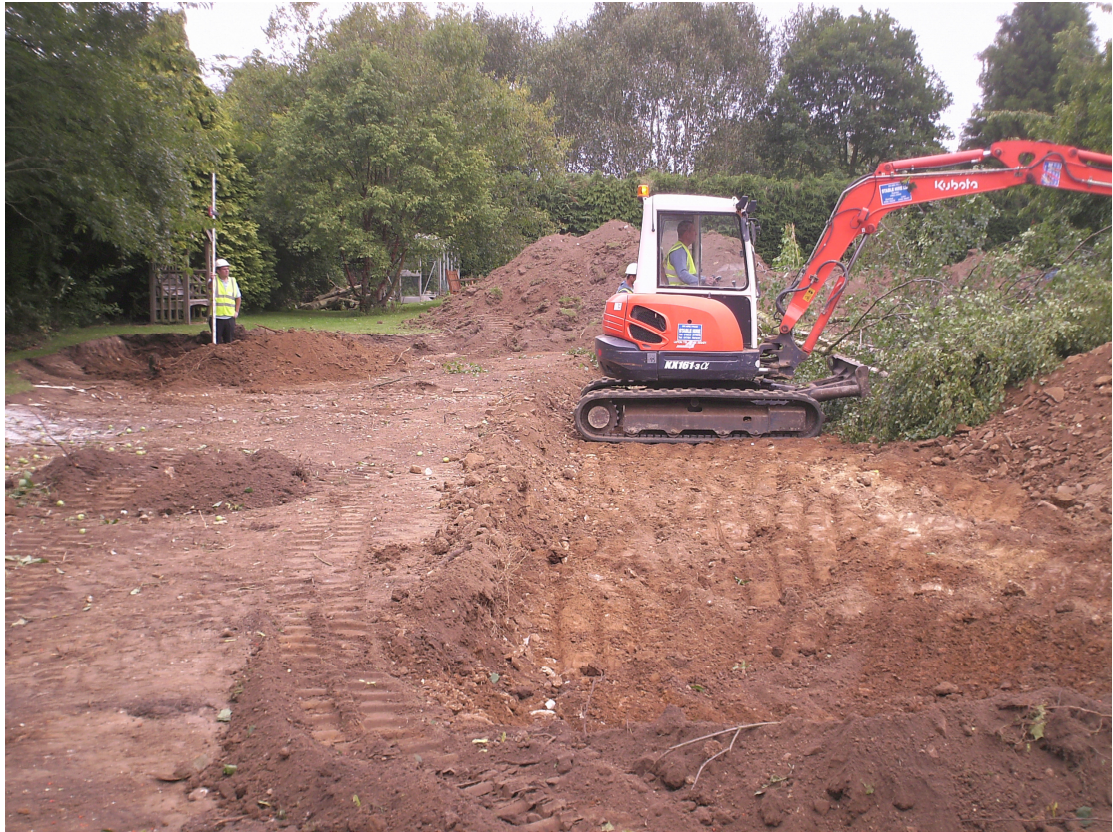
Plate 5: Stripping the remainder of the development area

Subsequent to the digging of the trial trench, the remainder of the site was stripped down to the level required for construction (Plate 5). The level was deeper at the south of the site and only just through the topsoil along the northern edge of the area, allowing for the natural gradient. However, the majority of the site was reduced down to natural deposits.

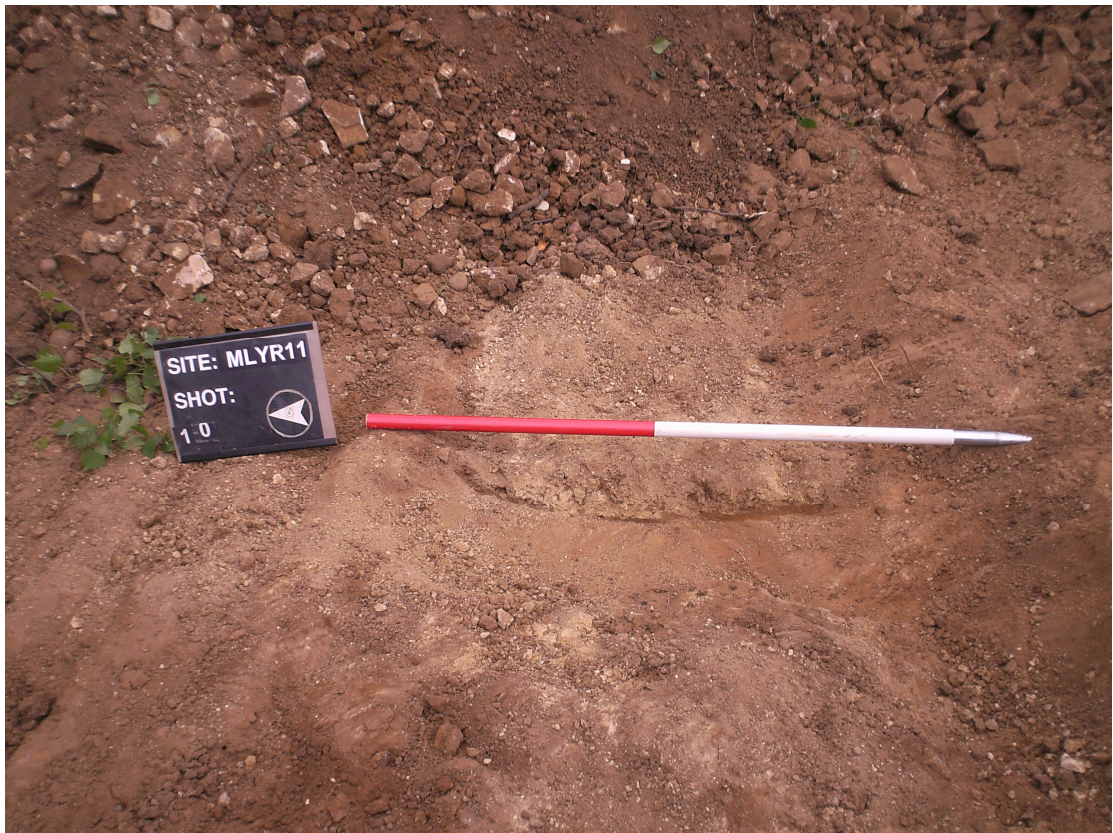
Plate 6: Shallow crushed limestone deposit (014)

A small deposit of fine crushed limestone (014) was observed to the central area of the site (Plate 6). Measuring at least 3m in length x 0.6m wide but only 0.12m in depth, this cut may be just a shallow dump of material intended to level a natural hollow.

The fine crushed limestone deposit (014) appeared similar to lime mortar and the linear nature of the deposit may be indicative of the base of a wall. If the site has been landscaped prior to the laying of surface (002) the rest of the wall may have been razed.
