**ARCHAEOLOGICAL MONITORING AND
RECORDING ON LAND AT A17/A52
BICKER BAR ROUNDABOUT,
SWINESHEAD,
LINCOLNSHIRE
(BBBF11)**

**Work Undertaken For
KG Contractors (Eastern) Limited**

August 2011

APS Report No: **93/11**

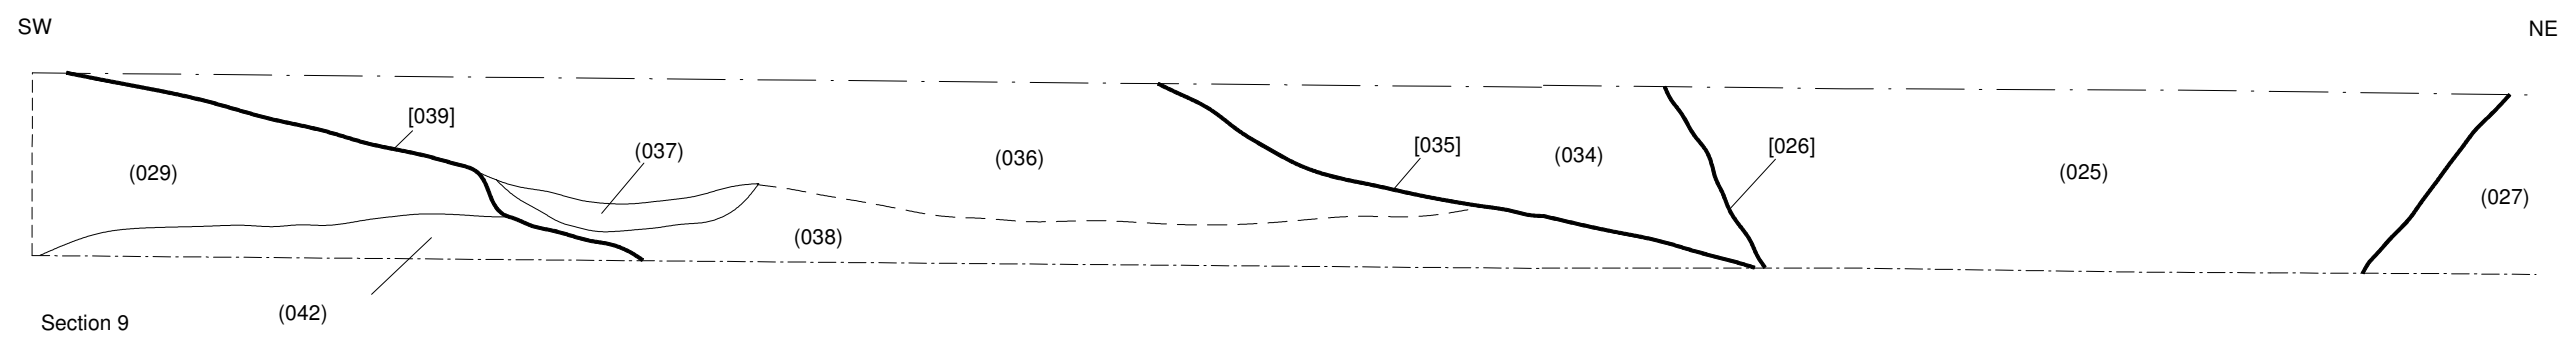
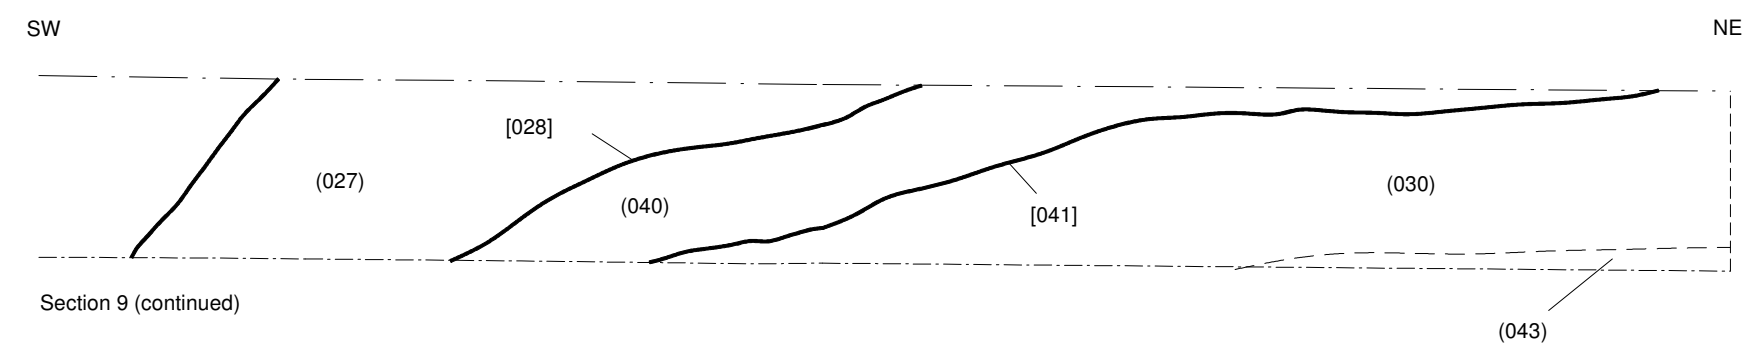
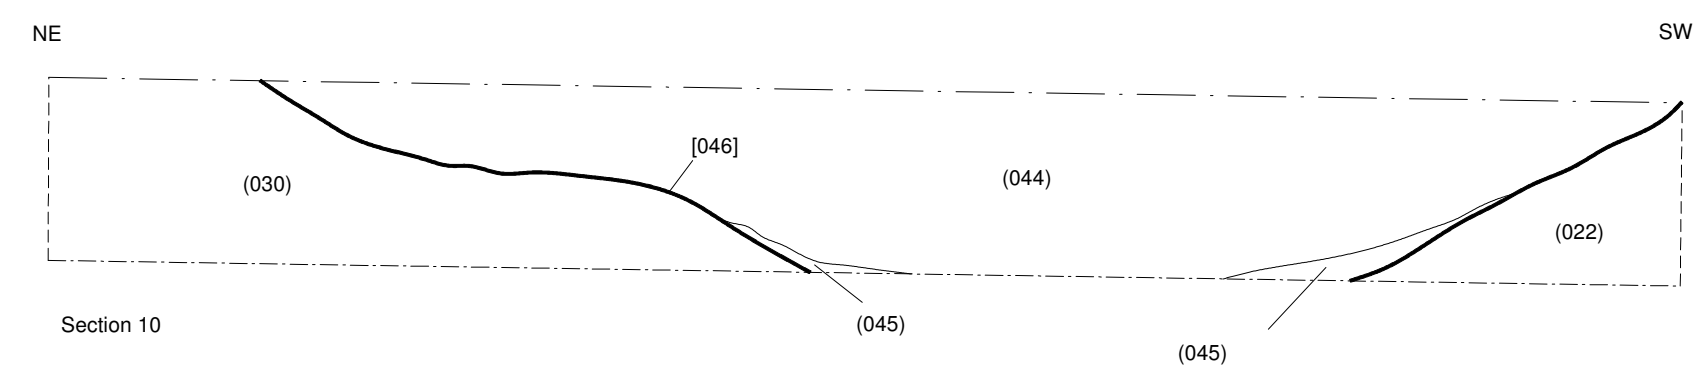
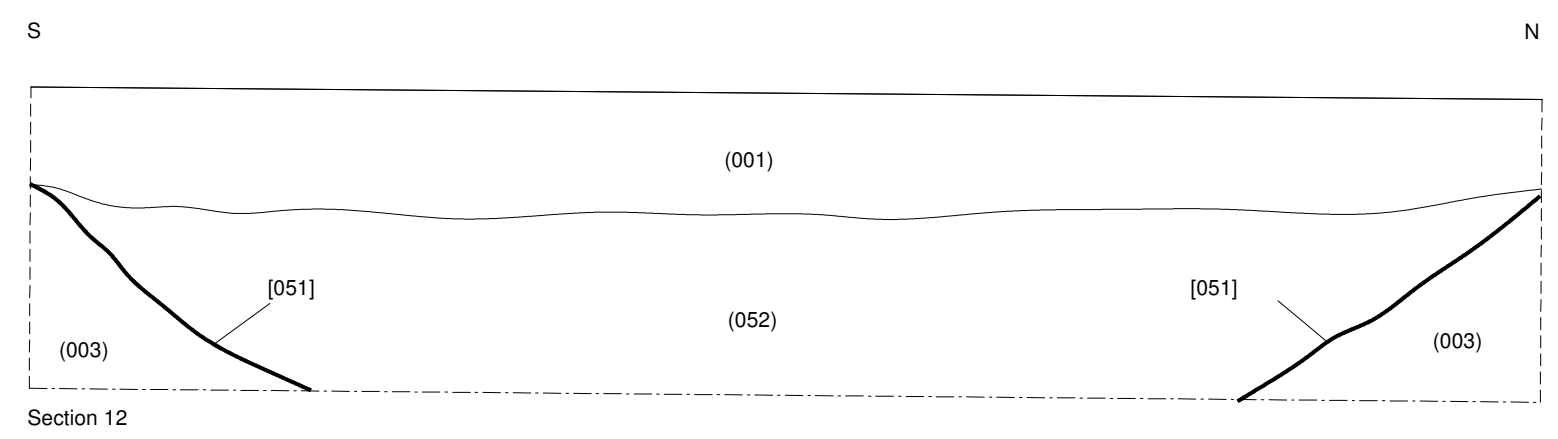
Figure 9 - Sections 9, 10 and 12

Located towards the centre of the site was a northwest-southeast aligned ditch (033/046). This measured 4.7m wide and was over 0.6m deep (Fig. 9, Section 10). A lower fill of grey clayey silt (045) was recorded above which lay deposits of brown silt (031 and 032) and greyish brown silt (044).

Representing a re-cut of the undated ditch (028/035) was ditch (026) that was 2.8m wide and over 0.6m deep (Fig. 9, Section 9). This ditch had been infilled recently with modern rubble (025).

Situated at the north of the site within the new drainage ditch was ditch (051) that measured over 3m wide and was deeper than 0.7m (Fig. 9, Section 12). This contained a single fill of brown clayey silt (052) that incorporated trimmed tree branches.

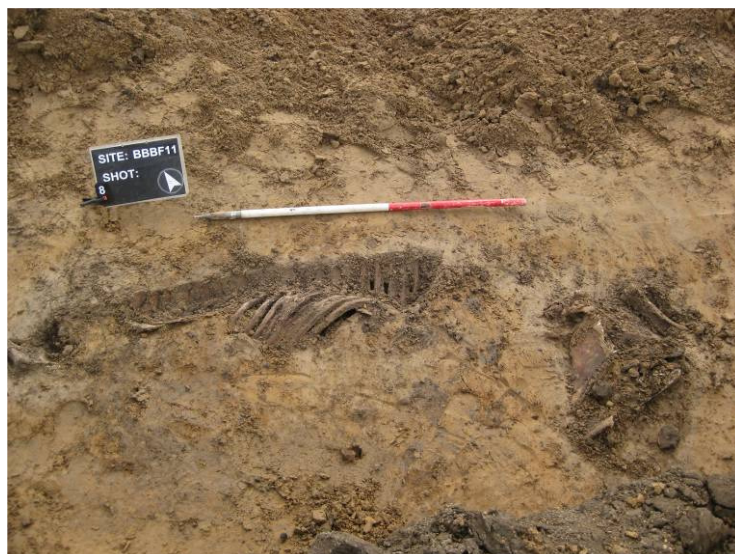
A horse skeleton, (004), thought to be of recent date, was found along the eastern part of the newly cut ditch.

Plate 3 – Horse burial (004), looking northeast

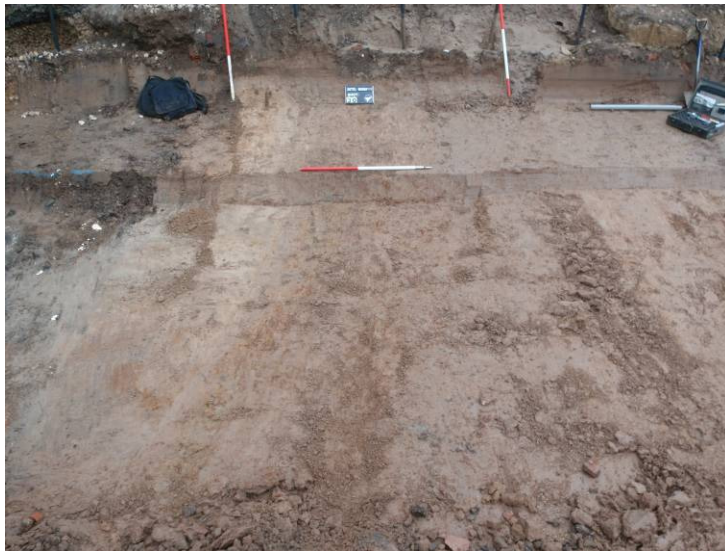
Aligned northwest-southeast (Fig. 7), to the southwest of ditch (033/046), was feature (039). Perhaps representing a natural channel, it measured over 4.1m wide and over 0.6m deep (Fig. 9, Section 9). Three fills were recorded, a lower of yellowish brown sandy silt (038), followed by bluish grey silty clay (037) and finally an upper layer of brown silt (036).

Parallel to this channel was a second channel (041) which may represent the northeast side of the same feature. This was over 3.8m wide and deeper than 0.6m and contained a single fill of greyish brown silt (040). If channels (039) and (041) represent the same feature, it would give a combined width of 12.34m.

Plate 8 – Sections 7 & 8 showing channel [039]/[041]

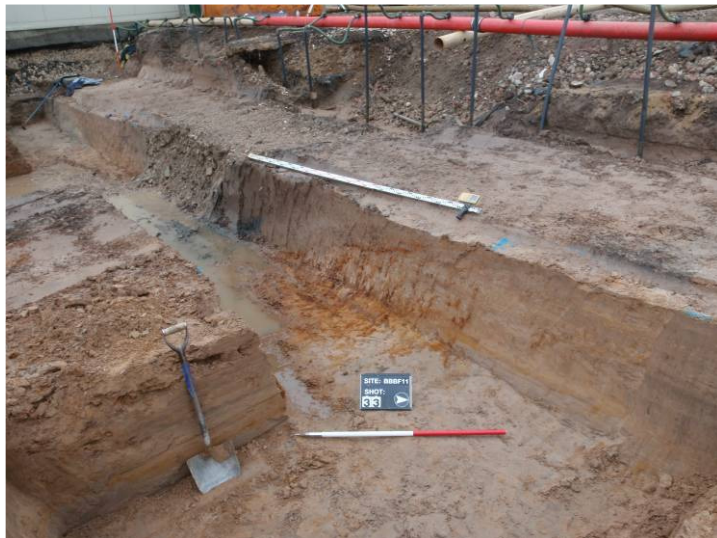
Plate 9 – Section 9 showing channel [039]/[041]

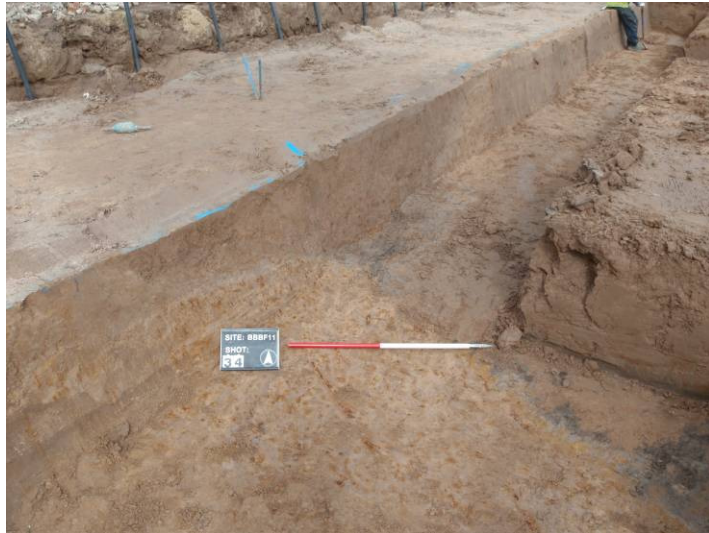
Plate 10 – Section 10 showing ditch [046], looking north

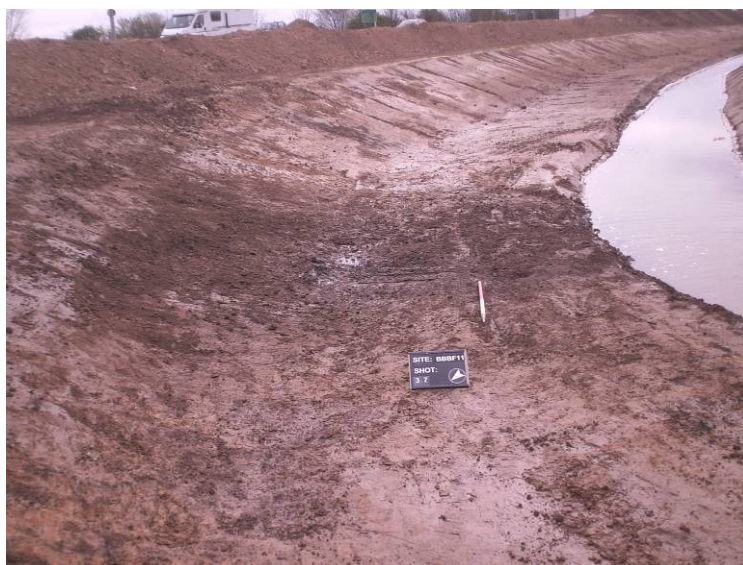
Plate 12 – Section 12, showing possible ditch [051]
