**ARCHAEOLOGICAL EVALUATION  
AT TATTERSHALL CASTLE,  
TATTERSHALL,  
LINCOLNSHIRE  
(TATC 11)**

**THE NATIONAL TRUST**

November 2011

APS Report No. **139/11**

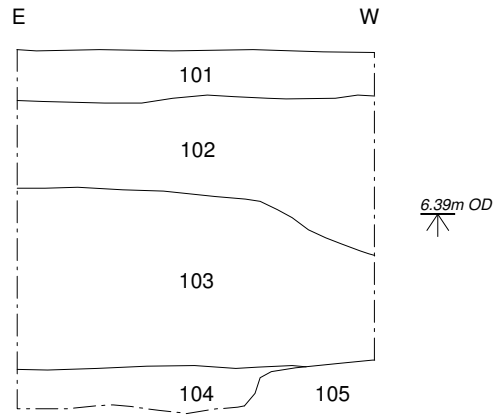
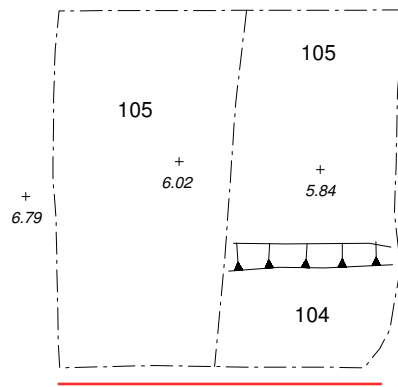
Figure 4 - Trench 1: Plan and section

##### *Trench 1* (Fig. 4; Plate 2)

Located at the base of this trench was a deposit of orange brown sand (105). Interpreted as a levelling deposit it was over 0.12m thick.

Developed over and against this was a former topsoil of greyish brown sandy silt (104) that measured in excess of 0.2m thick. This contained frequent gravel and brick/tile fragments. Pottery of 19<sup>th</sup> century date and earlier was retrieved from this layer.

The former topsoil was sealed by dumped deposits of grey silty sand (103) and orange grey sandy silt (102) both of which contained gravel, limestone and brick/tile fragments. The dumped deposits had a combined thickness of 0.87m and contained pottery of 16<sup>th</sup> – 17<sup>th</sup> century date.

Sealing the dumped layers was the modern topsoil/turf layer of greyish brown sandy silt (101) that was 0.15m thick.

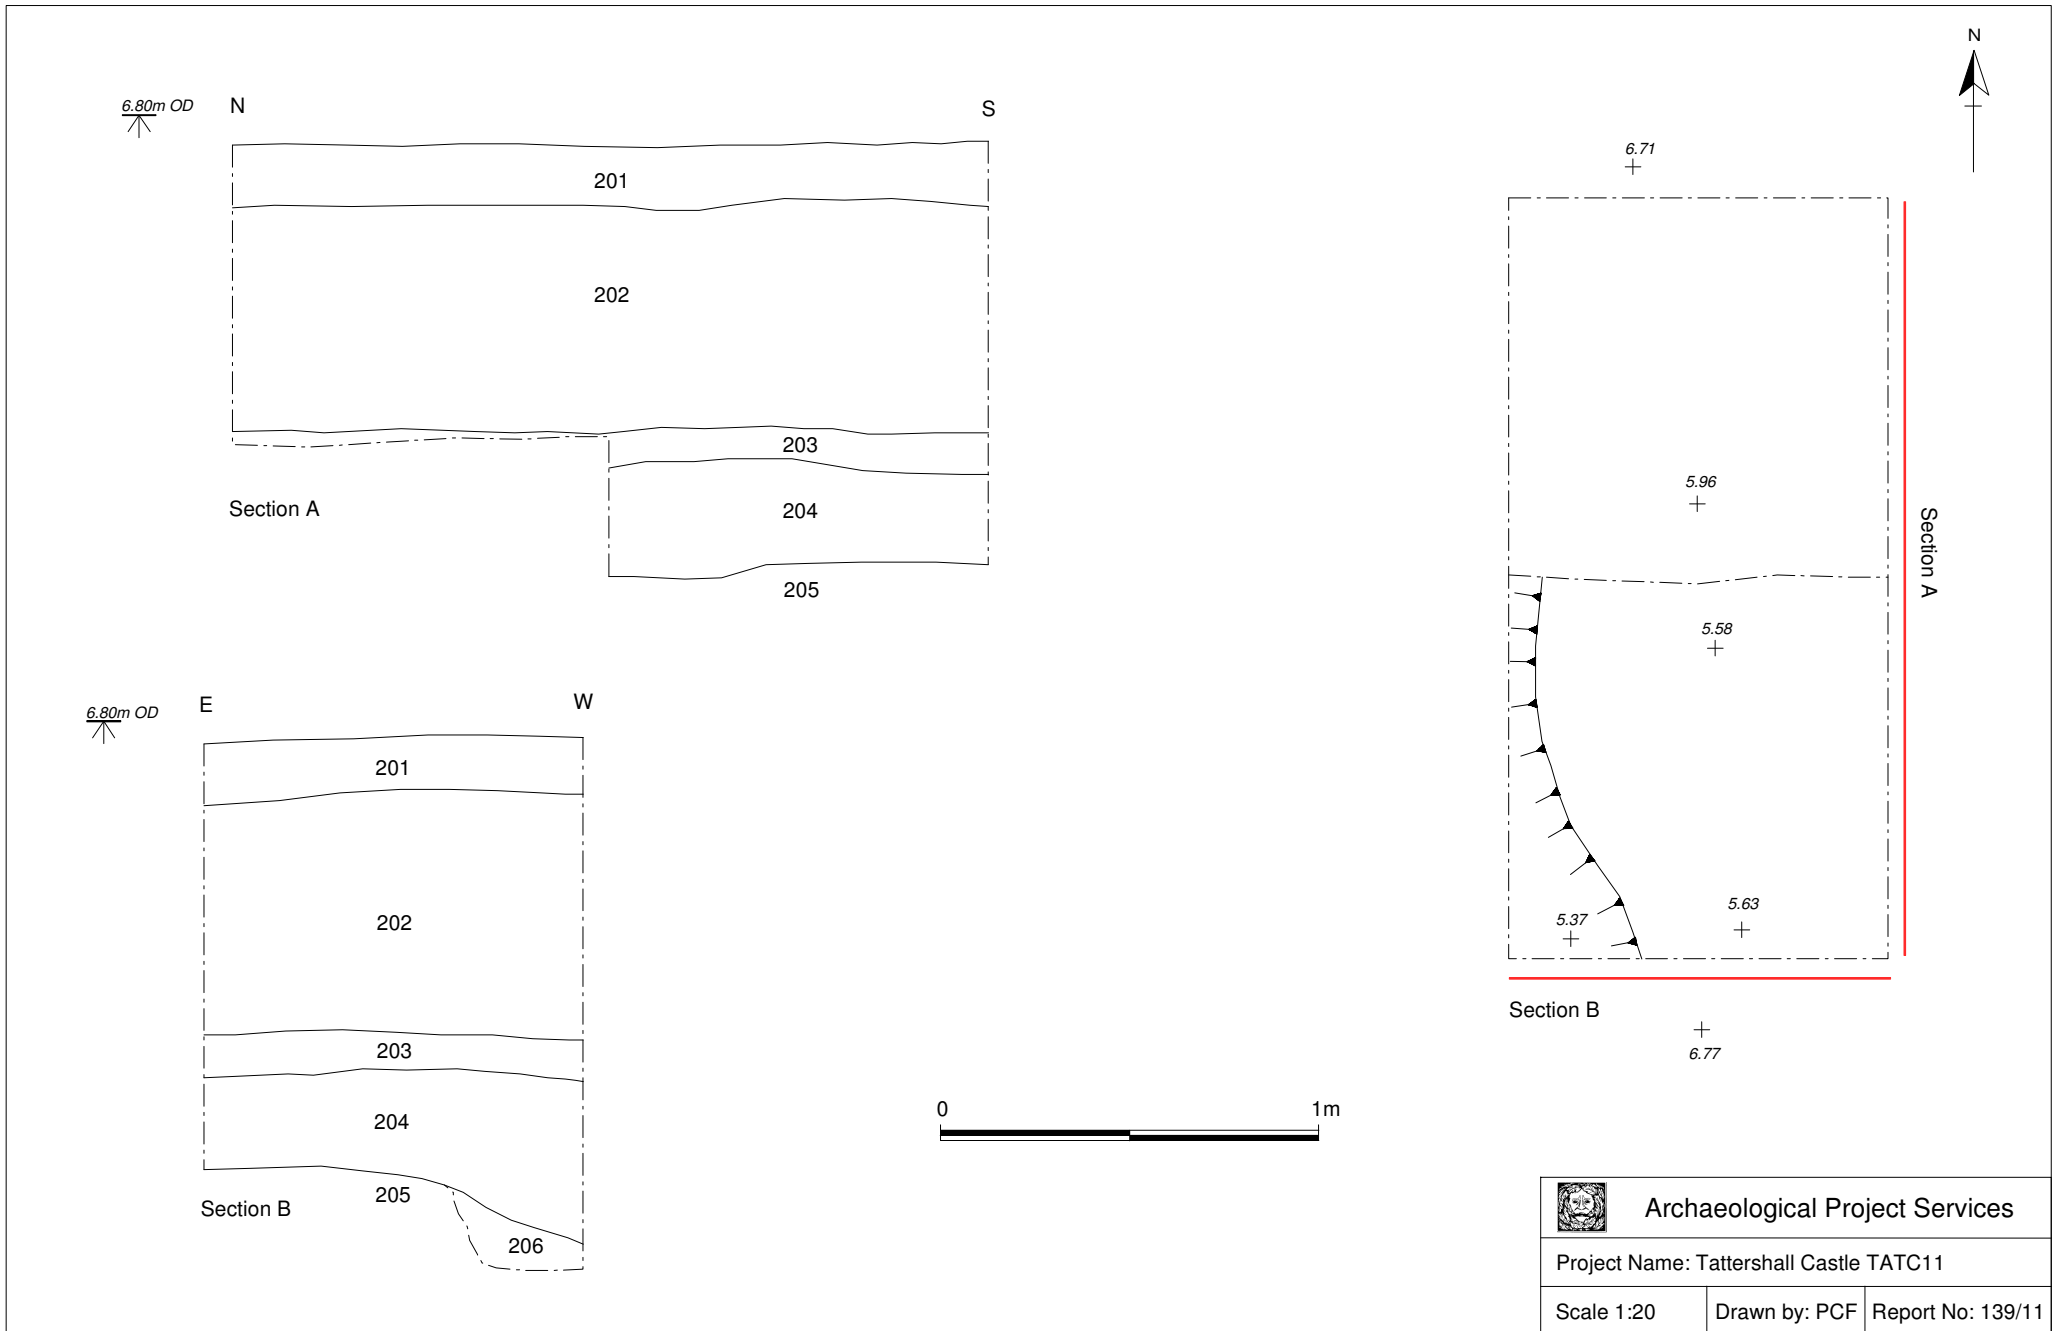
Figure 5 - Trench 2: Plan and sections

##### *Trench 2* (Fig. 5; Plates 3 and 4)

The earliest deposit recorded within this trench was a possible surface comprising limestone fragments and mortar (205). Adjacent to, and slightly overlying, this was a layer of brown sandy silt (206) that was over 0.22m thick.

Sealing these layers was a levelling deposit of yellowish brown sandy silt with frequent gravel (204). This was 0.42m thick and contained medieval pottery and 18<sup>th</sup> century clay pipe. This was in turn sealed by a former topsoil of brown sandy silt (203) that measured 0.11m thick.

Overlying this was a 0.65m thick dumped

deposit of limestone fragments, brick/tile and degraded mortar (202). Post-medieval pottery, glass and clay pipe was recovered along with medieval and later brick and tile. This trench was sealed by the current topsoil of greyish brown sandy silt (201).

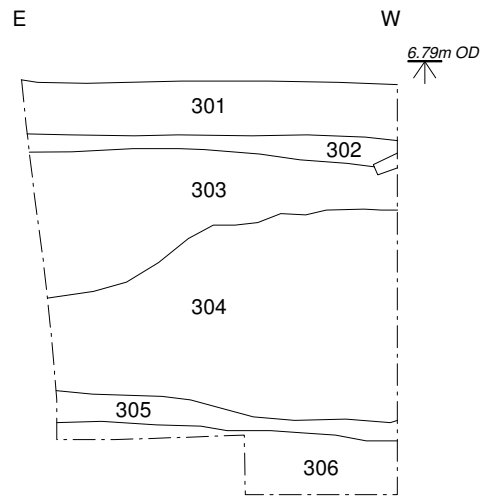
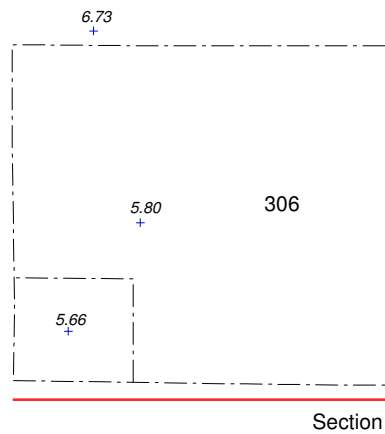
Figure 6 - Trench 3: Plan and section

**Trench 3** (Fig. 6; Plate 5)

A former topsoil of greyish brown silty sand (306) which was over 0.18m thick was encountered at the base of this trench. This was sealed by an 80mm thick layer of orange brown sand (305).

Dumping was evident in the form of brownish grey degraded mortar with brick and gravel (304) and yellowish grey silty sand and mortar with gravel, limestone and brick/tile fragments (303), that measured 0.56m and 0.38m thick respectively. Finds from these layers dated to the 17<sup>th</sup> century and earlier and included some medieval architectural stonework.

A thin layer of greyish brown sandy silt (302) overlay the dumped layers and was in turn sealed by further greyish brown sandy silt (301) of the present topsoil.

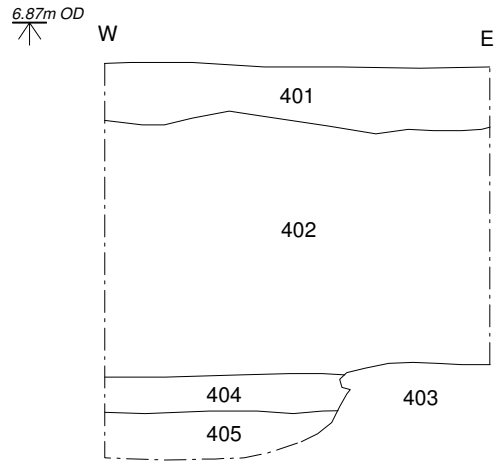
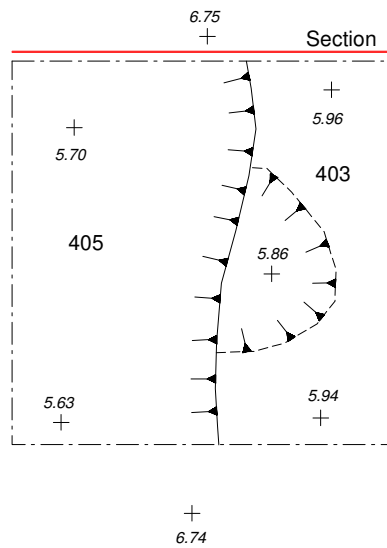
Figure 7 - Trench 4: Plan and section

**Trench 4** (Fig. 7; Plate 6)

The sequence of deposits encountered in this trench began with a levelling deposit of yellowish brown sandy silt with gravel and shell (405). This measured in excess of 0.14m thick and contained post-medieval glass.

An area of limestone fragments and degraded mortar (403) in the eastern part of the trench represents a remnant of wall core and was 0.2m thick.

Developed over the levelling deposit and wall core was a former topsoil of brown sandy silt (404) that was 0.1m thick.

A dumped deposit overlay the former topsoil. This consisted of yellowish brown limestone, brick and tile fragments and

degraded mortar (402) and was 0.67m thick. Finds of 17<sup>th</sup> century date and earlier were recovered from this layer. This was in turn sealed by the modern topsoil (401).

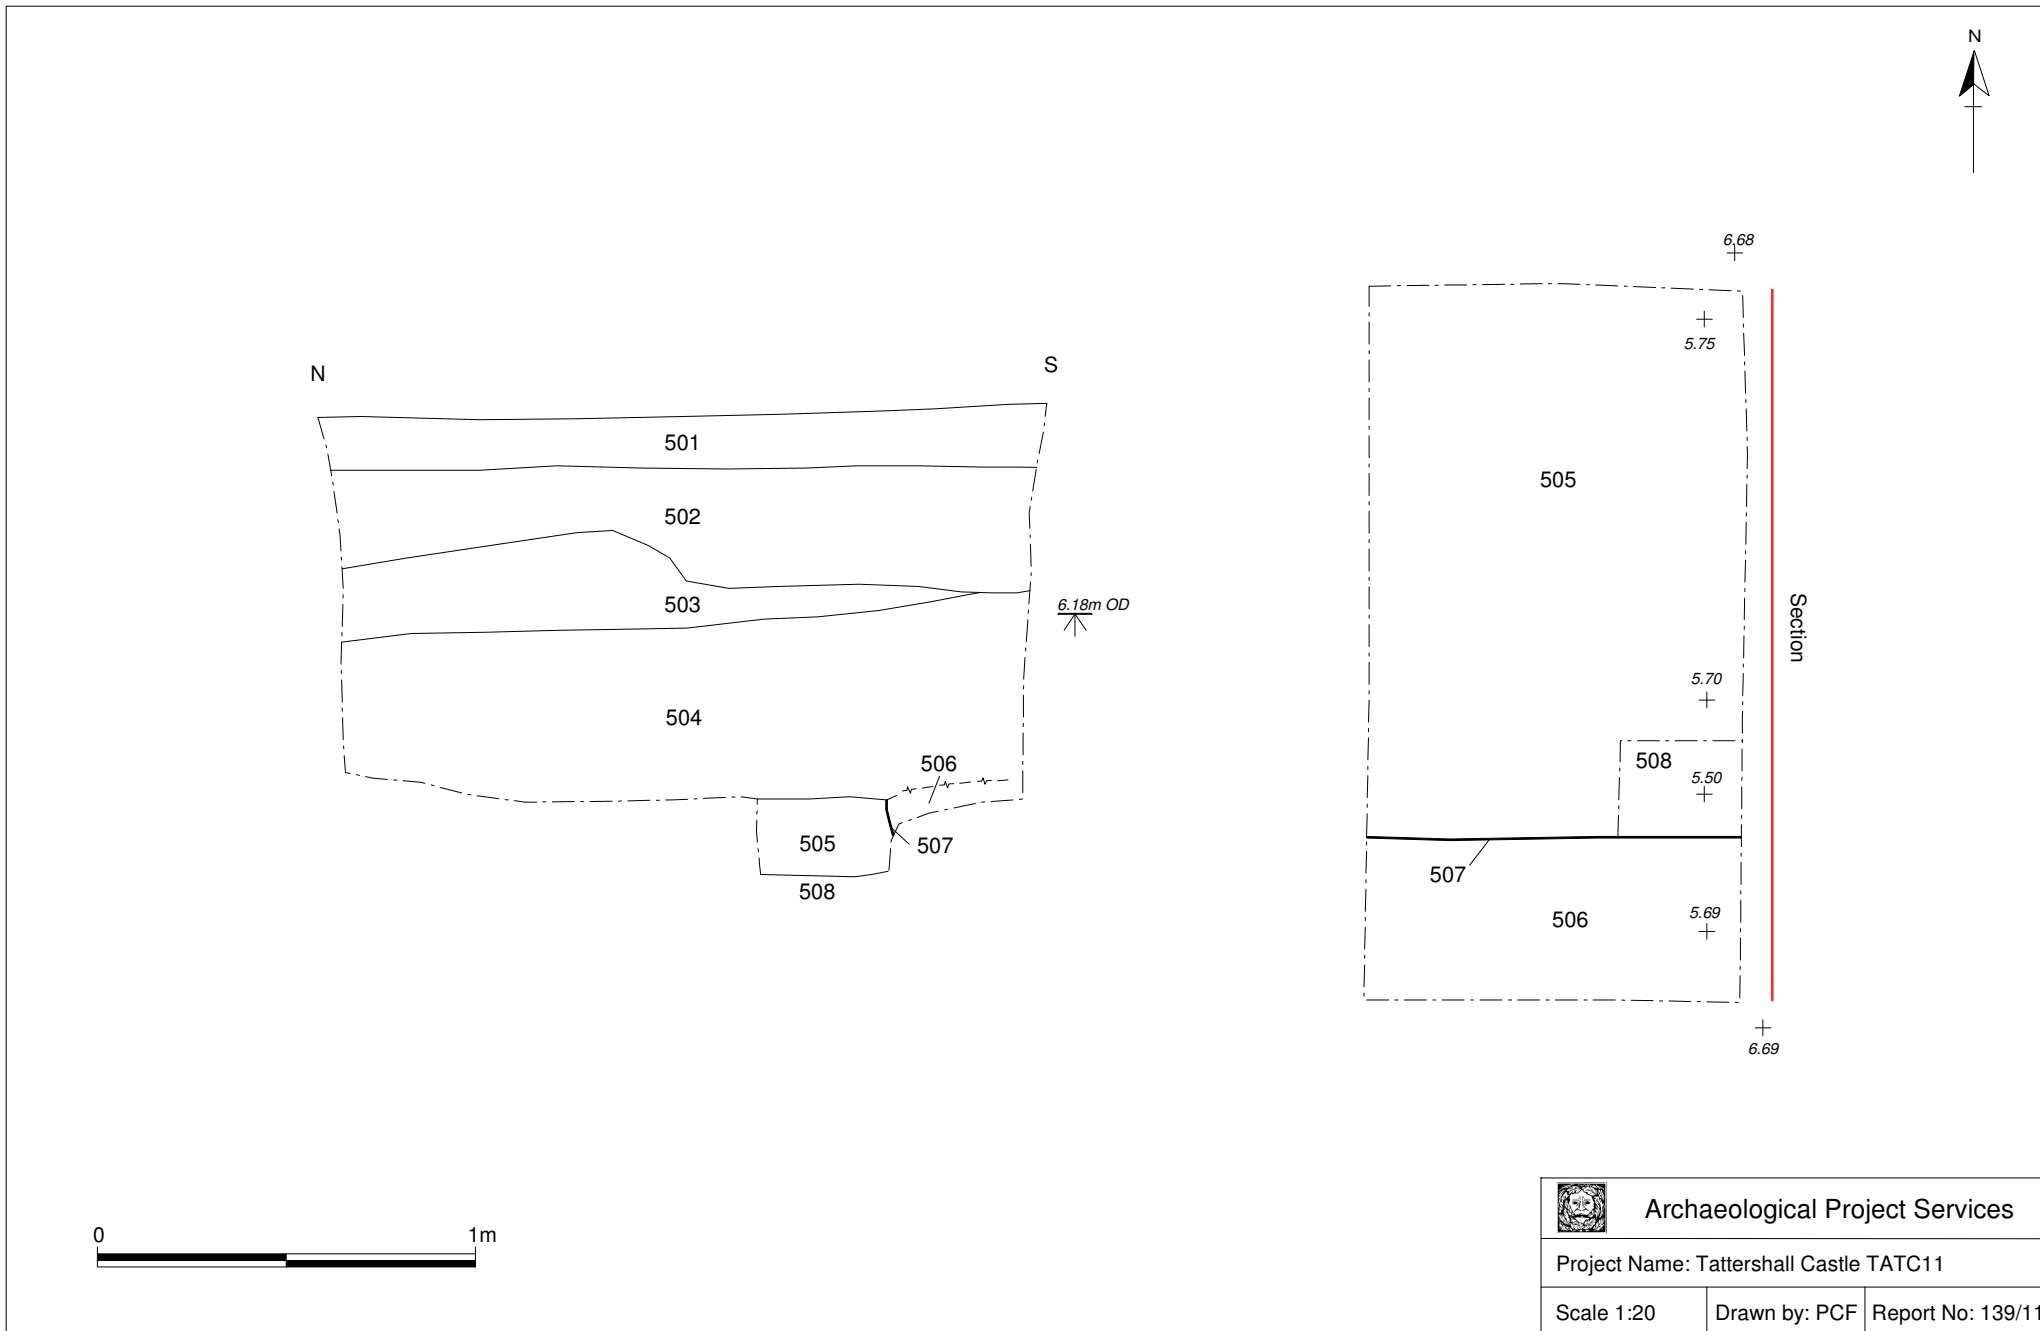
Figure 8 - Trench 5: Plan and section

**Trench 5** (Fig. 8; Plate 7)

At the base of this trench was a levelling deposit of reddish brown sand (508). This was overlain by a deposit of greyish brown sand (505) identified as a former topsoil. A possible Roman or later tile fragment was retrieved from this layer.

Cutting this was an east-west aligned foundation trench (507) that was over 0.37m wide and deeper than 0.2m (Fig. 8). Contained within this was a compacted deposit of sand, gravel and mortar with a number of brick fragments (506), perhaps the remnant of a wall.

The sequence within this trench continued with episodes of dumping as indicated by deposits of brown sand and gravel with mortar, brick/tile and plaster fragments (504), brownish grey sand (503) and brown degraded mortar with brick/tile fragments (502) with a combined thickness of 0.88m. A sherd of Roman pottery was recovered from (504), although the remainder of the finds were post-medieval in date.

Sealing all deposits within this trench was a topsoil of grey sand (501) that was 0.14m thick.

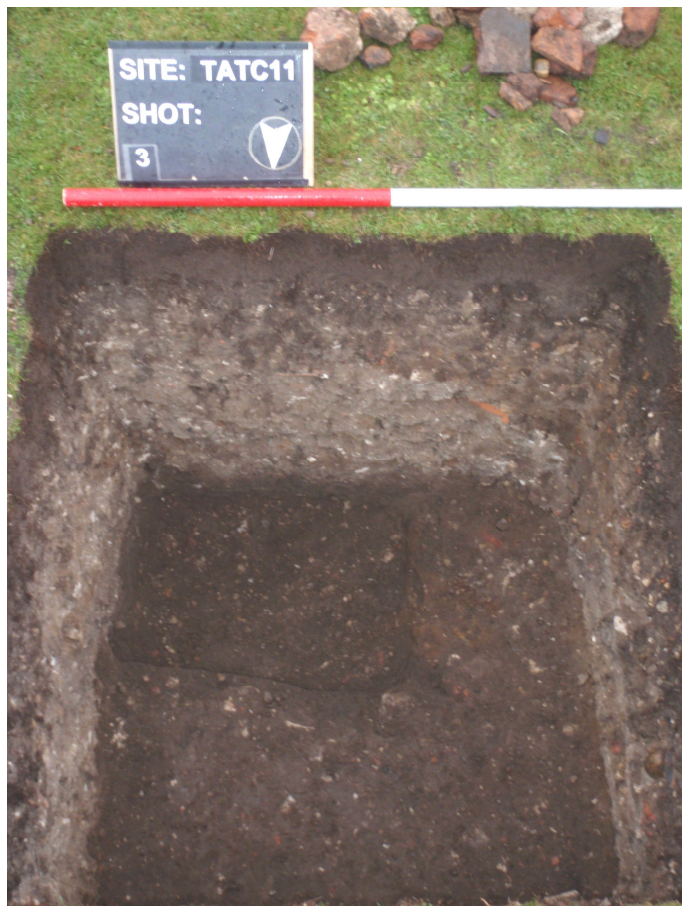
Plate 2 – Trench 1: Plan and section view, looking south

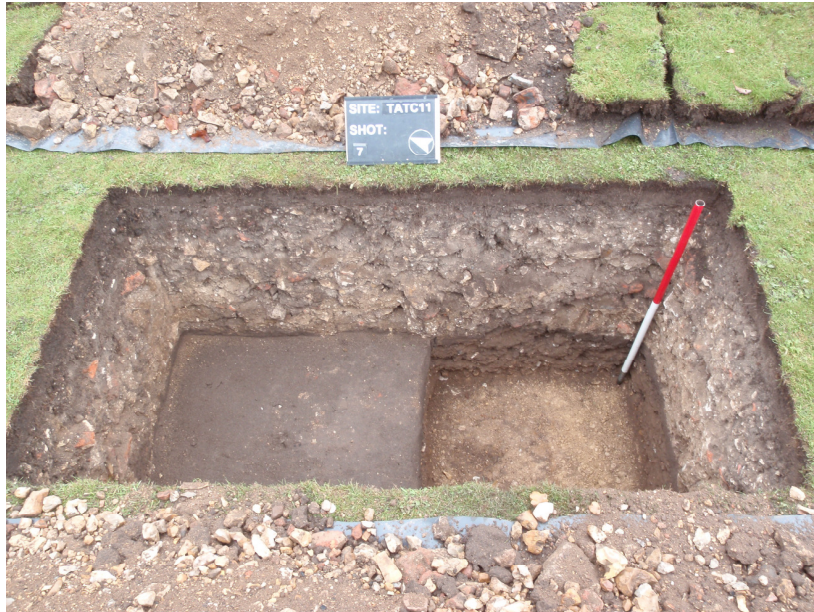
Plate 3 – Trench 2, west facing section, looking east

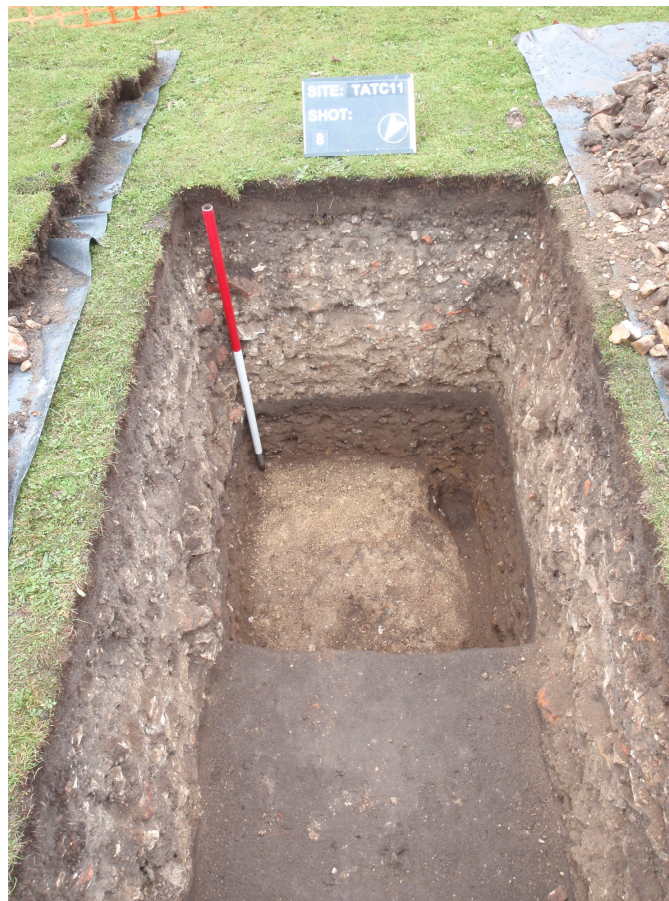
Plate 4 – Trench 2, north facing section, looking south

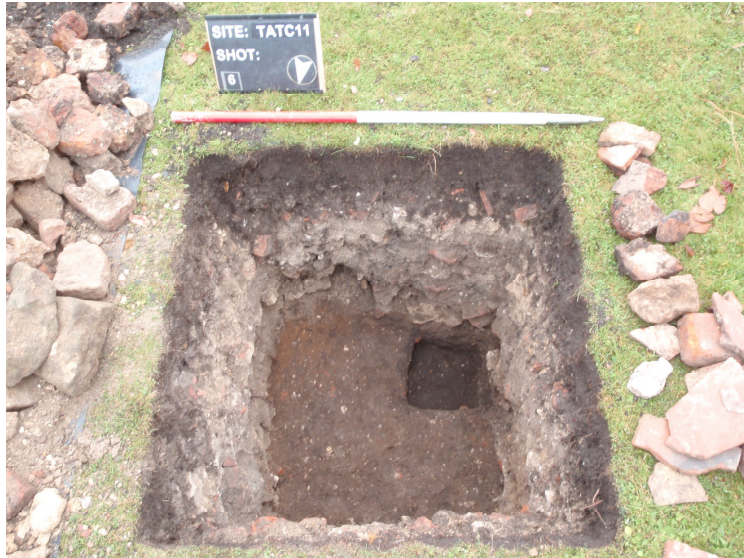
Plate 5 – Trench 3, plan and section view, looking south

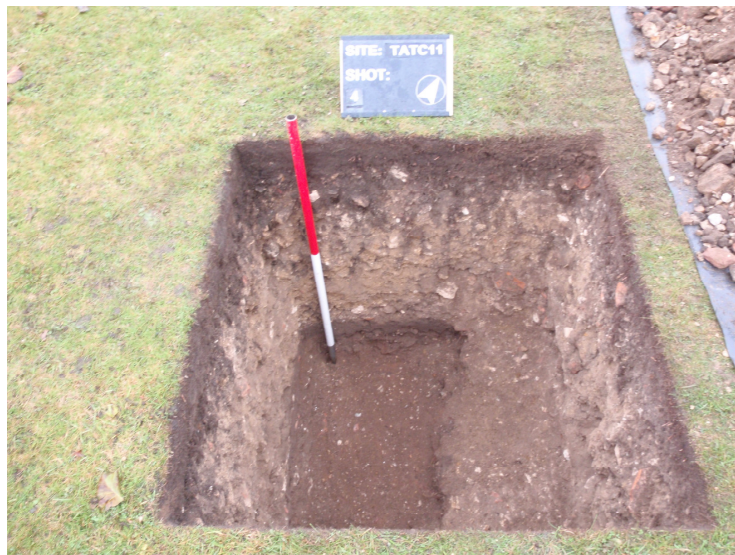
Plate 6 – Trench 4, plan and section view, looking north

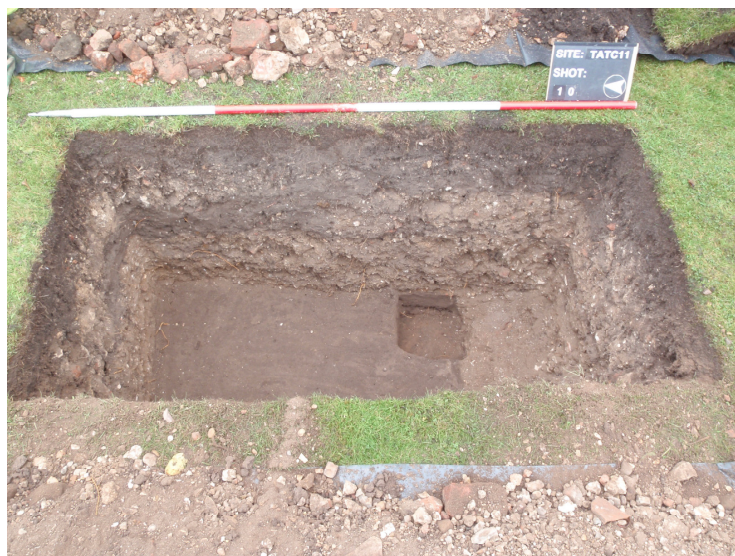
Plate 7 – Trench 5, plan and section view, looking east
