**ARCHAEOLOGICAL MONITORING AND
RECORDING
ON LAND AT
NORTH ROAD, GEDNEY HILL
LINCOLNSHIRE
(GHNC10)**

**Work Undertaken For
Deljon Properties**

APS Report No: **143/11**

**ARCHAEOLOGICAL
PROJECT
SERVICES**

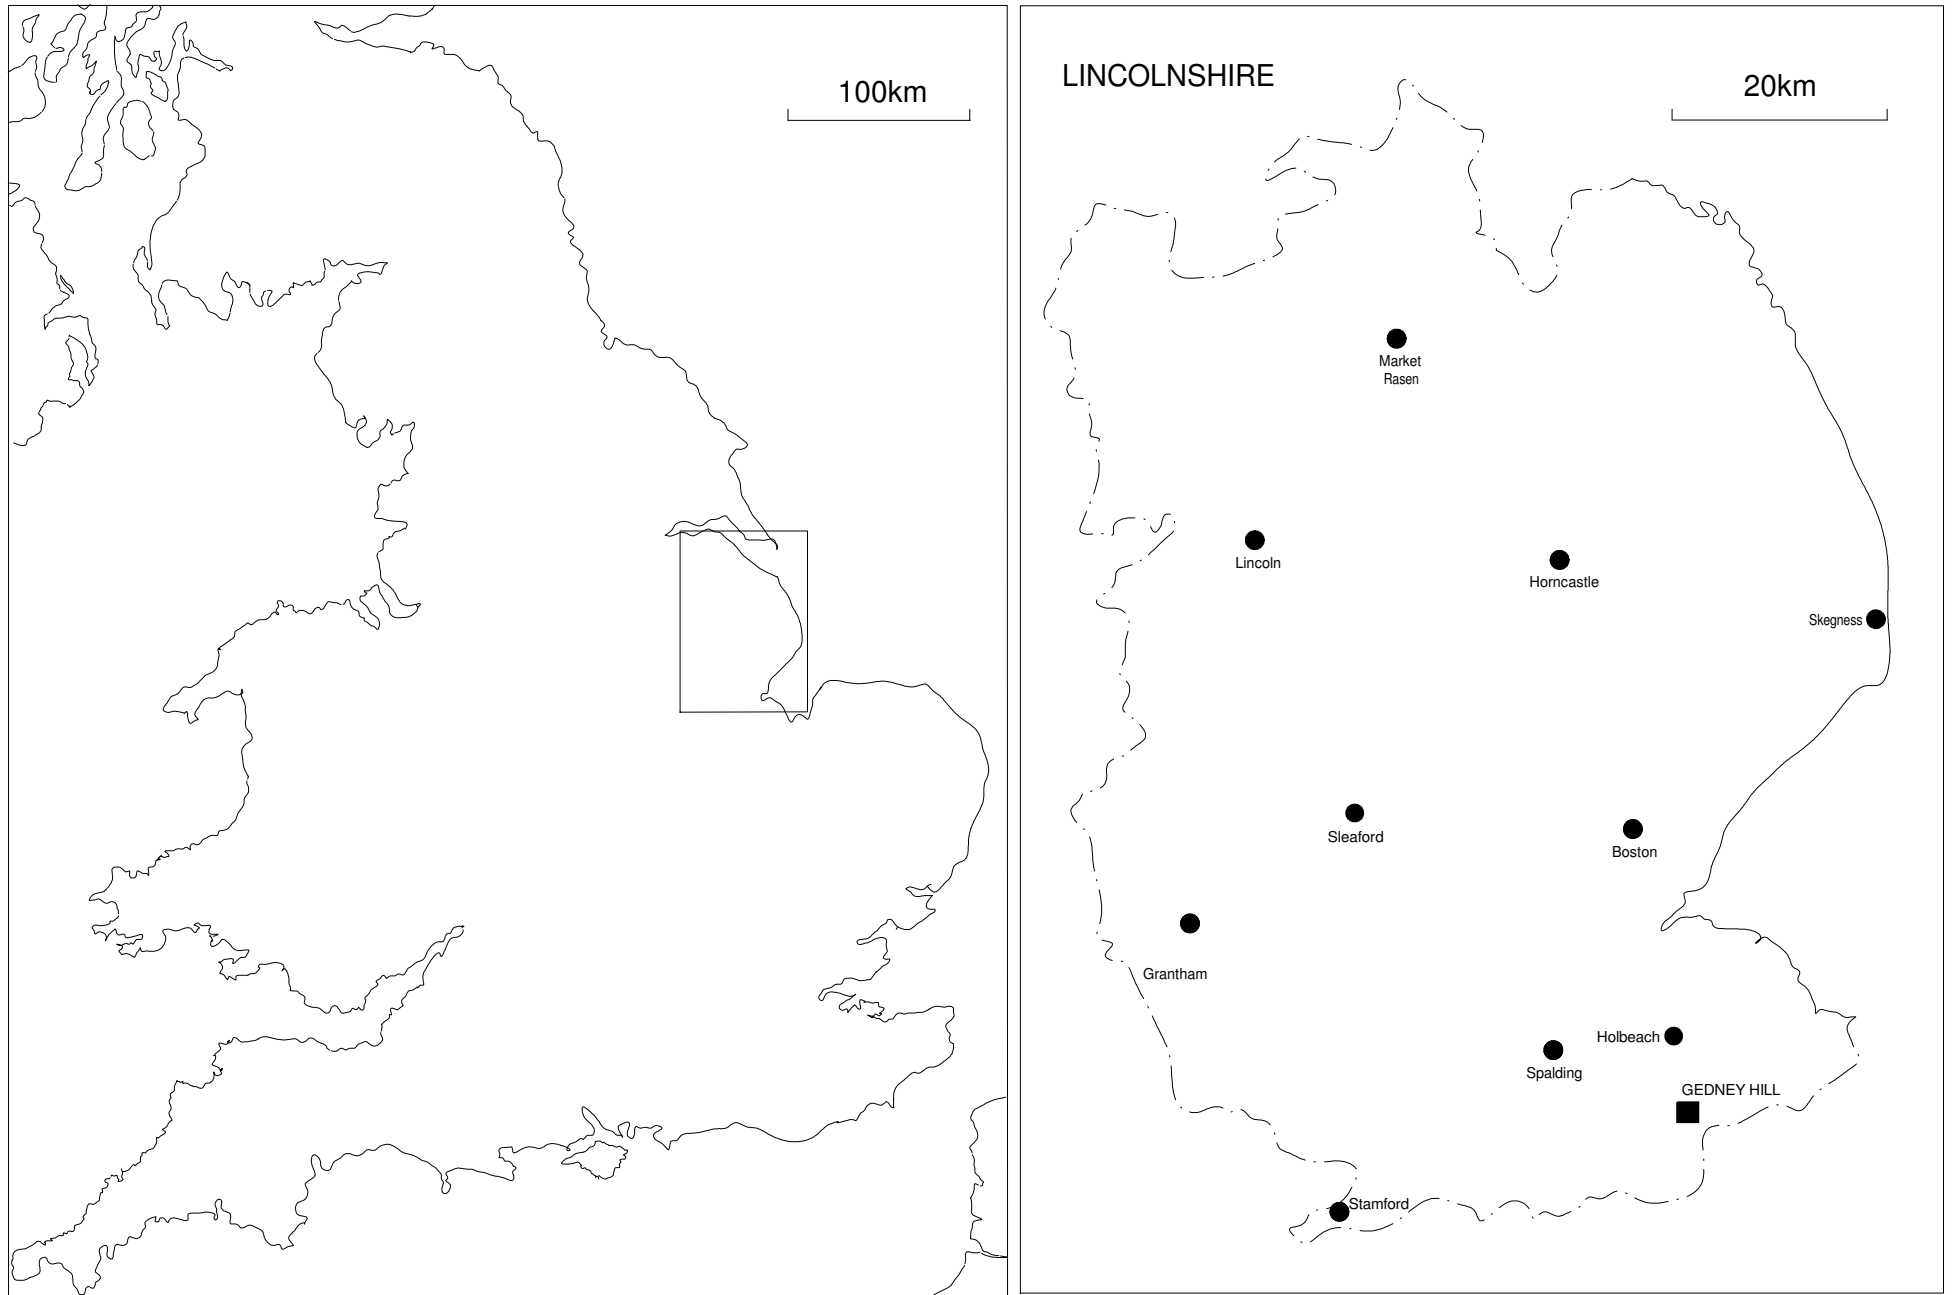
Figure 1 General Location Plan

Gedney Hill is located 15km southeast of Spalding and 12km west of Wisbech in the South Holland district of Lincolnshire (Fig. 1).

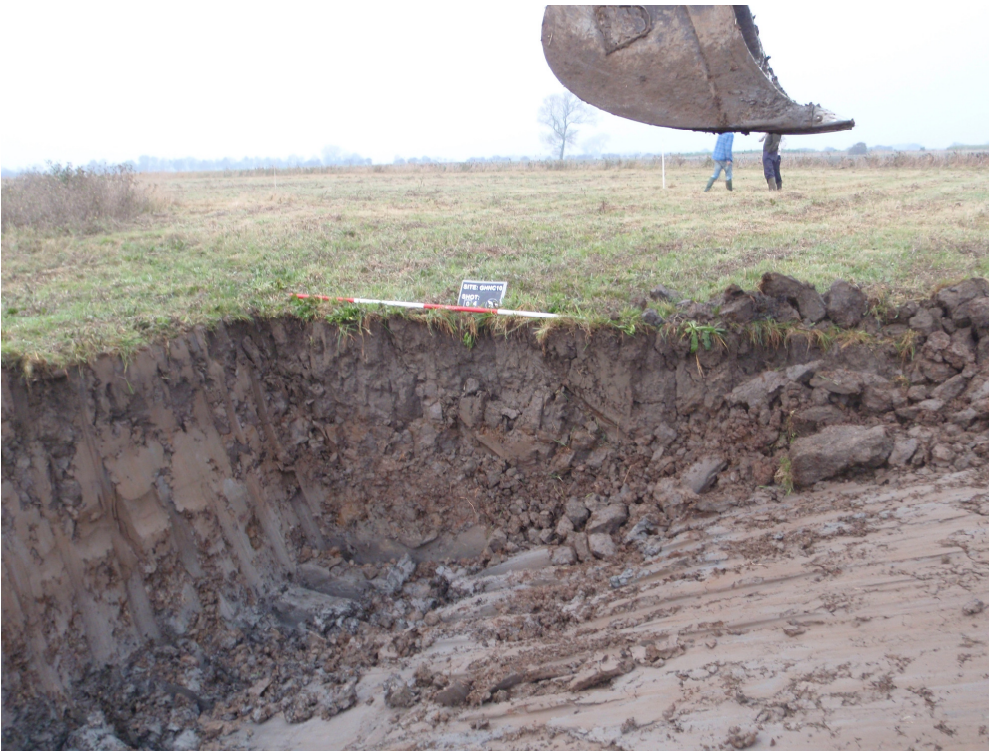
Plate 2: Section of ditch dug around perimeter

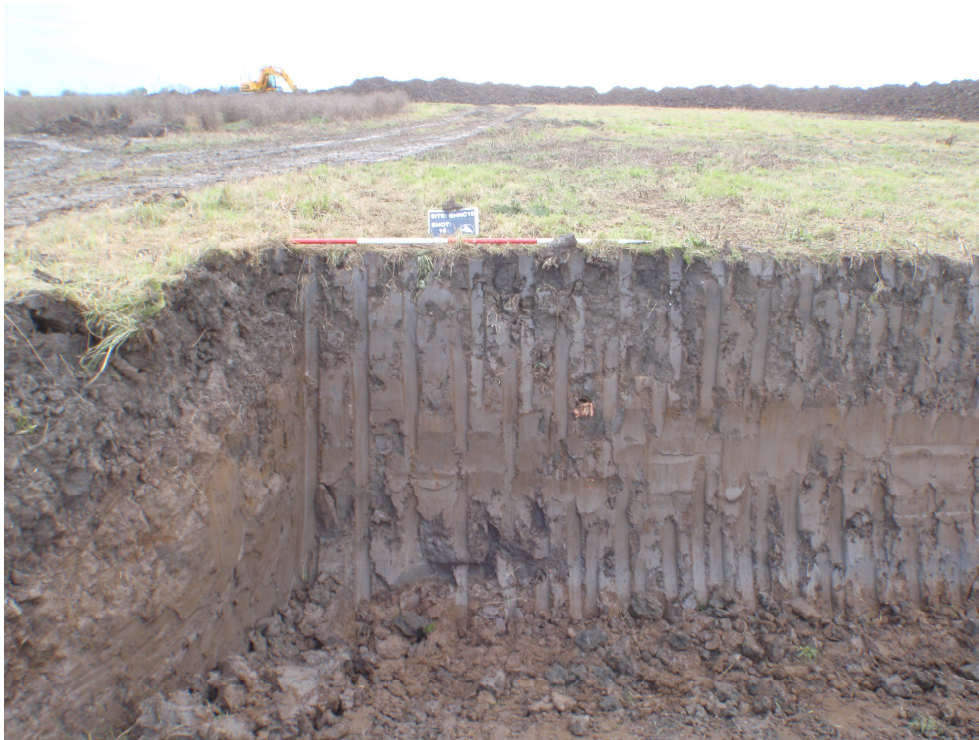
The earliest deposit recorded on site was a reddish brown clayey silt, (004). This alluvial deposit was only observed in one location on the site, during the deep excavations of the perimeter, where the overlying deposit (003) was thinner and had been removed completely (Figure 6 – Section 6; Plate 3).

Plate 3: Section 6 showing all deposits

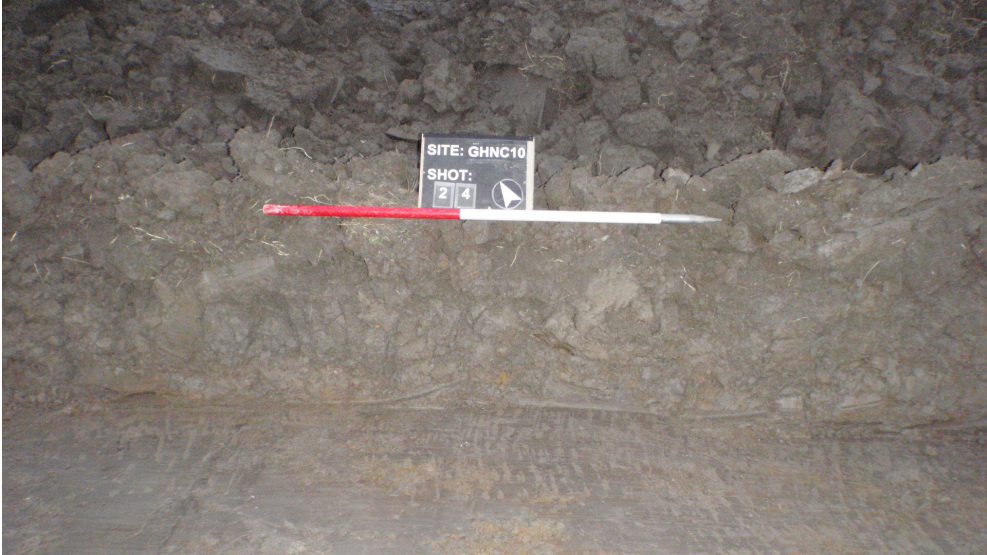
Plate 5: 1m representative section Trench 1
