**ARCHAEOLOGICAL MONITORING AND
RECORDING ON LAND AT TRINITY STREET,
GAINSBOROUGH,
LINCOLNSHIRE
(GBTS 11)**

**Work Undertaken For
McDonalds Restaurants Limited**

May 2012

APS Report No. **27/12**

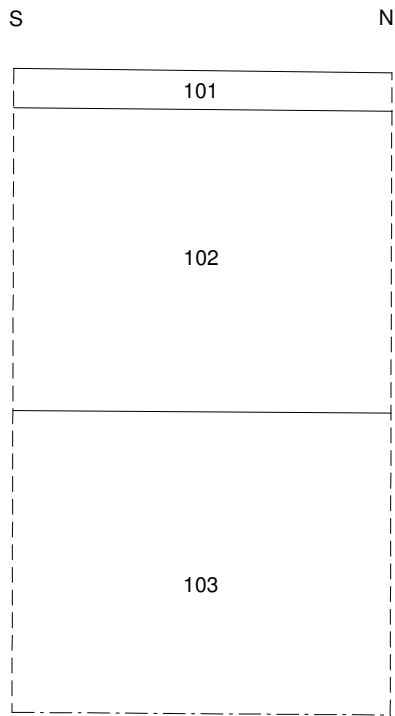
Section 1

The earliest deposit encountered within this Test Pit was a layer of light brown sand (103). Identified as natural, it measured in excess of 0.8m thick (Fig. 4, Section 1; Plate 2).

Overlying this was a 0.8m thick layer of mixed mortar and brick fragments (102). This was interpreted as a levelling deposit with demolition material. This was in turn sealed by the current topsoil comprising

brown sandy silt (101) which was 0.1m thick.

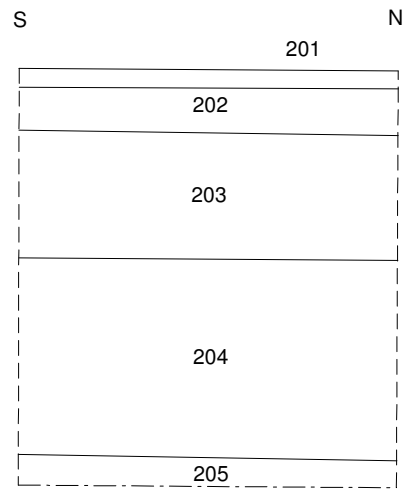
Section 2

Located at the base of this Test Pit was a natural layer of light brown sand (205) which was over 80mm thick. Above this was an organic black sandy silt (204) of unknown origin that was 0.52m thick (Fig. 4, Section 2; Plate 3).

This was sealed by a dumped deposit of black, with light grey and red patches, mix of sandy silt, ash and brick fragments (203). Perhaps derived from nearby industrial activities, it measured 0.33m thick.

This was in turn overlain by a 0.12m thick concrete raft (202) upon which was a tarmac surface (201) that was 60mm thick.

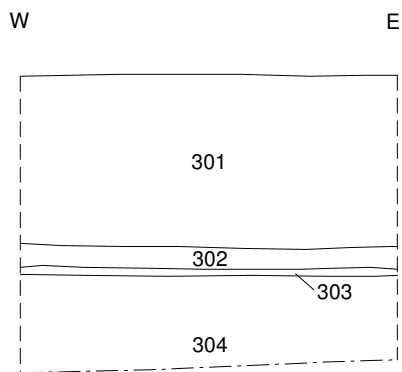
Section 3

No natural deposits were encountered across Area 1. The earliest layer was a levelling deposit of brown clayey silt (304) which measured over 0.21m thick. Above this was a dumped deposit of coal dust and fragments (303), measuring 50mm thick (Fig. 4, Section 3; Plate 5).

Further levelling deposits were encountered and comprised brown clayey silt (302) and red and brownish grey rubble, slate and mortar (301). These had a combined thickness of 0.5m.

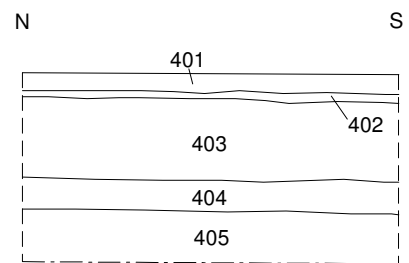
Section 4

Greyish brown sandy silt (405) measuring over 0.13m thick (Fig. 4, Section 4; Plate 7) was recorded across the stripped area. This was sealed beneath levelling layers of grey clay (404) and mixed red and brownish grey sand, brick and mortar fragments (403).

Sealing the above deposits was a layer of brick and rubble (402) providing make-up for the current surface of black tarmac (401).

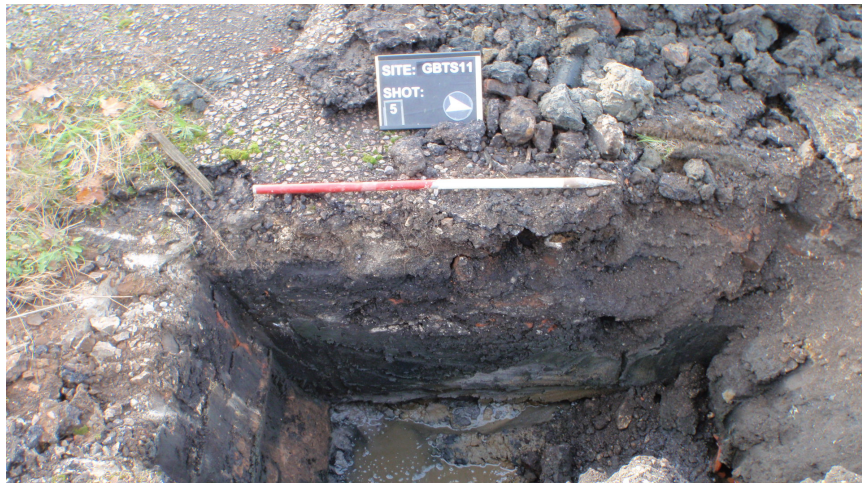
Plate 2 – Section 1 showing the general sequence of deposits, looking west

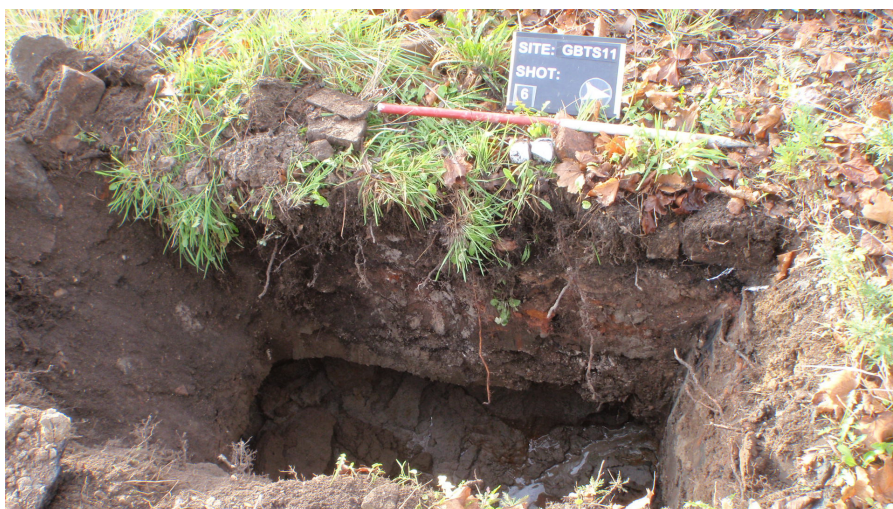
Plate 3 – Section 2, looking west

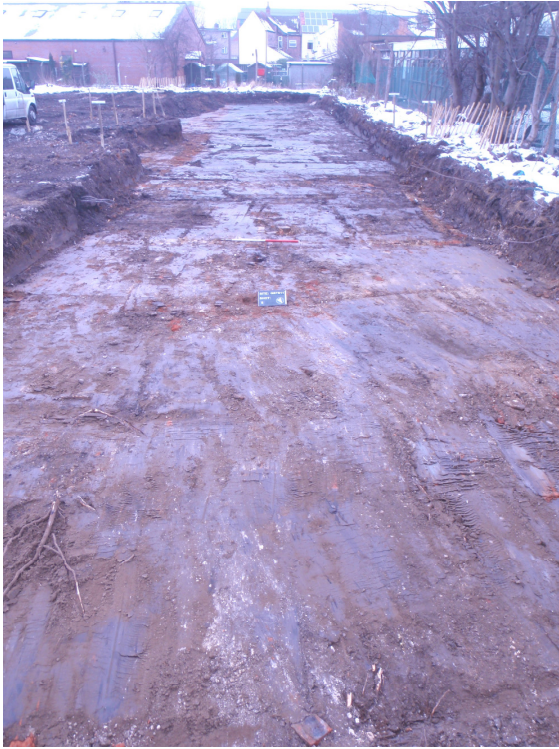
Plate 4 – Area 1 after stripping, looking west

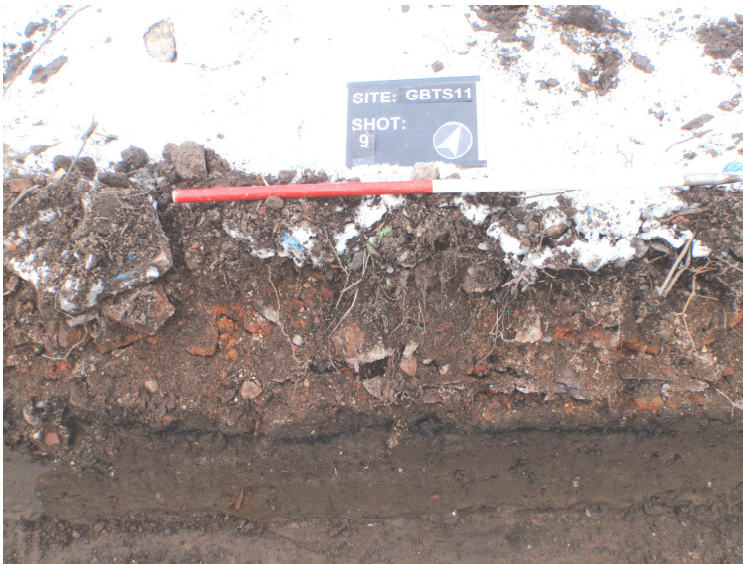
Plate 5- Section 3, looking northwest

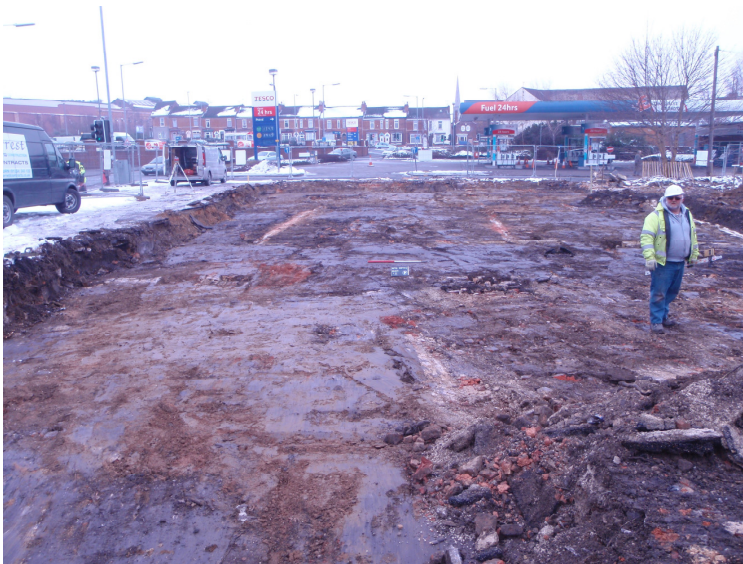
Within Area 2 were found the remnants of three brick built circular structures. The first (1000) was identified as a well and was located along the eastern boundary of the site (Plate 8). It measured over 5m deep with an internal diameter of 0.83m and was capped with a sandstone slab.

Plate 6 – Area 2 after stripping, looking south

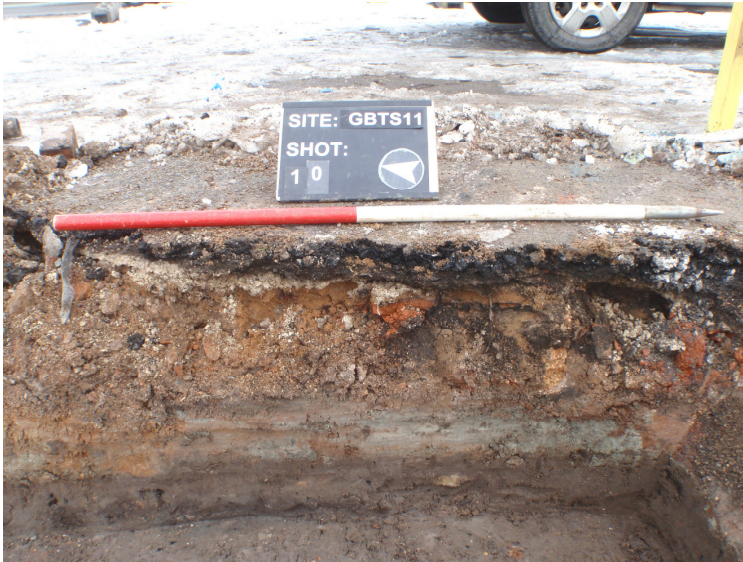
Plate 7 – Section 4, looking east

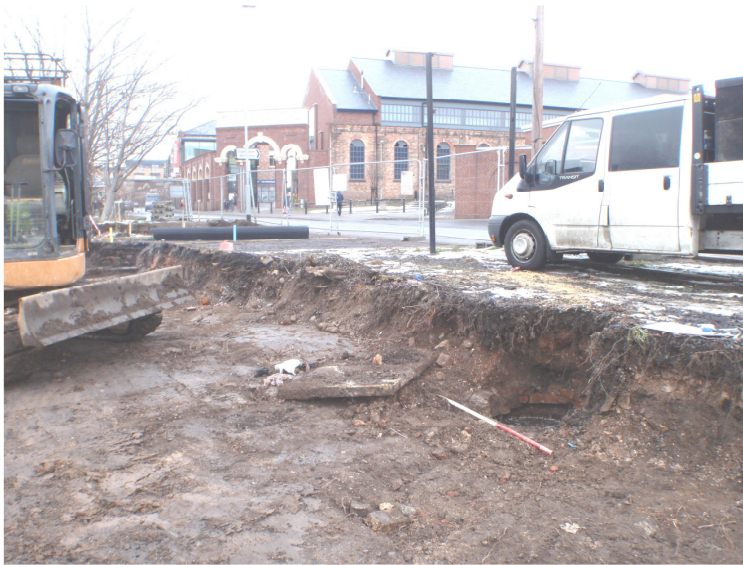
Plate 8 – Well (1000), looking northeast

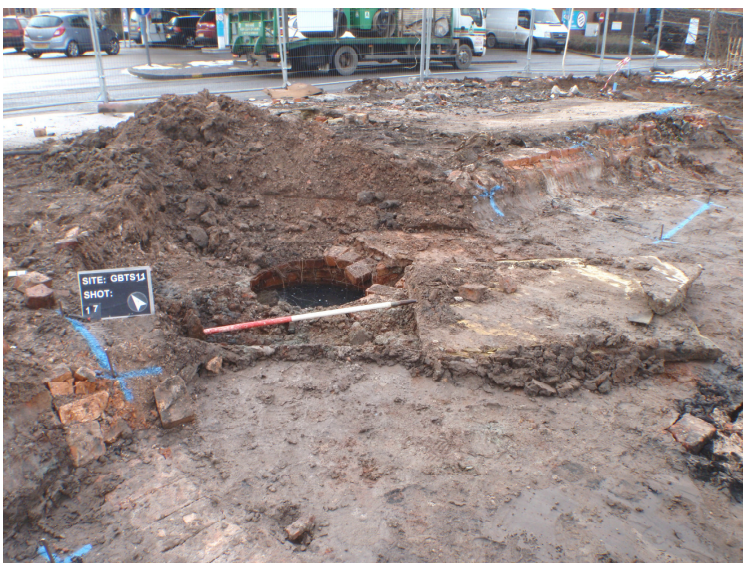
Located 22m to the south at the corner of the stripped area was a former cess-pit (1001) that had an internal diameter of 0.9m and also had a sandstone slab capping (Plate 9).

Plate 9 – Cess pit (1001) as exposed, looking east

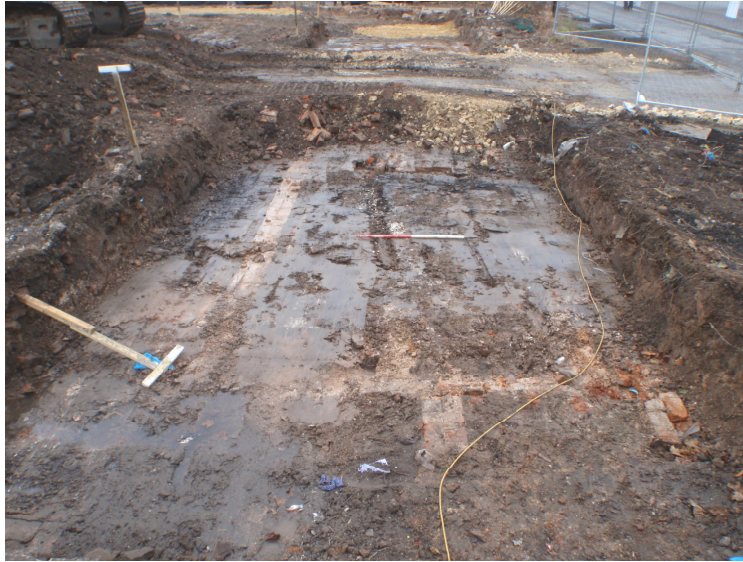
The foundations of several walls were planned within this area. There is an L-shaped wall with an internal north-south aligned dividing wall, creating a room 4.18m wide and at least 3.1m long (Plate 10). The north-south walls have buttresses.

Plate 10 – Area 3 showing the exposed brick foundations, looking east
