**ARCHAEOLOGICAL MONITORING AND
RECORDING AT
ST MARGARET'S CHURCH,
SIBSEY,
LINCOLNSHIRE
(SISM 11)**

**Work Undertaken For
Sibsey Parish Council**

April 2012

APS Report No. 30/12

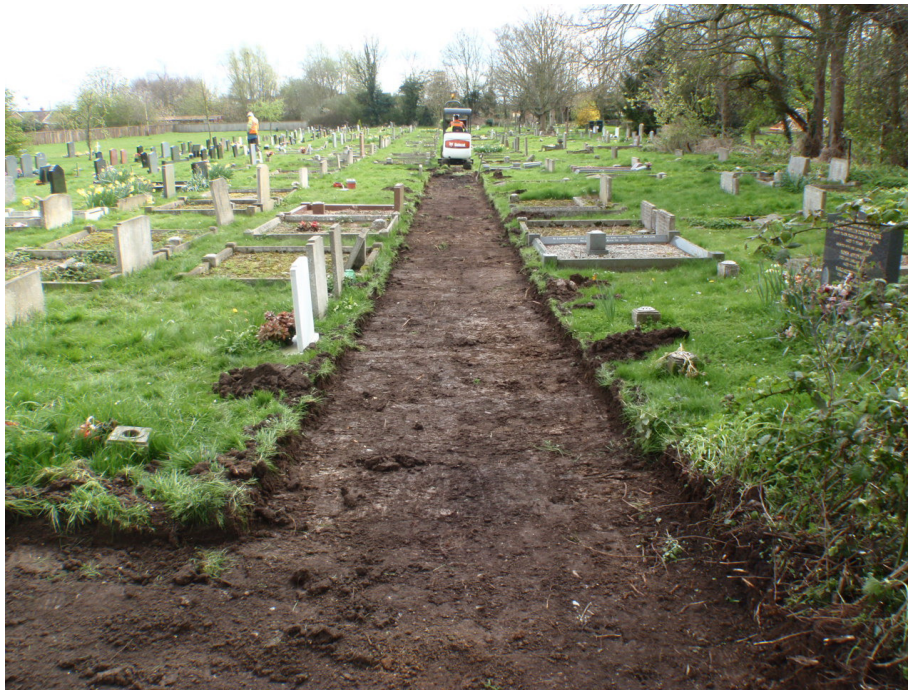
The route of the new pathway was stripped of overburden to a depth of 0.17m below the current ground level (Plate 1). Following excavation the stripped area was examined for archaeological features and deposits. Selected deposits were excavated further to retrieve artefactual material and to determine their function. Each deposit was allocated a unique reference number (context number) with an individual written description. A list of all contexts and their descriptions appears as Appendix 1. A photographic record was compiled and plans were drawn at a scale of 1:200 and sections at 1:10. Recording was undertaken according to standard Archaeological Project Services practice.

Plate 1 – View of the stripped area for the new pathway, looking south

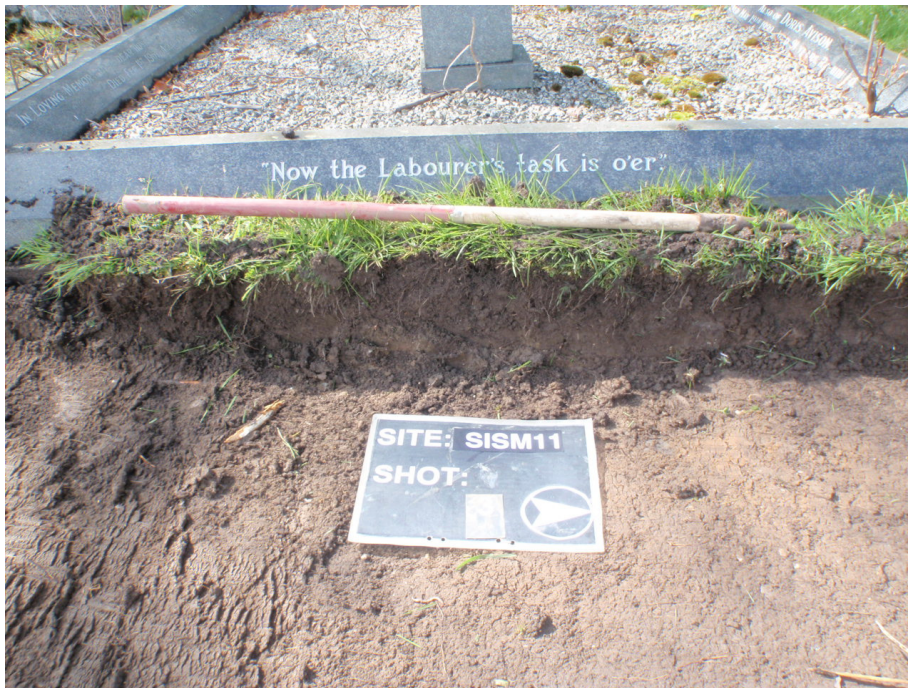
The earliest deposit encountered across the stripped area was a layer of greyish brown silty clay (001). Identified as a graveyard soil it measured in excess of 0.17m thick (Fig. 5, Section 1; Plate 2). Disarticulated human bone was observed, but not collected, within this deposit.

Plate 2 – section 1, looking west

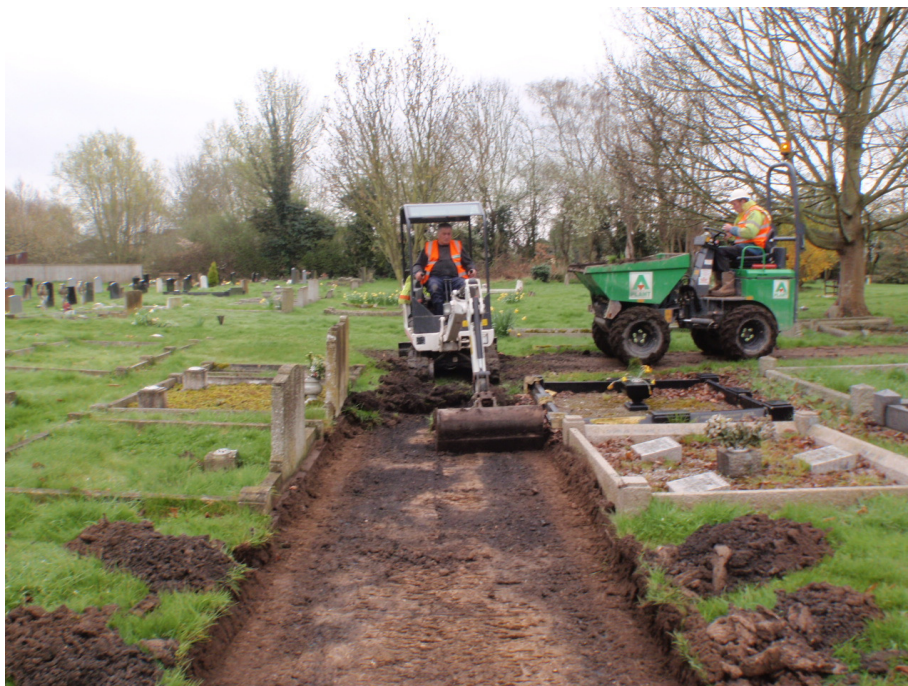
Along the north-south aligned parts of the stripped area (Fig. 4) were deposits of reddish brown silty clay with pebbles (002) and black coal fragments (003).

These were identified as former paths serving the cemetery (Plate 3).

Plate 3 – Detail of former path formed from coal fragments (003), looking south
