**ARCHAEOLOGICAL EVALUATION
ON LAND AT
COTTESBROOKE ROAD,
NASEBY,
NORTHAMTONSHIRE**

NCBR12

National Grid Reference: SP 68820 77545
Planning Application: DA/2011/0486
OASIS ID: archaeo11-125851

APS Report No. **37/12**

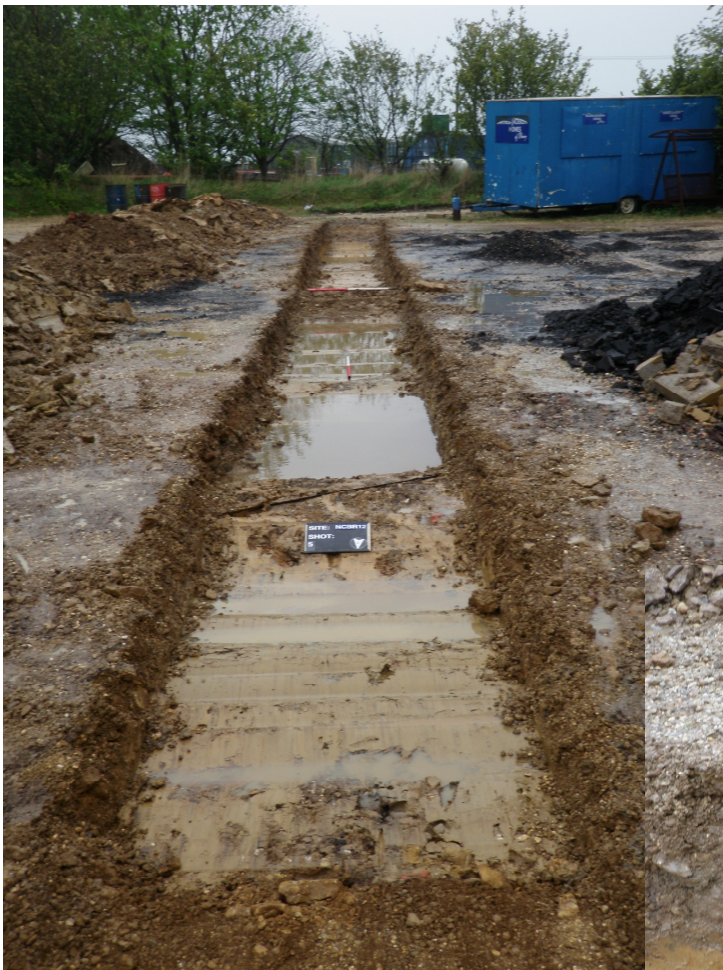
Plate 2 Trench 2, looking south

The proposed trenching layout was two twenty metre long trenches within the gravelled areas of the site. This trenching was based on the use of a 1.60m wide ditching bucket. As the machine provided by the client had a 1.20m wide ditching bucket, after consultation with the Assistant Archaeological Advisor, both trenches were lengthened to provide the same overall surface area. Trench 1 was c.30m long, approximately northwest-southeast aligned and positioned along the northern edge of the site (Figure 2, Plate 4). Trench 2 was c.24.5m long, approximately north-south aligned and located in the southeastern corner of the site (Plate 2).

Cut into this, near the northern end of the trench, was a construction trench [210] which contained modern concrete (209)

(Figure 3, Plate 2). This may have been part of the wall of a modern building.

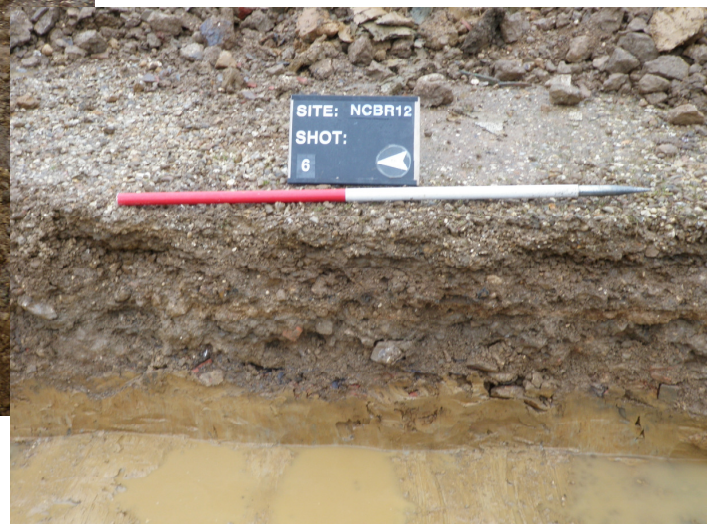
Plate 3 Trench 2, Section 1, looking east

Natural deposits in Trench 2 comprised mid greyish- yellowish-brown clay with occasional pebbles (205) (Plate 3).

Overlying this was (203), a 0.12m thick mid yellowish-brown mixed hardcore layer. This was in turn sealed by (202), a mid grey deposit of stone and sandy clayey silt. These two layers formed make-up for modern surfacing (201), an 80mm thick gravel layer (Figure 3, Plate 3).
