**ARCHAEOLOGICAL MONITORING AND
RECORDING AT
ST ANDREW'S CHURCH,
BACTON,
NORFOLK
(ENF 128831)**

**Work Undertaken For
Birdsall Swash and Blackman Limited
on behalf of
Bacton Parochial Church Council**

APS Report No. **39/12**

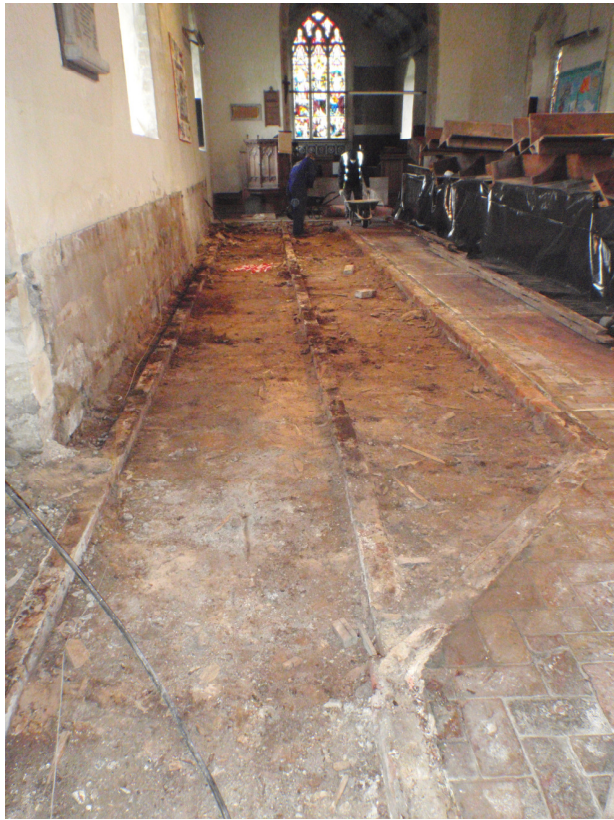
Plate 1 – View showing the area of works, looking east

The area of flooring beneath the pews on the north side of the nave was initially stripped by hand of wooden flooring and levelling deposits to a depth of c. 50mm (Plate 1). Foundation trenches for new supporting walls were then excavated to a

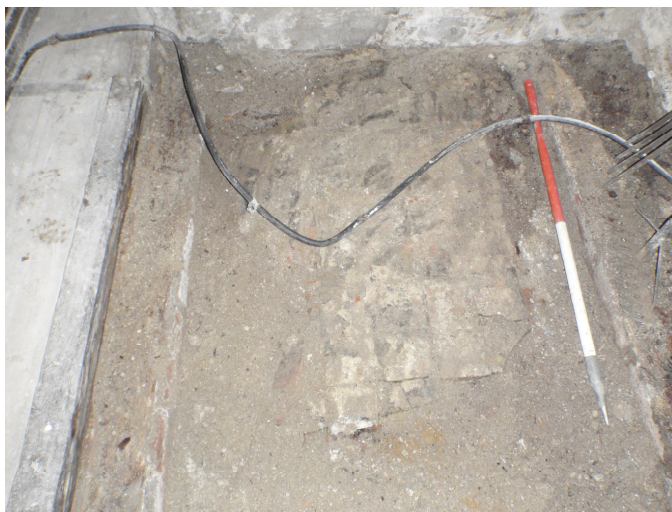
Above (003), at the western end of the stripped area was a small remnant of brick/tile flooring (002) measuring 1m by 0.8m in extent (Plate 2).

Plate 2 – Brick/tile surface (002), looking west

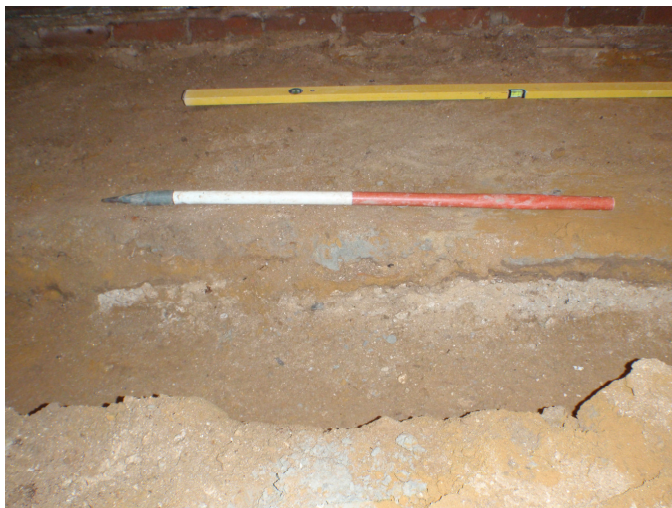
The earliest deposit encountered at the east end of the nave was a levelling layer of grey/white sand and mortar (004) which was over 70mm deep (Fig. 4, Section 1; Plate 3). The remaining area was composed of another levelling layer of orange brown sand (003).

Plate 3 – Section 1, looking south
