**ARCHAEOLOGICAL MONITORING AND
RECORDING AT
ALL SAINTS' CHURCH,
EAGLE,
LINCOLNSHIRE
(EASC 12)**

**Work Undertaken For
Tim Benton Architect**
On behalf of
Eagle Parochial Church Council

APS Report No. **44/12**

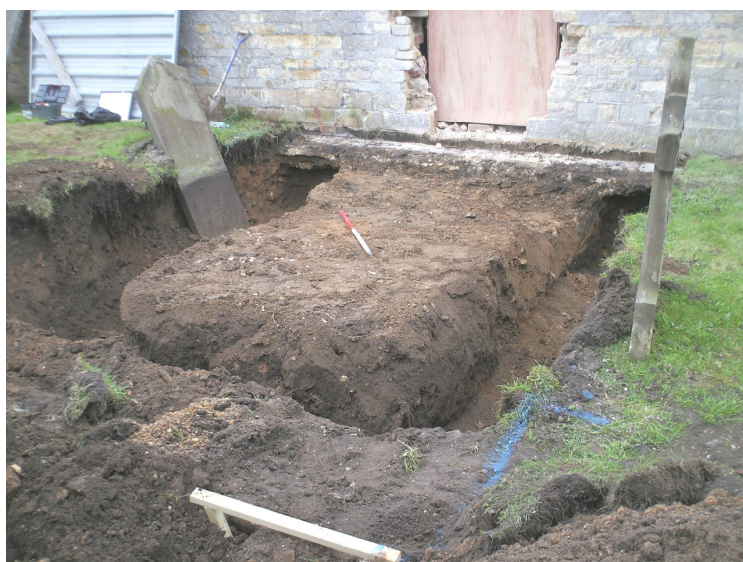
Plate 2 – The excavated foundation trenches, looking southeast

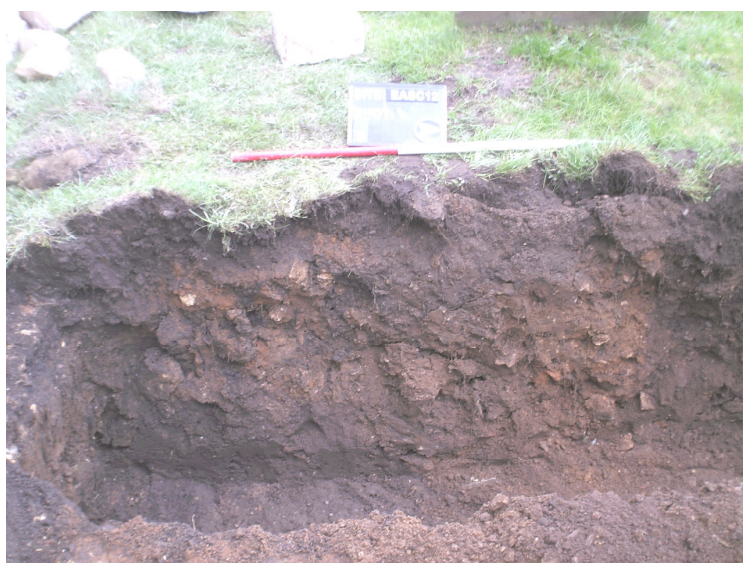
Plate 3 – Section 1, looking west

The earliest deposit encountered within the foundation trenches was a layer of disturbed graveyard soil comprising greyish brown sandy silt (105) that measured in excess of 0.84m thick (Fig. 4, Section 1; Plate 3). Two iron coffin handles of probable 19th century date were retrieved from this deposit.

This was overlain by a further graveyard soil of greyish brown sandy silt with frequent stone fragments (104). This was cut by a grave (103) that had a corresponding tombstone recording the burial of Catherine and Robert Roe in the early 20th century. The grave was backfilled with yellowish brown sandy silt with frequent stone fragments (102). The fill contained coffin furniture, a plate and stud, of 19th century date.

Sealing all deposits was the current topsoil of greyish brown sandy silt (101) that measured 0.2m thick. Roof tiles of ceramic and stone types were retrieved as unstratified material.
