**ARCHAEOLOGICAL MONITORING AND
RECORDING AT
ST MARGARET'S CHURCH,
PASTON,
NORFOLK
(ENF 129491)**

**Work Undertaken For
Paston Parochial Church Council**

October 2012

APS Report No. **77/12**

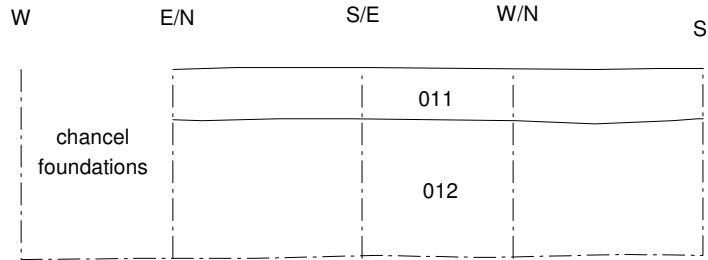
Section 5

Only subsoil (012) and topsoil (011) were encountered within this trench (Fig. 5, Section 5). The foundations of the chancel were noted to extend deeper than the trial pit, over 0.5m below the current ground level.

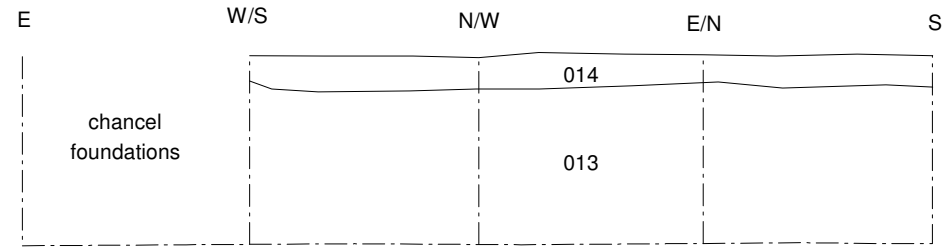
Section 6

Again, only subsoil (013) and topsoil (014) deposits were revealed (Fig. 5, Section 6). The foundations of the chancel were noted to be similar to those encountered in Test Pit 5 (Plate 5).

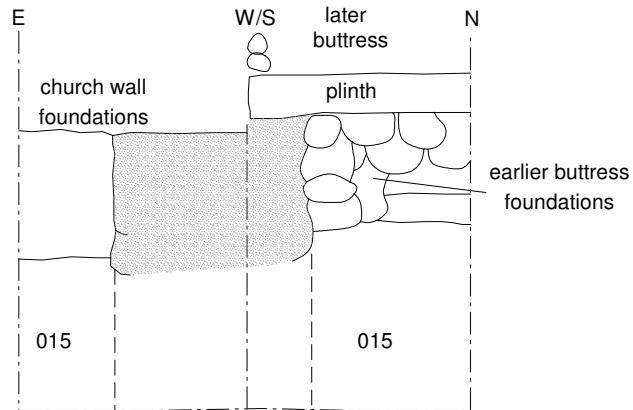
Section 7

Measuring over 0.5m thick was a graveyard soil, comprising grey sandy silt (015). This was in turn overlain by topsoil (018) which sealed the stepped foundation of the church against which was an earlier buttress. The later buttress was again larger.

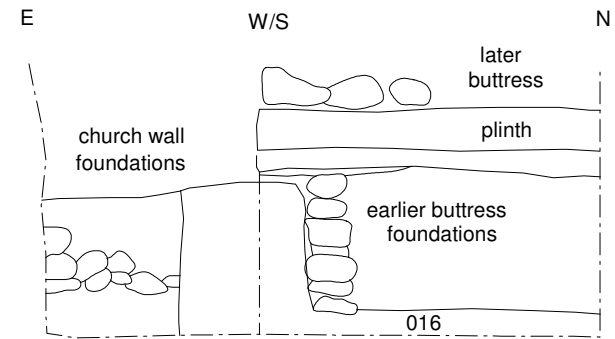
Section 8

Beneath the foundations of the buttress was a graveyard soil of grey sandy silt (016) which was overlain by topsoil (017). The stepped foundations of the earlier buttress and church wall were also revealed (Plate 6).

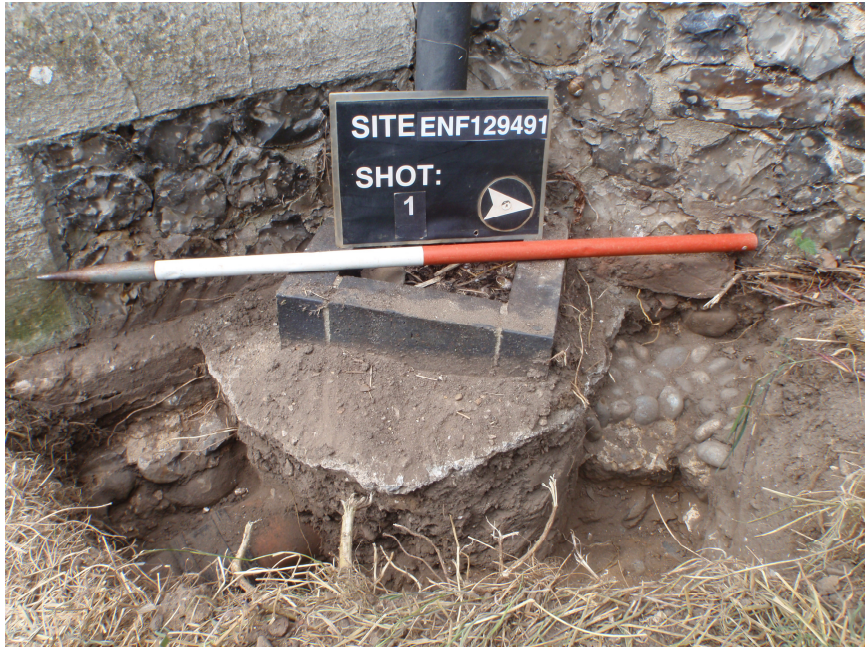
It was noted within this trench that the porch foundations were stepped out (Plate 1).

Plate 1 – Test Pit 1, showing the porch foundations, looking west

into graveyard soils and this may indicate that the church had been widened. The south porch also had slightly differing foundations and is also presumed to be a later build.

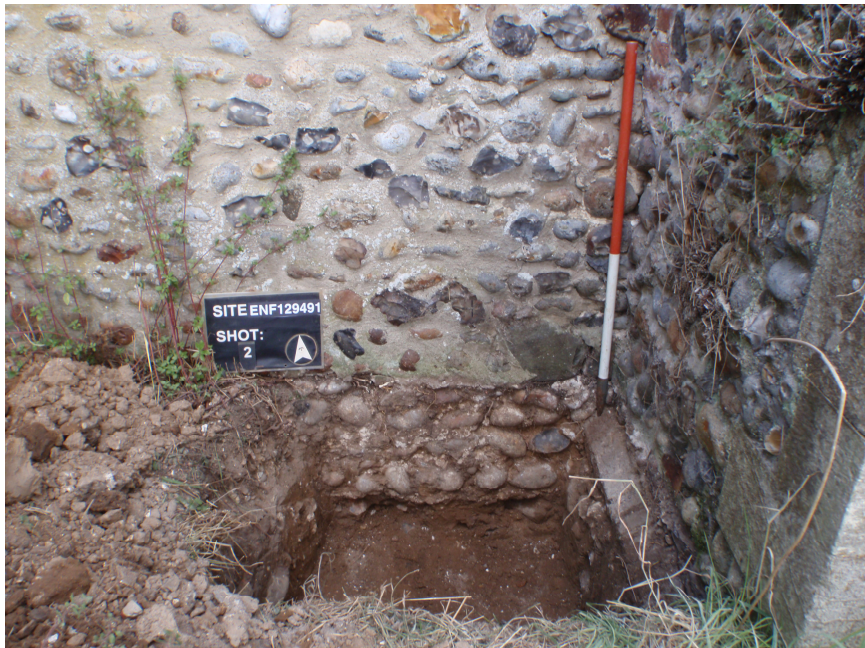
The mortared flint foundations of the church building were also revealed. Butting against these was a slightly offset foundation, possibly of an earlier buttress, upon which was built the current and slightly larger buttress (Plate 2).

Plate 2 – Test Pit 2, Foundations of the church with buttress overlying earlier buttress (left), looking north

The foundation courses of the church and its buttresses were revealed in all trenches, although there were no buttresses associated with the chancel. Traces of earlier buttresses were recorded which butted against the wall, indicating that they are later than the body of the church. The buttresses were replaced, and as one of the southern buttresses has a date of 1601, it is possible that these works date to this time.

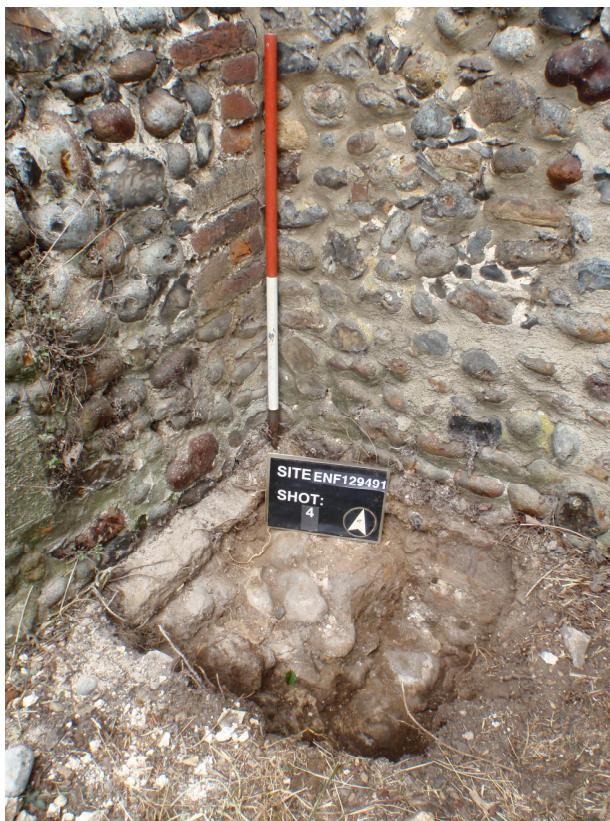
The earlier buttress was also visible within this test pit (Plate 3).

Plate 3 – Test Pit 3 showing the extent of the earlier buttness, looking northwest

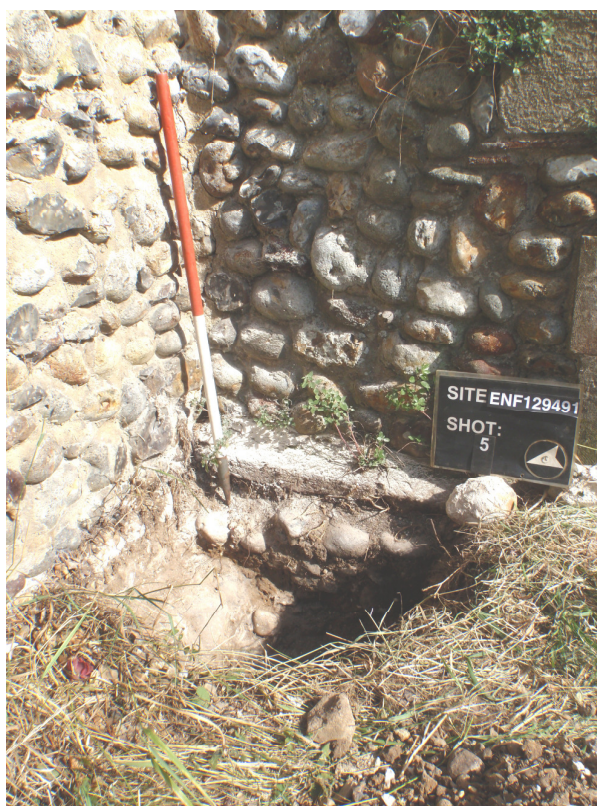
The foundations of the church were slightly stepped out. Abutting these was traces of an earlier buttress (Plate 4).

Plate 4 – Test Pit 4, earlier buttness overlying stepped foundations of the nave, looking northeast

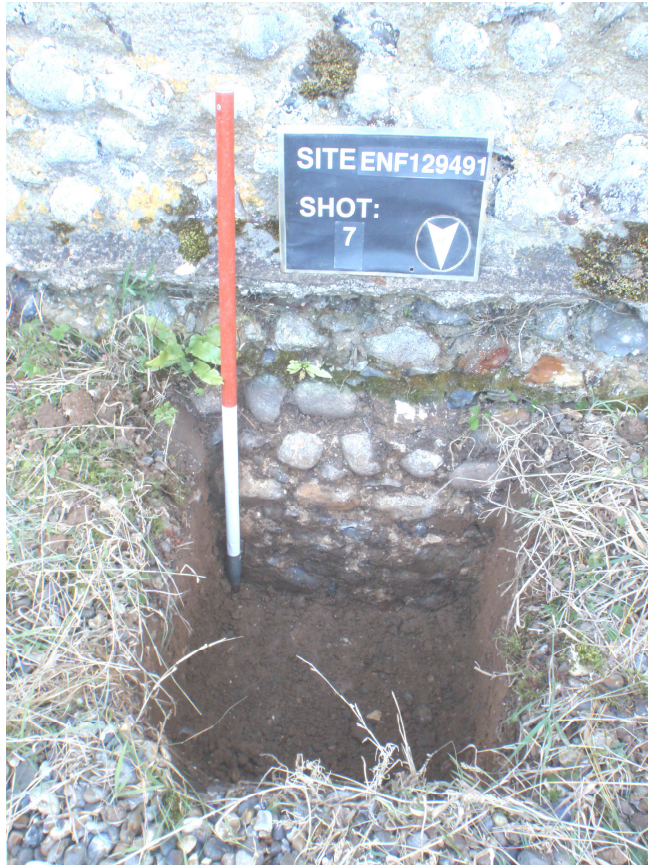
Plate 5 – Test Pit 6 showing the foundations of the chancel, looking south

The foundations of the chancel (as revealed in Pits 5 and 6) were not stepped out and this would suggest that it was of a different build to the nave. No subsoil was encountered in the two northern pits (Test Pits 7 and 8) where the wall was inserted

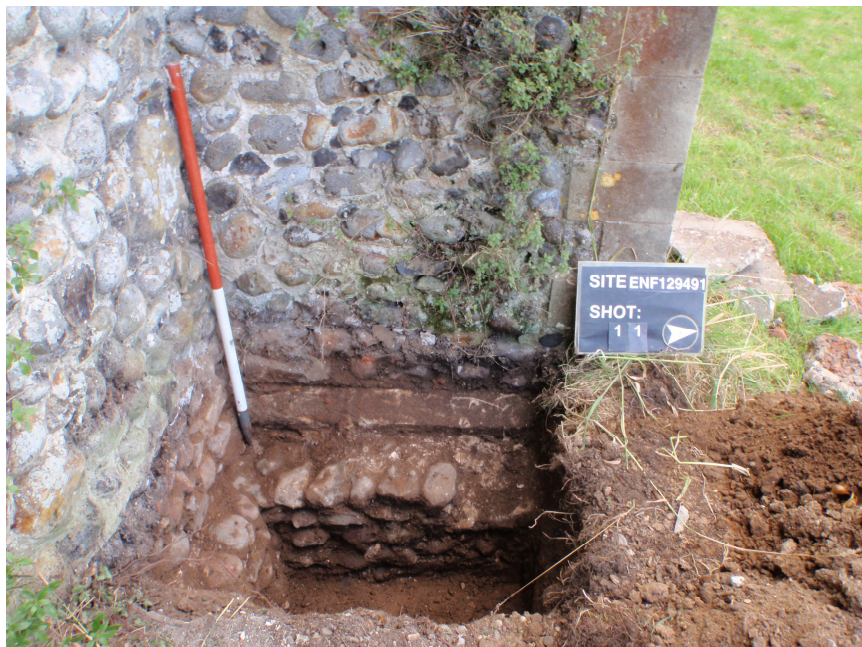
Plate 6 – Test Pit 8, stepped foundations of the church with the earlier and later buttresses built against it, looking west
