**ARCHAEOLOGICAL MONITORING AND  
RECORDING AT  
ST ANDREW'S CHURCH,  
HOLT,  
NORFOLK  
(ENF 129173)**

**Work Undertaken For  
Birdsall Swash and Blackman Ltd  
On behalf of  
Holt Parochial Church Council**

December 2012

APS Report No. **97/12**

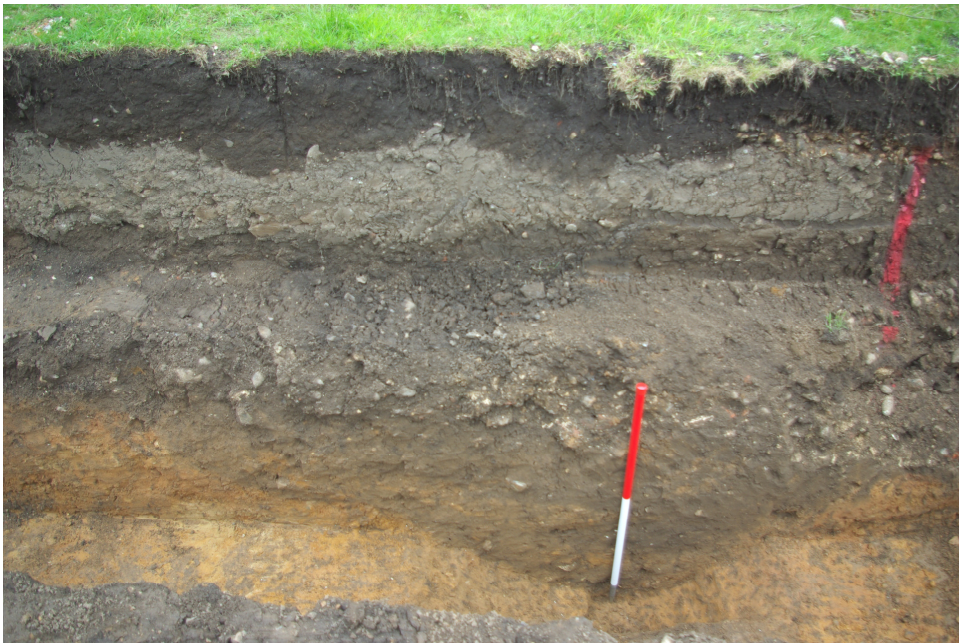
Plate 2 – Section 5 showing medieval ditch (047), looking northeast

In the southern part of the site, cut into the natural, was a northeast-southwest aligned ditch (047 and 060) that had previously been recorded during the evaluation and dated to the medieval period. This had a combined visible length of 20m and was 2.6m wide by 0.95m deep (Fig. 5, Section 5; Plate 2). A primary fill of orange brown clayey sand (053) was recorded over which were further fills of orange brown clayey sand (052), brown clayey sand (050 and 051), greyish brown sandy silt (048), brown sandy silt (049) and a final fill of brown sandy silt with limestone fragments (054). Brown sandy silt (061) was also recorded in the unexcavated part of the ditch to the west. Finds from (048) and (061) were dated to the 11<sup>th</sup> – 15<sup>th</sup> century.

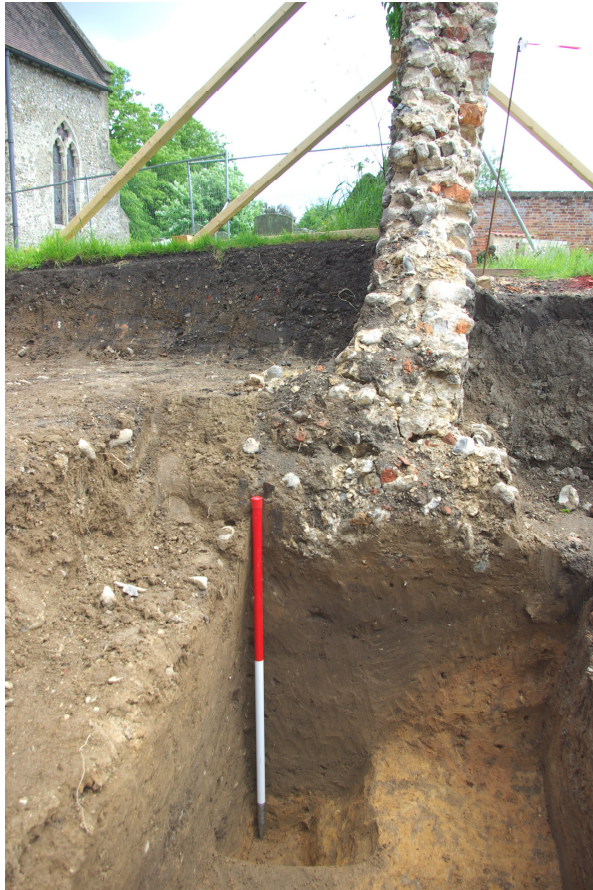
Plate 3 – Section 4 showing medieval ditch (027) with post-medieval wall (034) above, looking northeast

Located beneath the boundary wall to the churchyard was ditch (027). This had a similar recorded length to the ditches above and was over 0.9m wide and deeper than 1.02m (Fig. 5, Section 4; Plate 3). The lowest fill was a brownish orange silt (035) above which was brown silt (028), yellowish brown silt (029), yellowish brown sandy silt (031) and the uppermost fill of orange brown sandy silt (032). Pottery of 11<sup>th</sup> – 13<sup>th</sup> century date was retrieved from the fills of this ditch.

Cutting through the subsoil and into the upper fills of ditch (027) was an east-west aligned foundation trench (039), measuring over 0.8m wide and 0.41m deep (Fig. 5, Section 4). At the base of this was a deposit of orange brown sandy silt (038),

upon which the extant churchyard wall of flint (033 and 034) had been constructed. The foundation trench had been backfilled with greyish brown organic clayey sand (040) and loose rubble (037), the latter producing a complete 19<sup>th</sup> century blacking jar.

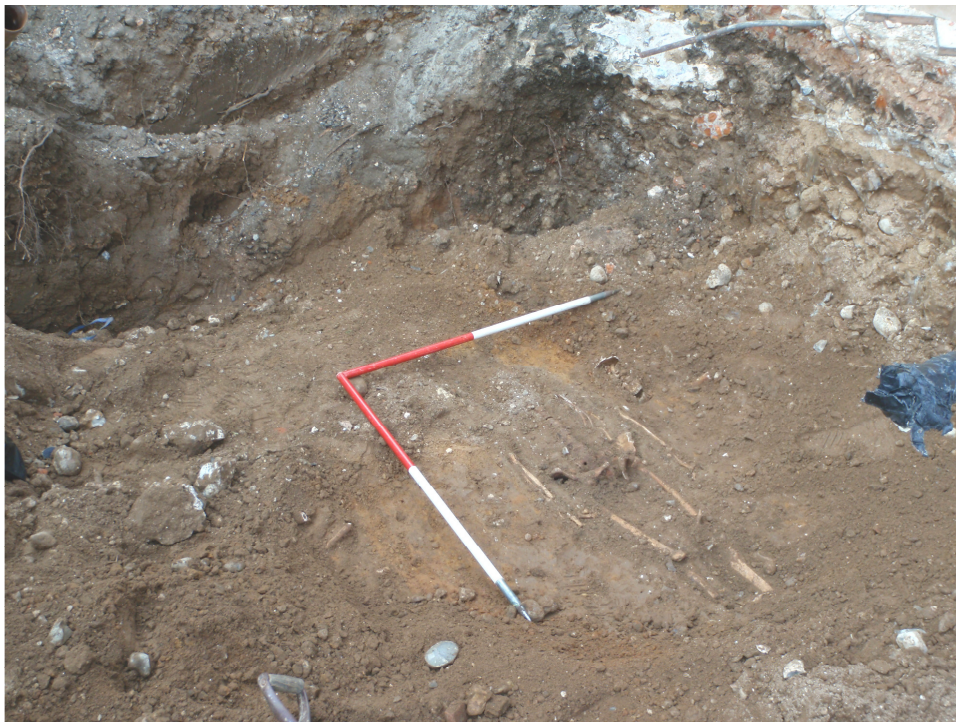
Plate 4 – Graves (010), (012) and (013) south of the porch, looking northwest

Immediately south of the porch and sealed by the graveyard soils were three graves (010, 012 and 013) of which burials were noted in (010 and 012). The graves were aligned east-west and were only partly exposed during the groundworks (Plate 4).

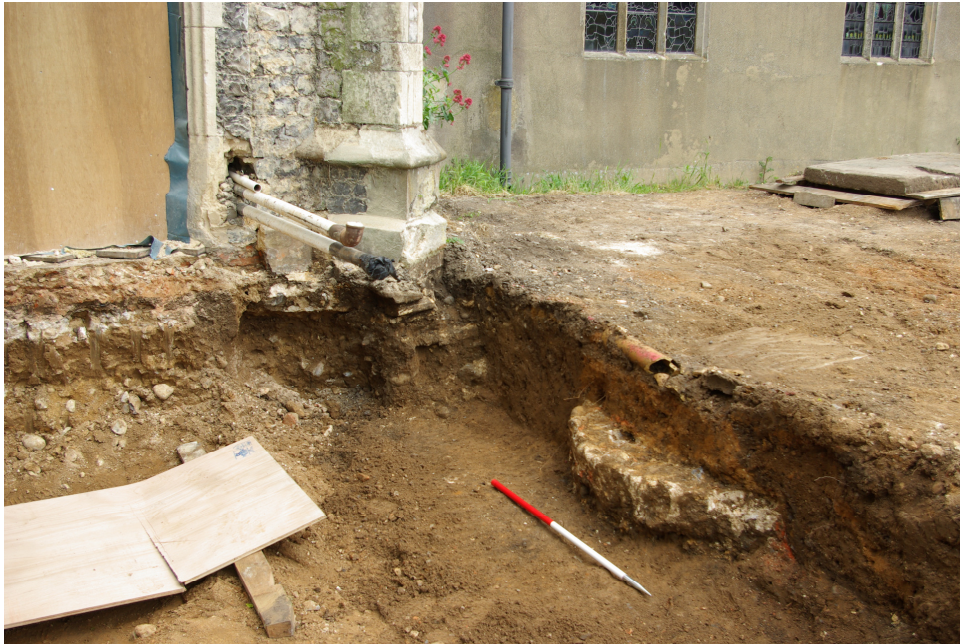
Plate 5 – Section 3 showing the post-medieval cistern (014), looking northeast

A circular feature (014) was partly revealed to the immediate southeast of the porch (Fig. 3; Plate 5). This measured 1.6m in diameter and was probably at least 2.4m in depth. Constructed within this was a flint built cistern with brick upper courses (015) that had been capped by a stone slab. The cistern had an internal diameter of *c.* 1m and an external diameter of 1.4m. A pipe was noted leading towards the church on the north side. The cistern was empty, although at the base lay a bottle of probable early 20<sup>th</sup> century date. The cut for the well had been backfilled with brown silty sand (025).

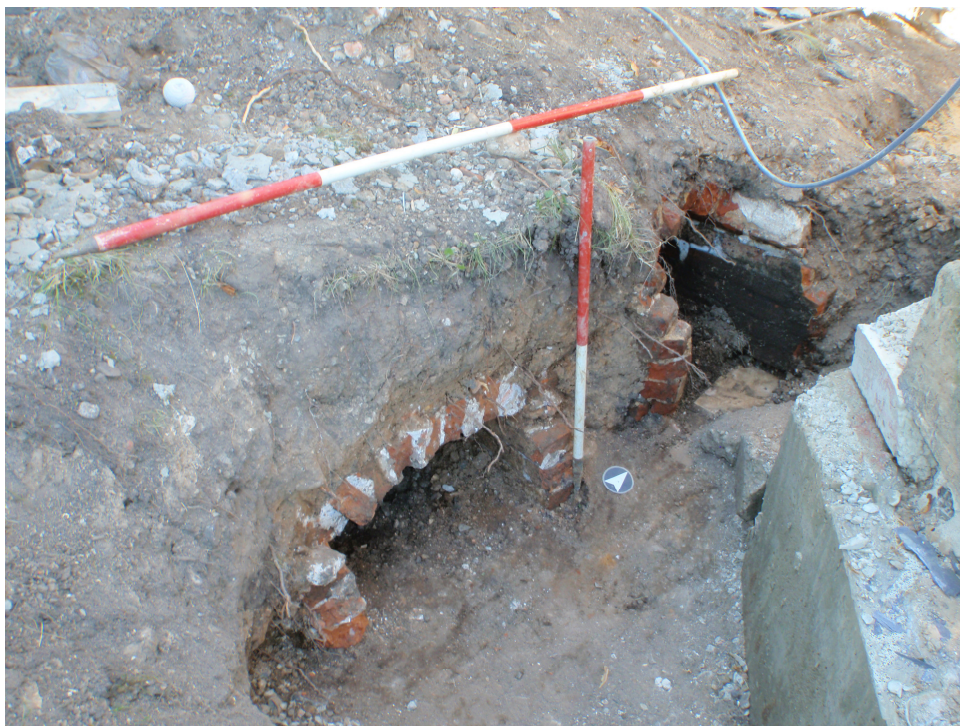
Plate 6 – Brick-lined tombs (086) and (087), looking northwest

Situated to the west of the porch were two brick-built graves. The more southerly (086) was 0.88m wide and 0.48m high (Fig. 7, Section 12; Plate 6) with the bricks in stretcher bond. The interior of the tomb was not examined and no coffin or burial was noted.

tomb (087) that was 0.7m wide and 0.68m high. This had a tile floor (089) which was overlain by a mixed deposit of grey, reddish brown and brown silty sand (088) that was 50mm thick.

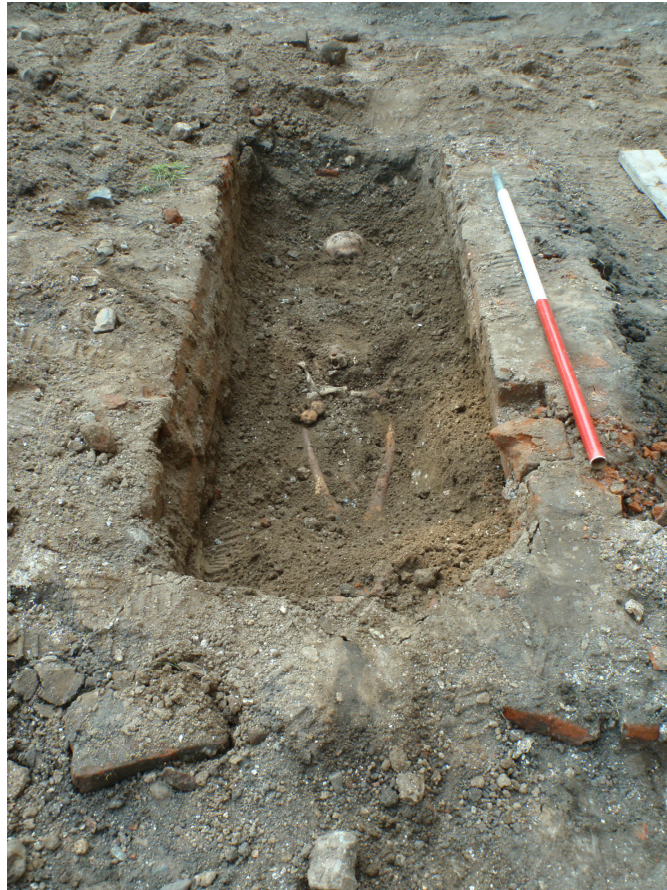
Plate 7 – Tomb (005) with the skeleton identified as Rebecca Blyford, looking west

Located east of the porch was a brick-lined table tomb (005) which measured 1.9m by 1.1m in extent and was covered with a stone slab. One burial, that of a woman, was disturbed during the works in this area with further burials noted within the tomb (Plate 7). The woman was wearing a gold mourning ring (Plate 8) dedicated to Sir Christopher Myngs, identifying the female as that of Rebecca Blyford, his daughter. The ring was not further examined as the Parochial Church Council took immediate ownership of it.

The table tomb east of the porch was later identified as the grave of Francis Blyford (d. 1708), his son Matthew (d. 1731) and daughter-in-law Rebecca (d. 1734), the latter wearing a gold mourning ring inscribed with the initials 'S<sup>r</sup> C.M.' and the date 'June 10<sup>th</sup> 66'. This was identified as

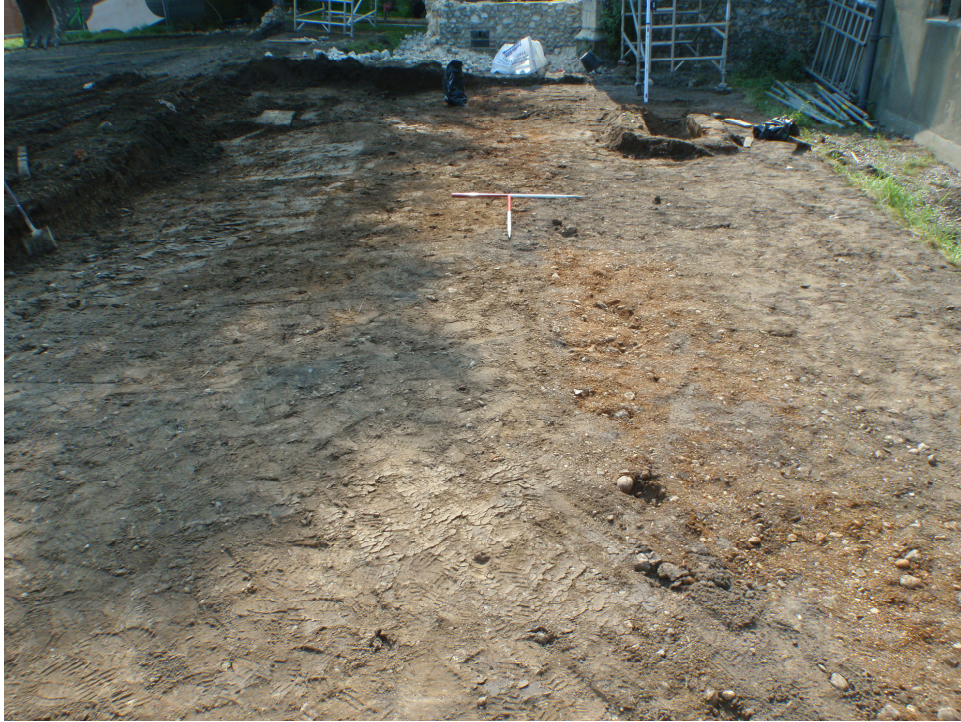
Plate 9 – Path remnant (003) looking west

Overlying this last brick-lined grave was a northeast-southwest aligned feature (003), possibly a former pathway. This measured 0.8m wide (Fig. 3; Plate 9) and contained a fill of orange brown sand, gravel and flints (004) but was not excavated further.
