**ARCHAEOLOGICAL MONITORING AND  
RECORDING AT  
ST ANDREW'S CHURCH,  
POTTERHANWORTH,  
LINCOLNSHIRE  
(POSA 12)**

**Work Undertaken For  
Mr A Reid**

January 2013

APS Report No. 2/13

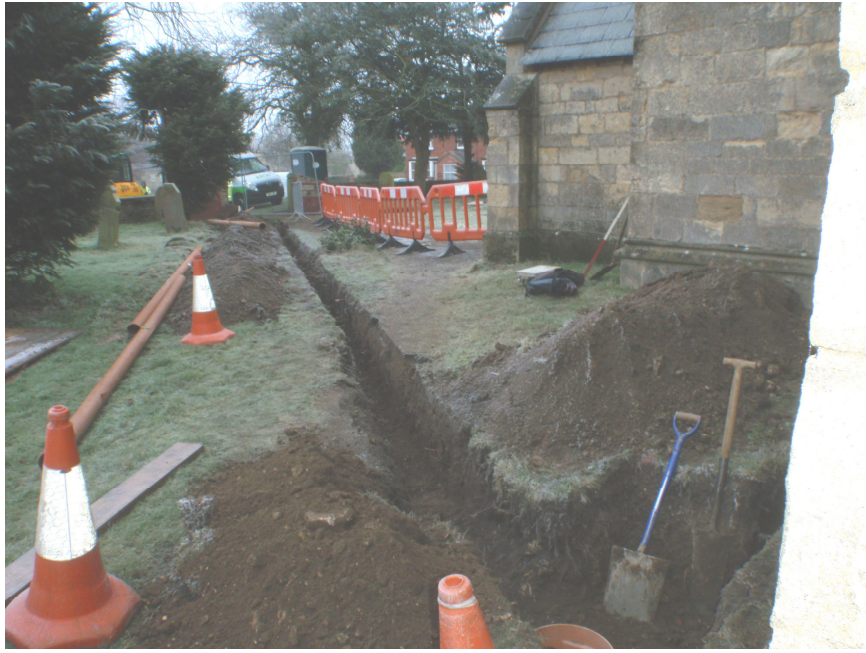
Plate 1 – View showing the extent of drainage works in relation to the church, looking northeast

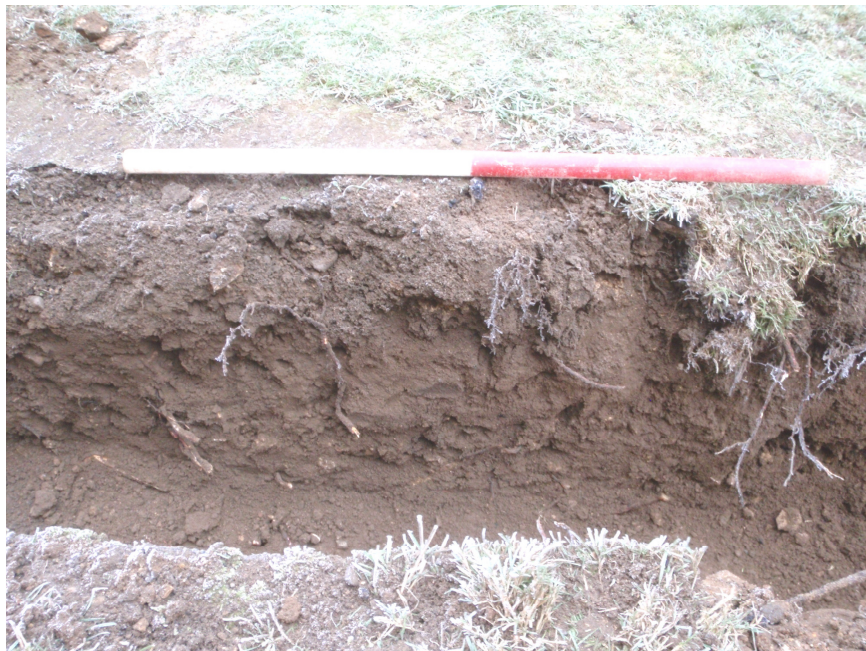
To the north of the church, the earliest deposit was a graveyard soil comprising brown sandy silt (002) that measured over 0.75m thick (Fig. 4, Sections 1 to 4). Closer to the church, the graveyard soil was recorded as (006) and a fragment of mortar, either Roman or medieval in origin, was recovered.

Plate 2 – Section 2, looking northwest

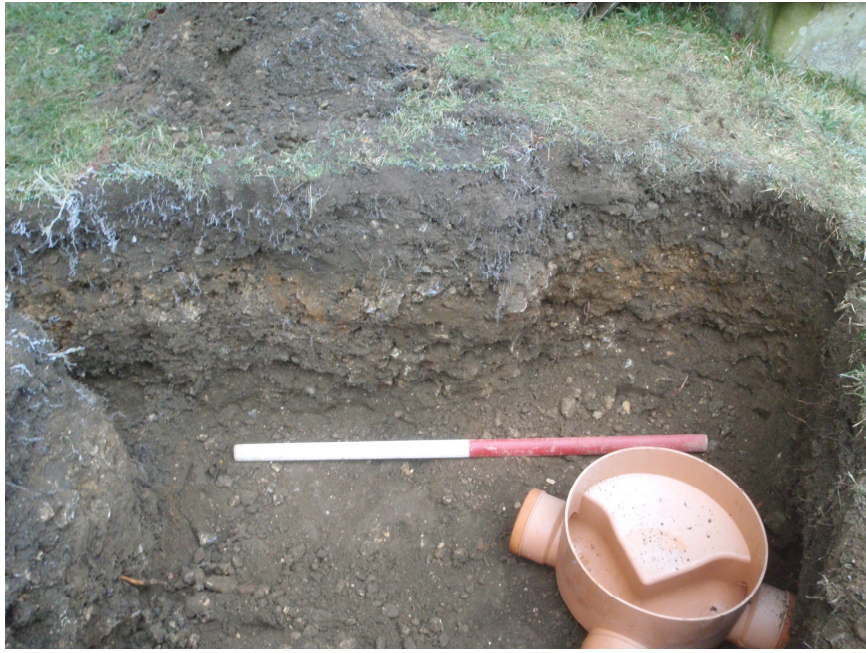
Overlying (006) to the west of the north aisle were construction deposits of brownish orange silty sand and gravel (003), yellow mortar and limestone fragments (004) and orange brown sandy gravel (005). These deposits measured between 0.13m and 0.35m thick (Fig. 4,

Plate 3 – Section 3 showing the construction deposit (003),  
looking south

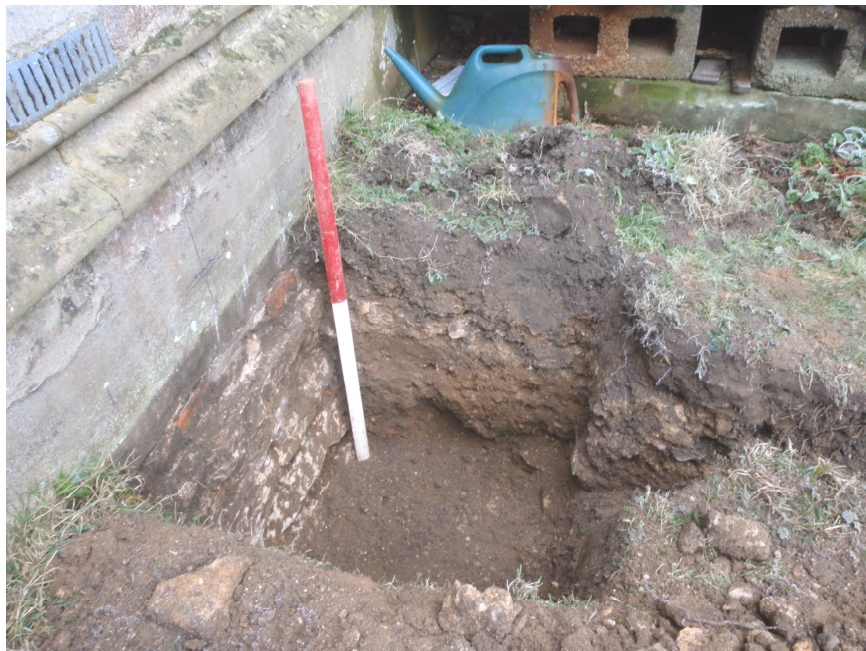
Part of the north aisle wall was exposed within the drainage trench (Fig. 4, Section 6). A foundation course of coursed rubble limestone (009) was overlain by a single course of bricks (008) upon which was built the ashlar wall of the aisle. These presumably date from the rebuild or restoration of the 18<sup>th</sup> or 19<sup>th</sup> centuries.

Plate 4 – Sections 5 and 6 with the rebuilt/restored north aisle (left)  
and associated construction deposits, looking southeast
