**HERITAGE STATEMENT
LAND AT
HANSLOPE ROAD,
HARTWELL,
NORTHAMPTONSHIRE**

**Work Undertaken For
Lark Energy Ltd**

January 2013

APS Report No. **HS013**

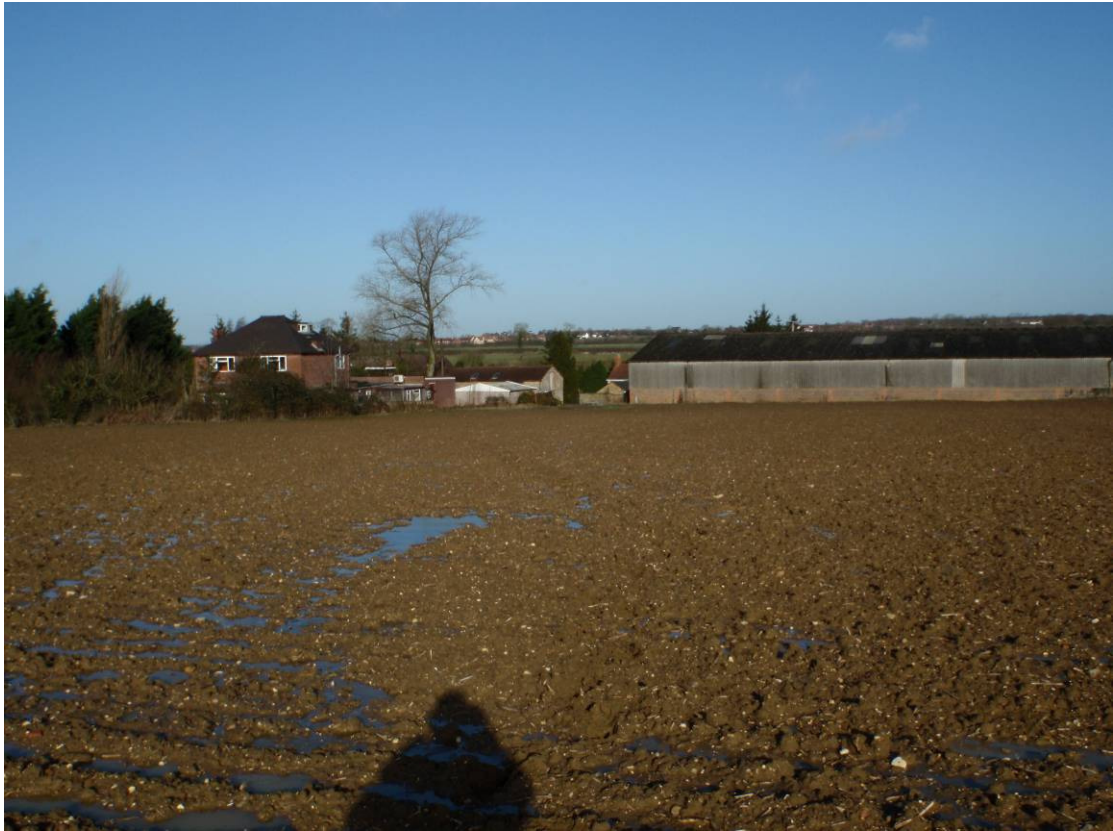
- 3.2.8.1 **Field A:** Located immediately south of the buildings of Stonepit Farm (not in The Site). Newly harrowed and planted, wet. Buildings of Stonepit Farm and the adjacent dwelling, The Poplars, are evident just outside the boundary of The Site. The buildings are mostly of mid-late 20th century date but some older, probably 19th century, structures are also present (**Plate 1**). No evidence of any archaeological remains.

Plate 1 View across Field A towards buildings of Stonepit Farm, looking northwest

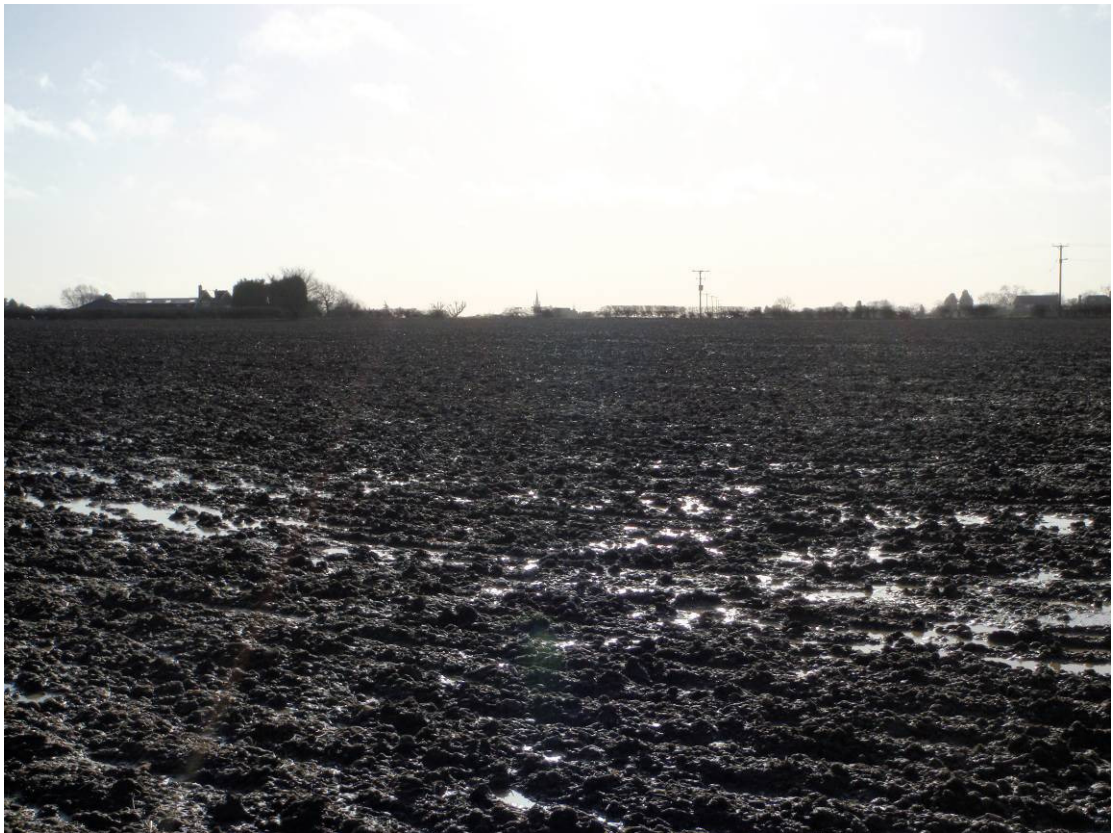
- 3.2.8.2 **Field B:** Located southeast of Field A. Newly harrowed and planted, wet. Crossed by overhead cables attached to poles. Farm buildings, mostly modern, evident south of The Site. South of The Site, in the distance, the spire of Hanslope church is also visible (**Plate 2**). No evident archaeological remains.

Plate 2 View across Field B towards Milton Keynes Borough, showing spire of Hanslope Church (centre), and buildings of Roselane Farm (on left), looking south

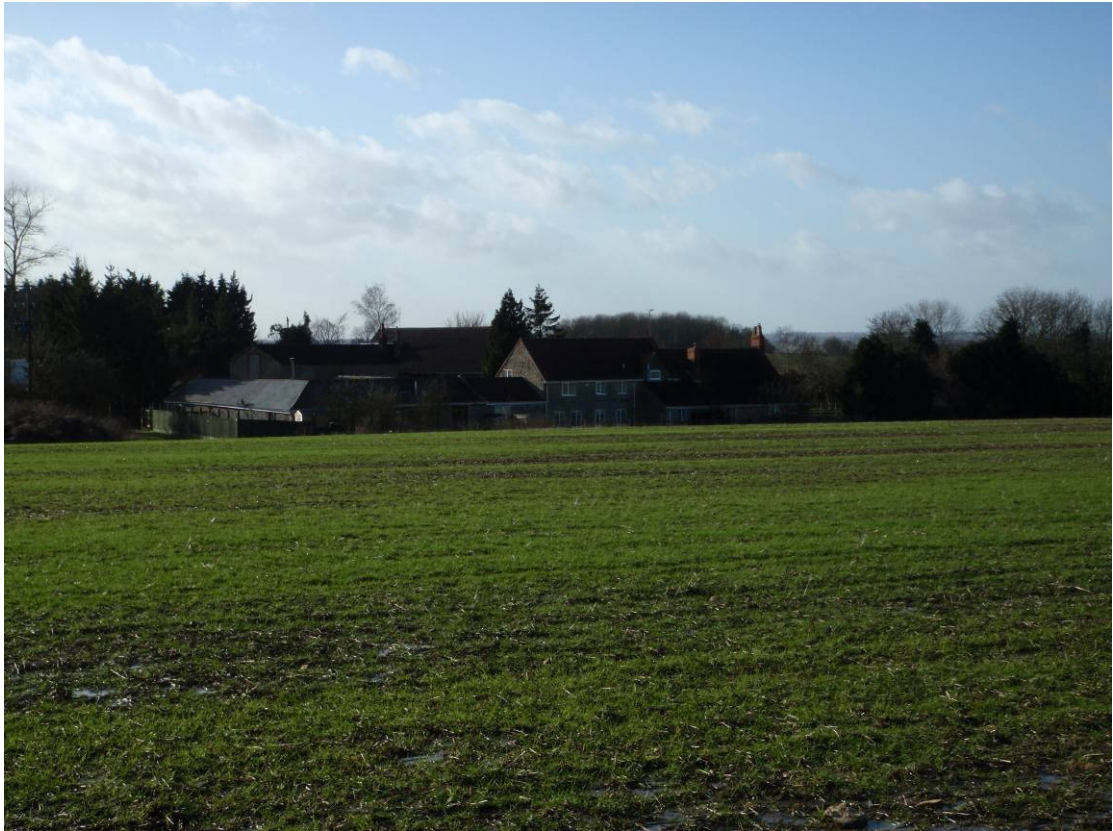
- 3.2.8.3 **Field C:** Situated north of Fields A and B and immediately east of Stonepit Farm (**Plate 3**). Field surface declines gently to the northwest. Crossed by overhead cables attached to poles. Very young crop, fairly dry. Linear bands of more advanced growth are evident and perhaps indicate the furrows of post-medieval steam ploughing, although there are no or only very slight earthwork remains (**Plate 4**). The field boundary at the northeastern corner is on a slight bank (**Plate 5**). In the field to the northeast, beyond The Site boundary, is another slight bank on a similar northwest-southeast alignment (**Plate 6**). Alongside the southeastern boundary of the field a cluster of stone roofing tile was noted (**Plate 7**). In the same area two pieces of medieval, probably 13th-14th century, pottery were observed. In the base of the adjacent hedgerow were several blocks of stone (**Plate 8**).

Plate 3 Field C, view towards Stonepit Farm House and associated farm buildings, looking south

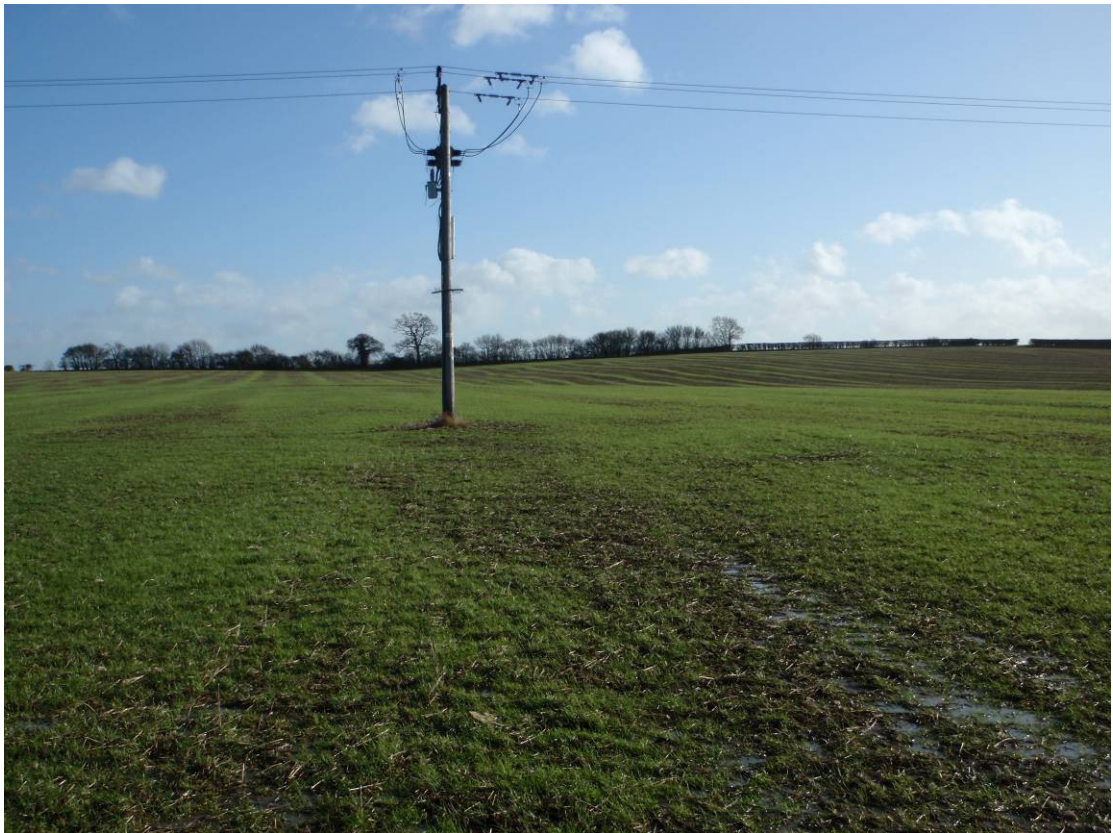
Plate 4 Field C, showing banded crop growth, looking southeast

- 4.3 The site has had a prolonged period of agricultural use, as indicated by evidence of steam ploughing observed during the walk-over reconnaissance of The Site. This arable usage is likely to have caused some disturbance and impact, probably minor, to any potential buried archaeological remains within the part of The Site.

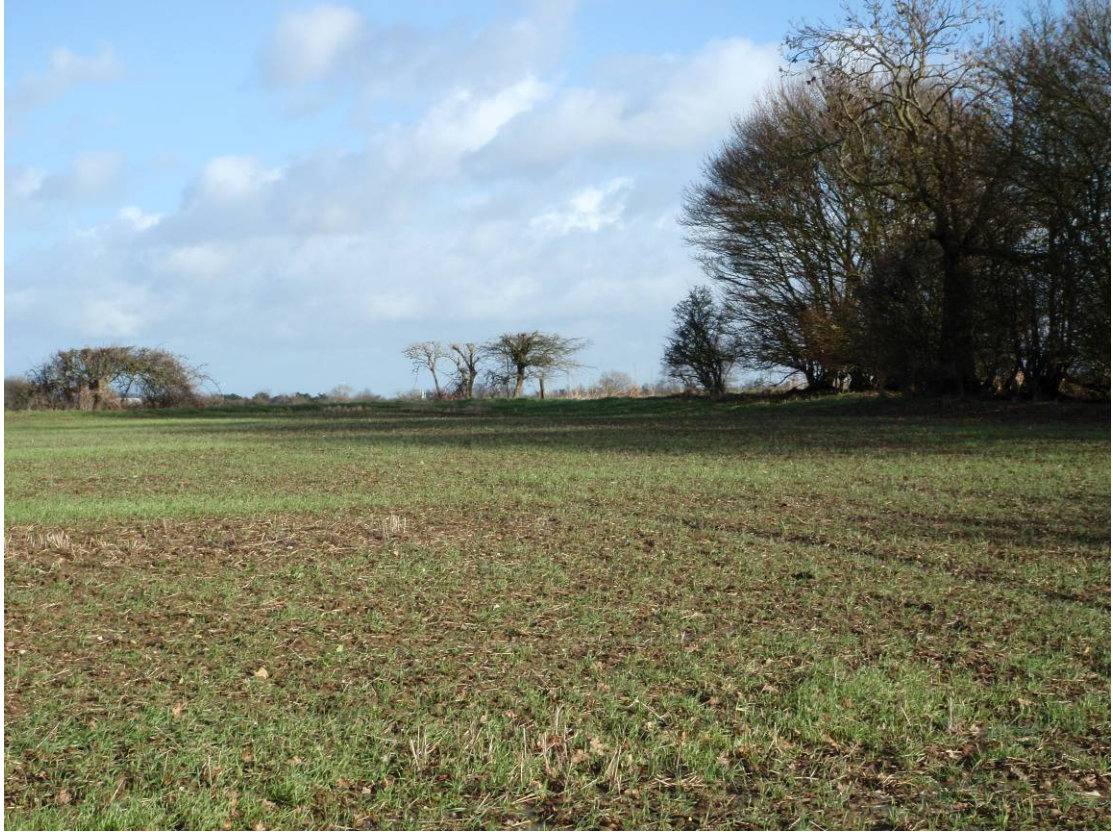
Plate 5 Field C, embanked hedgerow on northeast side, looking northeast

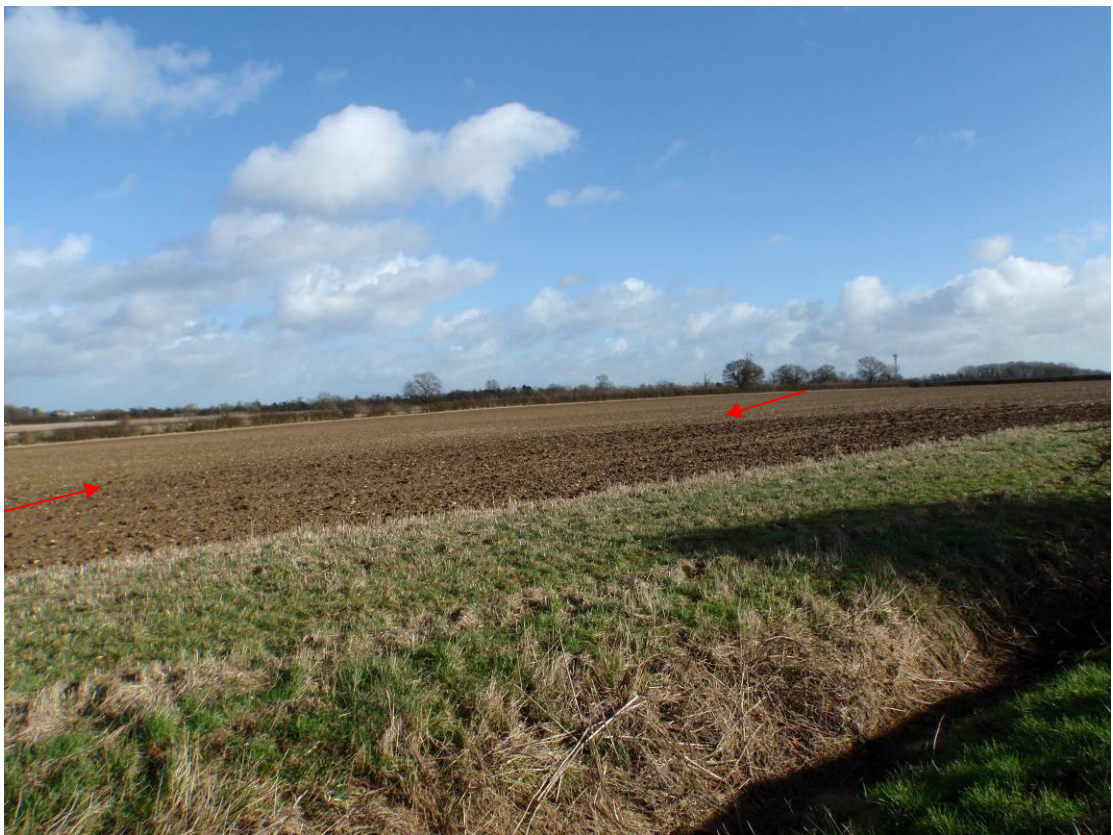
Plate 6 View from Field C to field to the east, beyond The Site, showing slight bank (highlighted by arrows), looking east

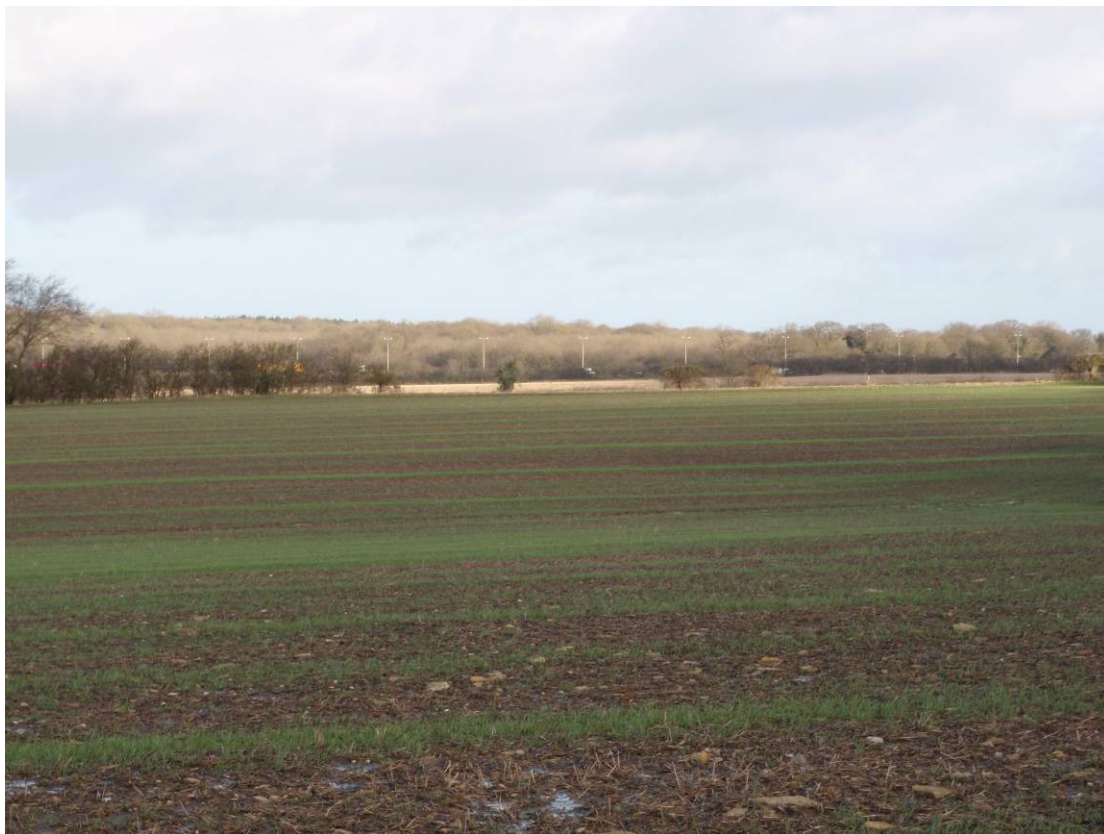
Plate 7 Field C, view towards motorway, showing stony area in foreground, looking northeast

- 6.2.1 Based upon the available information it is recommended that any further archaeological investigation should be minimal. It is proposed that such investigation comprises localised, targeted programmes of archaeological monitoring and recording (a watching brief) on: (i) the course of the postulated Roman road; (ii) the northern tip of The Site which may fall within the Hartwell End area of deserted medieval settlement, and; (iii) the area of stonework and medieval pottery identified, during the walk-over survey, on the east side of The Site. The nature and level of investigation should, however, be agreed with the Northamptonshire Historic Environment Service.

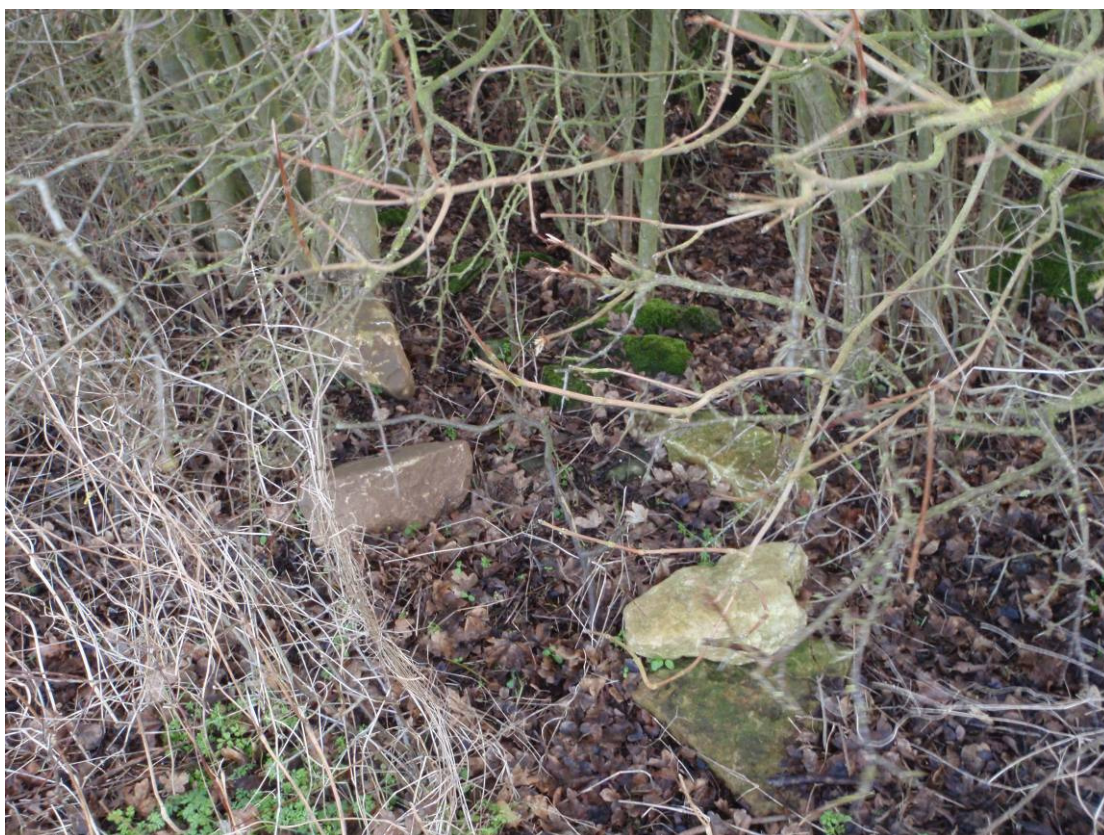
Plate 8 Field C, showing stone blocks in hedgerow bottom, looking northeast

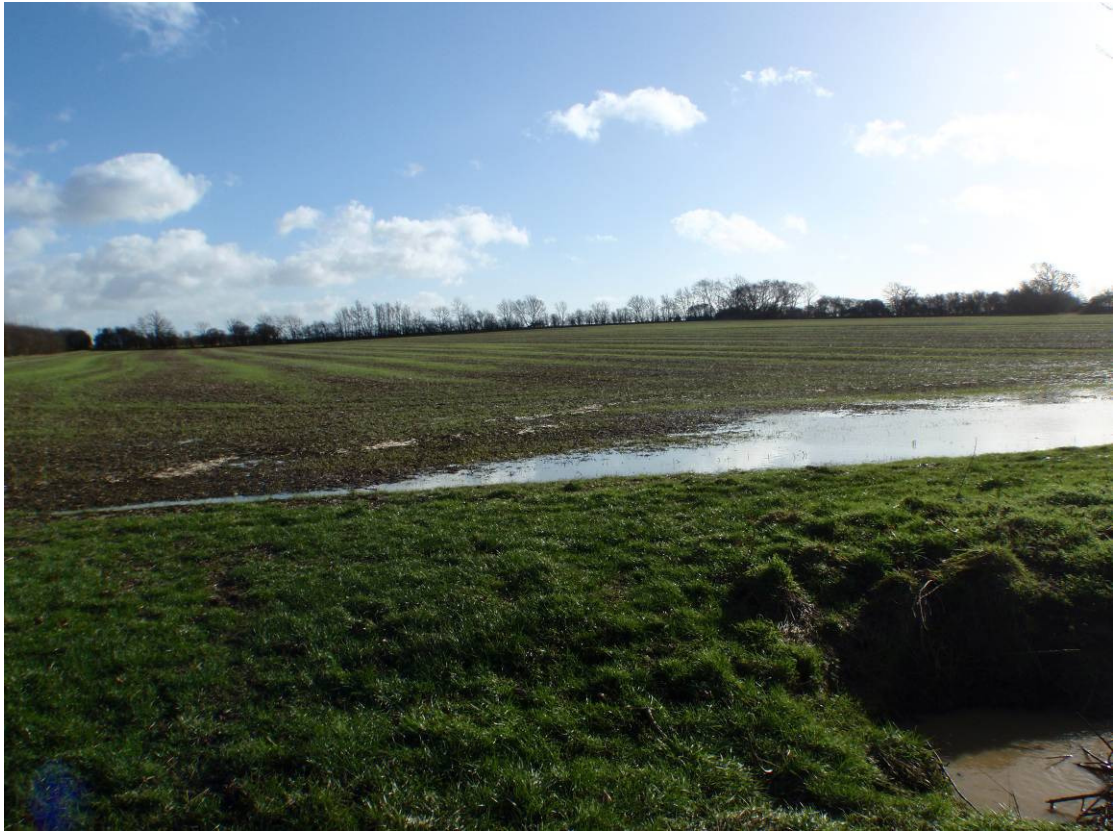
- 3.2.8.4 **Field D:** Located on the northeast side of Field C. Field surface declines gently to the northwest, wet. Very young crop, with linear bands of more advanced growth which probably indicate the furrows of post-medieval steam ploughing, although there are no or only very slight earthworks surviving (**Plate 9**). No other archaeological remains are evident.

Plate 9 Field D, showing banded crop growth, looking southeast

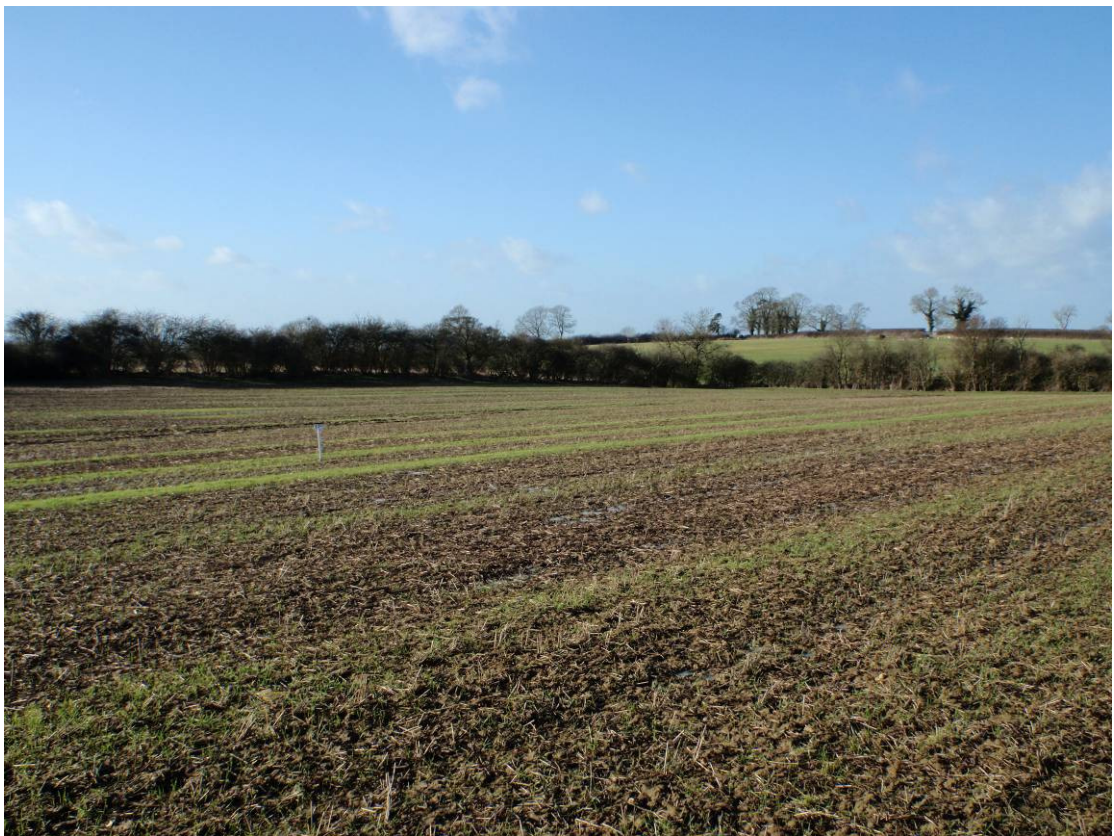
- 3.2.8.5 **Field E:** Located at northern end of The Site, to the west of Field D. Field surface wet, gently sloping down to the northwest where there is a stream. Beyond the stream, and outside The Site, the land rises to the northwest. There is a very young crop which has linear bands of more advanced growth. This probably reflects the presence of furrows of post-medieval steam ploughing, but there are no distinct earthworks (**Plate 10**). Along the northeast side of the field there is a bank with adjacent ditch (**Plate 11**). No other archaeological remains were observed.

Plate 10 Field E, showing banded crop growth, looking west

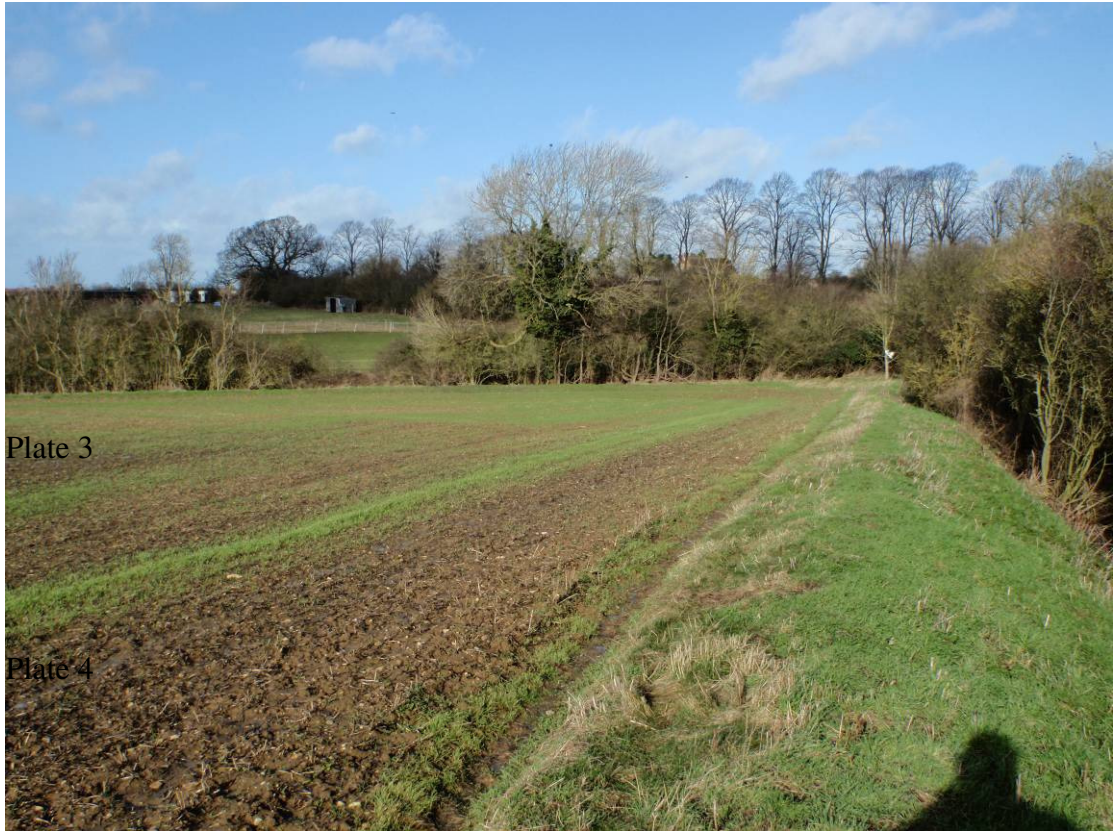
Plate 11 Field E, view towards stream, showing boundary bank and ditch on east side, looking north

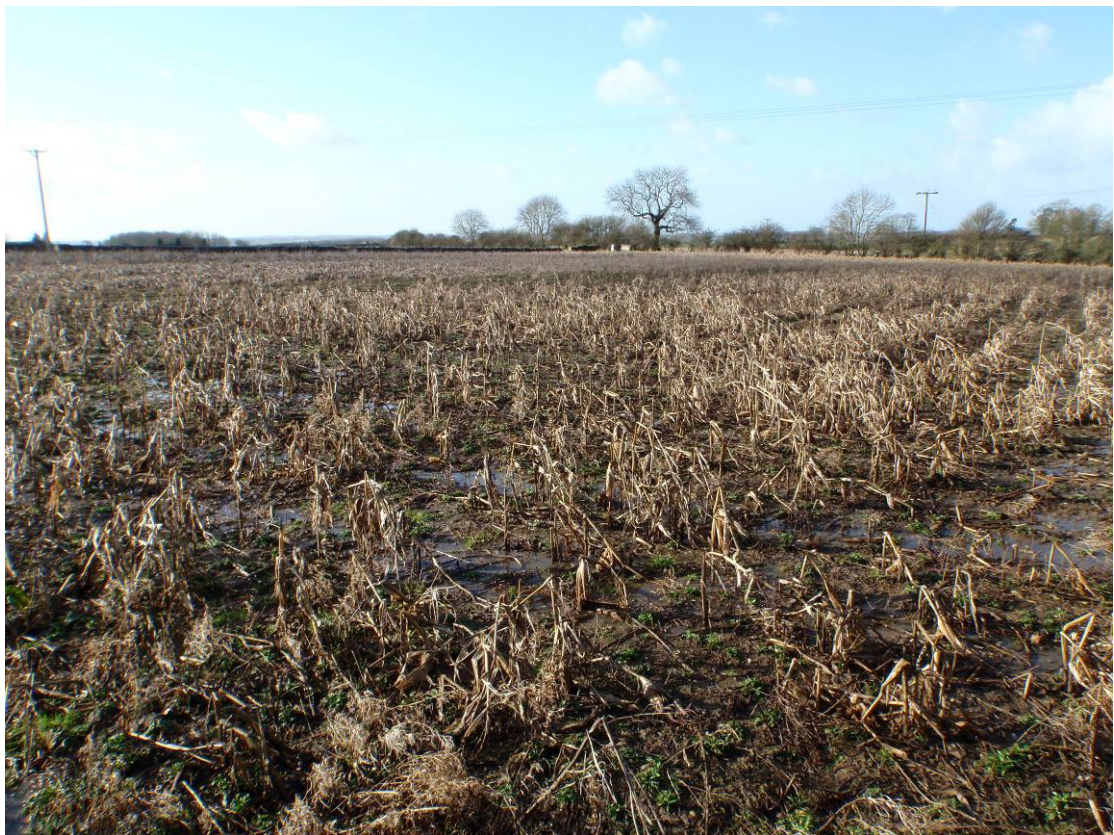
- 3.2.8.6 **Field F:** Situated south of Field E, west of Field D, and north of Field C. This field is separated from Field C by a row of stacked hay bales. The field surface is wet and it contains stalks of a remnant sweetcorn crop (**Plate 12**). Overhead cables attached to poles cross the field. No archaeological remains were observed.

Plate 12 Field F, general view, looking southwest
