**PHOTOGRAPHIC RECORDING OF HULKS ALONG THE
WITHAM FORESHORE,
BOSTON,
LINCOLNSHIRE
(BOHA 13)**

**Work Undertaken For
Interserve Construction Limited**

APS Report No. **25/14**

**ARCHAEOLOGICAL
PROJECT
SERVICES**

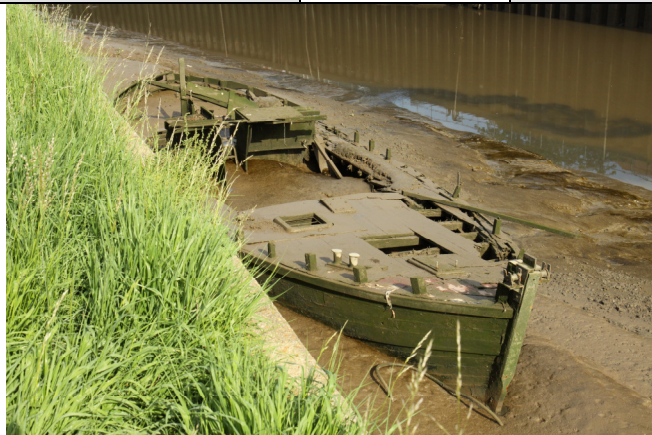
Vessel No.	3	National Grid Reference	TF 32863 43477
Type	MFV?	Condition	Sunken, silted
Orientation	SW-NE	Visible dimensions	15m long by 5m wide
Hull Construction	Carvel	Material	Wood

<p>Bow view showing two hatches and largely intact decking</p>

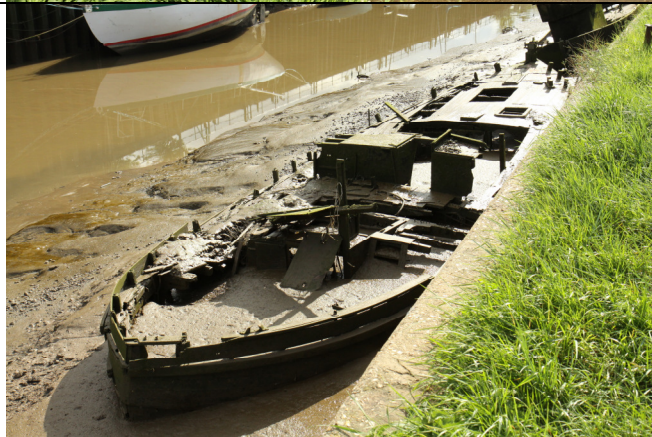
<p>Aft view with damaged deck and rounded stern</p>	
Additional notes	Possible motor fishing vessel (MFV) adapted from a small launch. Central recess for cabin and perhaps engine.

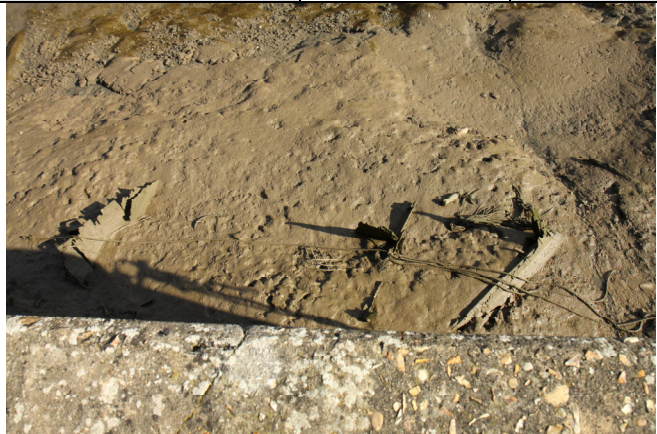
Vessel No.	4	National Grid Reference	TF 32888 43506
Type	Unknown	Condition	Sunken, silted
Orientation	SW-NE	Visible dimensions	8m long by 4m wide
Hull Construction	Clinker	Material	Wood

<p>Visible elements of the central part of the hulk</p>

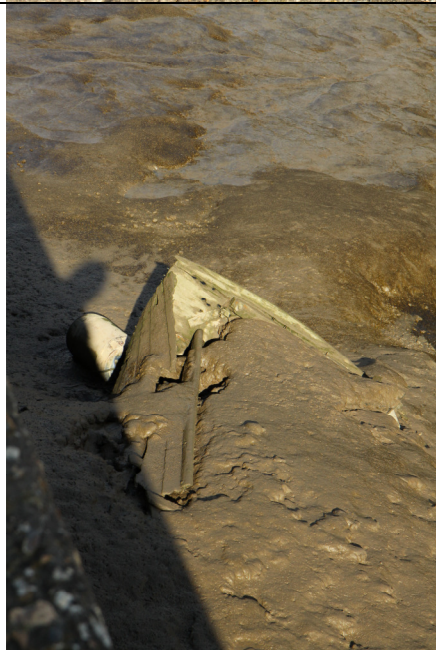
<p>Surviving stern section</p>	
Additional notes	Transom stern

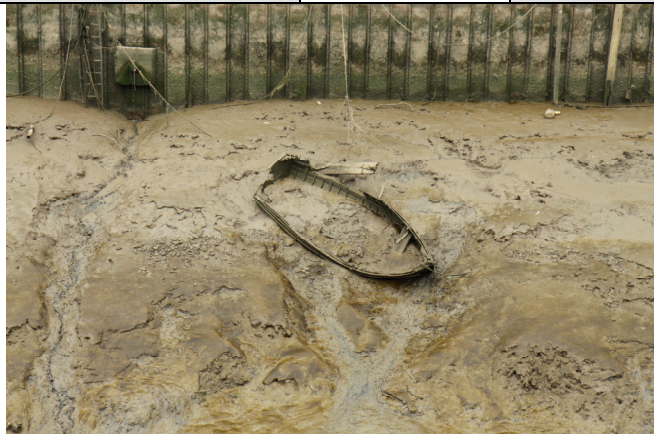
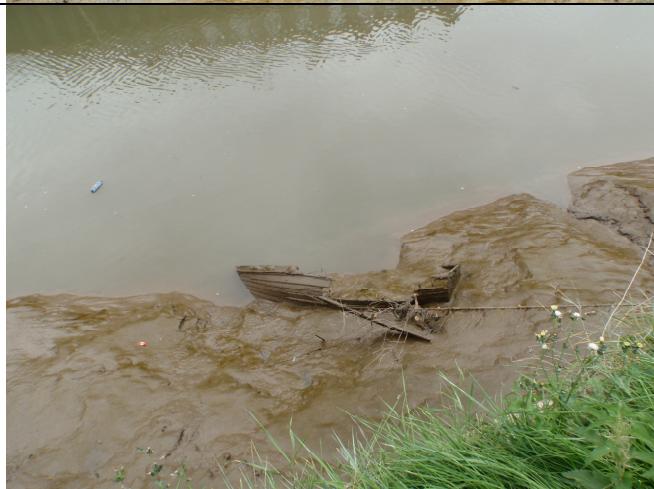
Vessel No.	6	National Grid Reference	TF 32901 43539
Type	Lifeboat	Condition	Sunken, silted
Orientation	E-W	Visible dimensions	3m long by 1m wide
Hull Construction	Clinker	Material	Wood

Additional notes	Transom stern

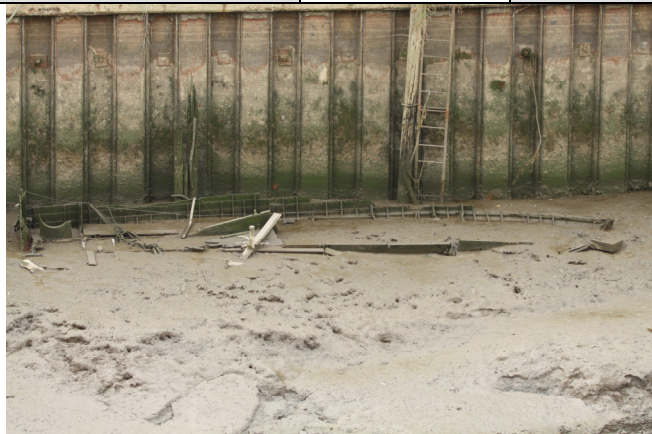
Vessel No.	9	National Grid Reference	TF 32910 43571
Type	Launch	Condition	Sunken, silted
Orientation	S- N	Visible dimensions	7m long by 3m wide
Hull Construction	Clinker	Material	Wood

View showing port side

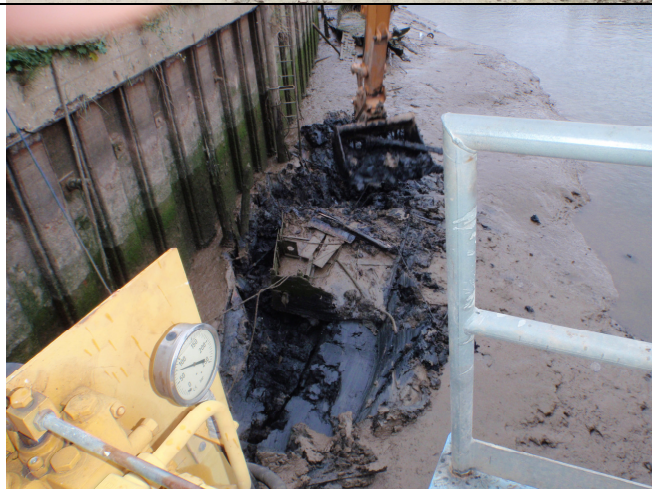
Vessel 9 during lifting. Decayed wood showing as black staining.	
Additional notes	Fragile nature of the vessel was revealed during lifting. Subsequently little more information could be added

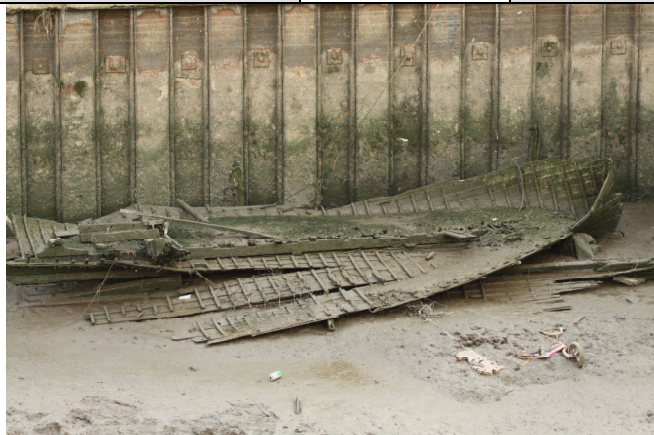
Vessel No.	10	National Grid Reference	TF 329083 43584
Type	Small launch	Condition	Sunken, silted
Orientation	NW-SE	Visible dimensions	6m long by 3m wide
Hull Construction	Clinker	Material	Wood

View showing the starboard side of the vessel	
Additional notes		Possibly overlies a second clinker built boat, although this may be a section of hull from aft which has moved beneath the collapsed fore hull elements

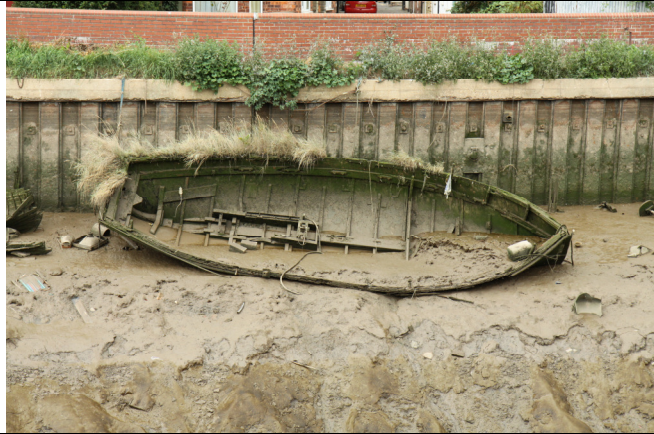
Vessel No.	11	National Grid Reference	TF 32863 43477
Type	Launch	Condition	Sunken, silted
Orientation	SW-NE	Visible dimensions	8m long by 4m wide
Hull Construction	Clinker	Material	Wood

View of starboard side of vessel	
Additional notes		Double diagonal planked vessel, probably associated with the Royal Navy/lifeboat service (Doughty 2009, 6). Converted to a fishing vessel. Transom stern with interior wooden engine mounting.

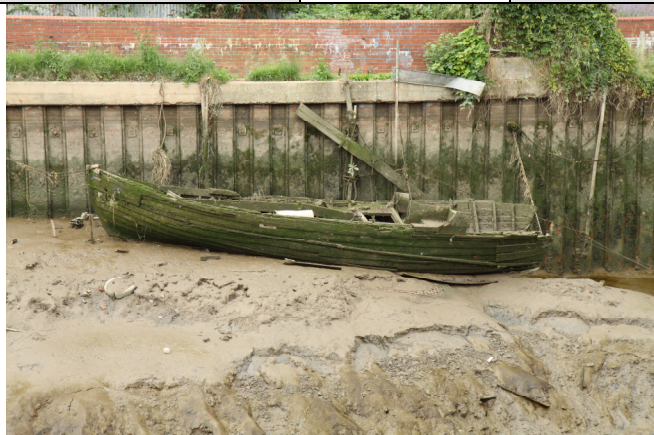
Vessel No.	12	National Grid Reference	TF 32900 43604
Type	MFV	Condition	Sunken, silted
Orientation	S - N	Visible dimensions	8.5m long by 3m wide
Hull Construction	Clinker	Material	Wood

View of port side of vessel	
Additional notes		Doughty (2009, 6) records that this vessel is of a similar type to Royal Navy vessels that have been converted for fishing. The hull was coated in cement to prolong its life, though no traces of this are now apparent.
