**ARCHAEOLOGICAL MONITORING AND
BUILDING RECORDING AT
FORMER GLEN EAGLE MANOR HOTEL,
LUTON ROAD, HARPENDEN,
HERTFORDSHIRE
(HPLR13)**

Work Undertaken For
**RDT Design on behalf of
Jarvis Homes**

August 2014

APS Report No: **96/14**

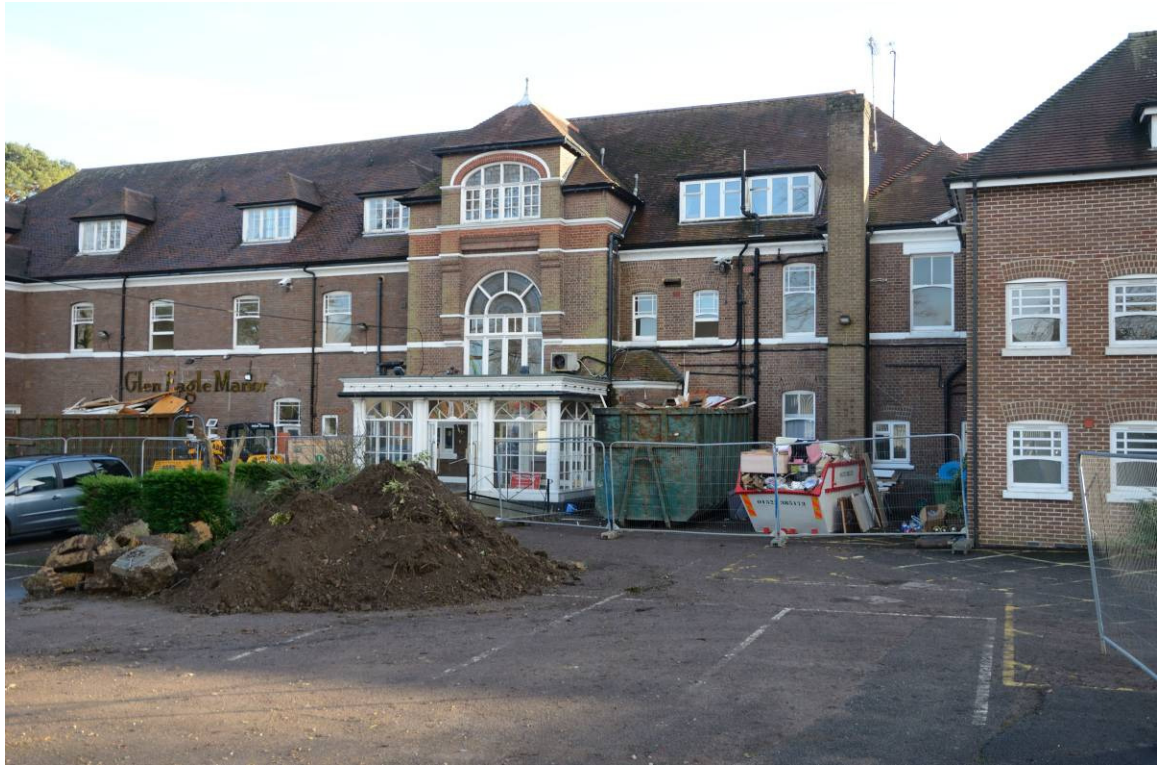
Plate 1. North facing elevation, looking *c.* southeast

In the north elevation (see *Plate 1*), the original facade was largely intact, except for the area east of the projecting element over the modern foyer. Original fabric, characterised by brickwork in Flemish Bond (in contrast to the more recent build in stretcher bond) includes the projection and all of the area east of a modern wing extending forward from the west end of the facade. There appears to have been some alteration in the arrangement of windows at first floor level, indicated by a blocked window immediately west of the projection (denoted by the surviving brick arch). At least one of the pair of small windows is a late insertion replacing the larger window indicated by the arch. The attic window is also late and relates to a hotel room built into the roof space (see below).

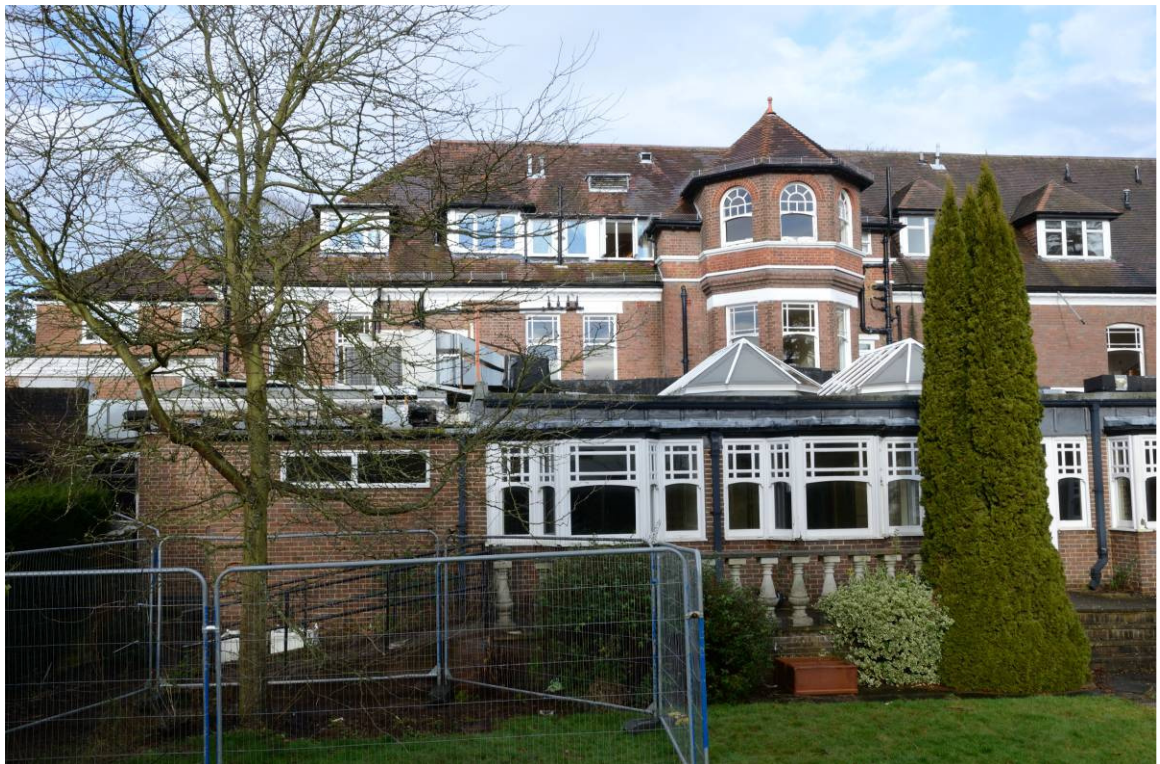
Plate 2. South facing elevation looking *c.* northwest

In the south elevation (see *Plate 2*), the bay survived at first and second floor levels and the area to the west was intact (including the five portrait windows at first floor). The central dormer window appears to have been original but the windows to either side were late alterations. Bay windows visible at the southeast corner on historic photographs appeared to have been demolished as part of works to construct the late extension east of the surviving bay windows.

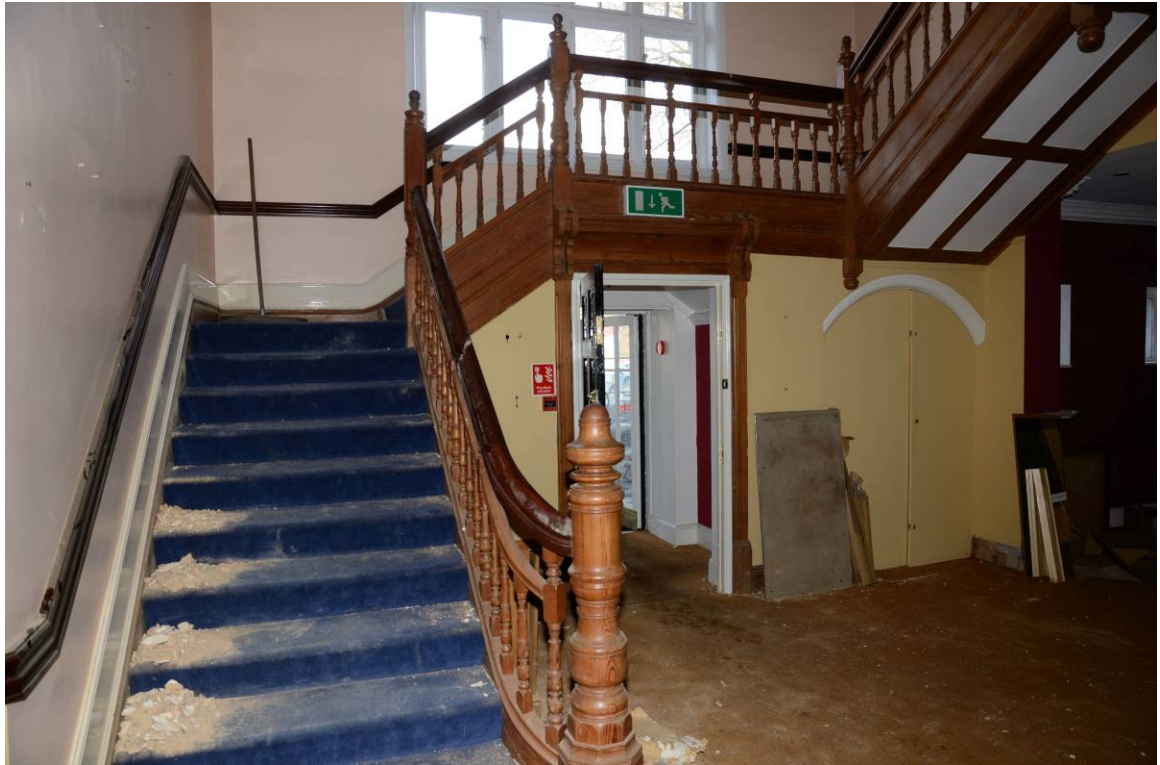
Plate 3. Staircase viewed from ground floor level facing NNW

Internally, the original oak staircase was largely intact on the north side of the building, in the area behind the projecting

entrance (see *Plate 3*), as was the large window in the north wall (see *Plate 4*). Woodwork around the landing at first floor level (see *Plate 5*) and the oak stairs to the second floor were also original (see *Plates 6 and 7*). At second floor level, the stairs were cased within late partition walls (*Plate 8*).

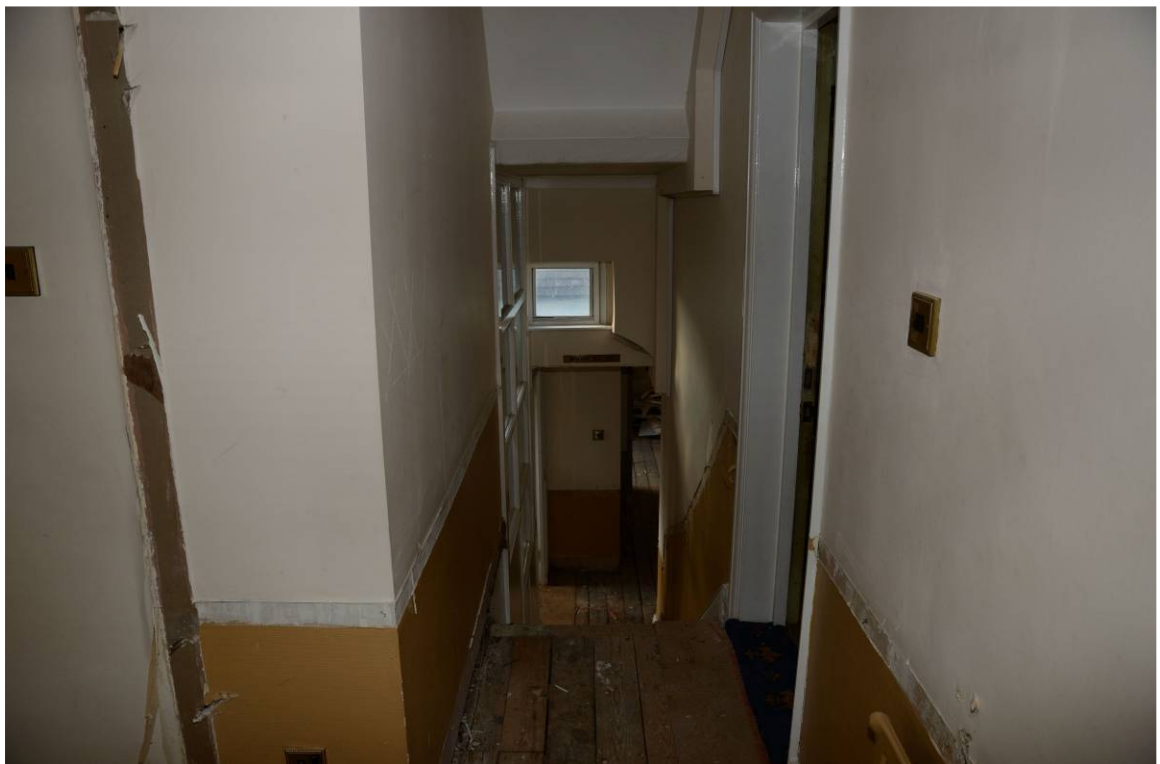
Plate 12. Second staircase from second floor, looking southwest

A second staircase at the west end of the house was probably used for services and was set conveniently near to adjacent outbuildings shown on the late Victorian Ordnance Survey map. The stairs extended west at ground floor (see *Plate 9 and 10*), before turning east and rising to first floor level (see *Plate 11*). The stairs originally turned north in the area of later panelling visible to left of view in *Plate 10*, but were extended to the west following the construction of the new wing and the opening up of the original west wall. The staircase continues up to the second floor (*Plate 12*).

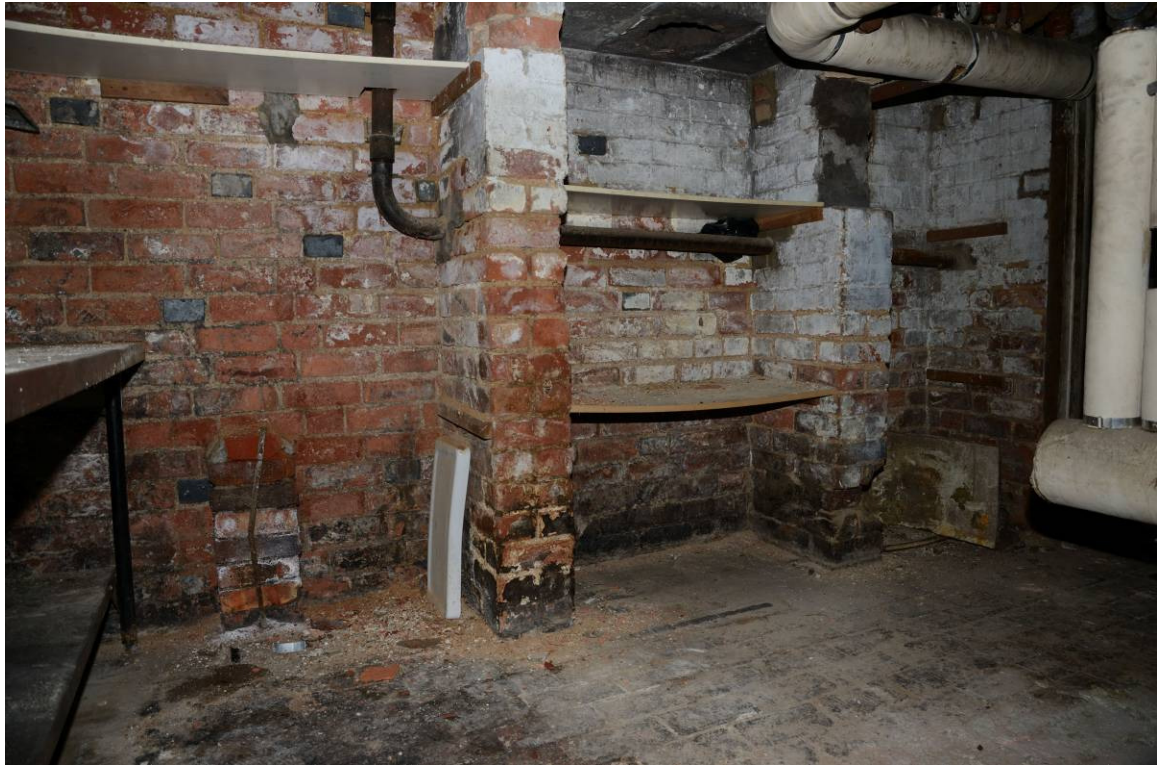
Plate 15. Basement northwest of the stairs, looking east

The basement, located in the western part of the house and apparently extending across the full width of the building, was reached from stairs descending to the east from behind a door located on the south side of the central east-west corridor. South of the stairs were two rectangular spaces aligned north-south, each with a barrel vaulted ceiling. The western area had brick supported shelves which probably originally functioned as a wine bottle rack along the west wall (see *Plate 13*), while the eastern area had a more recent wine rack along its west wall (see *Plate 14*). The northern space north of the stairs was most recently in use as a boiler room (equipment on the west side of the room and only partly visible in *Plate 15*).

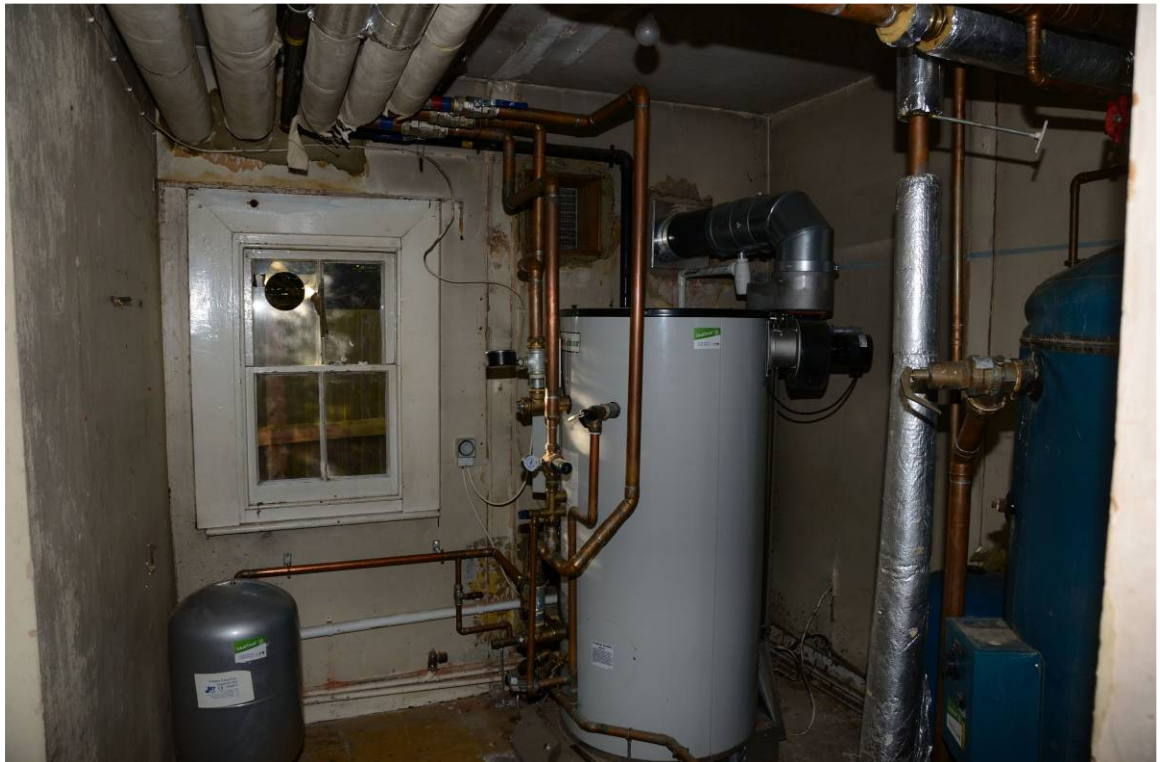
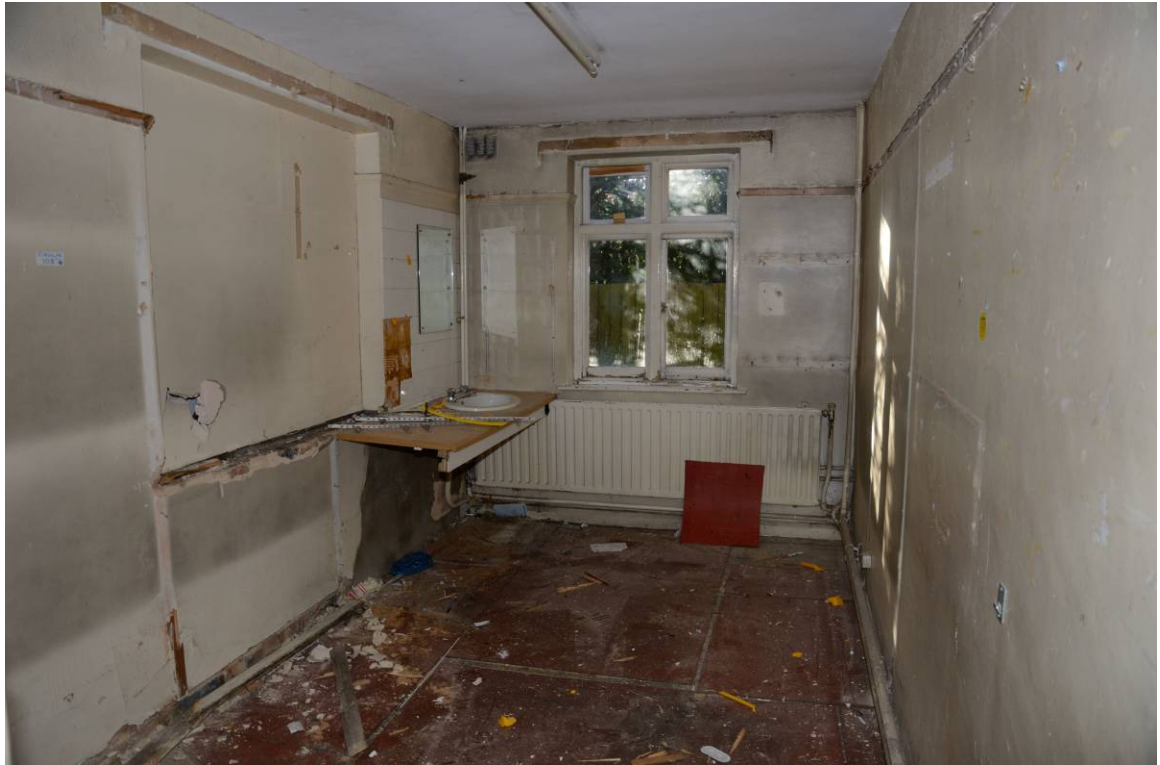
Some of the rooms used as service areas at ground floor at the western end of the building (see *Plates 16 and 17*) could have

been formed from outhouses situated to the west of the original building, although this was difficult to corroborate because of the extent of recent modification.

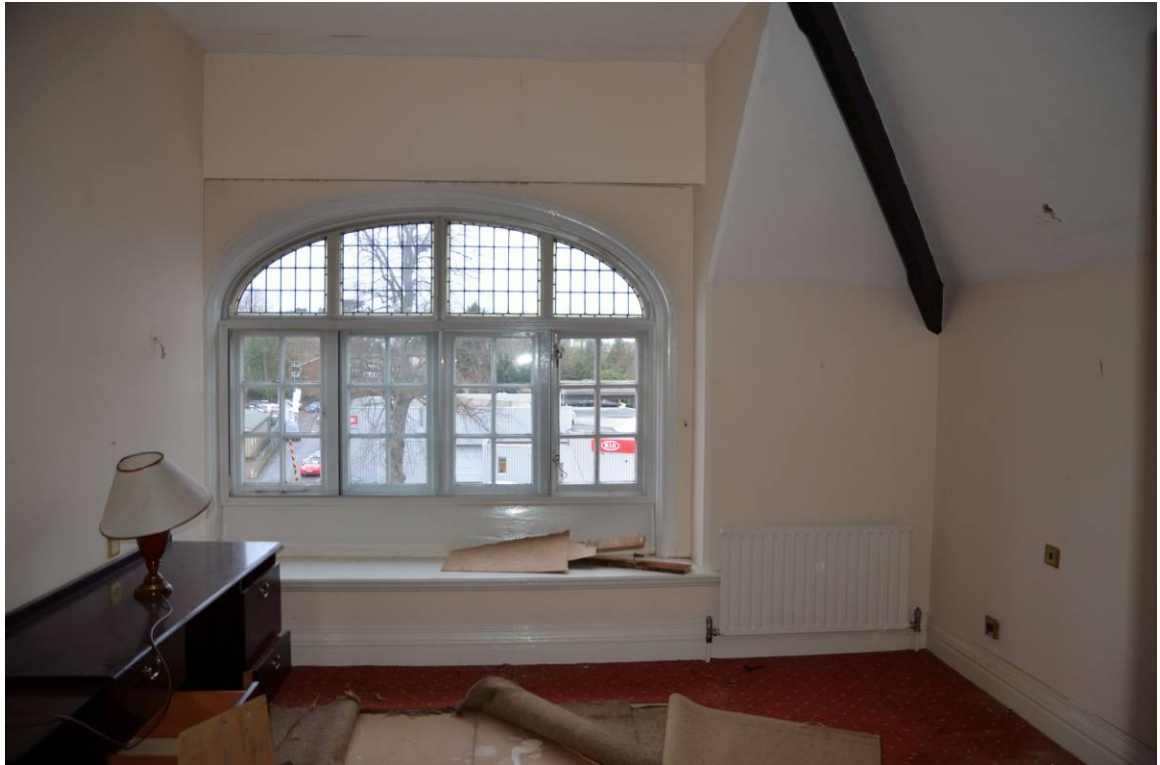
Plate 23. Second floor window in projecting bay to northwest, facing northwest

At second floor, the bedroom over the stairs on the north side of the building (see *Plate 23*) was apparently formed by partitioning on the south side, which would suggest that the area originally formed part of a ‘gallery’ situated to the north of the bay window bedroom. Components of the roof structure exposed in the room might have provided a decorative element in this ‘gallery’ (*Plates 24 and 25*). The bedroom in the bay on the south side of the second floor (see *Plate 26*) appeared to have been truncated on the east side, in similar fashion to the room below. West of the ‘gallery’ area the room on the north side of the building was apparently built into the roof space (see *Plate 27*), corresponding with the late dormer window seen from the exterior. However, a room on the south side (not depicted) is probably original as it corresponds with a window seen in historic photographs. Timbers at the northwest corner of the roof of the house were visible in a storeroom (see *Plate 28*).

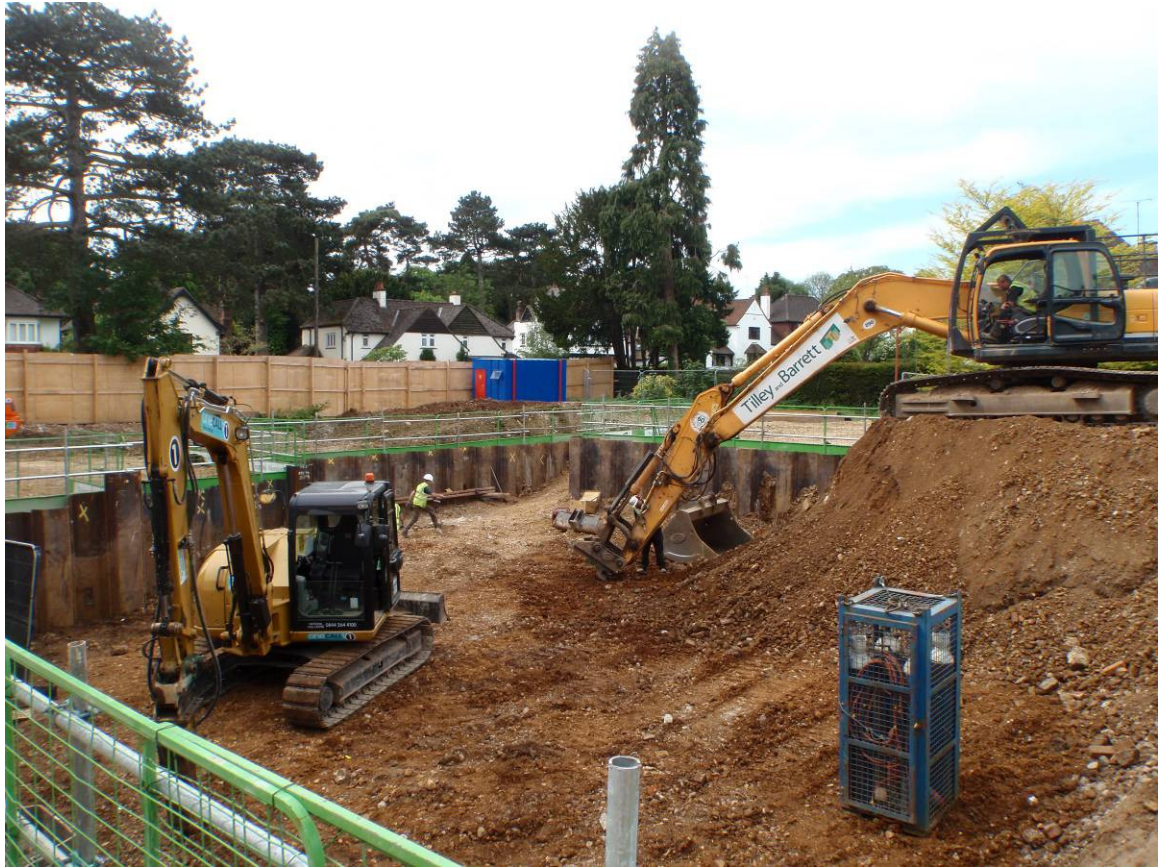
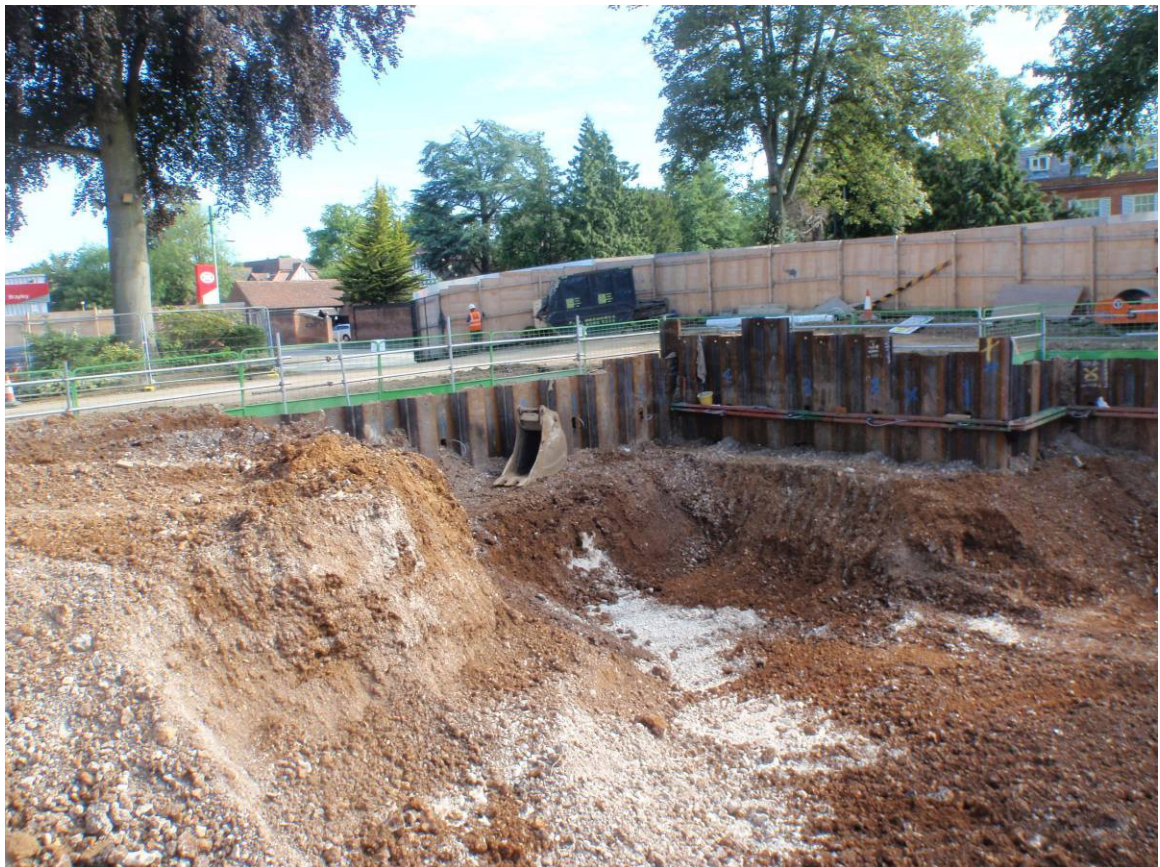
The footprint of the new building was first delineated by sheet piling. The area within, largely comprising the cellared area of the former hotel, was then reduced to the required depth by mechanical excavators (Plates 29, 30). Due to the method of excavation, an accessible straight section could not be recorded but an approximately 2m depth of sand and gravel natural deposits (002) was observed overlain by modern made ground (001). No archaeological features were observed.
