**HISTORIC BUILDING RECORDING
FORMER PRINT WORKS
5-6 LONDON ROAD
SPALDING
LINCOLNSHIRE
(SPLR14)**

Work Undertaken For
J. P. Builders Ltd

May 2014

A.P.S. Report No: **63/14**

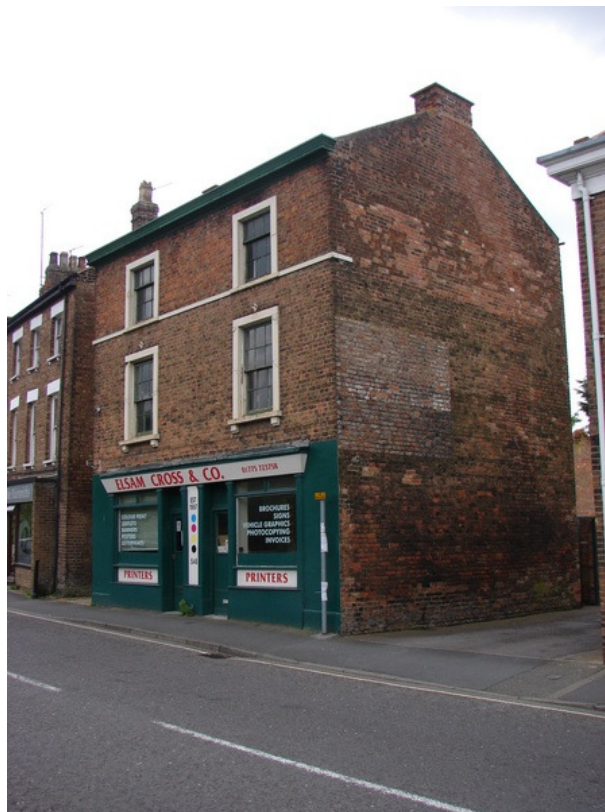
Plate 1. General view of the printers looking south west from London Road

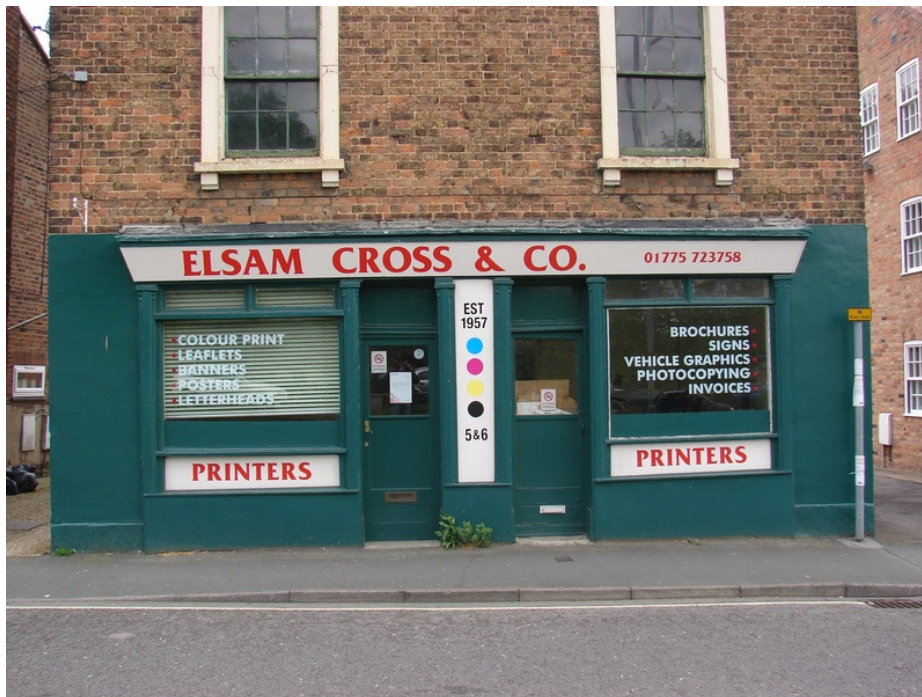
The double shopfront at ground floor level retains a number of its original features including the arrangement of doors although only the north door appears to be original, as evidenced by the beaded mouldings on the small lower panel and surviving thumb latch. The lower panels of the doors are now boarded, but may have originally been glazed, as would have been the plain rectangular fanlights above them.

Plate 2. General view of the double shopfront

The timber stall riser, window arrangement and ornamental pilasters and capitals are largely original in their layout although the cill is likely to be a later replacement as is the upper transom on the south window as it is plain in section and not moulded like that of the north. The lower transom to both windows is thought to be a later addition too as it does not line up with the door fenestration, which if it was an original feature it would do. The fascia above the shopfront is painted timber with vinyl lettering. This fascia is likely to be a modern replacement as it lacks the ornamental mouldings one would expect on a shop front fascia of this date.

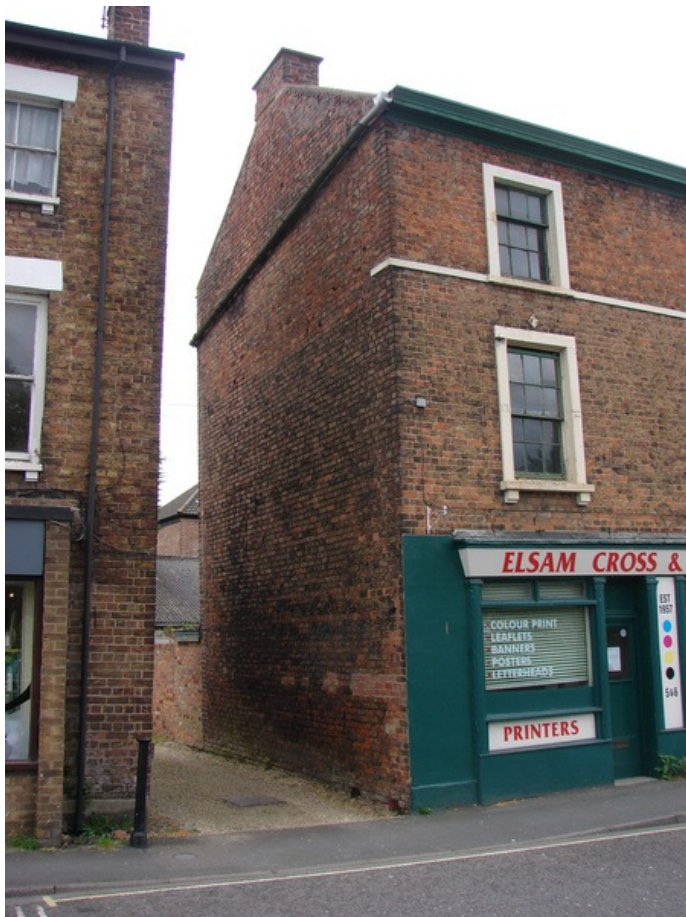
line with the painted stone window cills at second floor level is an ornamental painted stone string course which has a slight return on both the north and south elevations (Plate 3).

Plate 3. View showing south east corner of the building. Note the stone string course and return on south gable

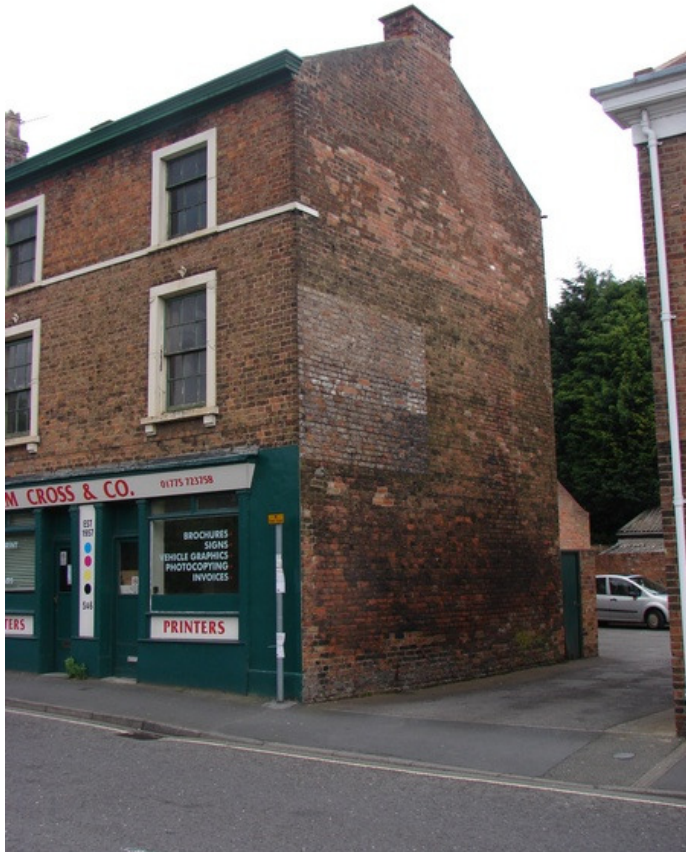
The north gable wall is of brick construction laid in English Garden wall bond. This elevation has very few features with the exception of a short gable apex chimney stack with a stone over sailing course and no chimney pots (see Plate 4). Some evidence of repointing and isolated areas of brick replacement at high level were also noted. On the north east corner are the remains of what appear to be a painted advert or sign which may have related to the original use of the shops.

Plate 4. North elevation with the remains of a possible painted advert relating to the former use of the shops

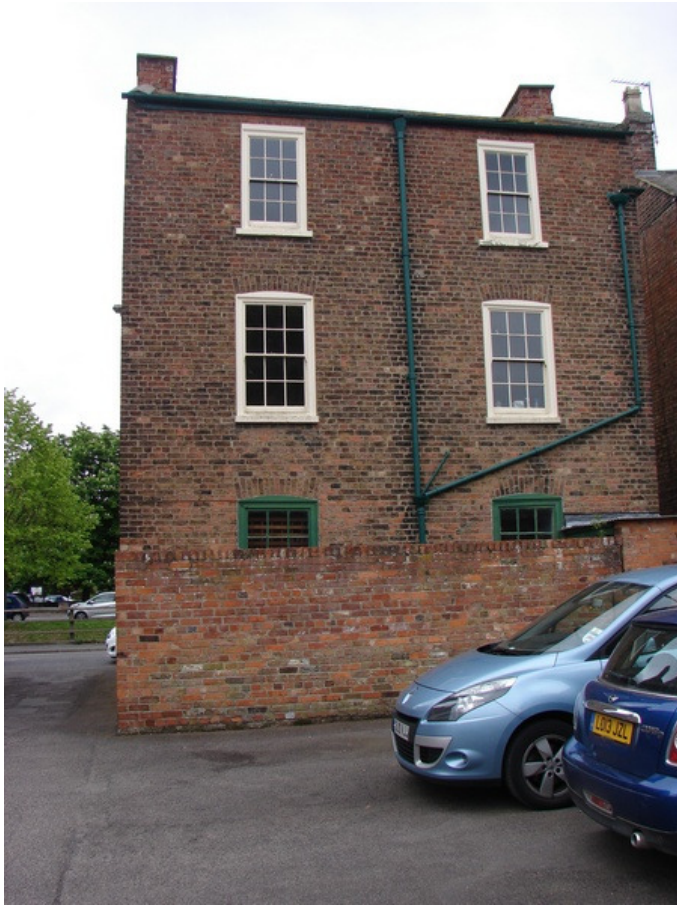
The rear or west elevation is symmetrically arranged with two six over six sliding sash windows at each floor level. The windows to ground and first floor level have a segmented soldier arch above them. The brickwork on this elevation is again in English Garden wall bond. All of the rainwater goods for the building are found on this elevation, the western roof slope discharges into half round cast iron guttering and then into a centrally placed cast iron downpipe (Plate 5). Similarly the water from the eastern roof slope has been guided

Plate 5. General view of west elevation

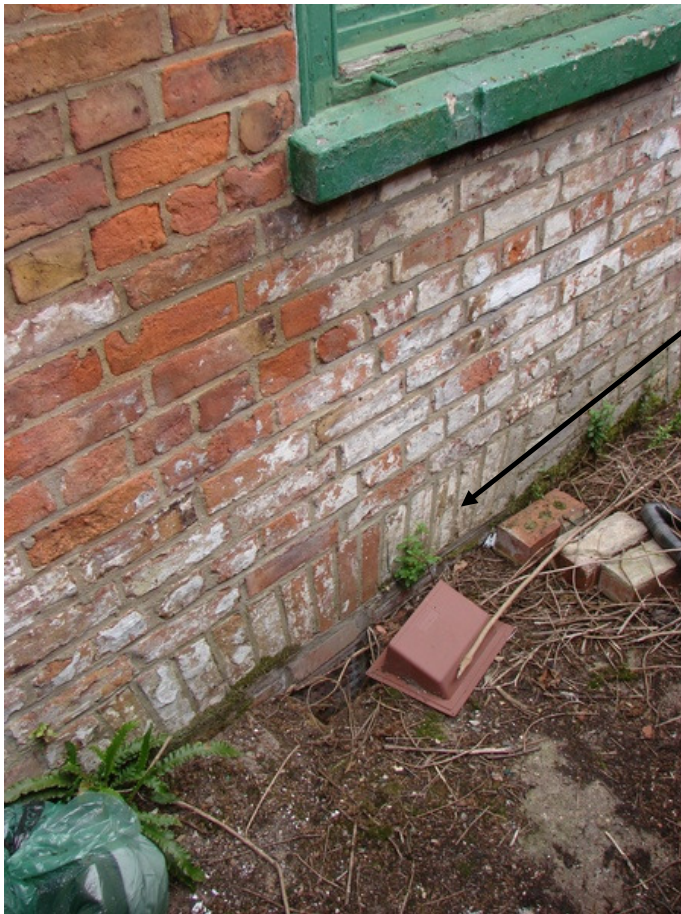
Windows on this elevation are all placed on painted stone cills. The first and second floor windows are relatively modern replacement sliding sashes – note the inappropriate historical detail of sash horns. The ground floor windows are the original sashes (without horns). At the bottom of this elevation are the remains of soldier arches at ground level indicating that there may have once been window openings or door openings at basement level and the current ground level here may be later backfill (Plate 6).

Plate 6. Partially buried former openings on the west elevation

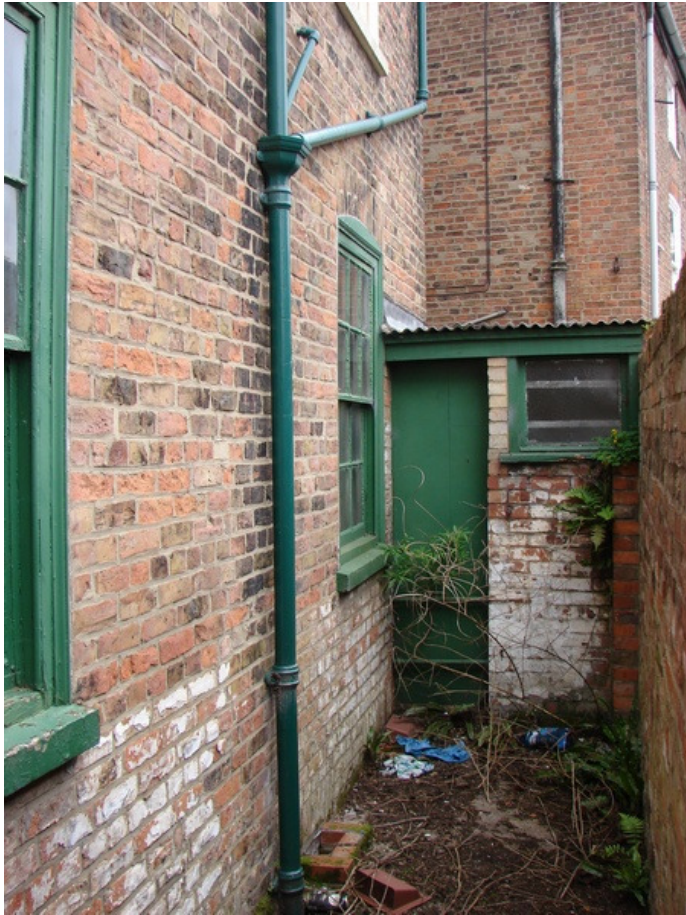
This elevation has a small ground floor extension for a toilet adjacent to the south window (Plate 7). On the north elevation of this extension is a blank timber panel which appears to be too narrow for a former door opening and to the right of this is a modern casement window. The brickwork beneath the window is in English Garden wall bond and a section of brick to the left hand side of the window appears to be of a more modern date. The rear yard is enclosed by a brick wall laid in English Garden wall bond which has a modern timber door/gate on the north side.

Plate 7. The small west elevation toilet extension

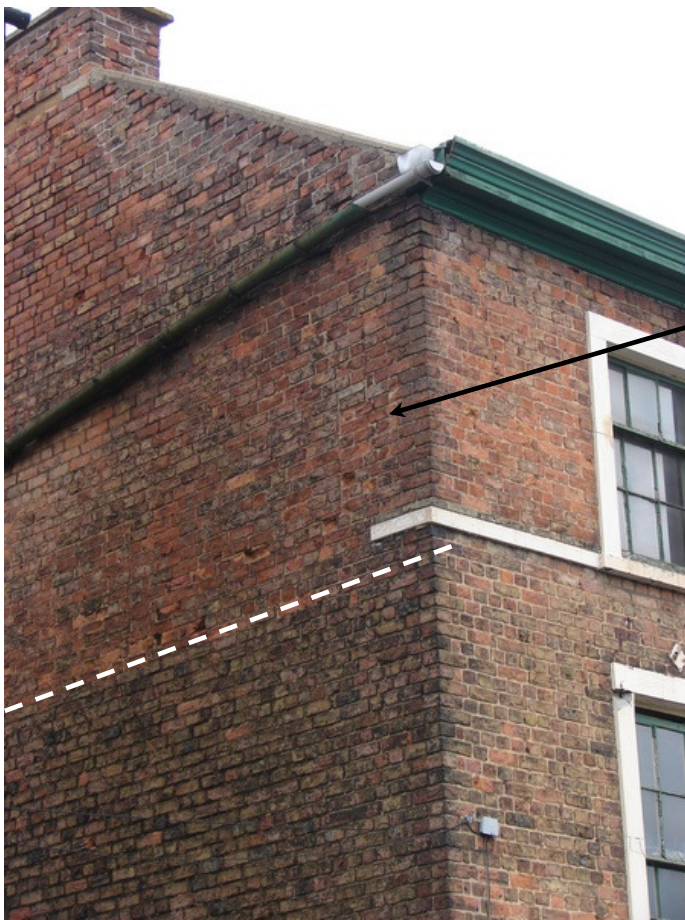
The south elevation is almost identical to the north elevation (see above) with evidence of some repointing and brick replacement at both low level and to the gable apex. One curious feature of this elevation is a small section of brickwork repair on the south east corner where a possible short straight joint is visible. It is unclear if this reflects a later repair or just poor quality brickwork when the structure was built. The brickwork in the apex looks slightly different to that below but this may be due to a weathering, the former position of guttering or a combination of both. From internal evidence (see below) there is nothing to indicate that the gable has been rebuilt.

Plate 8. The short straight joint in the brickwork on the south elevation. The dashed line indicates the change in the colour of the brickwork possibly due to the line of a former gutter

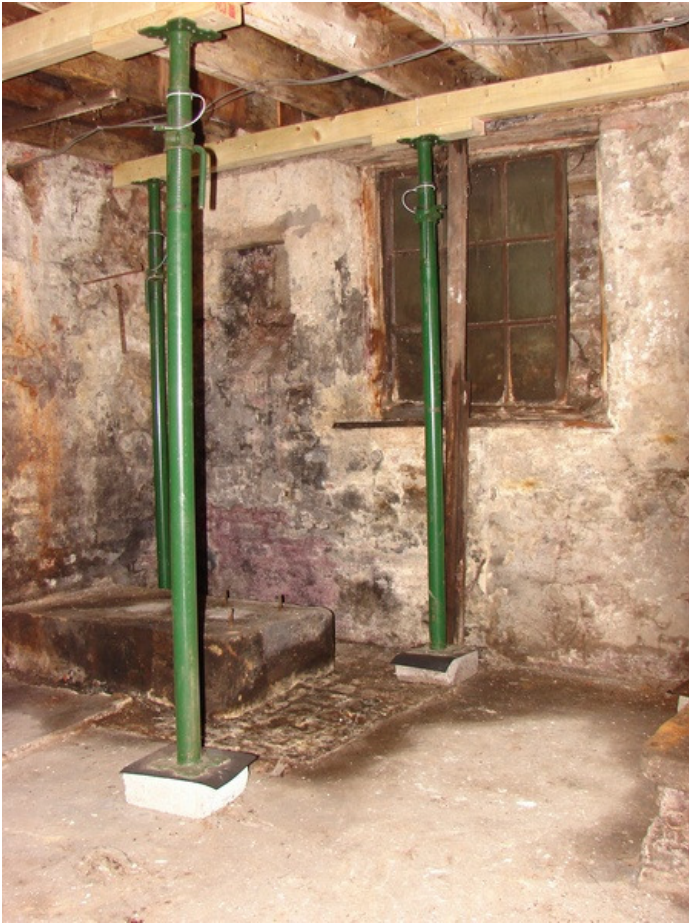
There are semicircular brick arched openings that lead through from both western rooms to the eastern rooms (see Figure 4). Both east facing rooms have the remains of a former window opening which presumably was once served by a light well with a metal grill from the main pavement above (Plate 9). Also in these rooms adjacent to the window is a masonry block with a shallow sink arrangement in it, a feature which survives more fully in Basement Room 2 (Plate 10). This could be a slop stone which was a common feature in Victorian basement kitchens. There is also evidence of a small coal shute or ventilation hole in each room adjacent the window; again this would also be a common feature in basement kitchens.

Plate 9. The east facing former window in Basement Room 4

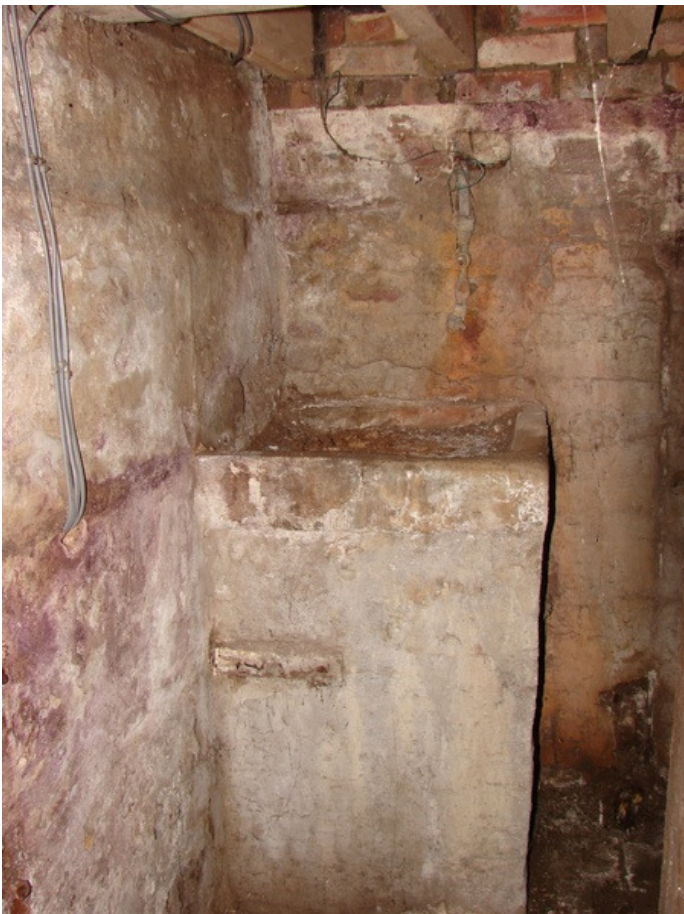
Plate 10. The possible slop stone in the north east corner of Basement Room 2

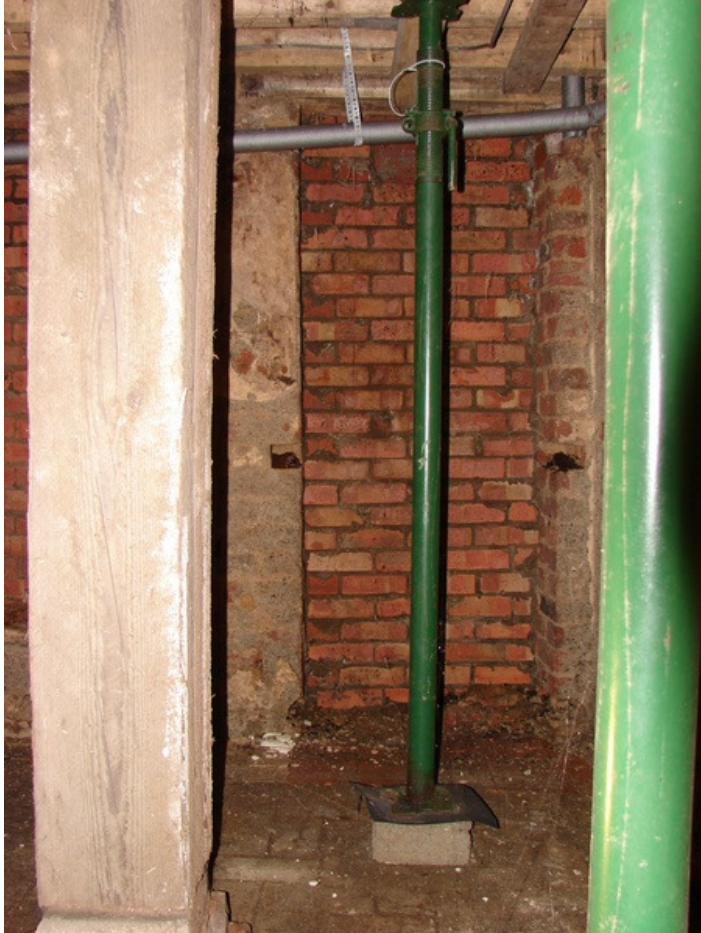
In the western rooms the floors are of quarry tile and have evidence of full height possible former door openings on the west wall (see Plate 11) which correspond with the soldier arches described on the lower west external elevation (see above). The smaller half height blocked up openings in these rooms may represent former small windows. Both these rooms also have surviving chimney breasts although they have been blocked up and do not retain any evidence of former fireplaces.

Plate 11. A blocked door opening on the west elevation of Basement Room 1

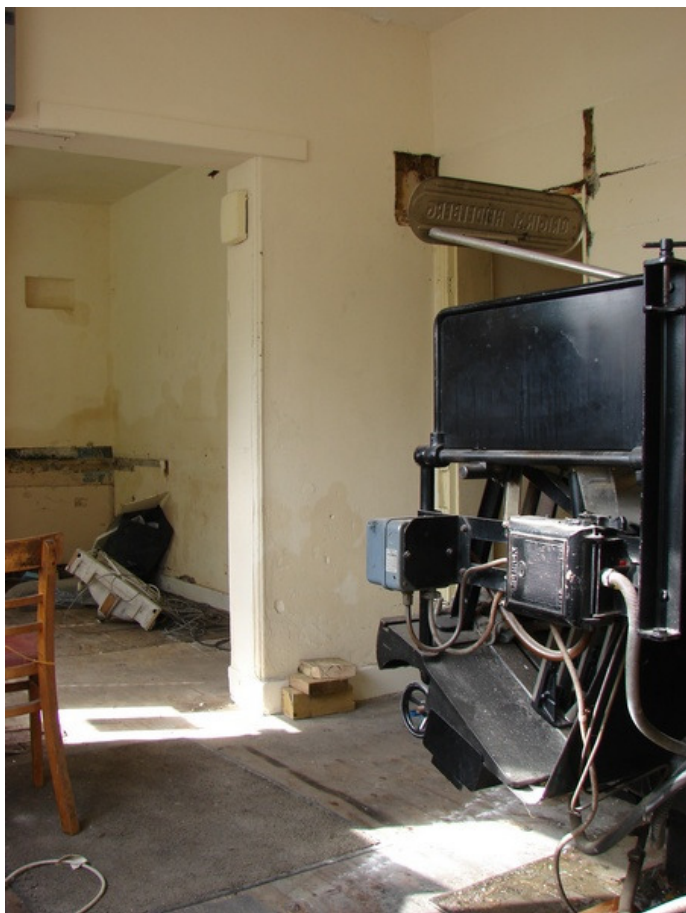
The ground floor comprises four main rooms and a small toilet extension on the west elevation. The Reception and Print Rooms have been combined by forming an opening through the central spine wall. The ceilings in these rooms are a mixture of original lath and plaster and modern plasterboard. The walls are all plastered and do not have any surviving original features. All skirting boards are square edged and the fire places have been removed. The chimney breast in the Print Room has also been largely removed and now only survives as brick stubs. The timber shop fronts and timber stall risers can be clearly seen from the interior. These have been described above.

Plate 12. A general view looking across from the Print Room through to the Reception Room (looking north to south)

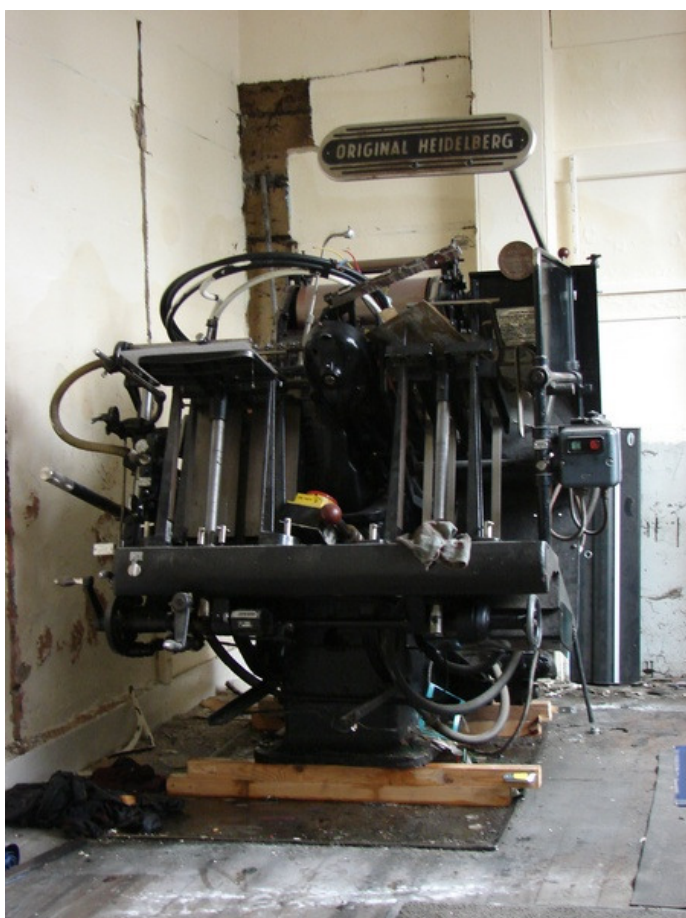
Plate 13. The 'Original Heidelberg' printing press in the Print Room

The surviving printing equipment is the large printing press in the Print Room (Plate 13). This is an 'Original Heidelberg' from Germany. The new owner of the property has confirmed that this printing press still works and was used until the printing business here closed.

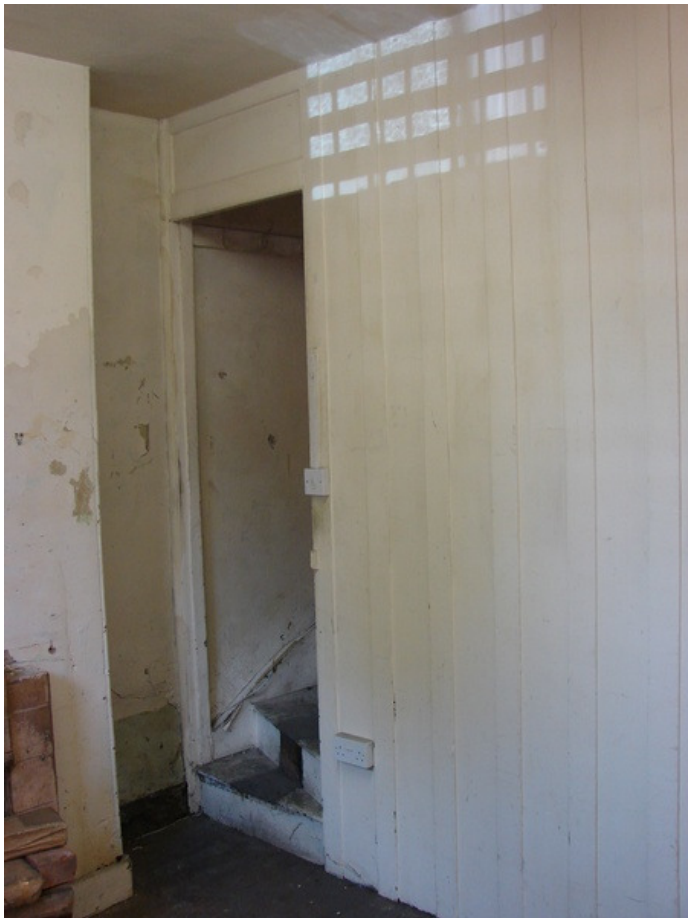
The Print Store has staircase access to the upper floors and also the basement level. The staircase enclosure is constructed of vertical timber boards with smaller timber laths placed over the joints (Plate 14). This enclosure appears to be a surviving original feature. The original door to the staircase enclosure is no longer present. As with the rooms described above there are few original architectural features surviving in this room. The one exception is the small full height cupboard on the north wall next to the fireplace, although even with this only the lower door survives. The fireplace is of a later 1930s style and is therefore a later replacement. The wide floorboards noted above survive over a greater area in this room and are on average 26cm wide and are therefore likely to be an original feature.

Plate 14. The staircase enclosure in the Print Store

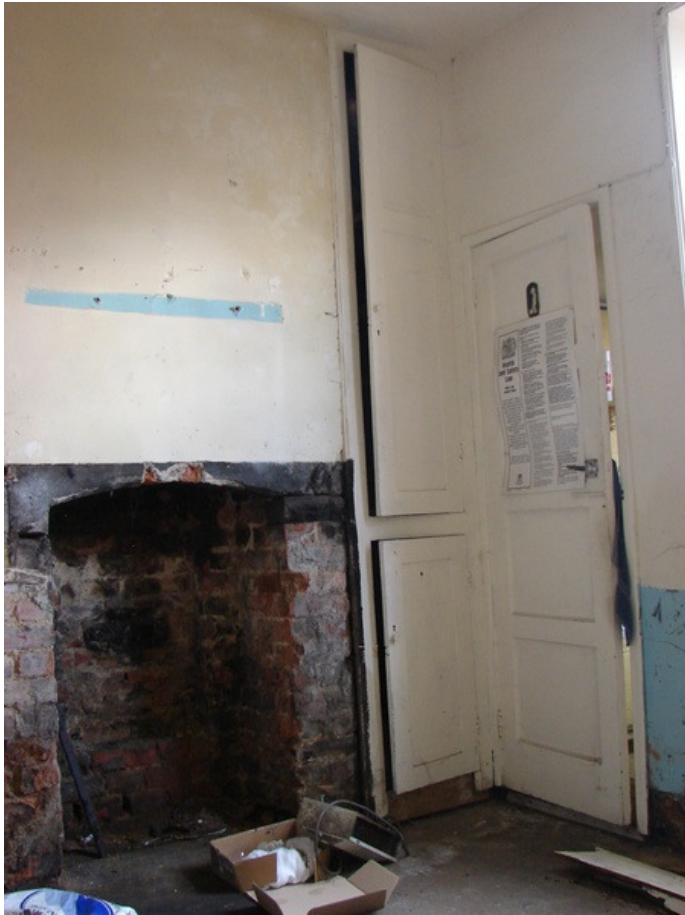
The room formerly used as the kitchen /utility space for the print shop is almost the same as the Print Store described above with the same surviving staircase enclosure, but this time still retaining its original four panelled door and thumb latch. The original cupboard adjacent to the chimney breast also survives complete with both of its original doors (see Plate 15 below). No fireplace survives in this room although the opening where it was once installed is evident. Leading from this room down a couple of steps is a small toilet extension which has been added to the original structure. The door leading into this room looks to be of a 1930s date with four equally sized panels divided by horizontal rails. There are no other features of note within this room.

Plate 15. The surviving store cupboard in the kitchen area, with 1930s style door leading to toilet extension adjacent

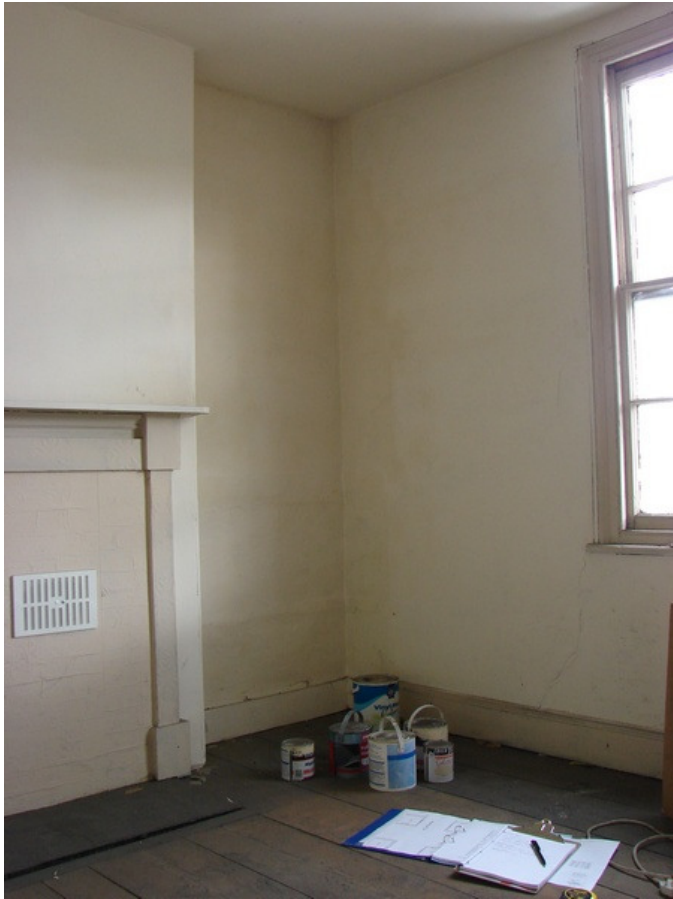
Plate 16. Store Room 4 looking towards the north east corner. Note the blocked fireplace and the wide floorboards

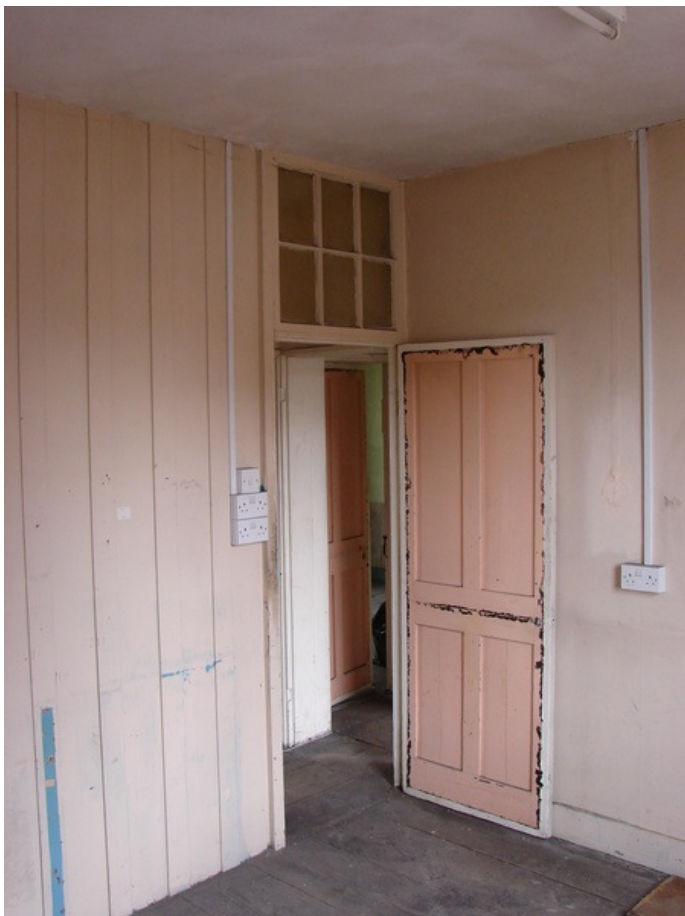
Plate 17. Store Room 3 looking towards the south east corner showing the original four panelled door and the hinged borrowed light over

The landing area on this floor has been made by forming a door opening between either half of the building and is the area where the staircase from both sides meet. The doors leading to this area from Store Rooms 1 and 3 have an unusual borrowed light arrangement above them which not only provides additional light across the interior but appears to also have provided the potential for additional ventilation too as both are hinged (see Plate 17 above).

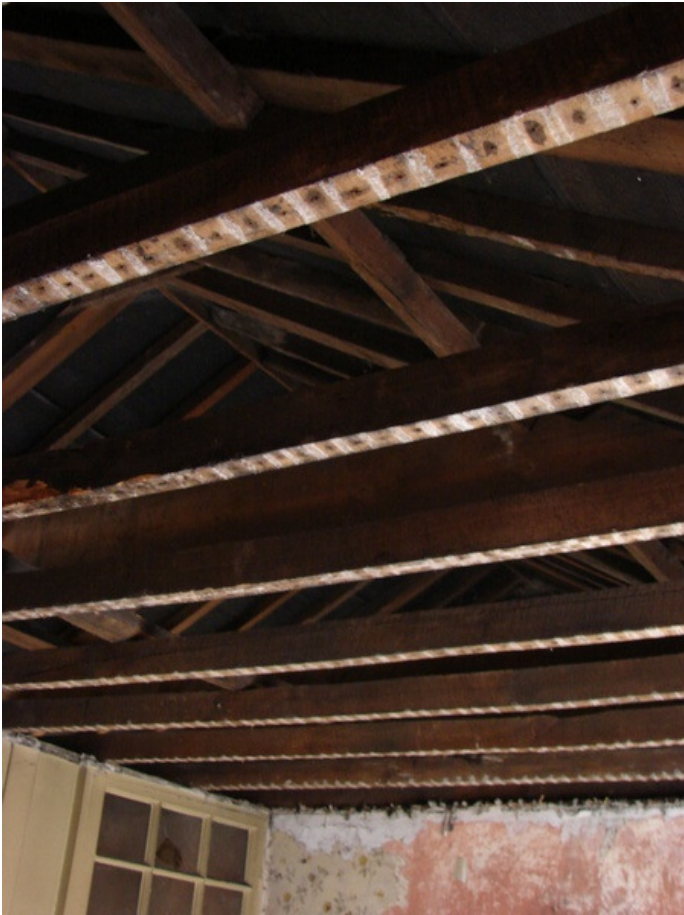
Plate 18. General view of the roof structure looking north west

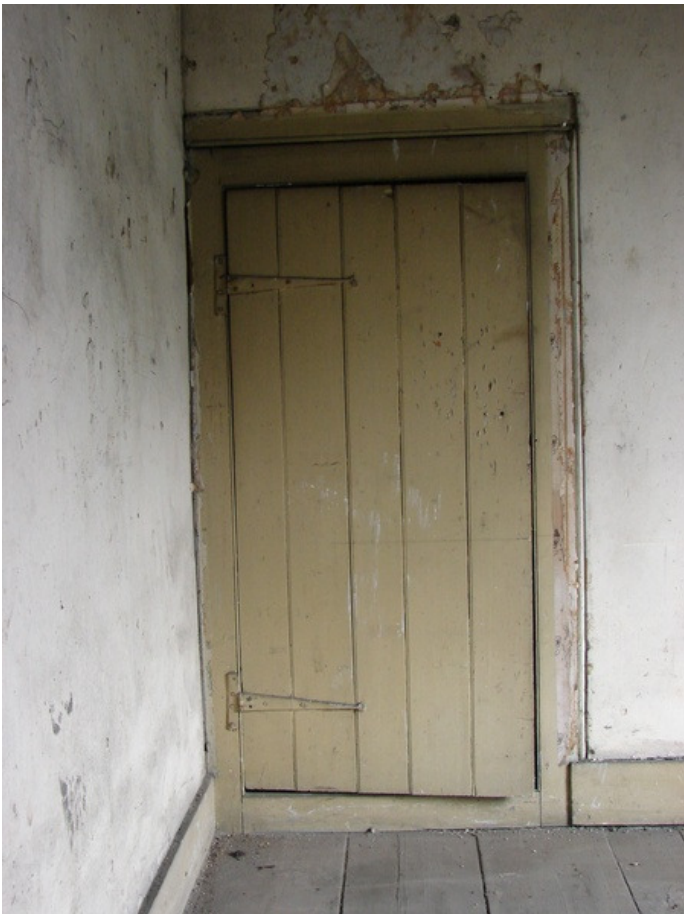
Plate 19. Cupboard door in Store Room 8

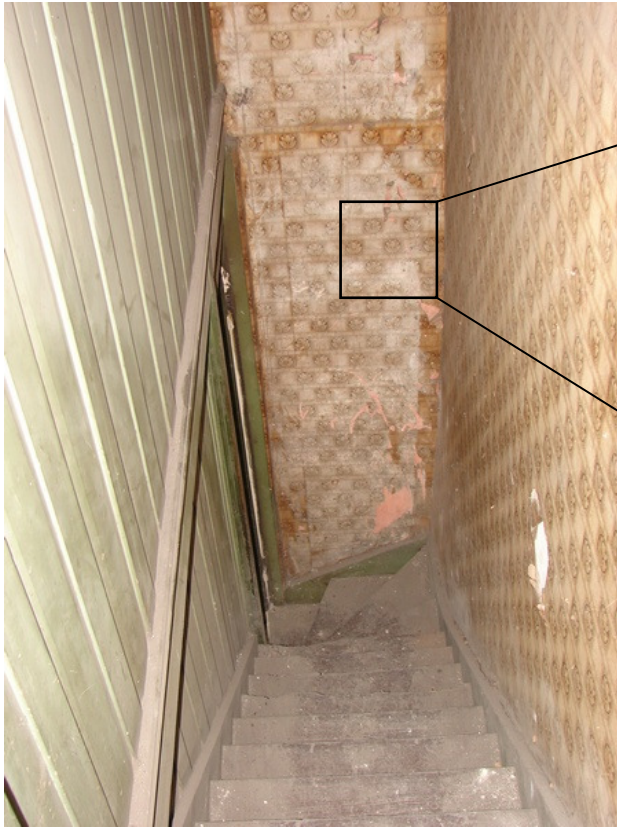
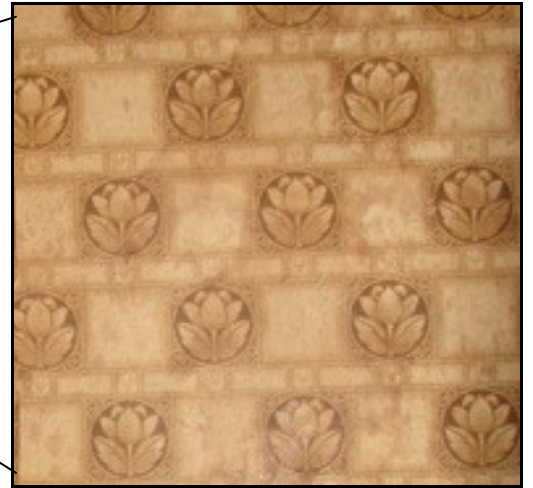
Store Rooms 5 and 7 are in the south west and north west corners respectively. These rooms contain almost identical details, the most prominent of which are the staircase enclosures which are the same as described above. Within the southern staircase the surviving wallpaper appears to be of a 1930s date (see Plate 20 below).

Plate 20. View of first floor north staircase illustrating possible 1930s wallpaper enlarged above

The later changes evident all seem to relate to use as a printers, include combining the two ground floor eastern rooms by removing a section of the central spine wall, reinforcing the suspended timber ground level floor with timber posts in the cellar to support the heavy printing equipment and removing all but small brickwork stubs of the north east and south east chimney breasts to increase the floor area. The works also included providing a kitchen area which had the (1930s?) toilet extension leading off from it. The first and second floor levels were similarly combined and then appear to have been simply used for storage. All of these changes may have resulted in the northern first floor staircase eventually going out of use, hence the survival of the 1930s style wallpaper in this staircase enclosure.

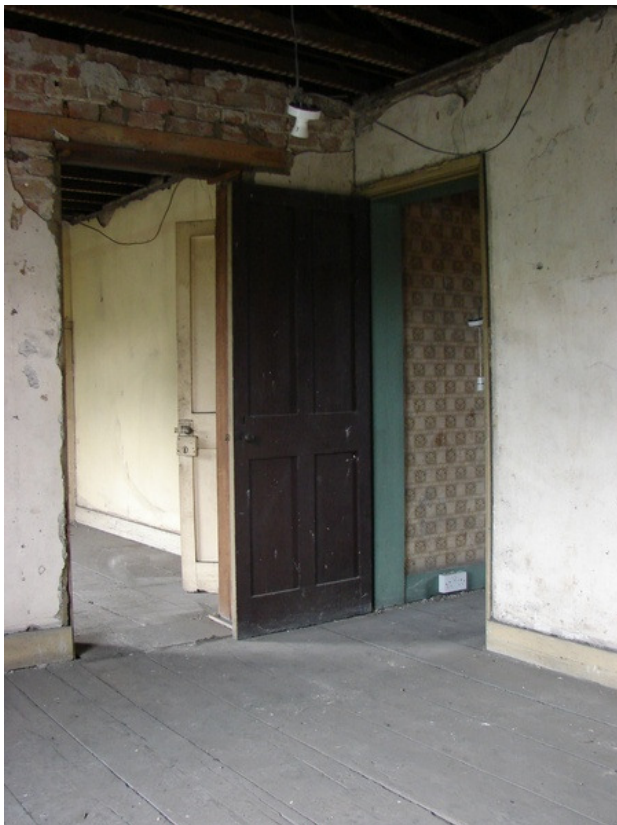
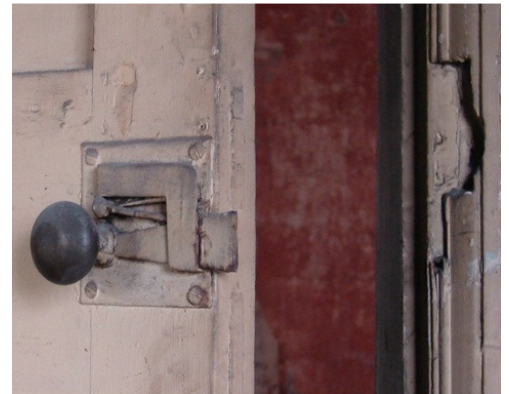
The main doors within these rooms are all of a plain four panelled design as seen elsewhere within the building. The door openings adjacent to the staircase enclosure both have six paned borrowed lights above them. The doors leading into Store rooms 6 and 8 appear to have retained their original ironmongery (Plate 21, detail, below).

Plate 21. Surviving original four panelled doors at second floor level. Note enlarged view of original ironmongery

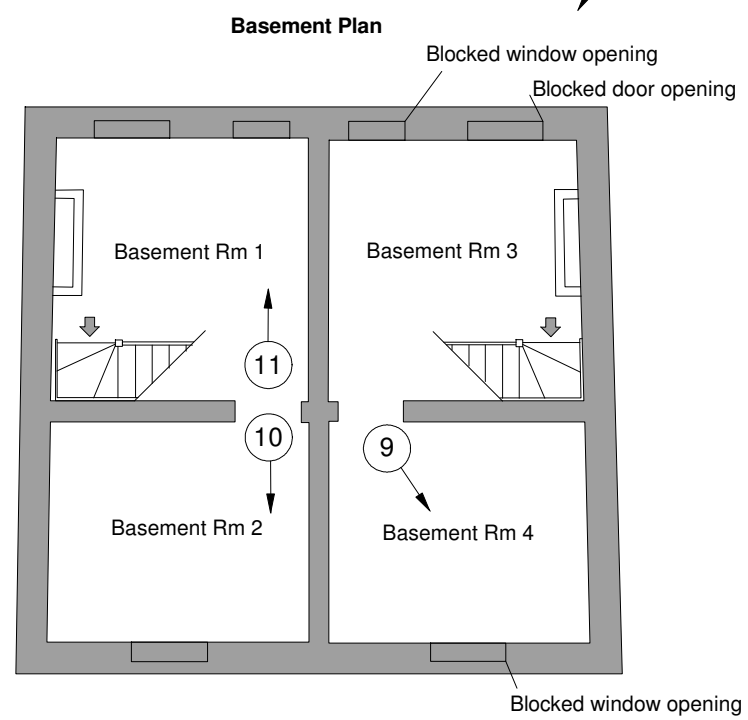
Figure 4: Detailed floor plans and plate arrangement

17 Plate number and direction of view
