**ARCHAEOLOGICAL WATCHING BRIEF
ON SERVICE TRENCH AT
SAINT JAMES & SAINT JOHN CHURCH,
DORRINGTON,
LINCOLNSHIRE
(DJJC13)**

**Work Undertaken For
PCC**

Report Compiled by
Andrew Failes BA(Hons) MA

National Grid Reference: TF 076 533
City and County Museum Accession No: LCNCC:2013.224
Oasis ID No: archaeo11-182209
APS Report No. **65/14**

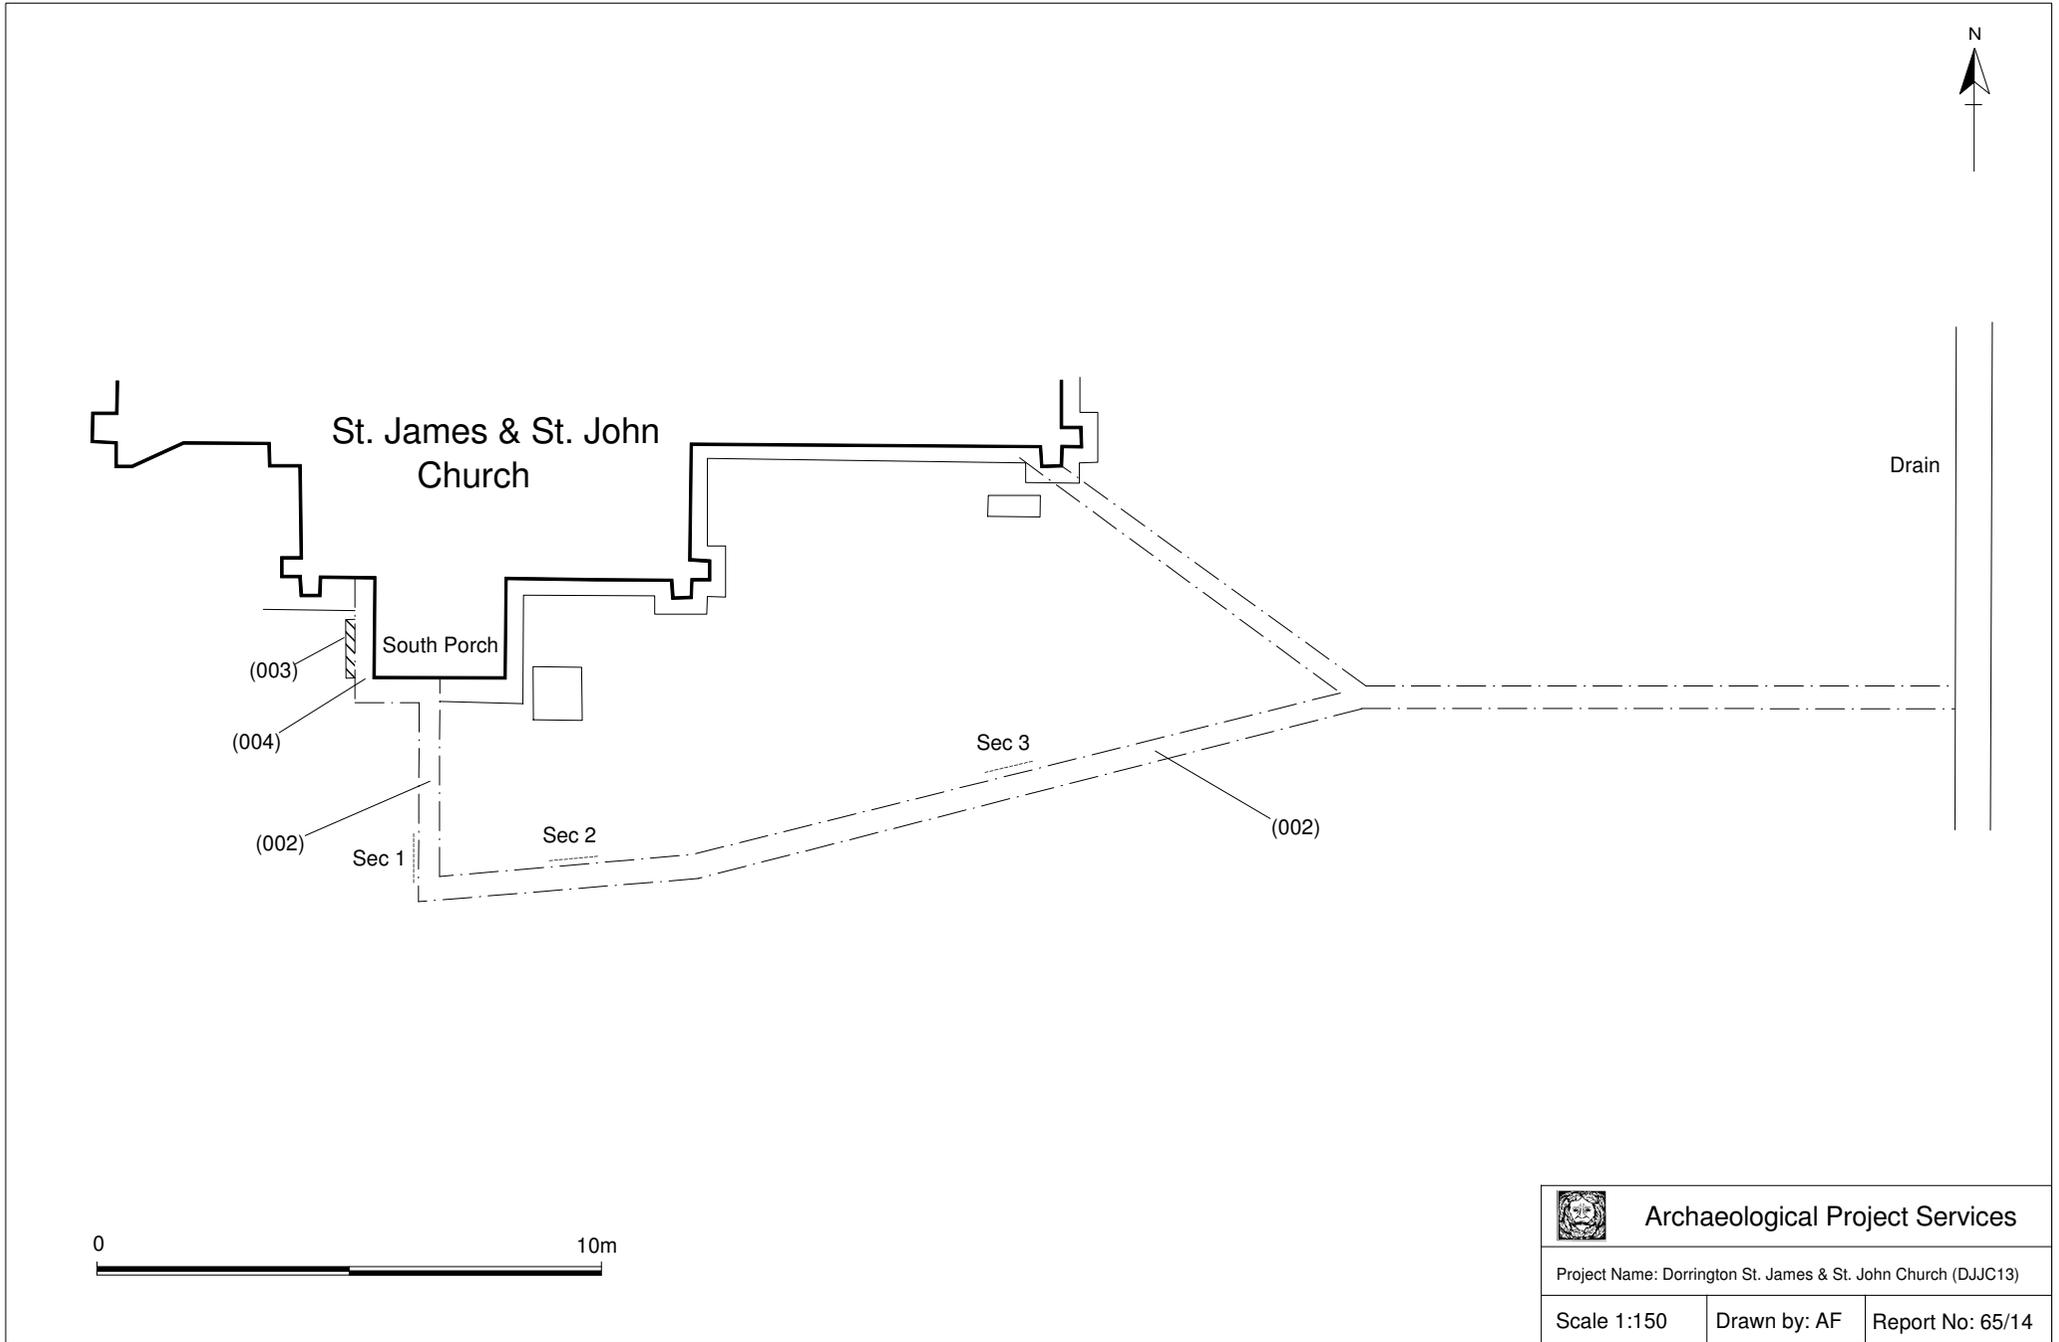
Figure 3 - Site plan and section locations

This deposit was encountered on the western side of the porch (Fig 3), although here it was designated context number (004) because it contained fragments of mortar and ceramic building material (CBM) (Plate 2).

Overlying deposit (004) around the western side of the porch was a discontinuous strip of brick edging (003) (Fig 3) with bricks measuring 235 by 115 by 75mm in size.

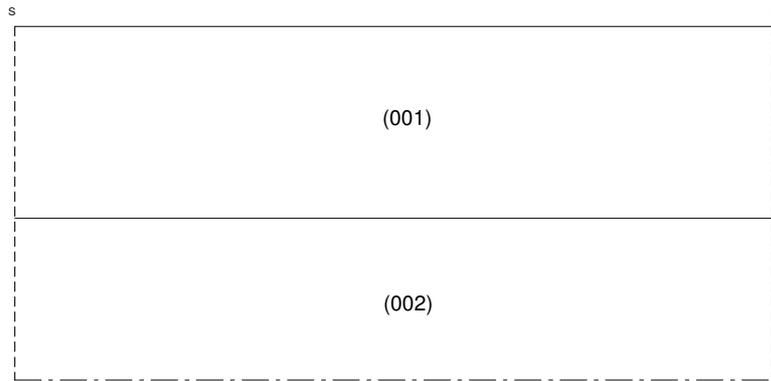
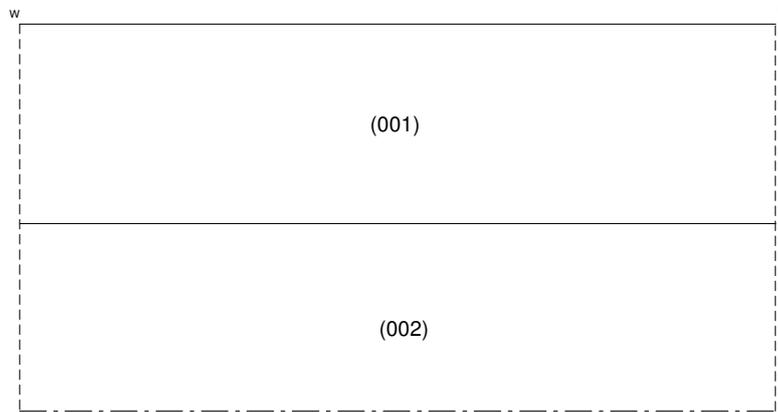
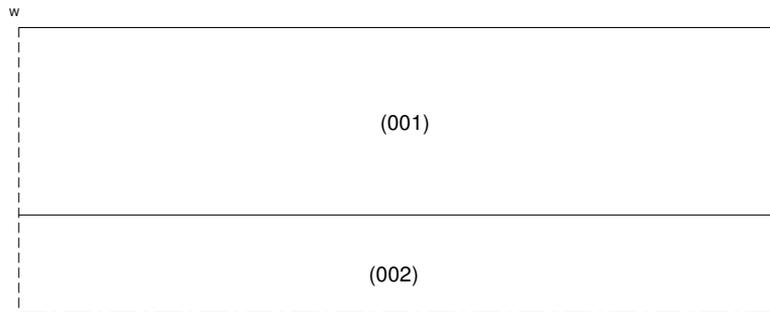
Figure 4 - Sections 1-3

The earliest deposit identified during the investigation consisted of firm mid olive brown silty sand (002) with moderate small sub-angular limestone fragments and grit (Figs 3-4, Sections 1-3) (Plates 2-4).

Deposit (002) was overlain by soft dark brown humic sandy silt topsoil (001), up to 0.28m thick (Fig 4, Sections 1-3) (Plates 2-4).

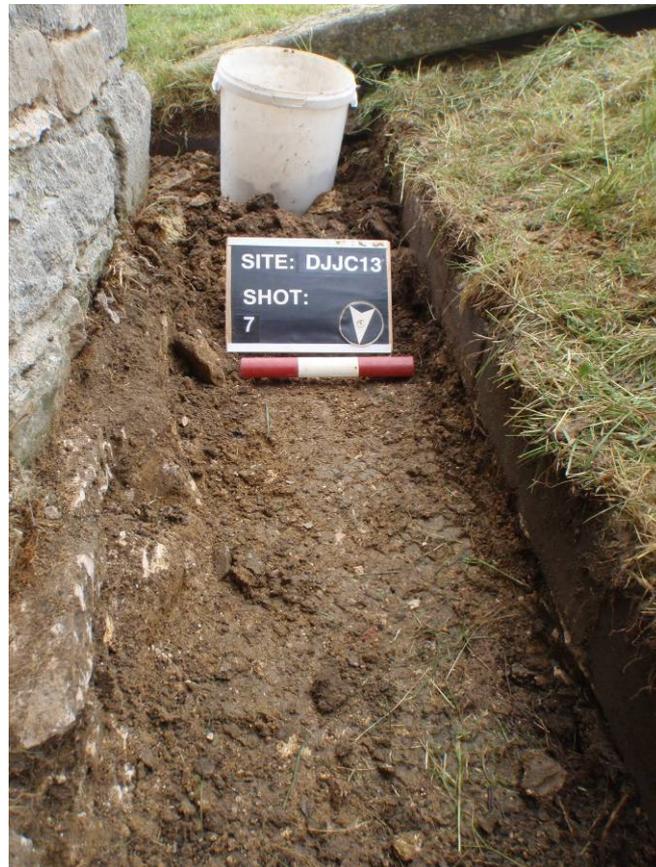
Plate 2 – Service trench at western side of porch, looking south

The earliest deposit identified in the base of the service trench was a mixed graveyard soil. To the west of the porch this graveyard soil contained fragments of mortar and CBM which indicates debris from possible construction or restoration.

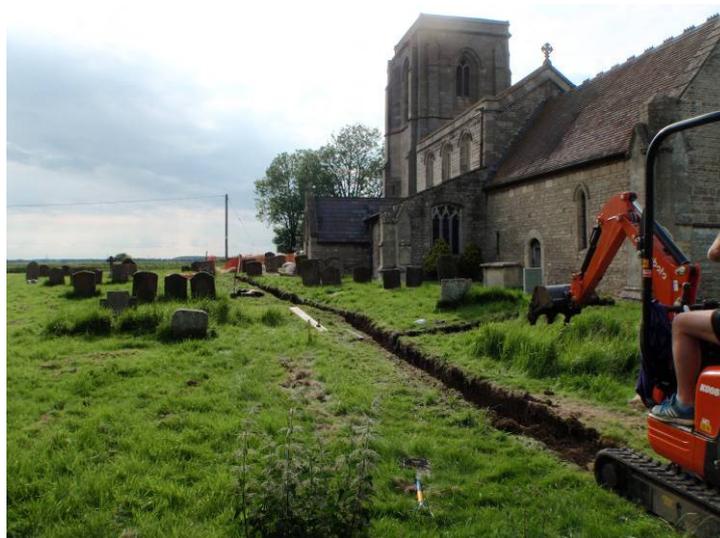
Plate 5 – View of service trench near completion, looking west

Throughout the rest of the trench the graveyard soil was overlain by the modern topsoil deposit.
