**HISTORIC BUILDING EVALUATION OF
WATER HALL BARN,
OFF HIGH STREET,
WIGHTON,
NORFOLK
(39775WGT)**

Work Undertaken For
Ian J. M. Cable Architectural Design
On behalf of
Coke Estates Ltd

June 2004

A.P.S. Report No. **79/04**

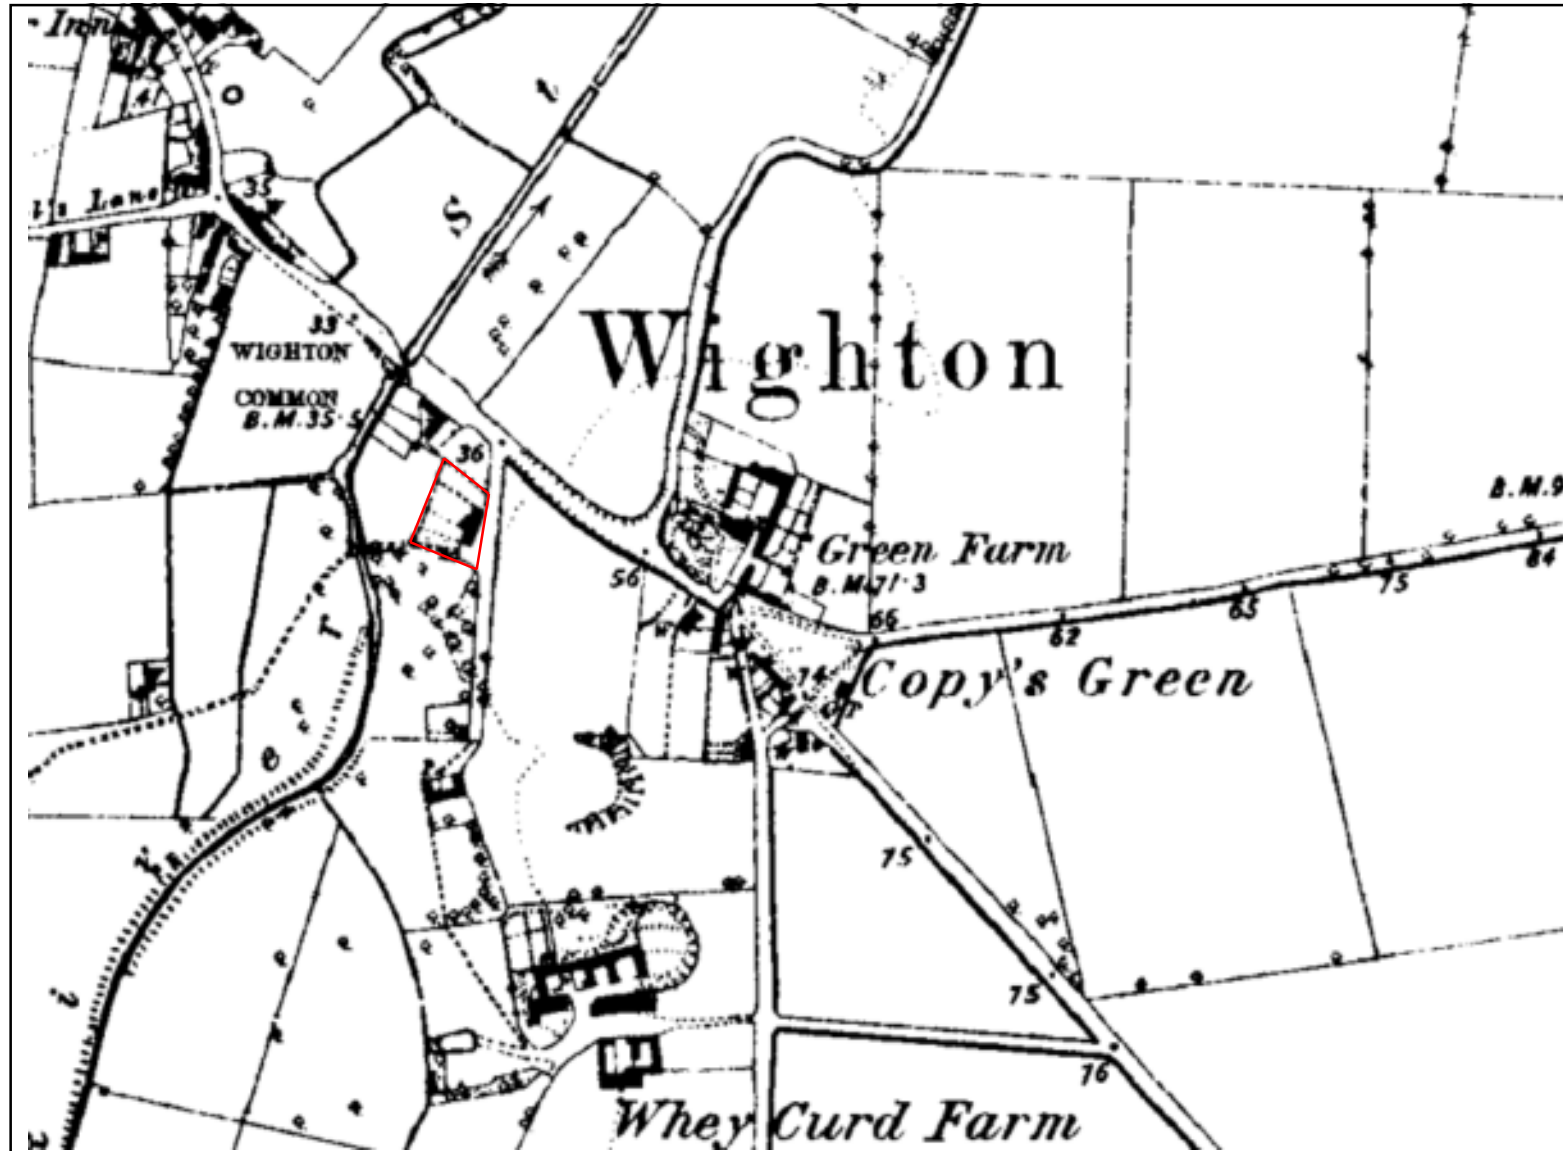
Figure 4 - Extract from the 1st edition Ordnance Survey Plan, 1891, showing location of recorded building

By 1891 when the Ordnance Survey mapped the area the building complex had diminished in size to the T-shaped

structure that presently occupies the site (Fig. 4).

In addition to the cartographic evidence, the barn itself embodies traces of attached structures. Scars of removed walls and roof lines on either side of the porch reveal that there were lean-to structures in these areas. The wall scars result from taking out of bricks and suggest that the removed structures were at least partially keyed in to the barn (Plates 11 and 15). A second roof line scar on the south side of the porch (Plate 16) indicates there have been two structures built against this part of the barn and removed at various times. Cartographic evidence establishes that these lean-to structures were removed by 1891 (Fig. 4).

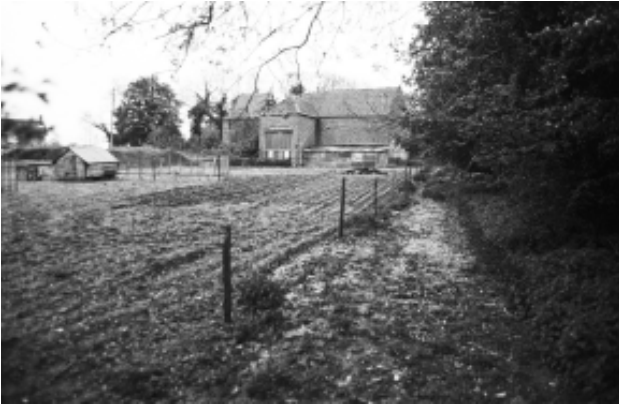
Plate 1 General View of Barn, from River Stiffkey, looking east

Norfolk (Fig. 1). Water Hall is about 600m south-southeast of the church, in the southern part of the village, close to the hamlet of Copy's Green, on the east bank of the River Stiffkey (Plate 1). Water Hall Barn is 170m north of Water Hall, to the rear of Bridge Cottages on land off High Street, at National Grid Reference TF 9425 3953 (Fig. 2).

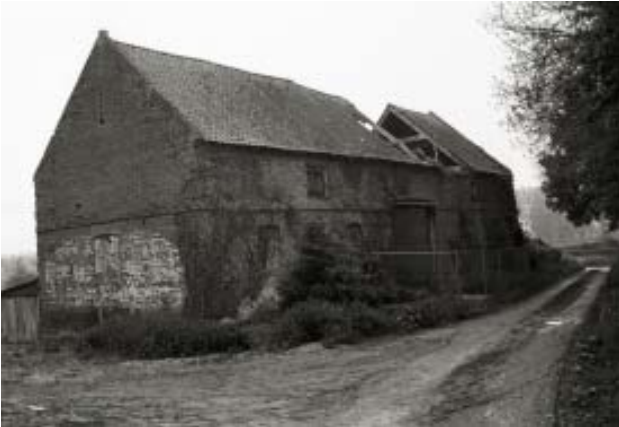
plat-band into two storeys. It is five bays wide with the central bay extended to the west by a porch. Internally, the barn is open to the roof. Part of the roof, over the 3rd and 4th bays from the south, has collapsed (Plate 2).

Plate 2 South and East Elevations of Barn, looking north

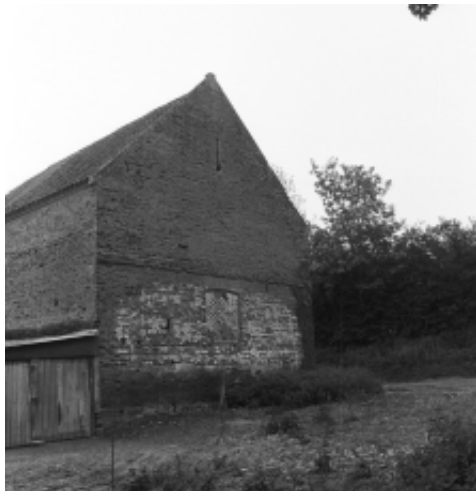
The north and south elevations are closely comparable, each with a very slight plinth. Both elevations have a central ventilation opening at ground floor level. These openings, broadly with the dimensions of a window and with gauged arches of brick rubbers, are filled with a chequerboard pattern of bricks with alternate gaps. Although the southern ventilation opening has had the holes blocked with mortar (Plate 3), the northern is still open (Plate 4).

Plate 3 South Elevation, showing blocked ventilator window and breather slit, looking northeast

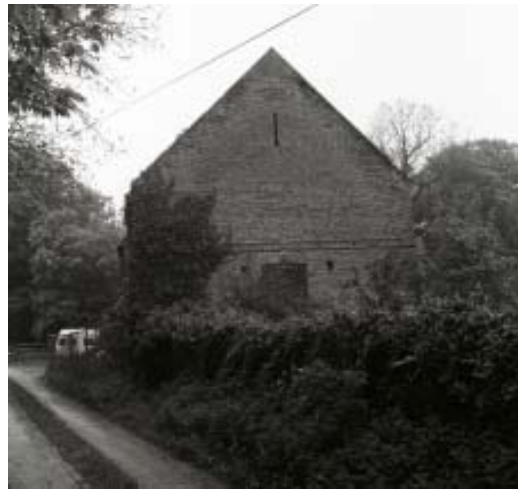
The main differences between these two gables are in the numbers and positions of sockets from removed elements. In the south wall there is a series of four, not equidistant, sockets on the line of the plinth. There are several other sockets, of varying dimensions, at other positions in this wall, though apart from two small holes in a pair near the western side of the elevation, no patterns are obvious. In the northern gable are two large sockets set either side of the ventilation opening (Plate 4).

Plate 4 Northern Elevation, showing ventilator window, breather slit, plat-band and sockets, looking south

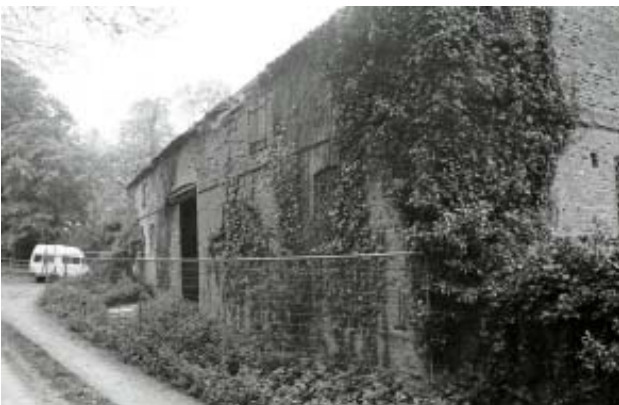
The eastern elevation, which is on a very slight plinth, is divided into five bays with a central entry of high, planked double doors, these having collapsed (Plates 2 and 5). Over the doors is a segmental arch of brick rubbers, though these have a different appearance to the brick used elsewhere in the elevation.

Plate 5 Eastern Elevation, looking southwest

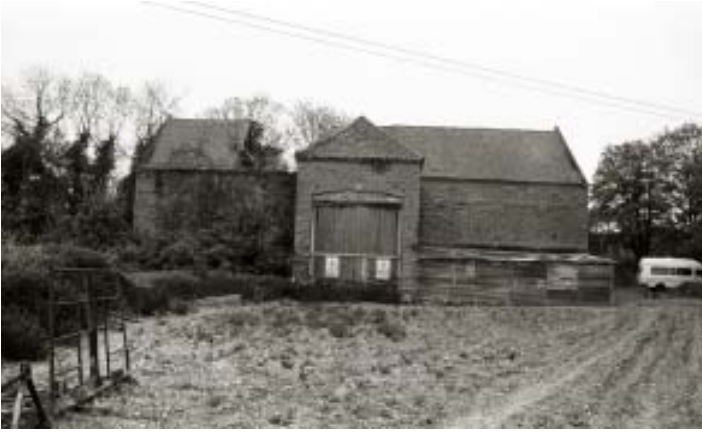
Plate 6 Western Elevation, general view showing central porch, looking southeast

The western elevation is interrupted by a porch that will be described separately, below. Otherwise, the eastern elevation is fairly plain. There is a low, corrugated iron lean-to structure against the southern part of the elevation (Plate 6). High up on both the north and south parts of the elevation is a horizontal line of intermittent timber lacing (Plates 7 and 8). Toward the south end of the elevation, above the lean-to, is a socket. At and just below eaves level in the southern part of the wall is an irregular strip of brick that is different to the other brick used in the façade (Plate 7).

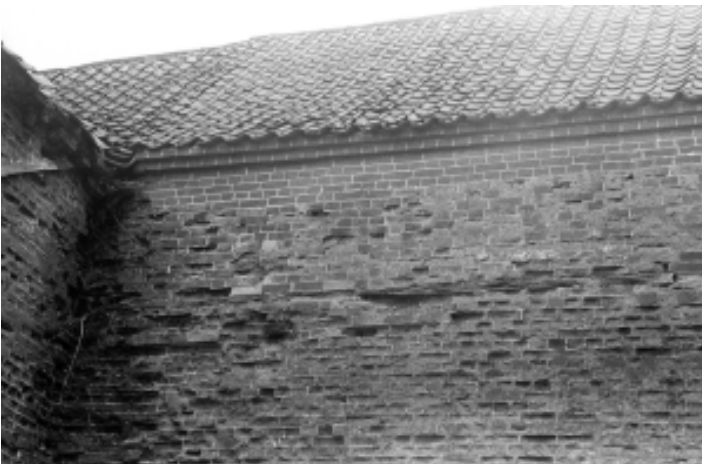
At the top of the south end of the west wall of the barn the brick is different to that in the walls below (Plates 7 and 26). It seems likely that this brick is a repair to the wall, rather than indicating a raising of the roof in this area. Additionally, the apex of each gable is in different brick to the rest of the walls. This appears to be an infill, perhaps of former ventilation holes. The brick in the two arches is also different from that used in most of the building. However, as the arch over the porch incorporates the datestone it seems probably that this was just use of a different brick for dressing, rather than a later replacement or rebuild of the arches.

Plate 7 Western Elevation, south side, showing timber lacing and variation in brick, looking east

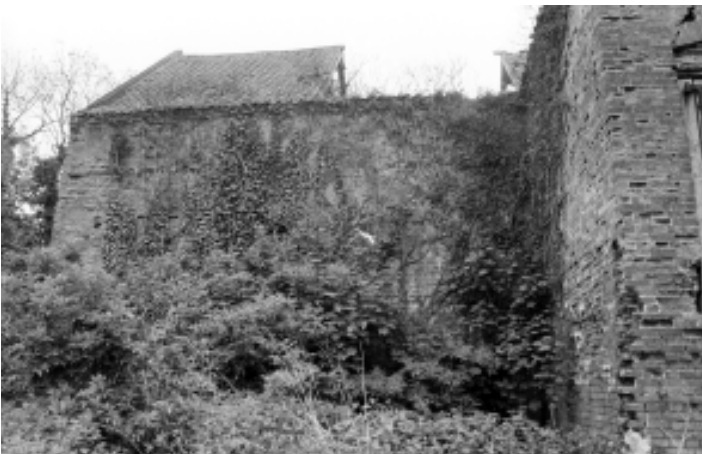
Plate 8 Western Elevation, north side, showing timber lacing, looking east

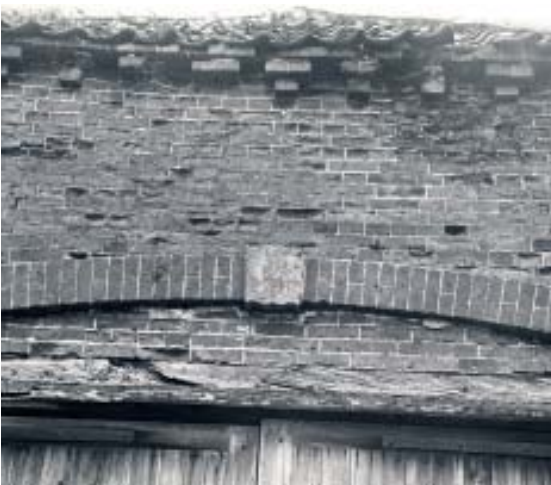
arch of brick rubbers, these bricks being of different appearance to those elsewhere in the elevation (Plate 9). At the apex of this arch is a dated keystone, worn and lichen covered but on which the initial 'W' and 1790 are evident (Plate 10).

Both the south and north walls of the porch are essentially blank. However, both have scars of removed walls on their west sides, and scars of pitched roofs coming down to these (Plates 15 and 16). Also, the south wall has a higher scar of a pitched roof, descending from the main eaves line of the building. All three sides of the porch have dentilled eaves (Plate 9).

Plate 9 Western Elevation of Porch, showing arch, keystone and dentil eaves, looking east

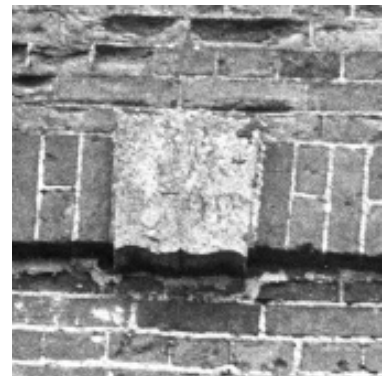
Plate 10 Detail of Keystone

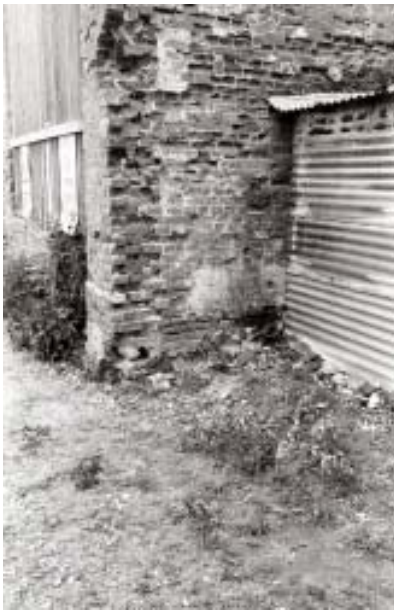
The southern part of this western face of the porch is on a flint cobble foundation (Plate 11). Additionally, in the middle of that section are two incised bricks, set approximately 1.5m and 3.5m from ground level (Plate 12). On the lower is incised 'F.B 1790' (Plate 13), while the upper is marked 'R.B 1790' (Plate 14). The lower brick measures 230mm x 60mm x 110mm.

At its western end, the south wall of the porch is on a foundation of flint cobble. It is unclear whether this material was the foundation for the entire building, or if it was from an earlier structure.

Plate 11 Porch, south side, showing flint cobble foundation and scar of removed wall, looking northeast

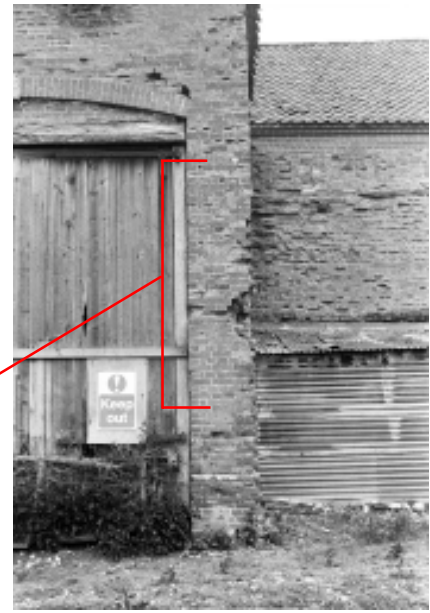
Plate 12 Porch, Western Elevation, showing positions of inscribed bricks, looking east

On the western face of the porch are two inscribed bricks and a dated keystone, all three marked 1790, apparently the construction date of the barn. The bricks are marked with initials, F.B. and R.B. It would seem probably that these different initials represent two members of the same family, though whether these were the brick makers or the owners/occupiers of the barn is unclear. However, the keystone is marked with the initial W (any other initials being obscured), which is most likely to indicate the owner/occupier. Therefore, the initials on the bricks probably signify the brick makers.

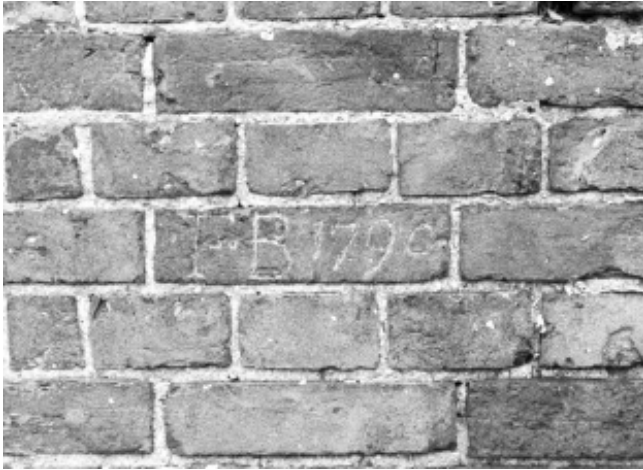
Plate 13 Porch, Lower Inscribed Brick, looking east

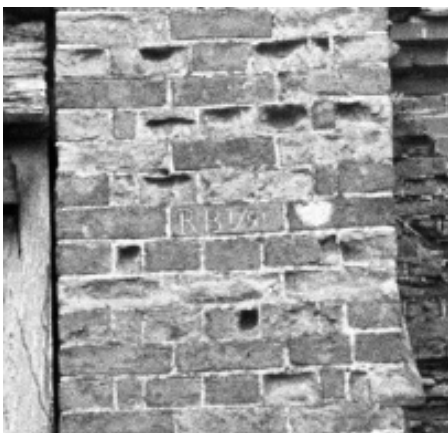
Plate 14 Porch, Upper Inscribed Brick, looking east

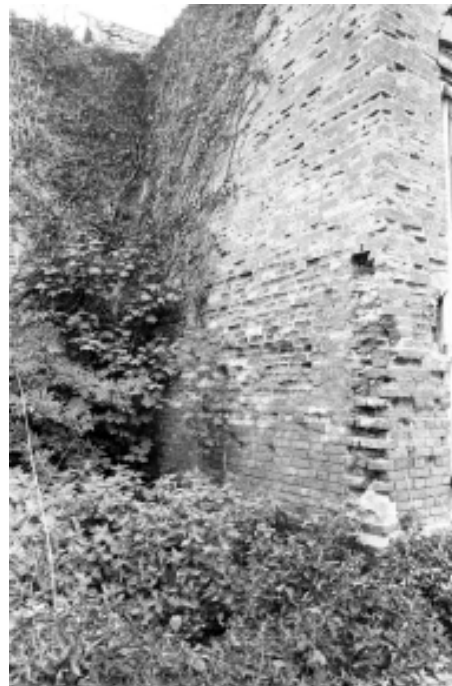
Plate 15 Porch, north side, showing scar of removed wall, looking southeast

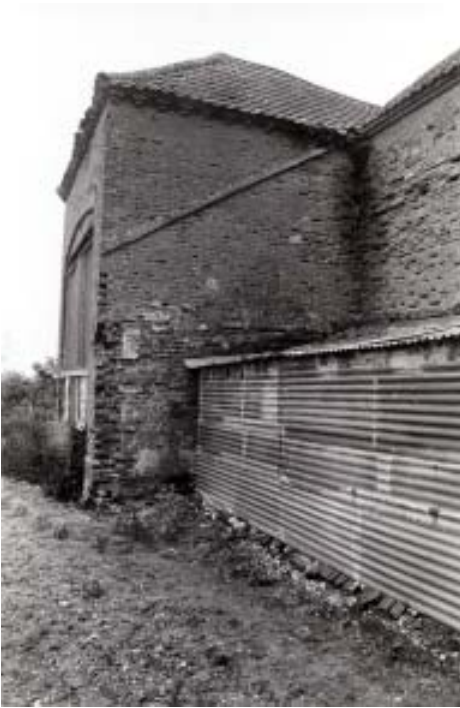
Plate 16 Porch,
south side, showing
scars of roof lines,
looking northeast

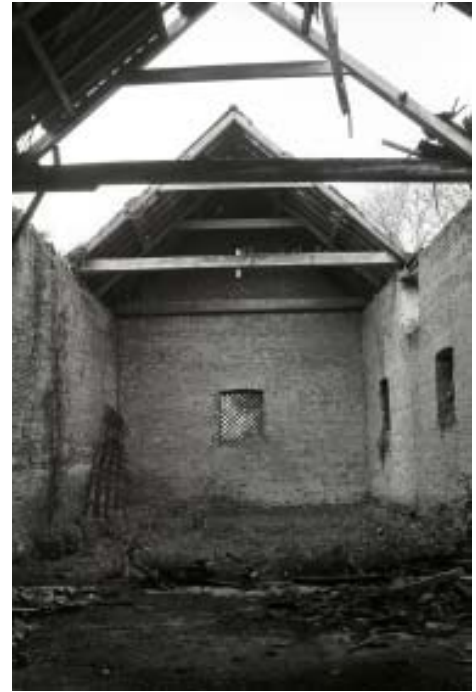
The interior of the barn is open to the roof and tie-beams divide the building into five bays (Plate 17). A collapsed timber has a wooden peg and carpenter's mark reading 'VII' (Plate 18).

The north and south internal elevations are closely similar, with the ventilator openings and breather slits observed on the exterior (Plates 17 and 23). Brick blocking covers the interior of the southern ventilator opening. Above and to either side of this opening are two sockets (Plate 24).

Plate 17 Barn
Interior,
looking north

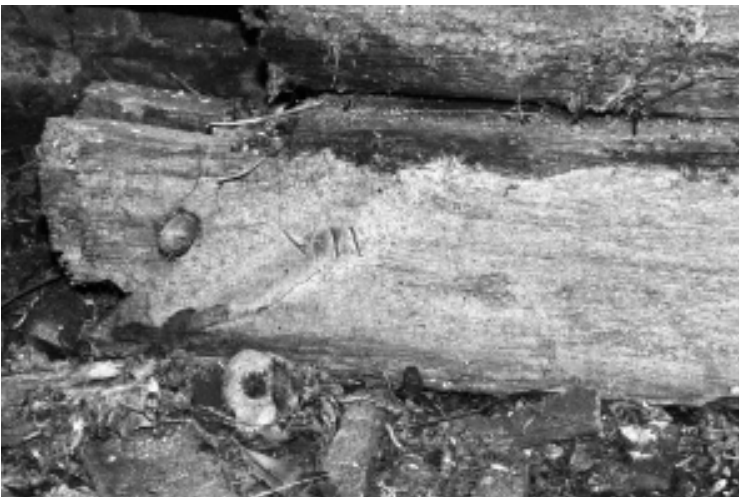
A fallen timber within the building has carpenters' mark, which would suggest that the other timberwork in the roof is similarly marked.

Plate 18 Fallen Timber,
showing wooden peg and
carpenters' mark

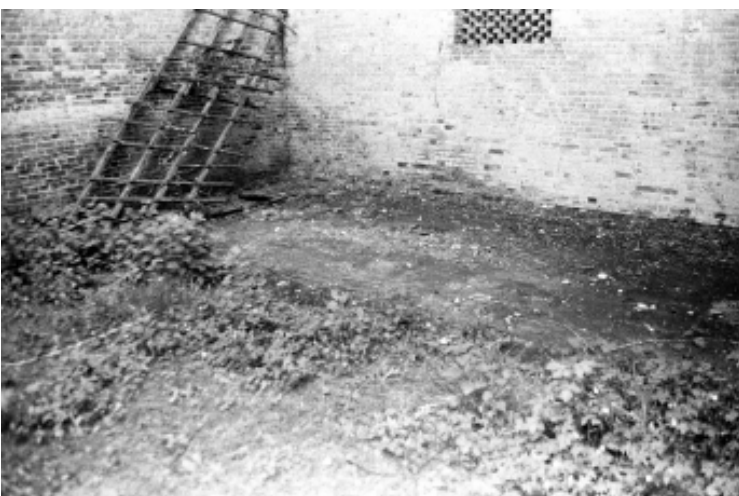
Brick provides the flooring of all the bays bar the central, which is in concrete with brick edging (Plates 19 and 20). This concrete flooring, which extends into the porch, is slightly higher than the brick floors to north and south. In the northwestern corner of the building an area of about 2m x 2m of the brick flooring is disturbed and slightly sunken (Plate 19).

Plate 19 Brick Floor of northern bay, showing
damaged/recessed area at northeast corner,
looking northeast

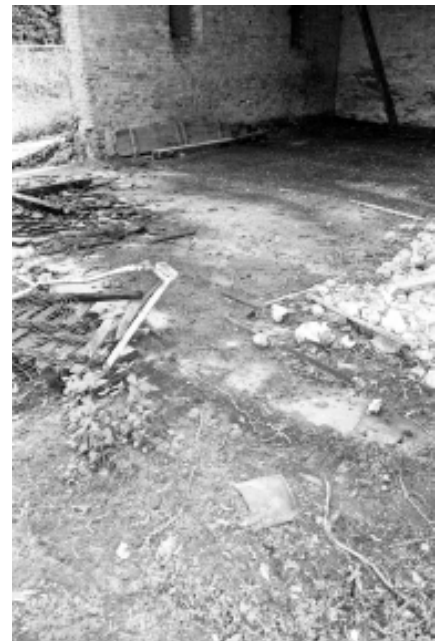
Plate 20 Concrete
Floor and Brick
Edging, Central Bay,
looking southeast

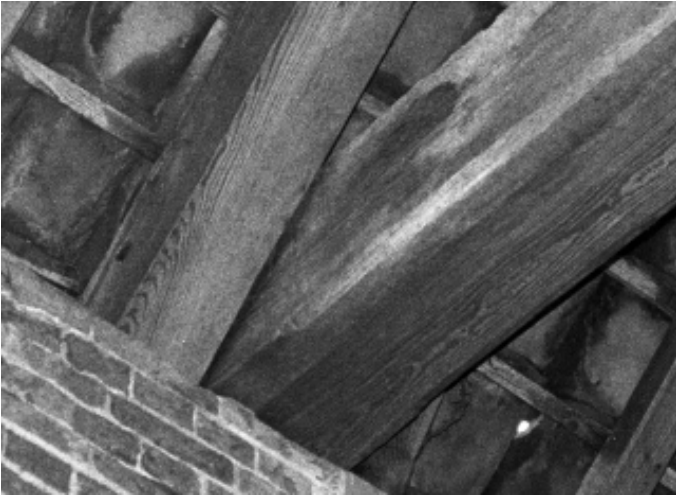
Six tie-beams cross the building, one each immediately alongside the north and south walls. From the south end, the 1st, 4th and 6th are chamfered on one side, and the 3rd and 5th on both sides (Plate 21). There is

Plate 21 Chamfered Beam,
detail, looking southeast

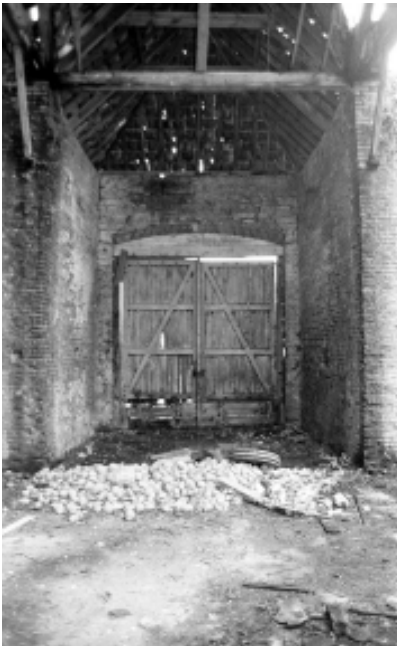
no chamfering on the second beam. Beams are also present across the extension into the porch (Plate 22), and above the porch entry, the latter chamfered on one side, the former not chamfered. All of the chamfered beams have stops that are similar to lamb's tongue stops.

Plate 22 Interior of Porch,
looking west

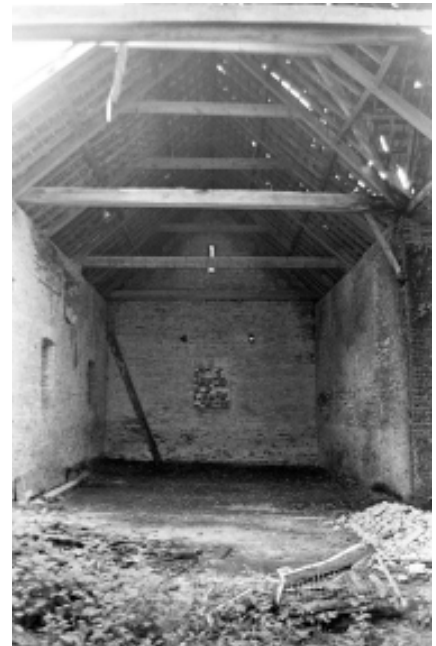
Plate 24 Barn Interior,
southern part, showing
blocked ventilator window,
looking south

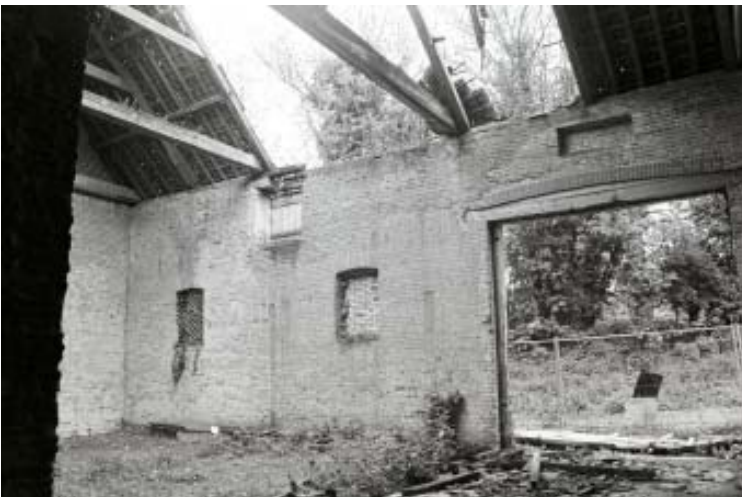
The eastern internal elevation largely matches the exterior. However, above the entry and below the eaves, is a small rectangular recess, about 1.2m wide, 0.5m high and 0.25m deep, with a timber lintel (Plate 25). There are also two sockets between the 1st and 2nd ventilator openings from the south. Each of the three ventilator openings from the south retains broken bricks as remnants of the chequerboard vents.

Plate 25 Barn Interior, northern part of
east wall, showing alcove over entry,
looking northeast

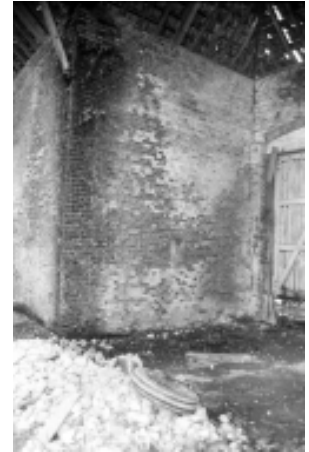
Most of the interior of the porch is plain, though there are two small alcoves in the north and south walls (Plate 27). These

niches are about 1.5m from ground level, about 0.4m high and wide and 0.2m deep, and topped with gauged arches of brick rubbers.

Plate 27 Porch Interior, south wall, showing alcove, looking southwest

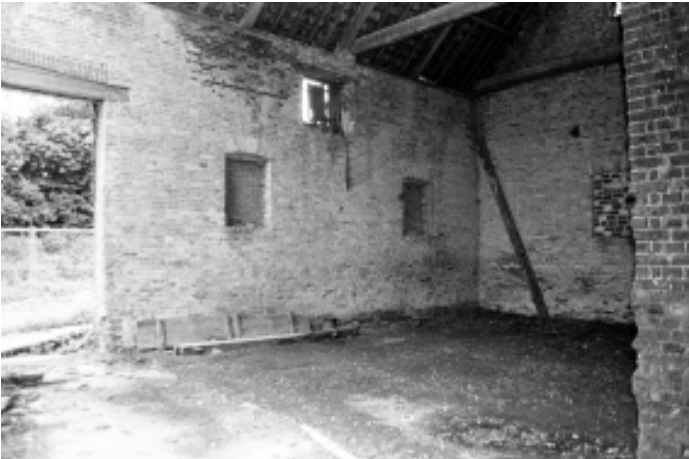
Plate 28 Barn Interior, southern part of east wall, showing blocked ventilator windows and pitching hole above, looking southeast

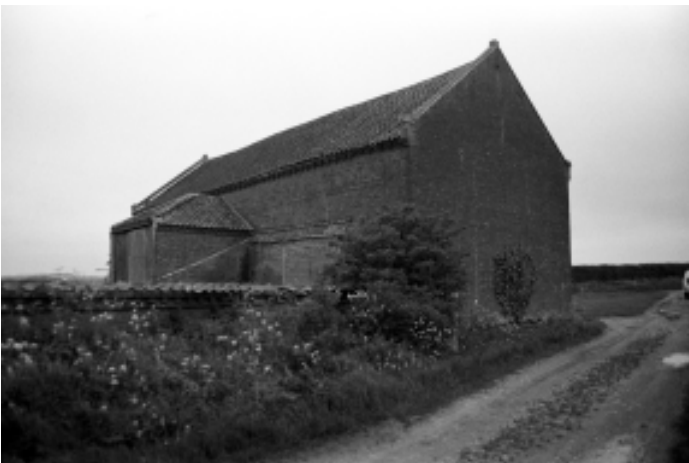
Another field barn, about 1.5km to the southeast, is extremely similar to the surveyed building and was probably built to the same plan (Plates 29 and 30). Similarly Listed Grade II, this second barn, to the southeast of Whey Curd Farmhouse, is also a three storey building with a central porch on one side. Constructed of red brick with a red pantile roof, this is on a brick plinth and has a plat-band dividing the exterior into two storeys, a central cart entrance with the doors running to eaves level, tumbled gables and honeycomb brick ventilation windows (DoE 1983, 66). Above the cart entrance is a segmental brick arched head incorporating a keystone dated 1803 and with the letter W evident. This barn was built for William Coke in the style of William Wyatt as part of Whey Curd Farm (DoE 1999). Due to the very close similarities in plan and style between the two barns, and their broad contemporaneity, it is probable that the initials on the keystone of the surveyed barn are 'WC', for William Coke (1752-1842), the 1st Earl of Leicester, who owned the land the barn is built on, and much other in the area.

Plate 29 General View, Barn at Whey Curd Farm, showing porch, looking west

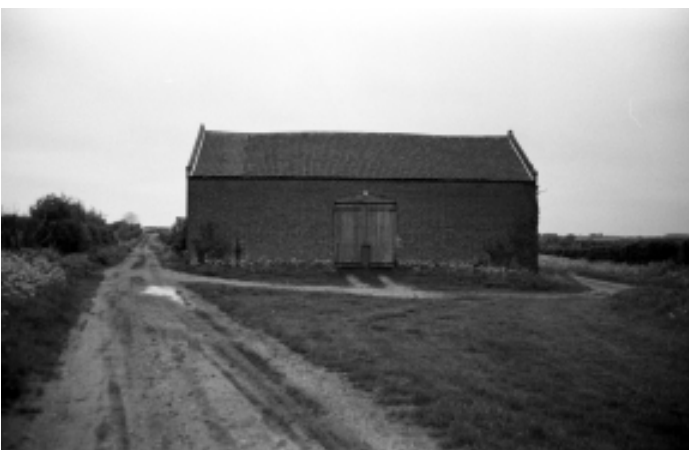
Plate 30 General View, Barn at Whey Curd Farm, showing cart doors and arch with dated keystone, looking southeast
