**HISTORIC BUILDING RECORDING
AND WATCHING BRIEF
TETNEY-SALTFLEET FLOOD DEFENCE SCHEME,
LINCOLNSHIRE
(TSFD12)**

Work Undertaken For
The Environment Agency

November 2014

A.P.S. Report No: **119/14**

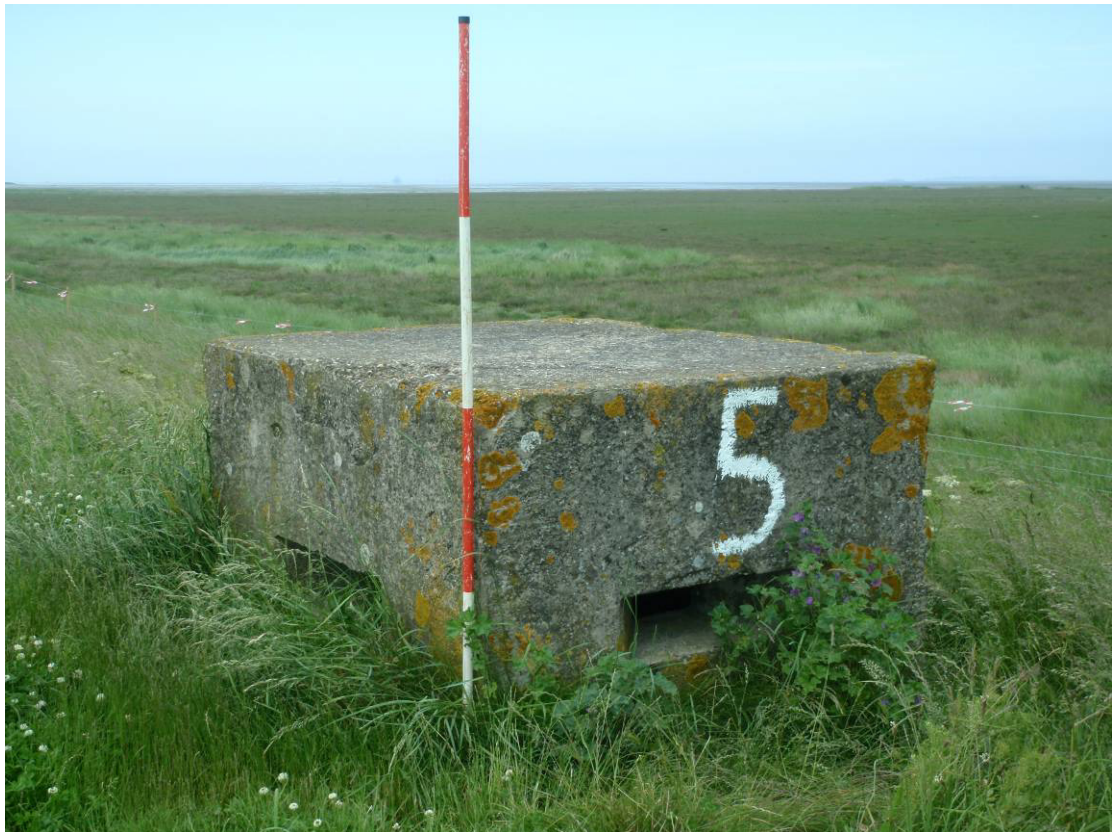
Plate 12. Asset 169 Tetney, pillbox 169, Elevation 3, looking north

This was a concrete underground bunker with a look-out turret or pillbox prominent on the sea bank (Plate 12). The pillbox was 2m by 1.7m. The rectangular concrete tunnel underneath was 6.5m long by 0.9m wide. This also led to a Stanton shelter which had an exit on the side away from the pillbox access passage. The shelter was buried by sand (048) and (049) (Fig 10, Section 18, Plates 17, 18).

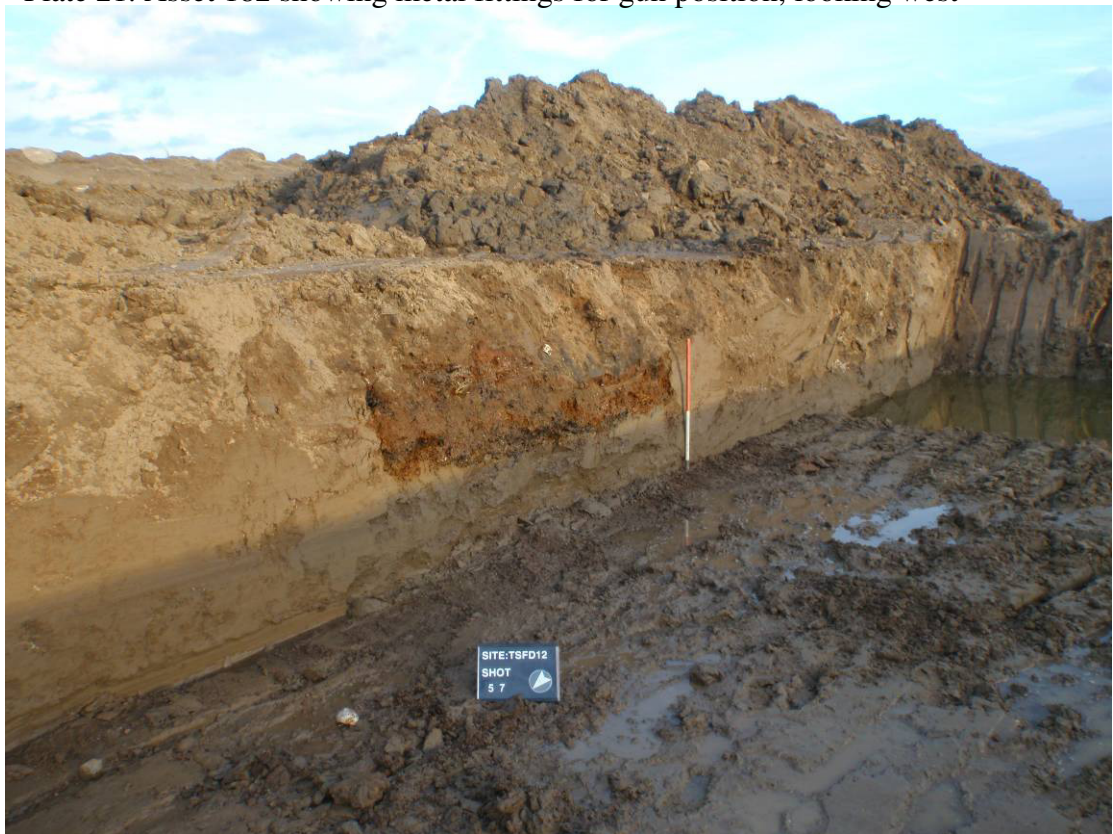
Plate 22. Section 13, pit [035], looking southeast

Sub-rectangular pit [035] (Fig 10, Section 13, Plate 23) with near vertical sides and a flat base was 4.1m wide and up to 1m deep. In the base of the south end of the pit was 0.96m thick fill (034) comprising mid brown sandy silt with cinders. This was sealed by mid to light brownish orange cinders (033) which also contained dumped airfield debris including mid 20th century pottery.

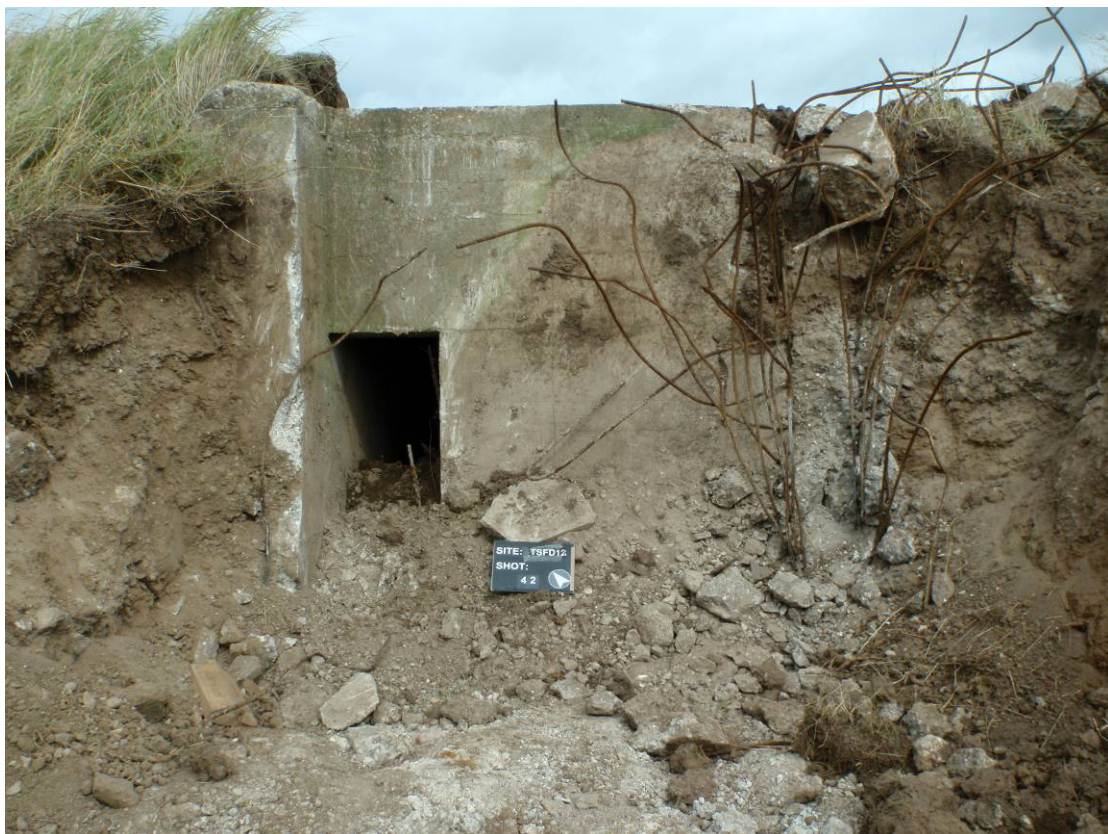
Plate 25. Asset 206/7 Tetney, pillbox looking south

The northernmost asset in the survey comprised a concrete pillbox, measuring 12m long by 2m wide and 2.1m high, set into and across the sea bank with an opening on its landward side. When initially exposed this feature appeared to be a 3-bay pillbox, the central bay open and earth-filled, with attached structures on the land-ward side (Plate 27). When excavated the central, open, bay was found to have a socket in the floor (Plate 29). This socket was a placement for a support for a light anti-aircraft machine-gun.
