**ARCHAEOLOGICAL
EVALUATION ON LAND AT
GREYFRIARS,
KING'S LYNN
NORFOLK
(5477 KLY)**

Work Undertaken For
King's Lynn and West Norfolk Borough Council

September 2003

A.P.S. Report No. **136/03**

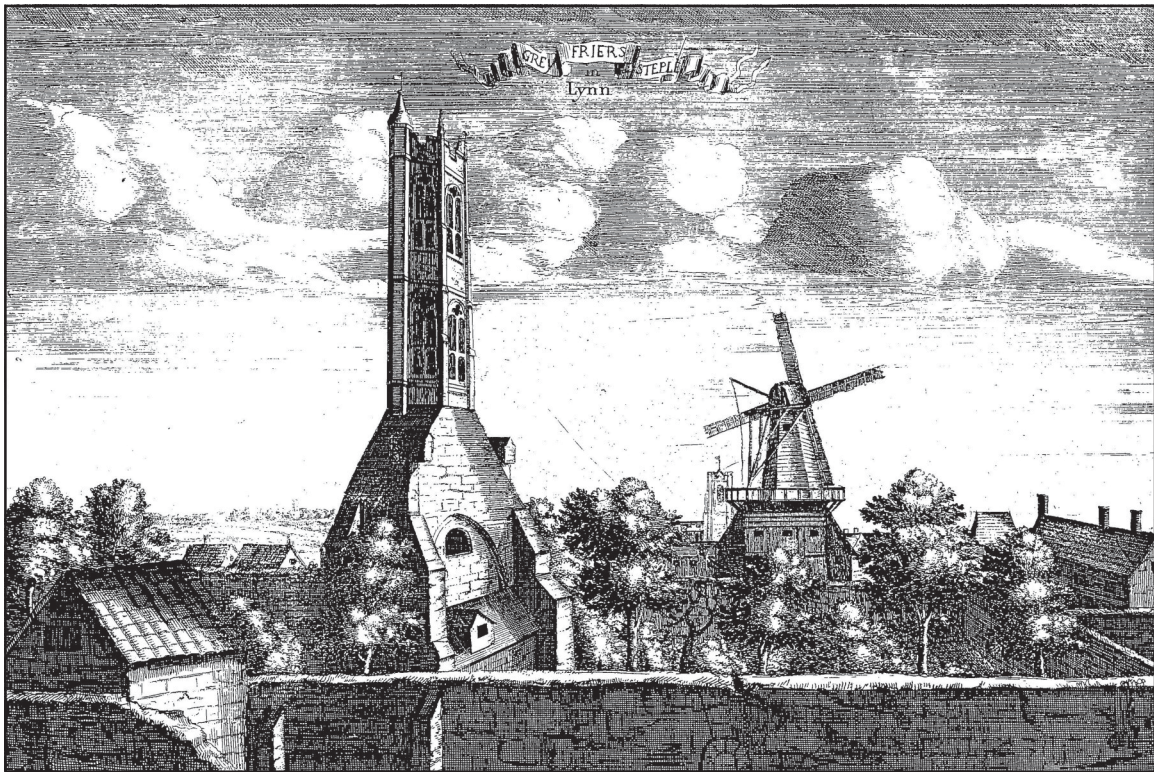
Figure 3 - A mid 18th century view of the tower, viewed from the north. Post-medieval adaption of the tower is apparent in the infilled nave arch that contains a dormer window. The wall in the foreground may be a remnant of the precinct wall and has an infilled arch (centre). There is a building abutting the wall (left) which may relate to the friary.

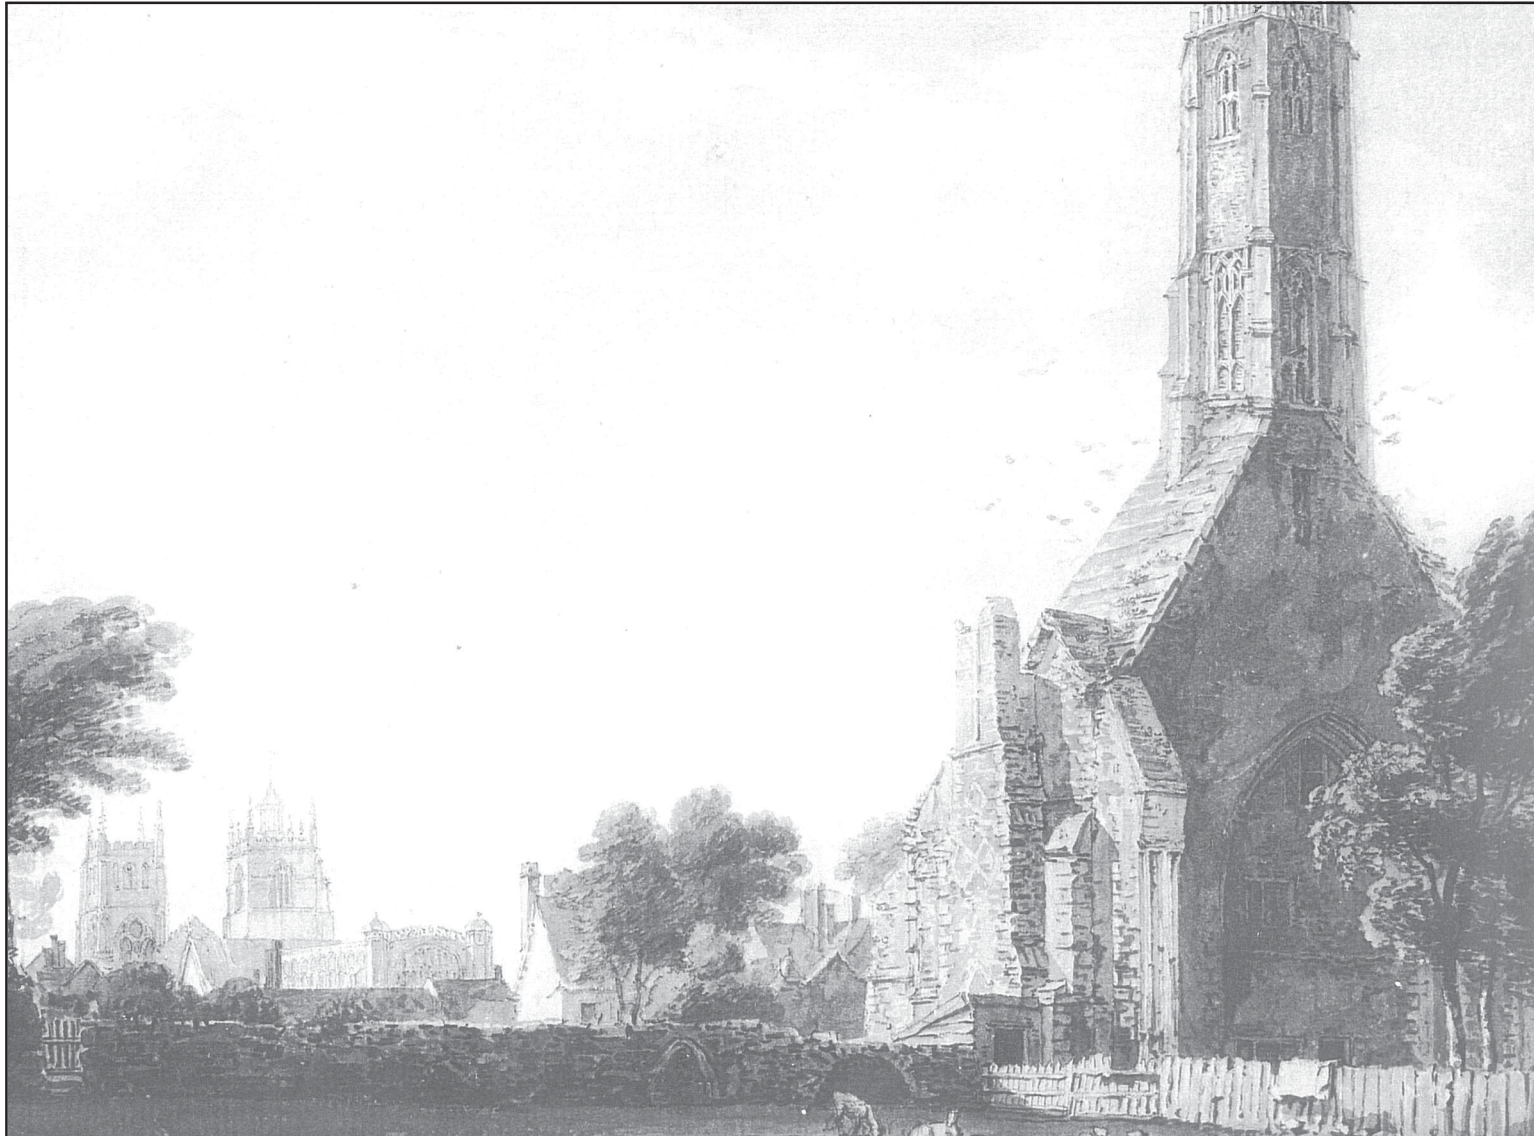
Figure 4 - Thomas Hearne's view of Greyfriars' tower, late 18th century. The infilled chancel arch is visible with three floors represented. A possible portion of the north chancel wall also survives (right). Also visible is the archway of the Chapter House door (centre) and a second arch to the right. Note also the Tudor diaper brickwork on the chimney stack butting the tower.

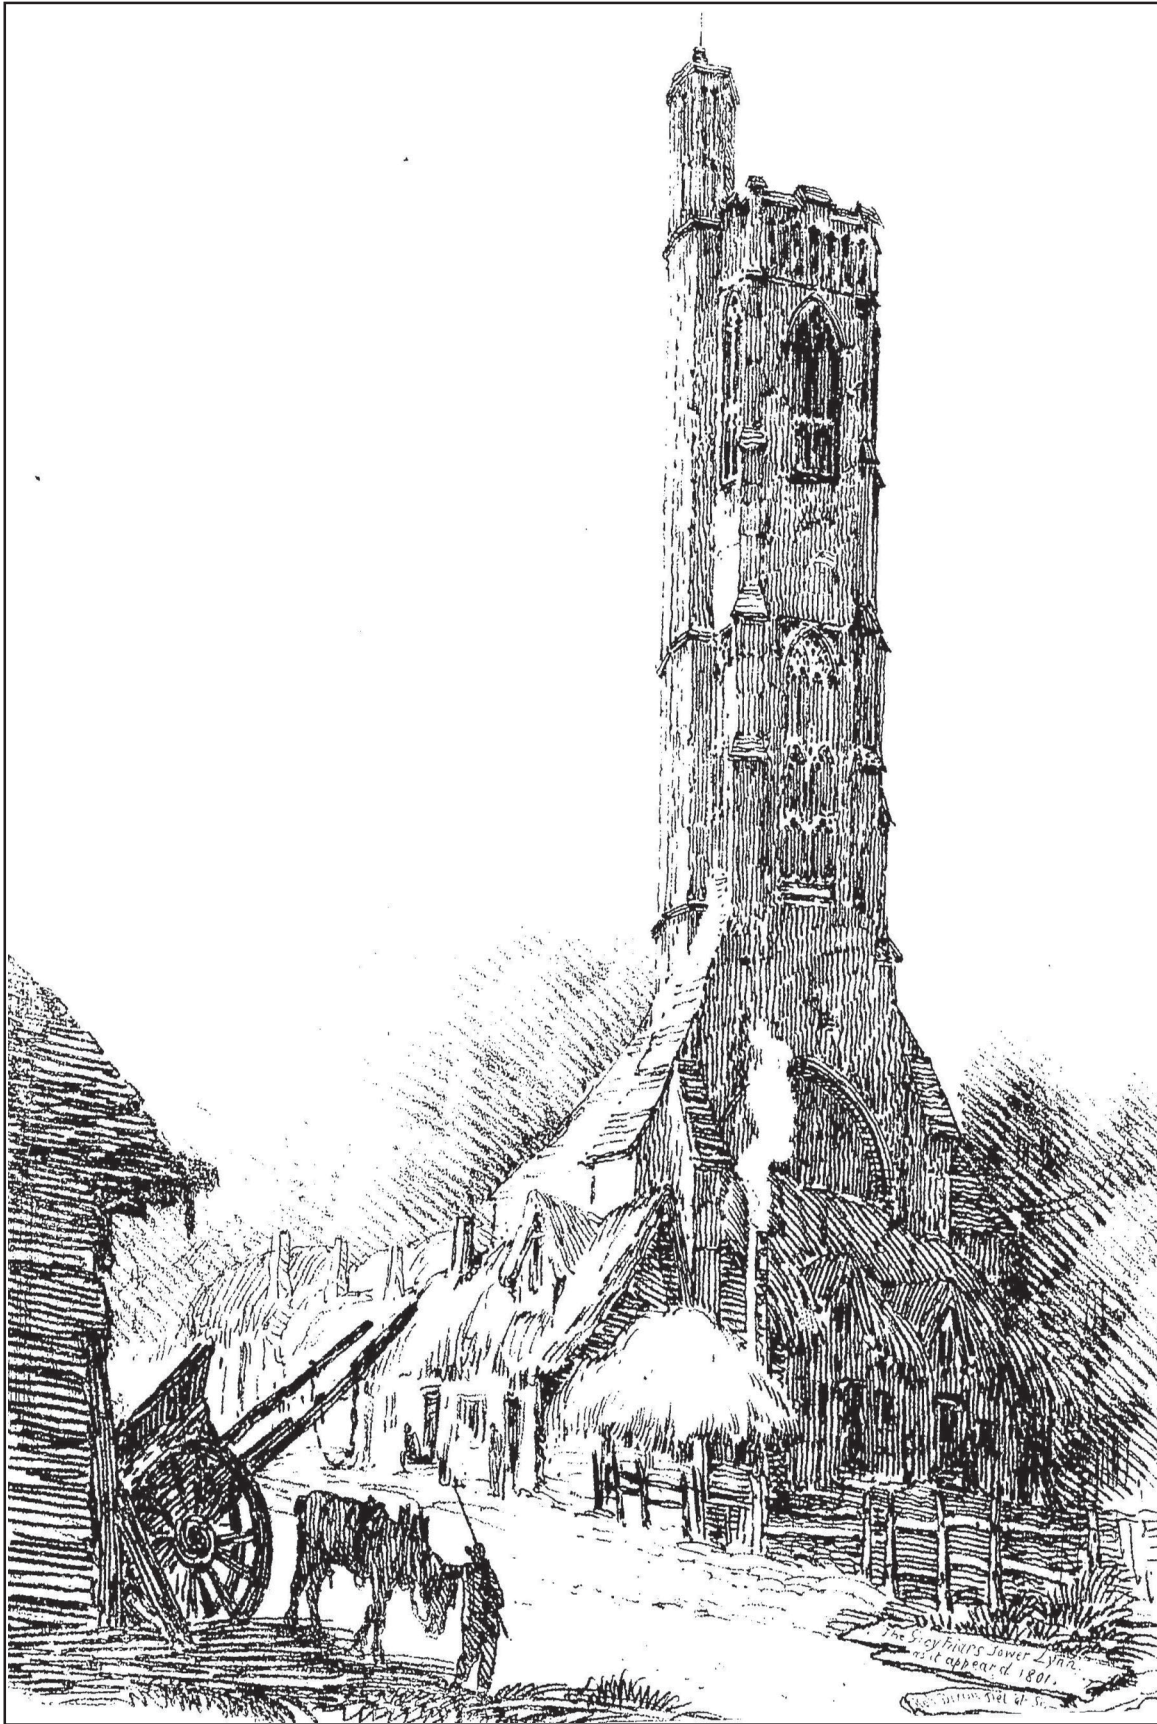
Figure 5 - Robert Dixon's sketch of Greyfriars' tower, 1801, showing the range of buildings built against the tower, many of which are thatched.

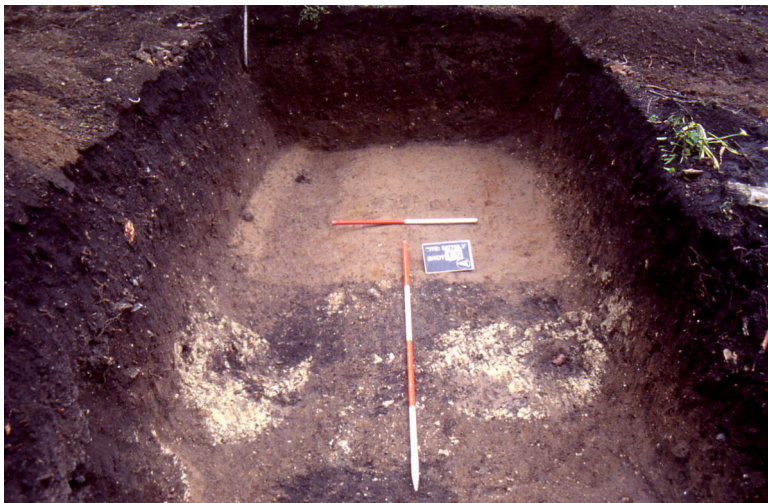
Plate 3 - Trench 1 post-excitation, showing the Gault Clay 'pads', looking east

Upon these consolidation layers were placed two discrete areas of greenish yellow clay (548 and 584), possibly derived from the Gault clay (Plate 3). Both these clay deposits were interpreted as foundation pads for pillar bases of the nave/north aisle, although (548) lies north of the line of the north aisle and nave junction. The clay deposit (584) contained 13th century pottery.

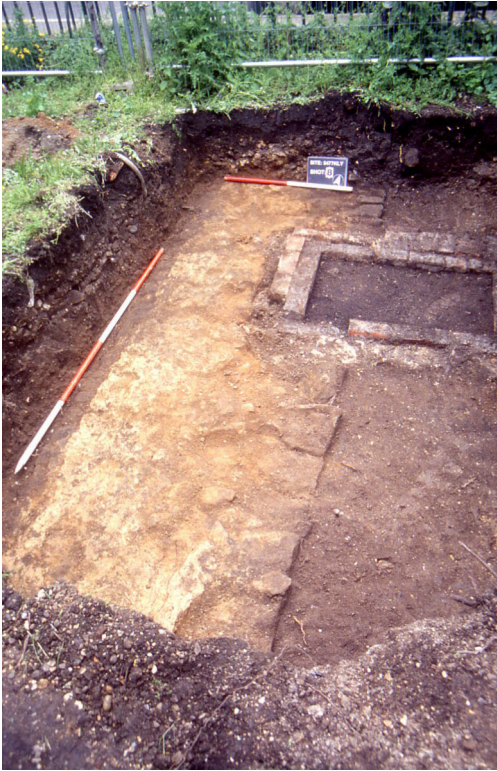
Plate 5 - Trench 2 after cleaning, showing the east wall of the north aisle (508), looking northwest

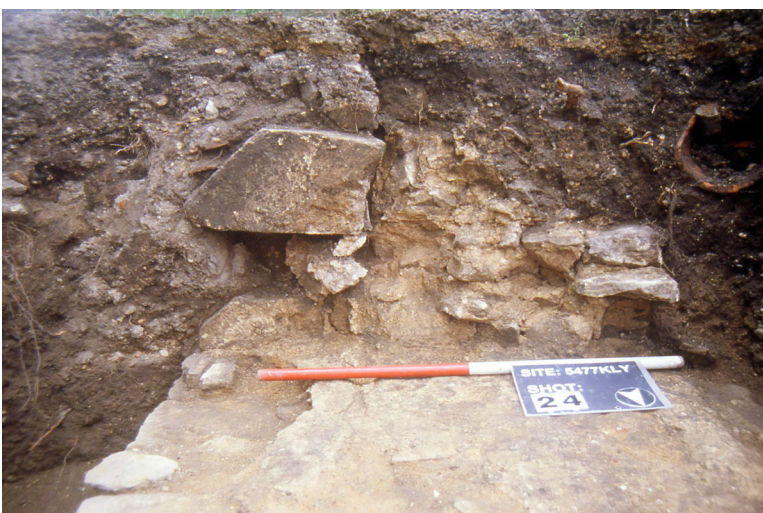
Plate 7 - Trench 2, Section 10 showing the limestone plinths, looking south

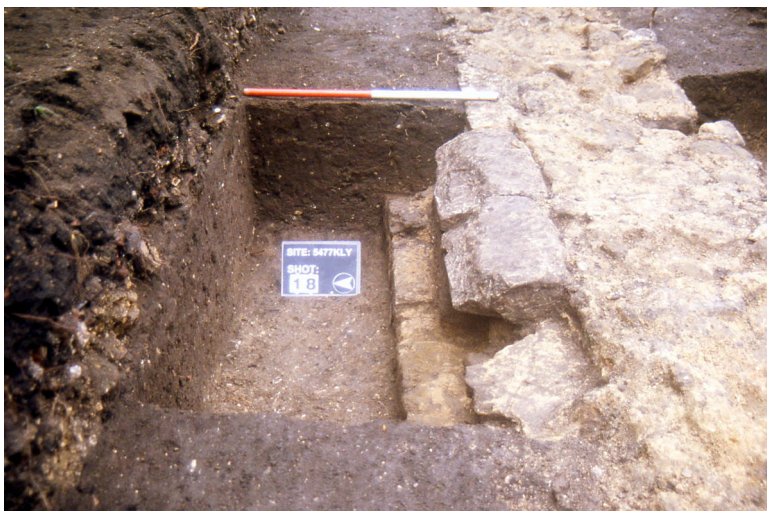
Plate 10 - Trench 3 showing the limestone plinths (562) in the presbytery wall (513), looking east

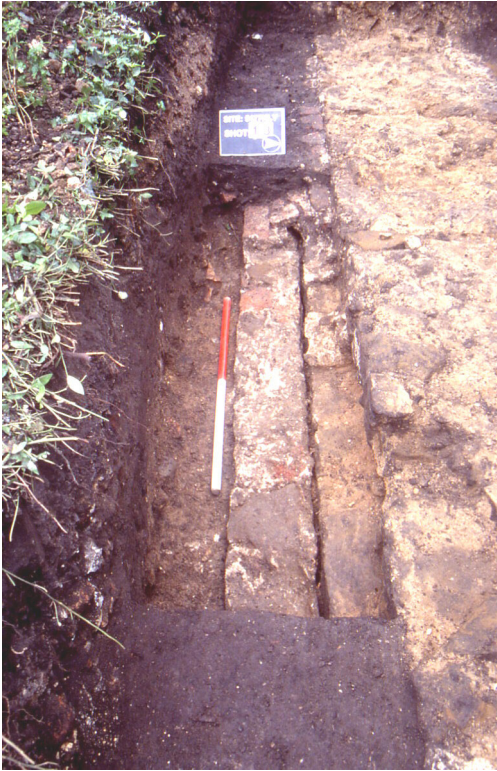
Plate 11 - Trench 3 showing the brick lining (514), probably representing the base of the choir stalls, and the presbytery wall (513), looking west

those recorded in the north aisle. Remodelling of the presbytery is evident with the construction of brick lining walls which can best be interpreted as the base of the friar's stalls. There is limited evidence for repair and re-facing of the external north wall.

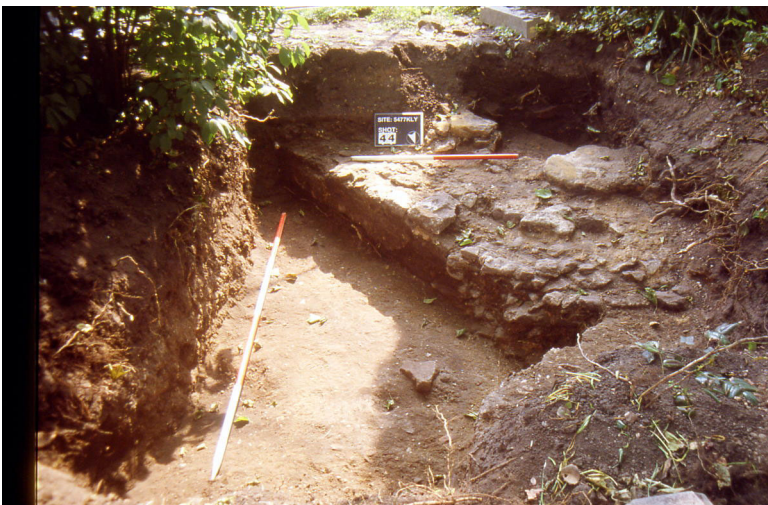
Plate 13 - Trench 4 showing the east end wall (652) of the presbytery, looking southwest

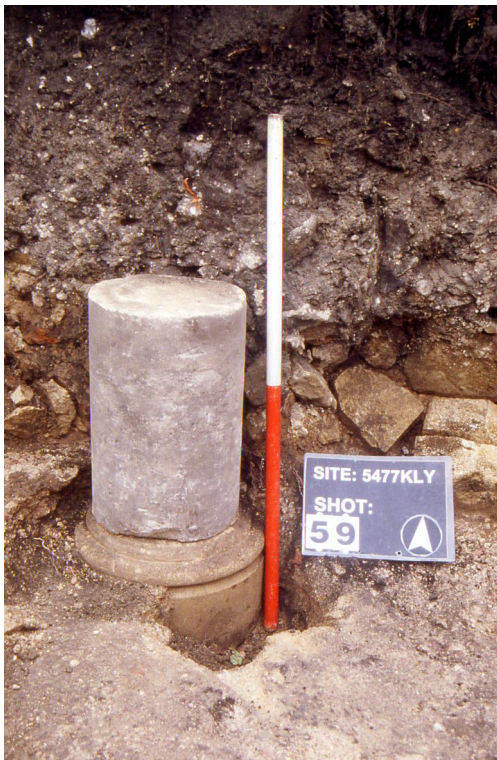
Plate 16 - Trench 5, base and column restored. Vaulting ribs can be seen in the section behind. Looking north

Therefore, the building in Trench 5 has floor levels 0.24m below the level of the 'corridor' with a column that probably supported a rib vault ceiling, giving the overall impression of an undercroft. This would then mean a range of first floor rooms as has been observed by Martin (1937, 30). The function of these undercrofts is generally thought to be for storage, although recent reassessment of Lincoln Greyfriars points out the elaborate stonework would not be appropriate for such a storeroom and suggests habitation for an infirmary chapel above (Stocker 1984, 143). The carved base found in Trench 5 may similarly indicate more than a storeroom was present, although resurfacing of the mortar floor subsequently masked the detail on the stonework. Painted window glass was also found in the demolition material and perhaps would also suggest a non-utilitarian function for the room.

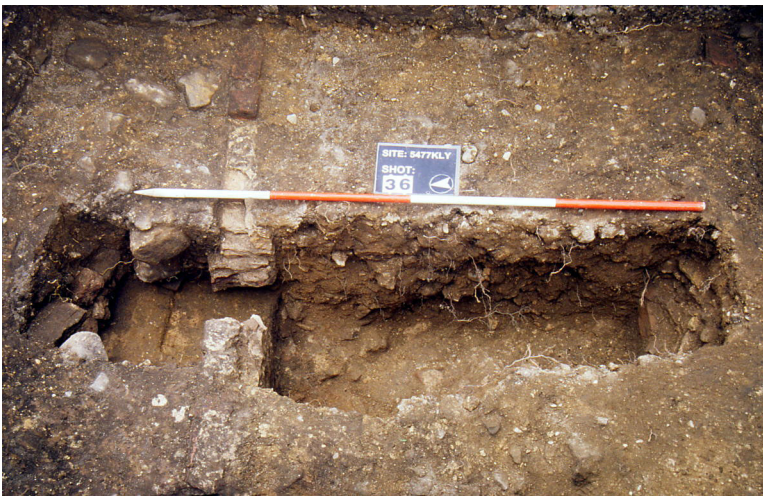
Plate 18 - Trench 6, Section 18, showing the brick base (635) for the stalls on the south side of the presbytery, looking east

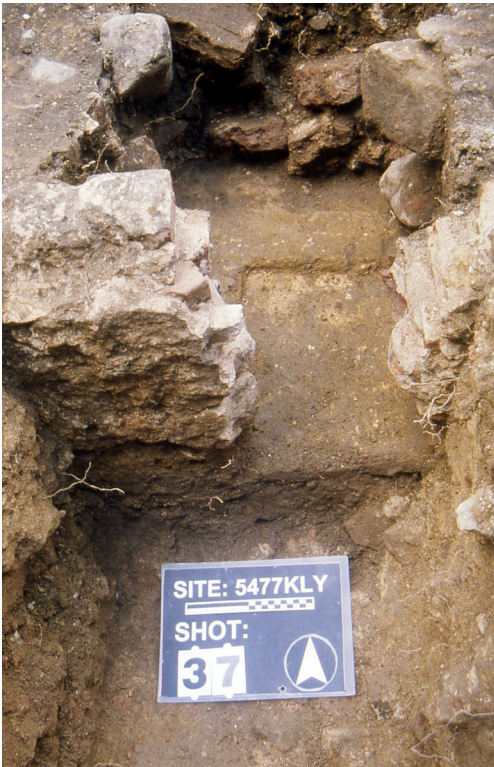
Plate 19 - Trench 6, detail showing floor level (637), looking north

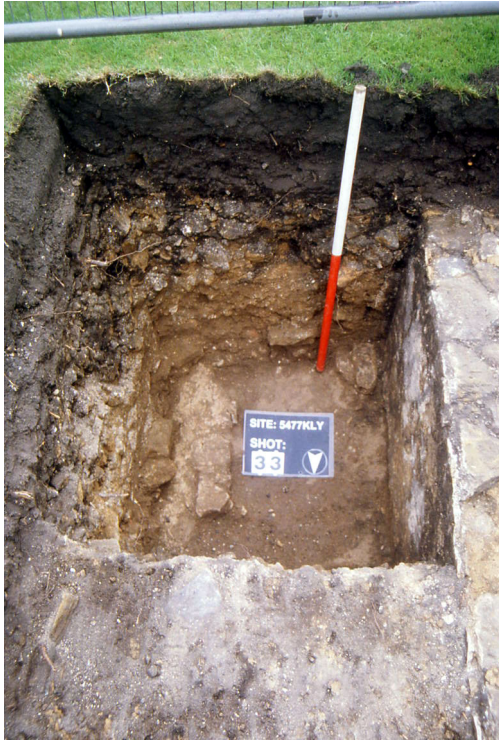
Plate 20 - Trench 7, detail of possible 'corridor' room east of the Chapter House, looking south

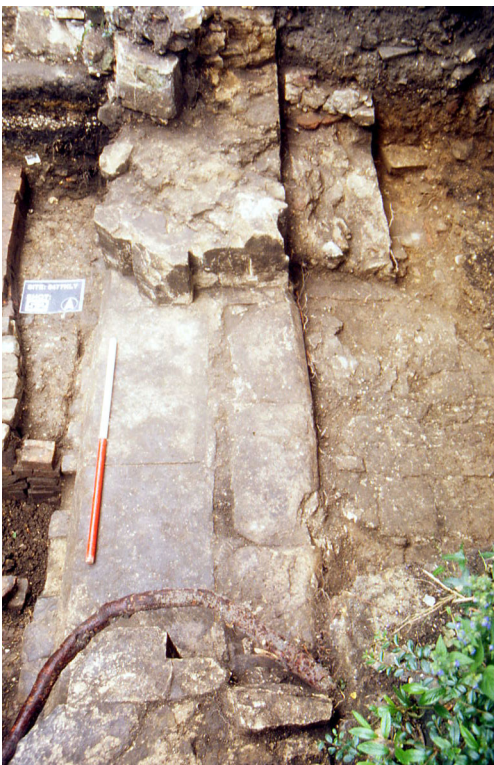
Plate 24 - Trench 9, detail of Chapter House doorway (679) and brick bench (678), looking north

Forming one side of a post-medieval drain (see below) was a foundation course (680) of random coursed Carstone at least 0.38m high. Upon this was built a Carstone wall which incorporated a limestone doorway (679) representing the entrance to the Chapter house (the northern jamb of this

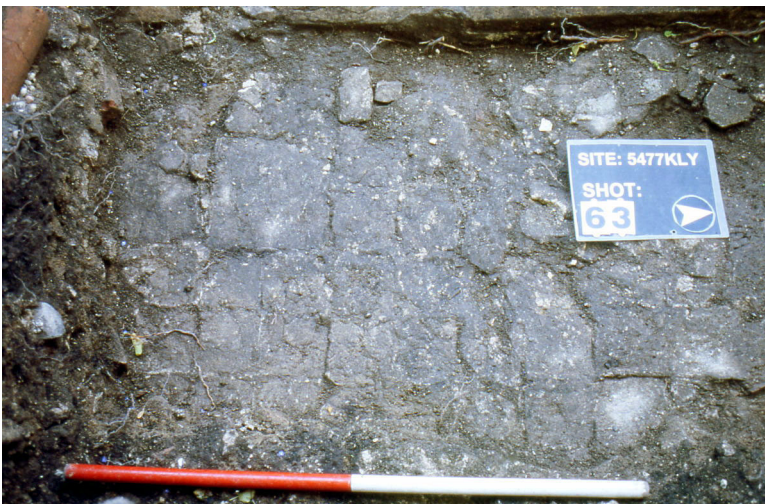
Plate 25 - Trench 9, tile impressions on mortar surface (682), looking west

To the east of the wall and doorway, within the Chapter house, was an area of brownish yellow sandy mortar (682) that retained the square impressions of floor tiles (Plate 25). A short length of brick, tile and mortar wall (678) was built upon this floor and against the Chapter house wall. This masked the bench end recess and indicates the replacement of the wooden bench by a more permanent seating arrangement.

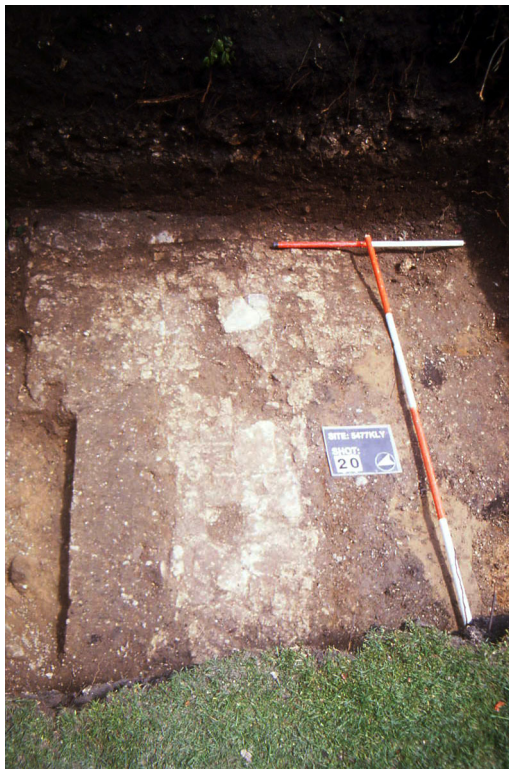
Plate 27 - Trench 10, the cloister walk showing tile impressions in mortar surface, looking east

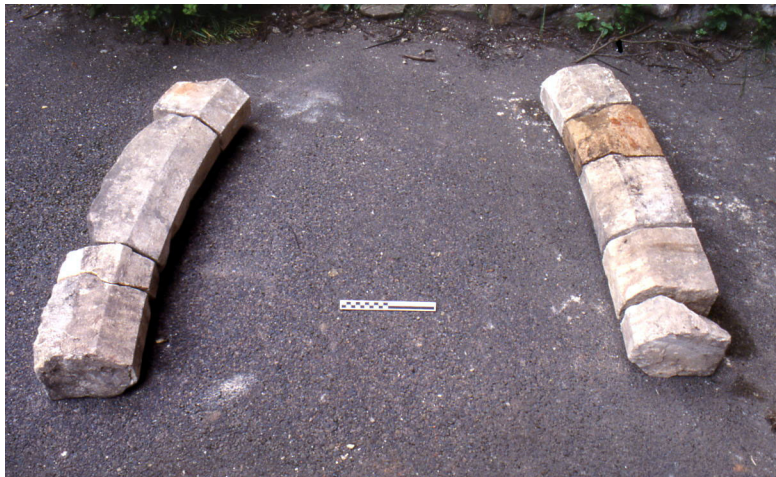
Plate 31 - Vaulting ribs from (505) showing the curvature of the voussoirs

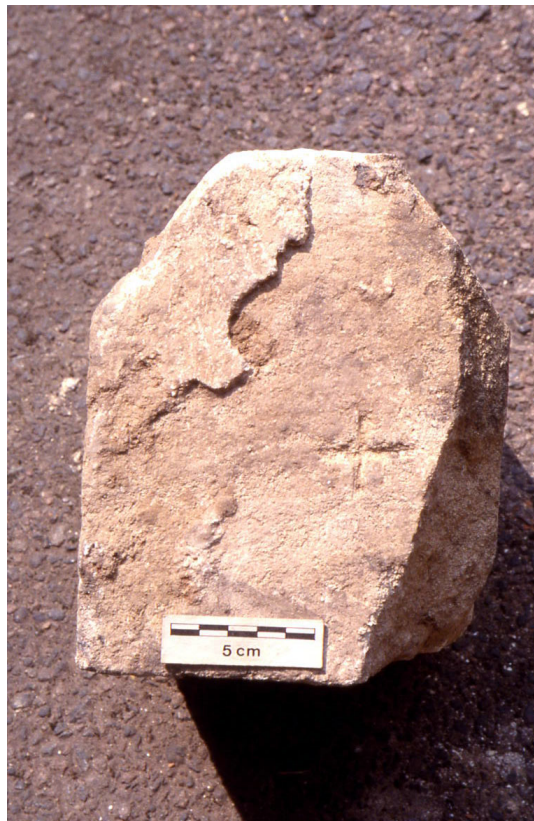
Plate 32 - Incised cross on bedding joint of voussoir rib
