**ARCHAEOLOGICAL MONITORING AND
RECORDING ON LAND AT
BURRINGHAM ROAD,
BURRINGHAM
NORTH LINCOLNSHIRE
(BUBR 15)**

Work Undertaken For
The Environment Agency

APS Report No. **78/15**

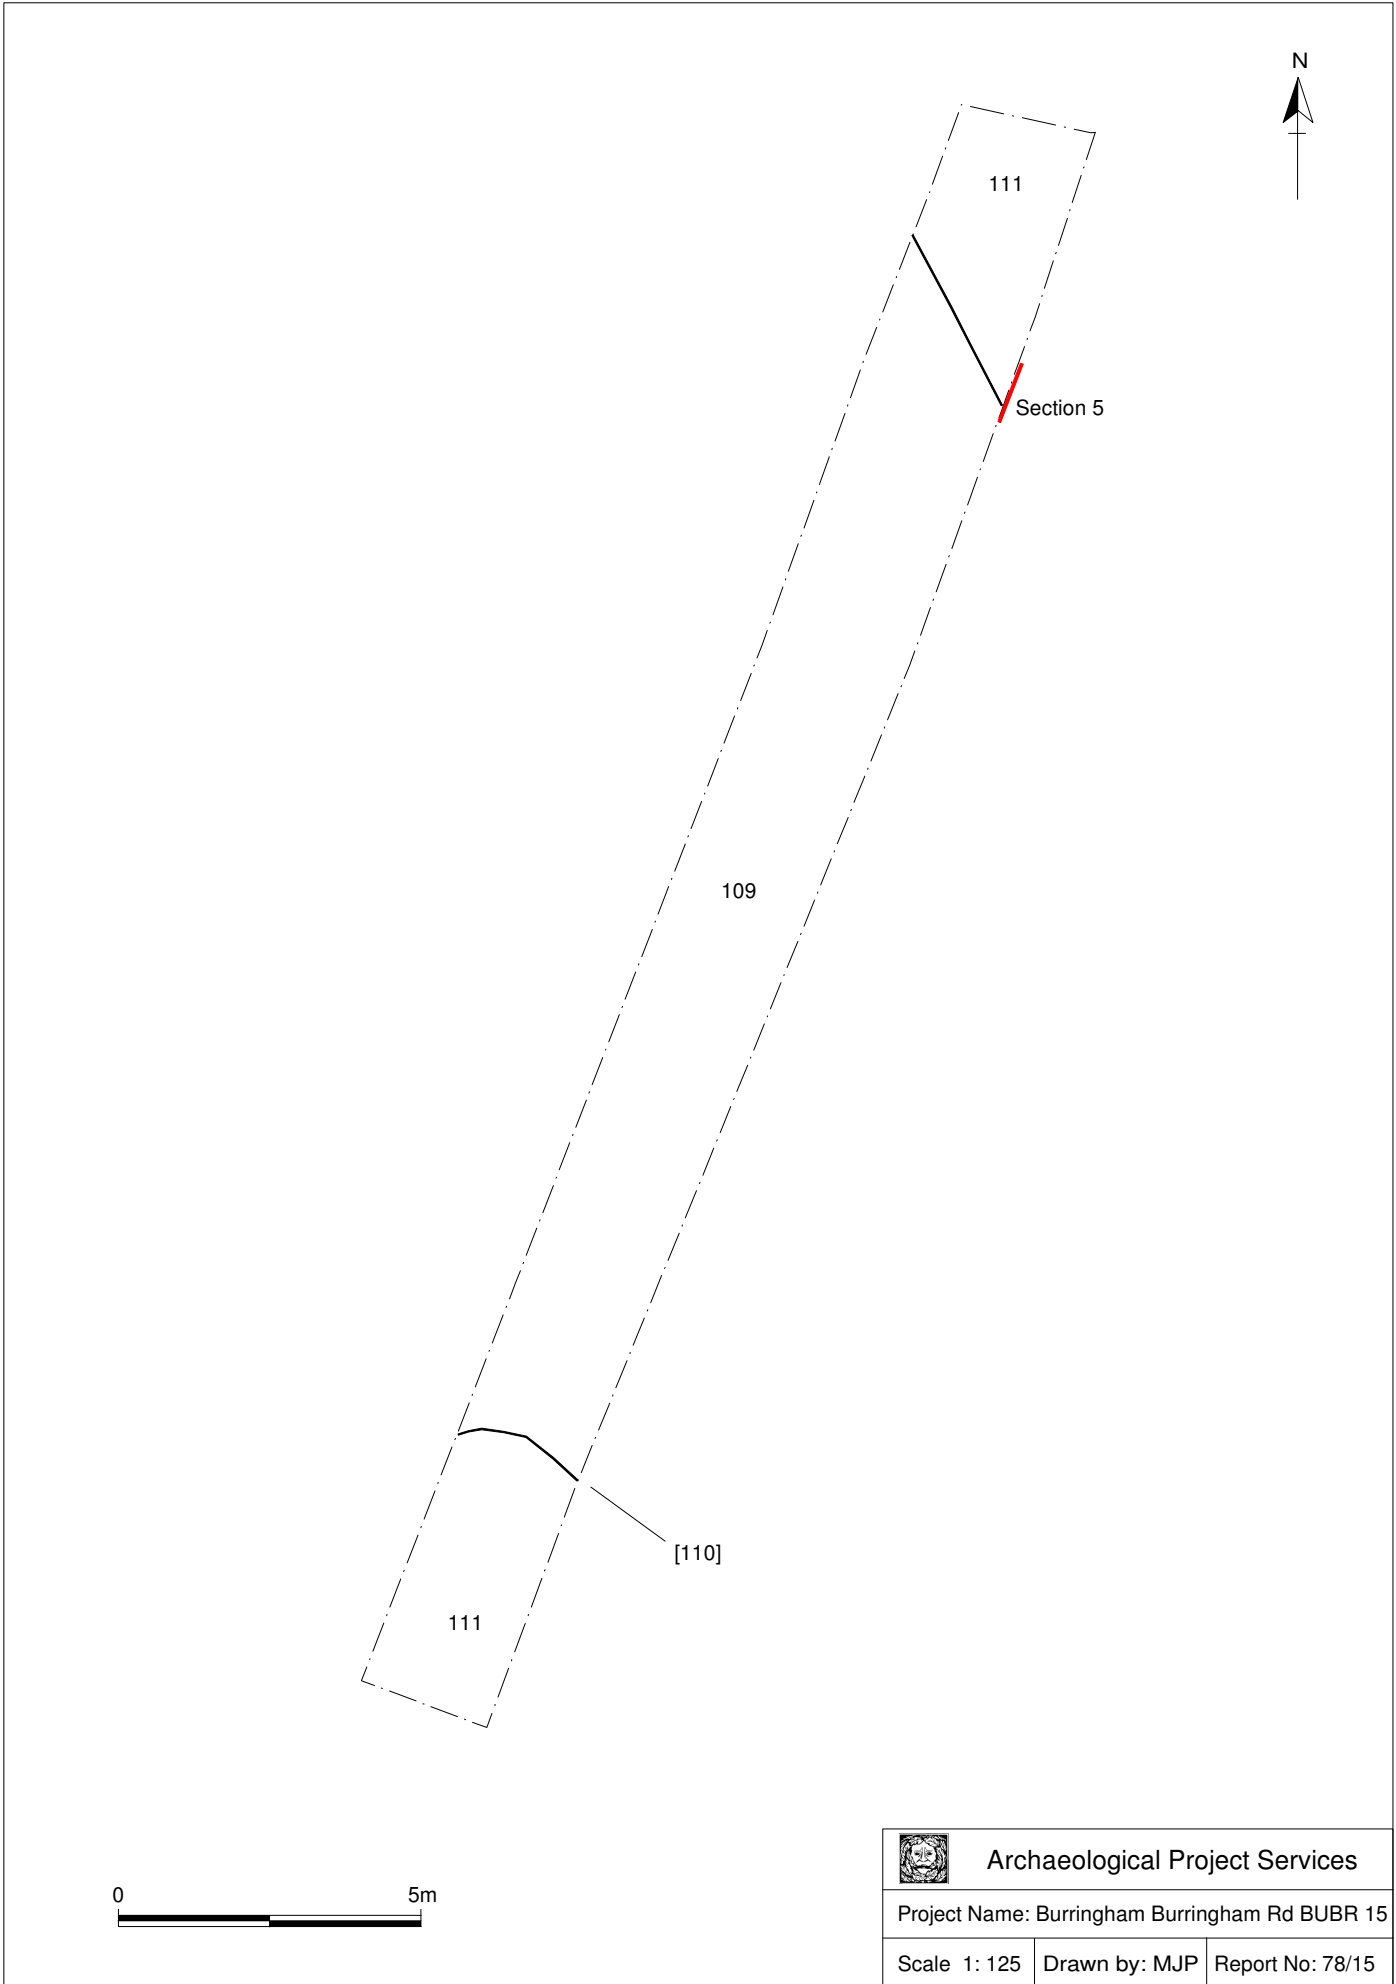
Figure 4. Trench plan

A trench was placed across the projected line of the warping drain parallel to the adjacent sluice, which lies beneath Burringham Road.

A layer (at least 0.45m thick) of mid to dark brown clayey silt alluvium (111) was cut by the east-west aligned warping drain [110]. The drain was 20m wide and was filled with mid to dark grey clayey silt (109) with occasional angular stones and organic material such as twigs. Mid 20th century pottery was retrieved from it. It was sealed by an up to 1.18m thick layer of mid brown/light grey silt (108), probably deliberately redeposited alluvium (Fig. 5; Section 5).

The trench across the warping drain was excavated between the river and the culvert under the road. As a result, the trench did not expose the culvert. However, the warping drain outfall was revealed as it widened out towards the river. It matches the position shown on OS maps of 1886, 1907 and 1951 (Parker 2015). Following the final opening of the sluice, at an unknown date, the outfall would have filled up with flood silts, from which 20th century pottery was retrieved. The silted up outfall had latterly been overlain by redeposited alluvium forming a flood defence bank.

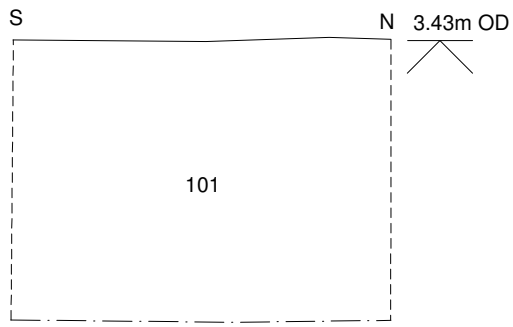
Section 1

Towards the north end of the trench, the deposits, to a depth of at least 0.7m comprised mid brown clayey silt (101) (Fig. 5, Section 1) overlain, in the east side of the trench, by 0.4m thick crushed limestone (102) (Fig. 5, Section 2) forming the contractor's track.

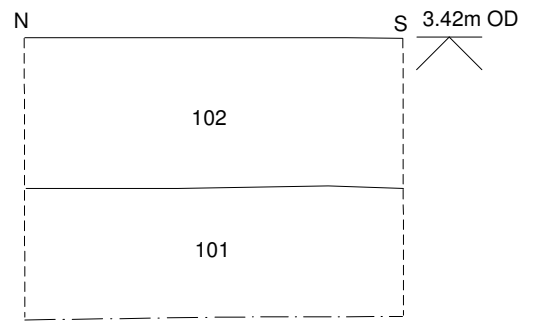
Section 2

In the area between the demolished buildings, the trench encountered tarmac layer (107), overlain by a 0.3m thickness of contractor's crushed limestone (102) (Fig. 5, Section 2).

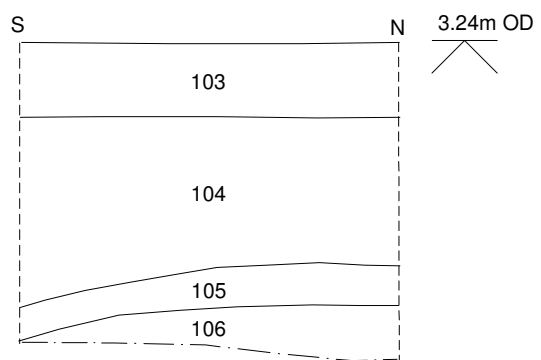
Section 3

Midway along the trench, at least 0.15m thick mid yellow brown clayey silt deposit (106), which contained 19th century pottery and ceramic building material, was overlain by a band of dark brown clayey silt buried topsoil (105). This was sealed by a 0.5m thickness of mid yellowish brown clay silt (104), the current flood defence bank, above which was 0.2m thick topsoil (103) (Fig. 5, Section 3; Plate 2).

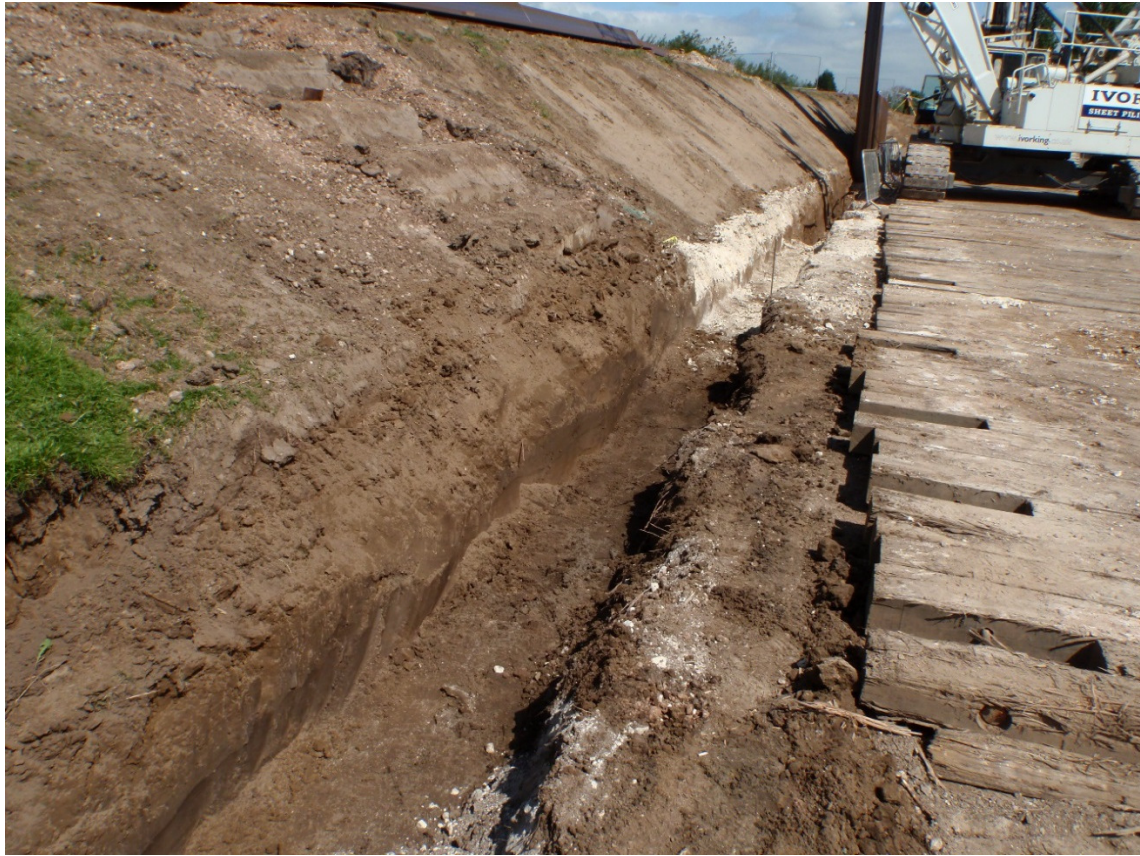
piling for the flood defence barrier (Plate 1).

Plate 1. Excavating the footing trench for the flood defence barrier looking north

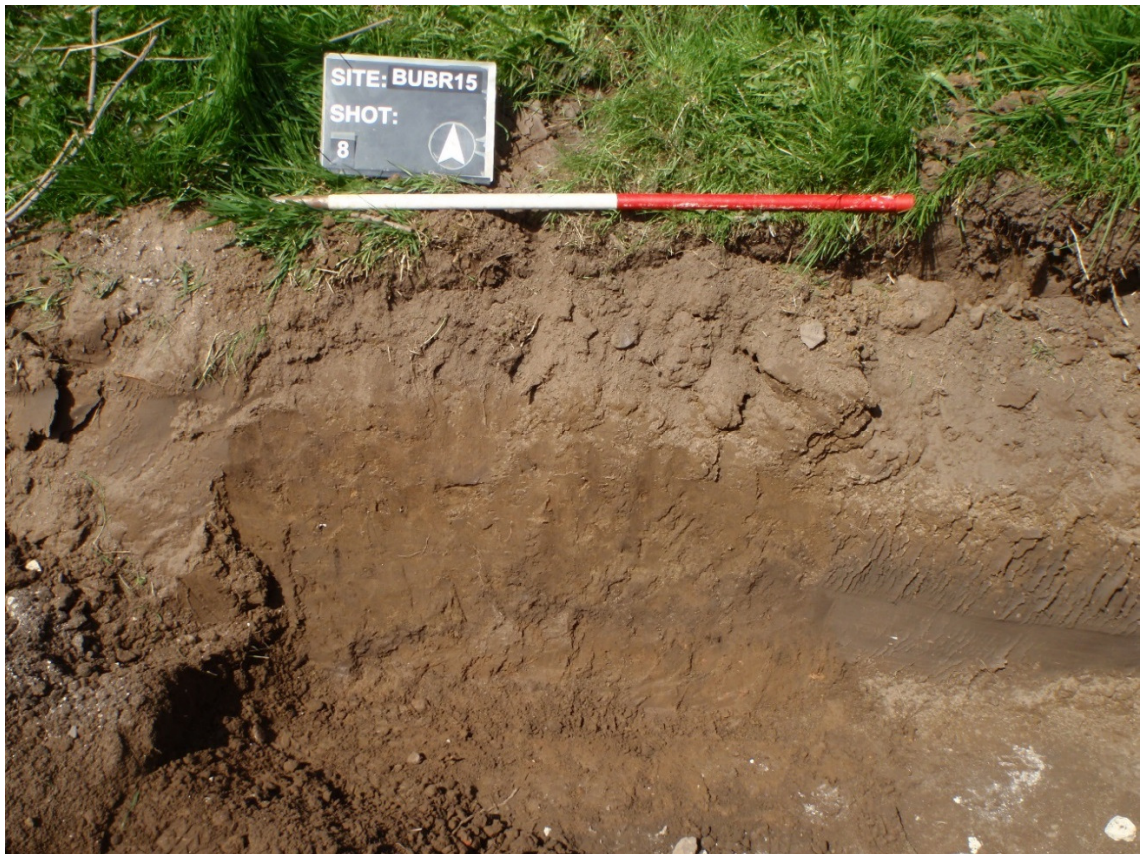
Plate 2. Representative Section 3 through barrier trench looking west

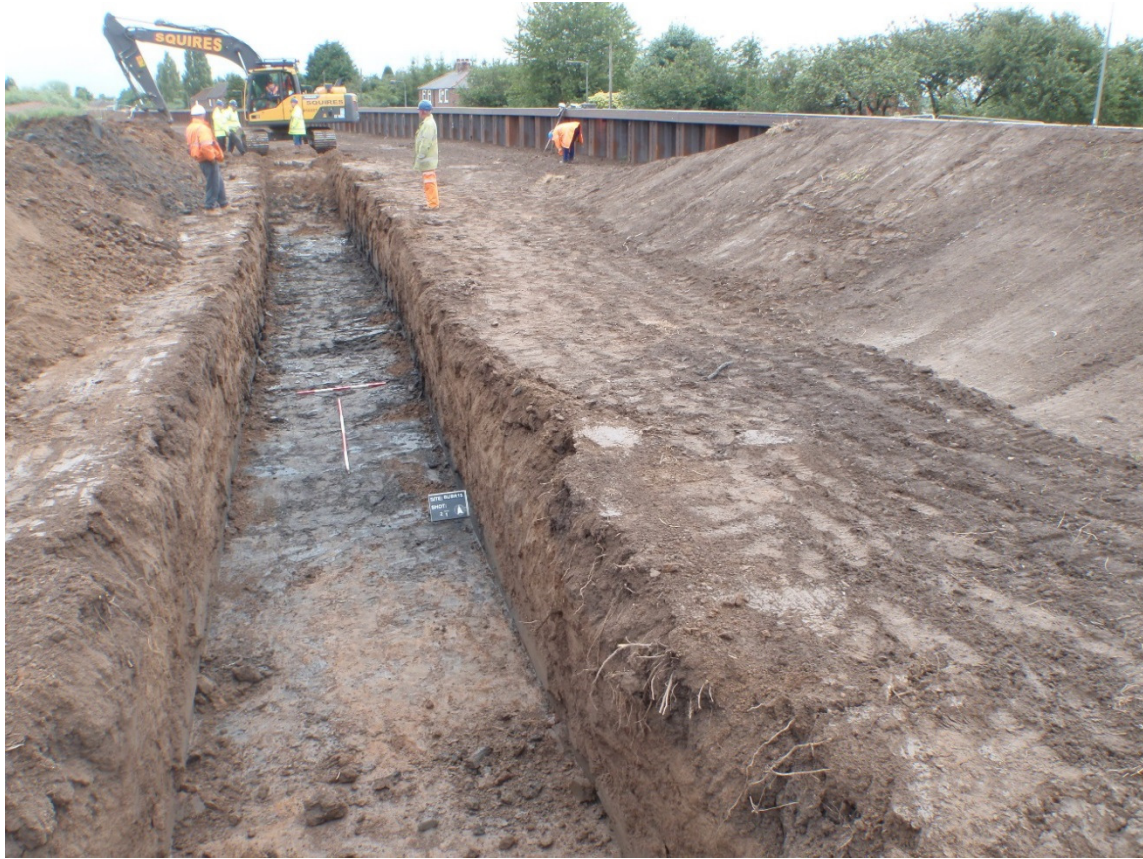
Plate 3. Trench across the warping drain looking north

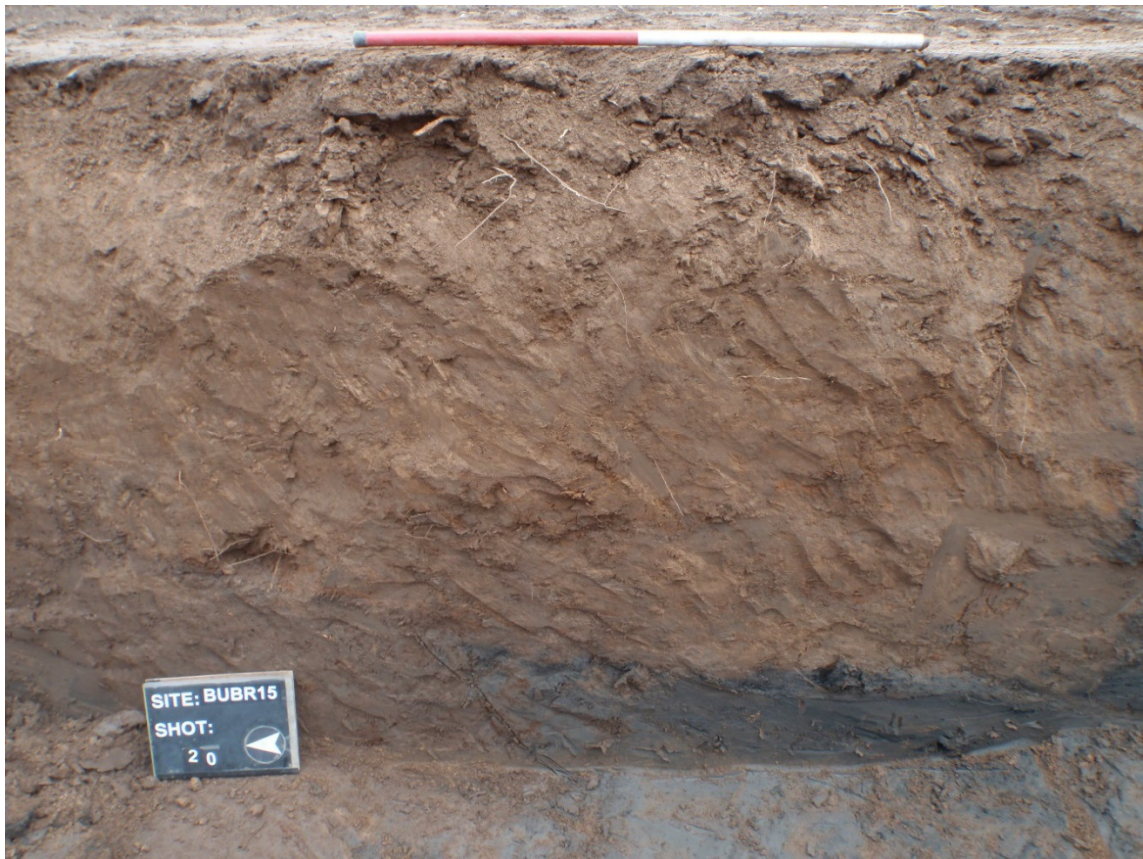
Plate 4. Section 5, showing edge of warping drain, looking east
