**ARCHAEOLOGICAL WATCHING BRIEF
AT 132 BRIDGE ROAD,
SUTTON BRIDGE,
LINCOLNSHIRE
(SBBR13)**

Work Undertaken For
S E King Building Contractors Limited

May 2015

A.P.S. Report No. **54/15**

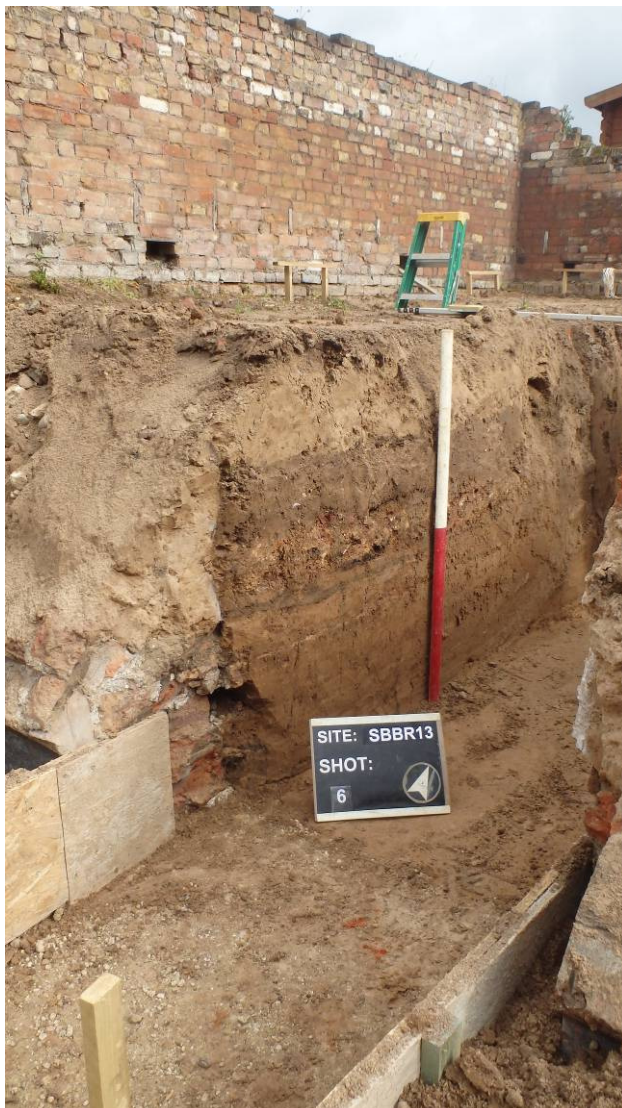
Plate 2. Plot 1, Representative Section 1, looking northwest

The natural deposit (010) was overlain by 0.11m thick light brown silt (009) with brick fragments (Fig 5, Section 1; Plate 2). A 0.03m thick layer of greyish brown silt (008) was overlain by 0.03m thick brown sandy silt (007). This was sealed by 0.12m thick light yellowish brown sandy silt (006) with brick and tile fragments, a probable demolition deposit. Above this was 0.15m thick greyish brown sandy silt (005). This was cut by rectangular construction cut [004] for brick structure [003], a water tank or cistern. Measuring 4.95m by 3.05m in plan and 0.75m deep, it was formed of red brick bonded with greyish white mortar and had been capped with a segmental brick vault.

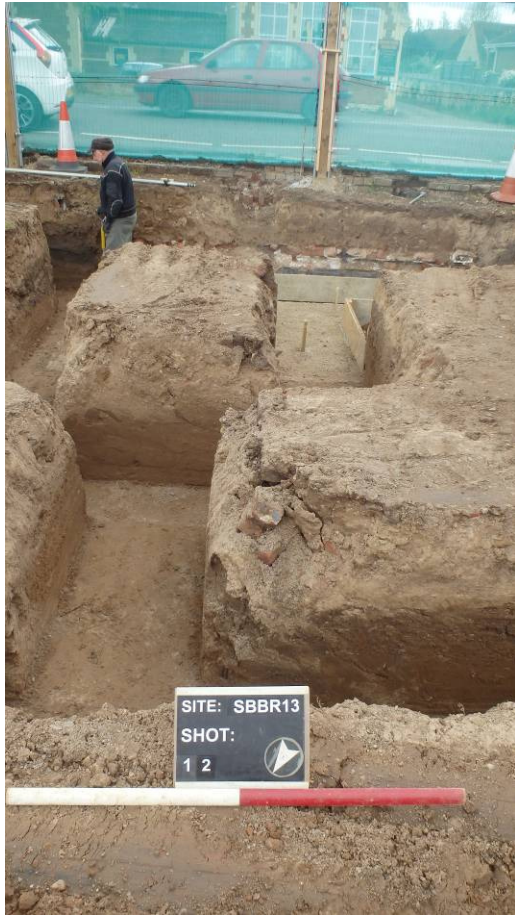
Plate 3. Plot 1, Wall [011] looking south

north-south aligned linear construction trench [012] for wall [011] (Plate 3). The wall was composed of red brick with mid grey mortar and was 0.3m wide with a single course remaining. Above this was the dark greyish brown sandy silt (001) surface of the site.

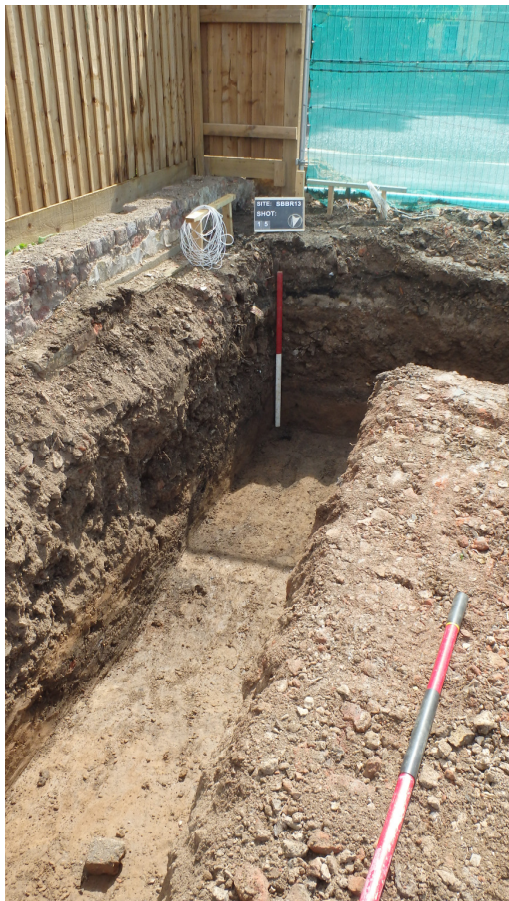
Plate 4. Plot 2, Pit [018], Section 2, looking south

In Plot 2 features were recorded which directly cut into the natural sandy silts. Along the southern edge of the plot linear feature [018] (Fig 5, Section 2; Plate 4) comprised a cut at least 0.75m long by 1.20m wide and at least 0.20m deep. The cut was orientated approximately east south-east to west north-west and was filled with a deposit of firm mid-dark greyish brown silt (017) with moderate coal and brick or tile fragments. In the southwest corner of the plot, linear cut [046] [Fig 5, Section 5; Plate 5) was at least 2.0m long by 0.25m wide and at least 0.16m deep. It potentially formed a continuation of [018] although did not directly follow its orientation, running roughly east to west. It was filled by a mixed deposit of mid brown and dark greyish brown sandy silt (045) with frequent coal fragments.

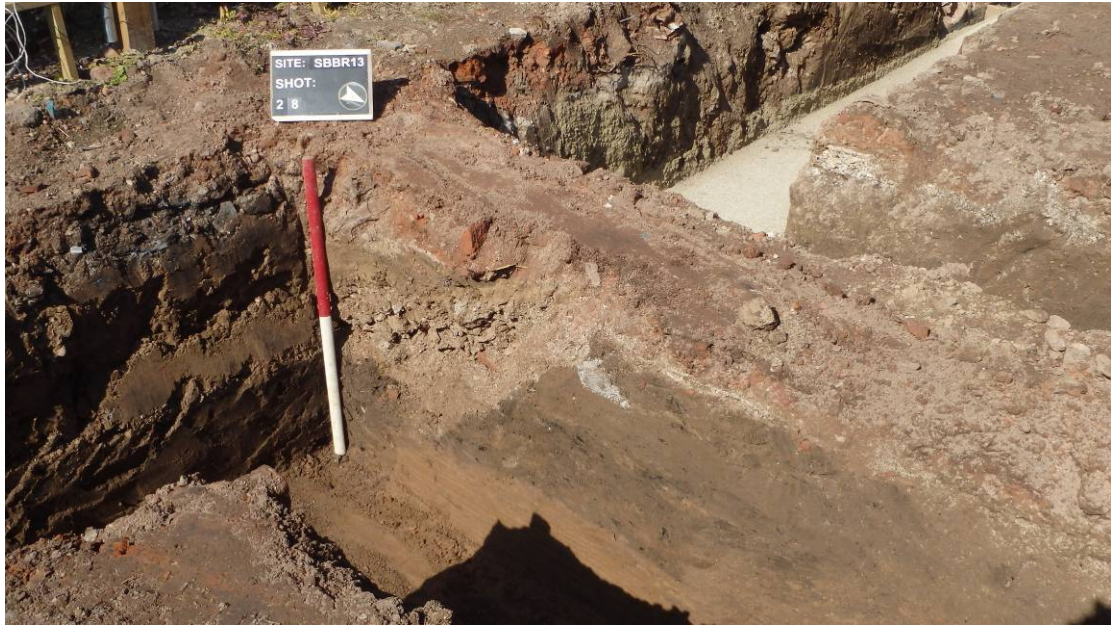
Plate 5. Plot 2, Linear features [041] and [046], Section 5, looking southwest

Ditch [046] was sealed by 0.3m thick dark greyish brown sandy silt (044) which was overlain by 0.14m thick mid greyish brown sandy silt (043) and 0.14m thick sandy silt (042). This was cut by a WSW-ENE aligned linear feature [041] (Fig 5, Section 5, Plate 5) which was at least 6.5m long, at least 1m wide and 0.56m deep. It was filled by 0.42m thick brick and mortar rubble (040) overlain by 0.2m thick greyish brown sandy silt (039).

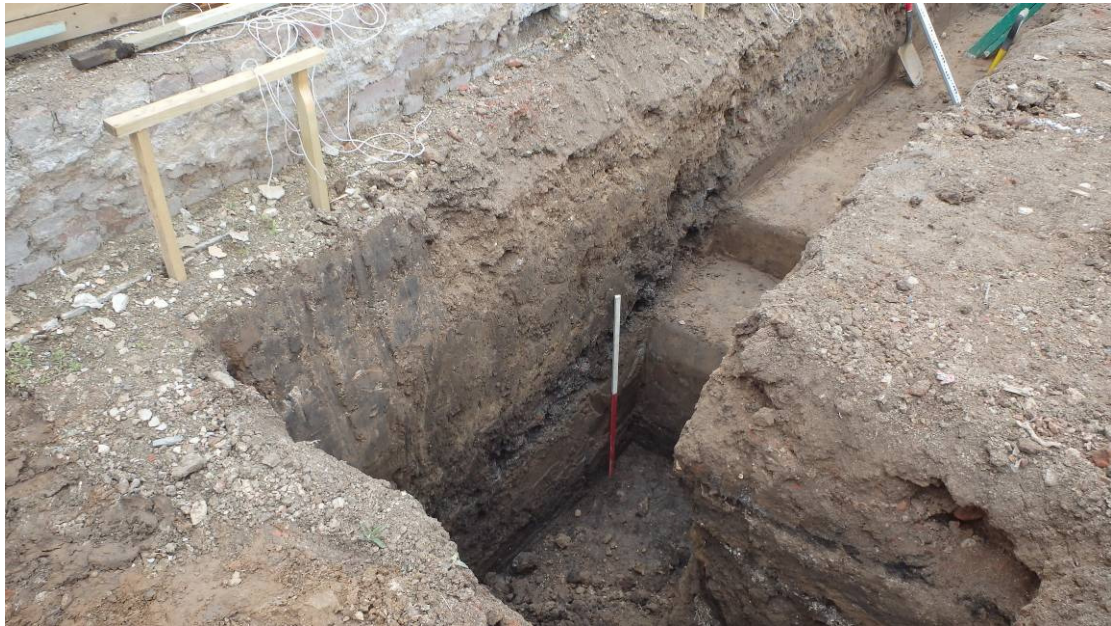
Plate 6. Plot 2, Pit [028], Section 4, looking southeast

In the northern third of the plot the silts were cut by large pit [028]/[030]/[050] (Fig 5, Section 4; Plate 6). This was at least 6.75m by 5.4m in plan and up to 2.5m deep. Finds (027) including late 18th to early 19th century pottery and glass were retrieved during the machine excavation of [028]. The basal fill in the northeast corner of the plot was 0.4m thick dark bluish grey silt (037) which contained 17th to 18th century pottery along with an 18th century clay pipe and leather shoes. Sealing this was 0.36m thick dark brown sandy silt (036). In the southeast part of the pit, mid greyish brown sandy silt lower fill (029) contained a sherd of late 17th to 18th century pottery. Both this and fill (036) were overlain by up to 0.5m thick brown sandy silt (035) above which was 0.18m thick mid to dark brown sandy silt (034). Above this was 0.5m thick brick and mortar rubble (033)

overlain by 0.4m thick brown sandy silt (032). In the northwest part of the footings, the pit fills were greyish brown sandy silt (049) overlain by light brown sandy silt (048) which contained an early-mid 19th century clay pipe bowl.
