**HISTORIC BUILDING RECORDING
AT
NEW ENGLAND FARM
DELGATE BANK
WESTON HILLS
LINCOLNSHIRE
(WEDB15)**

Planning Application No: H22-0904-14
National Grid Reference: TF 2886 2276
OASIS Record No: archaeo11-218804
The Collection Accession No: LCNCC: 2015.135

A.P.S. Report No. **71/15**

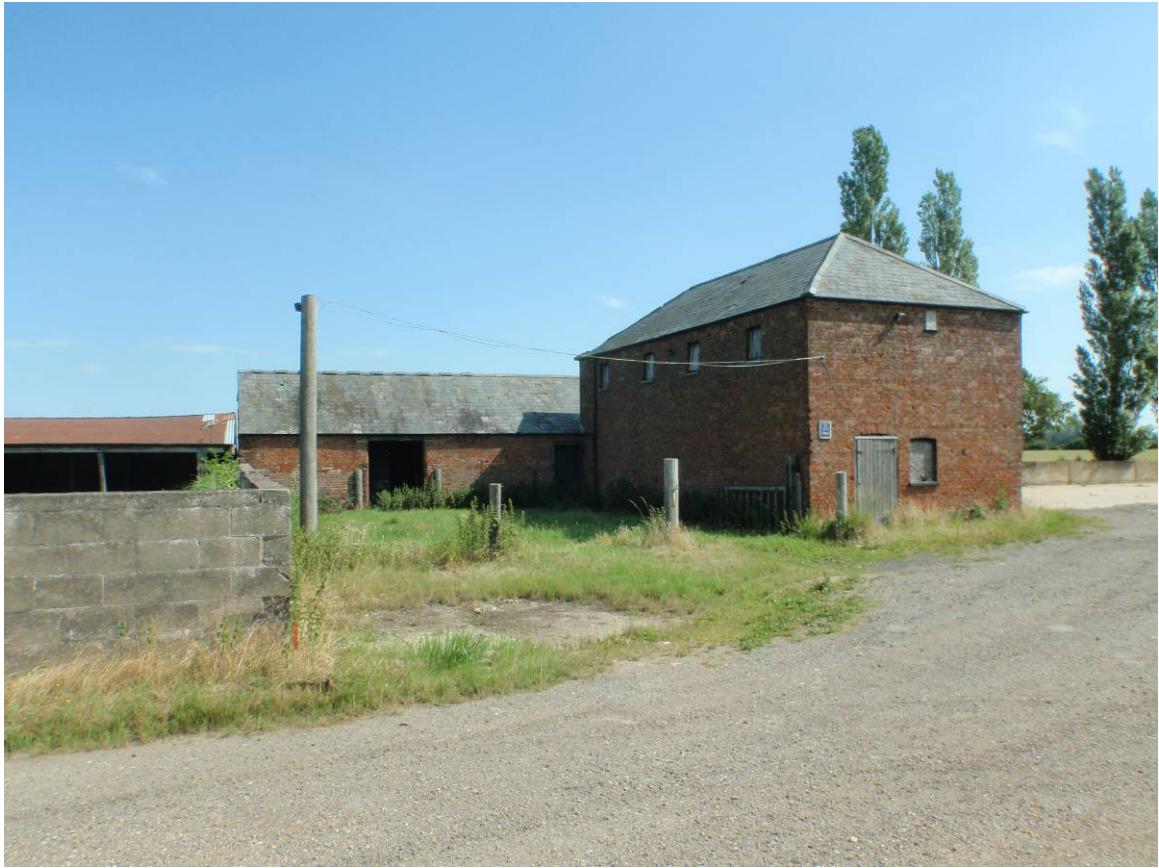
Plate 3. The recorded buildings, looking northeast

The recorded buildings form the east side of a C-shaped range around a pair of courtyards. Both ranges are constructed of handmade in English Garden Wall Bond, with a Welsh slate roof. The two ranges, the northern and the eastern (Plate 3), will be described separately.

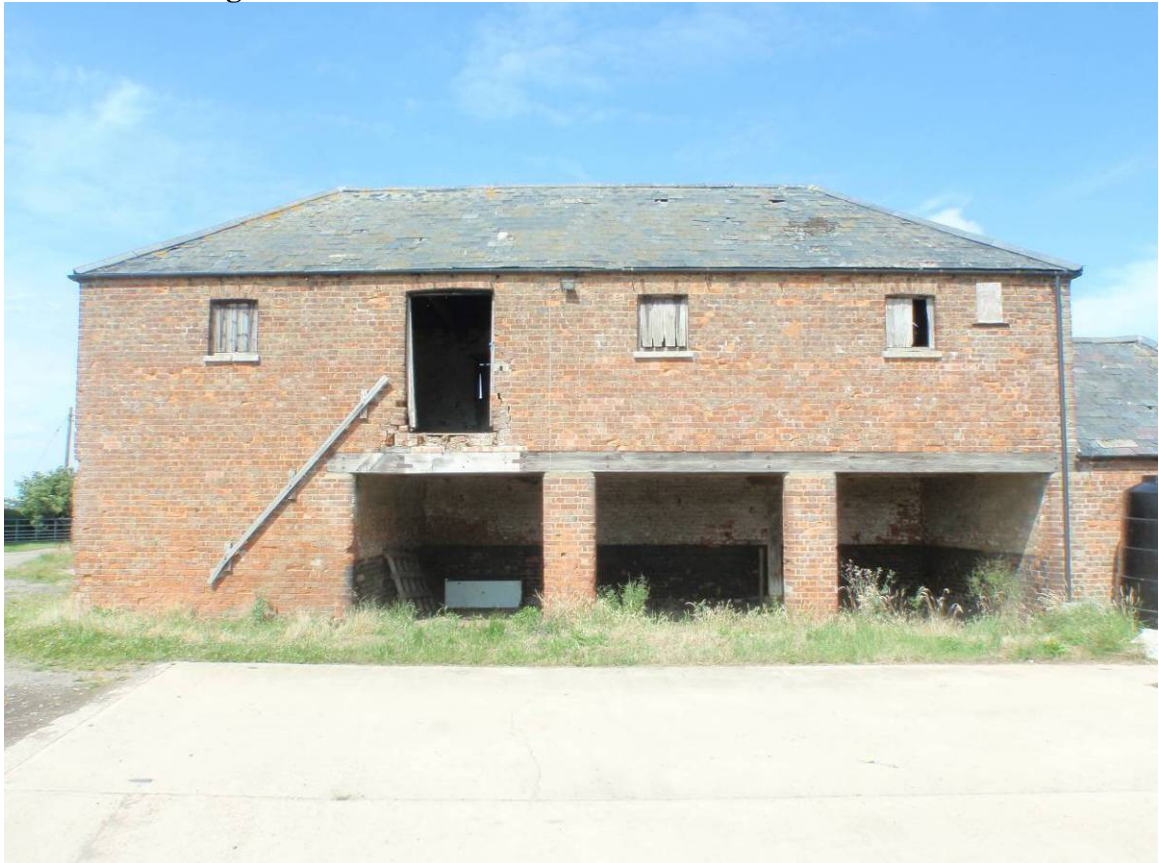
Plate 4. East range, eastern elevation, looking west

The east range is 2-storeys high with a hipped roof (Figs. 5 and 8). At its southern end the eastern elevation is fairly plain. Immediately to the north, the eastern elevation is open at ground floor level, with two brick piers separating three openings (Plate 4). The sides of the openings, and the piers, are edged with bullnose bricks. At the top of the piers, and at the uppermost parts of the outer edges of the open front, are slabs of York stone. These slabs support a large timber lintel.

Above the southern opening, at first floor level, is a doorway with a shallow gauged arch of brick rubbers. This was previously accessed by an external wooden stairway but this has been removed. In addition, at first floor level are three wooden shuttered windows, with fairly flat arches of brick rubbers. Just below the eaves at the northern end of the elevation is a small opening, now covered over. At its northern end the eastern elevation meets the northern range.

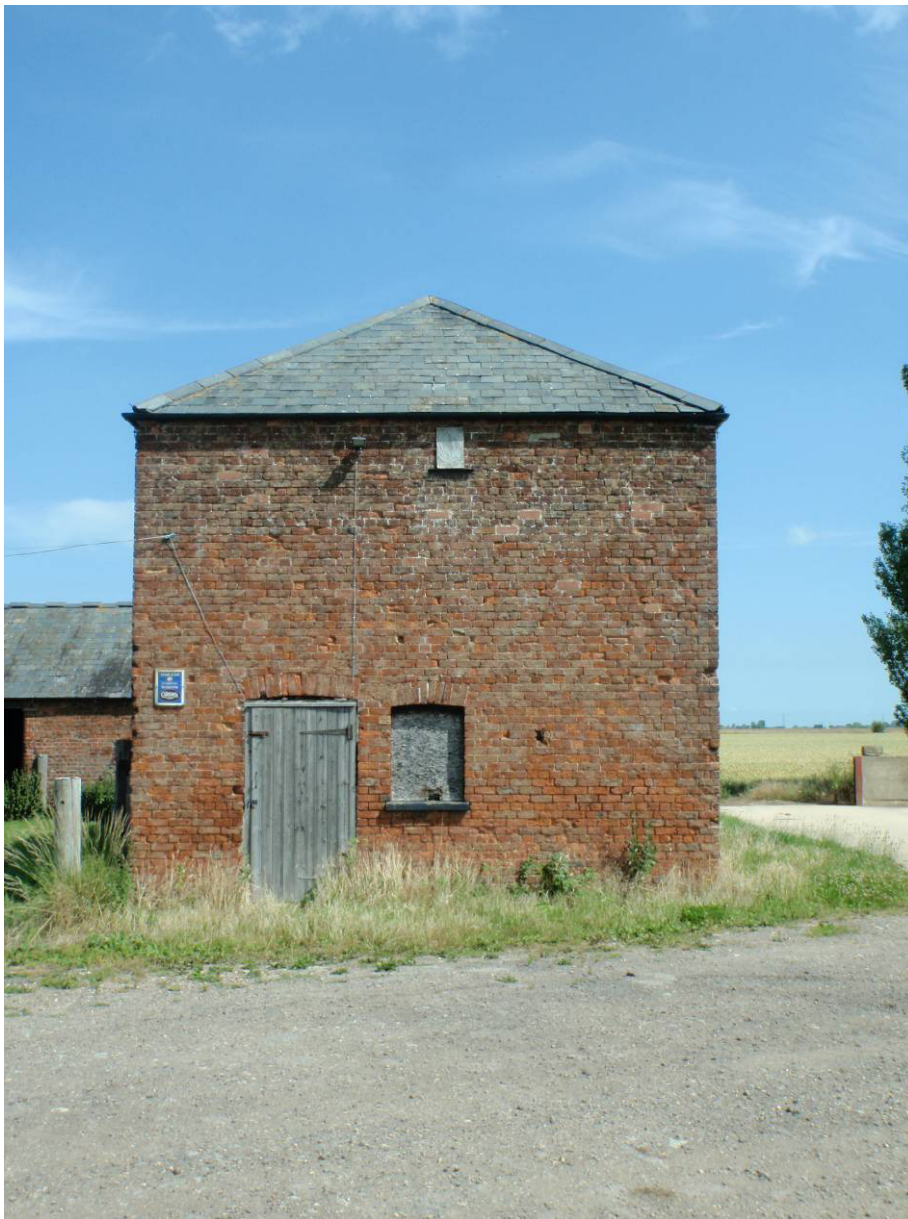
Plate 5. Eastern range, southern elevation, looking north

The southern elevation has a ground floor door to left of centre and, centrally placed, a window opening, now covered with board (Plate 5). Both door and window have segmental arches. By the western edge of the elevation is an advertising panel noting that the farm

The two small blocked openings high in the southern and eastern elevations may have been owl holes. Owls were encouraged into granaries to control rodents.

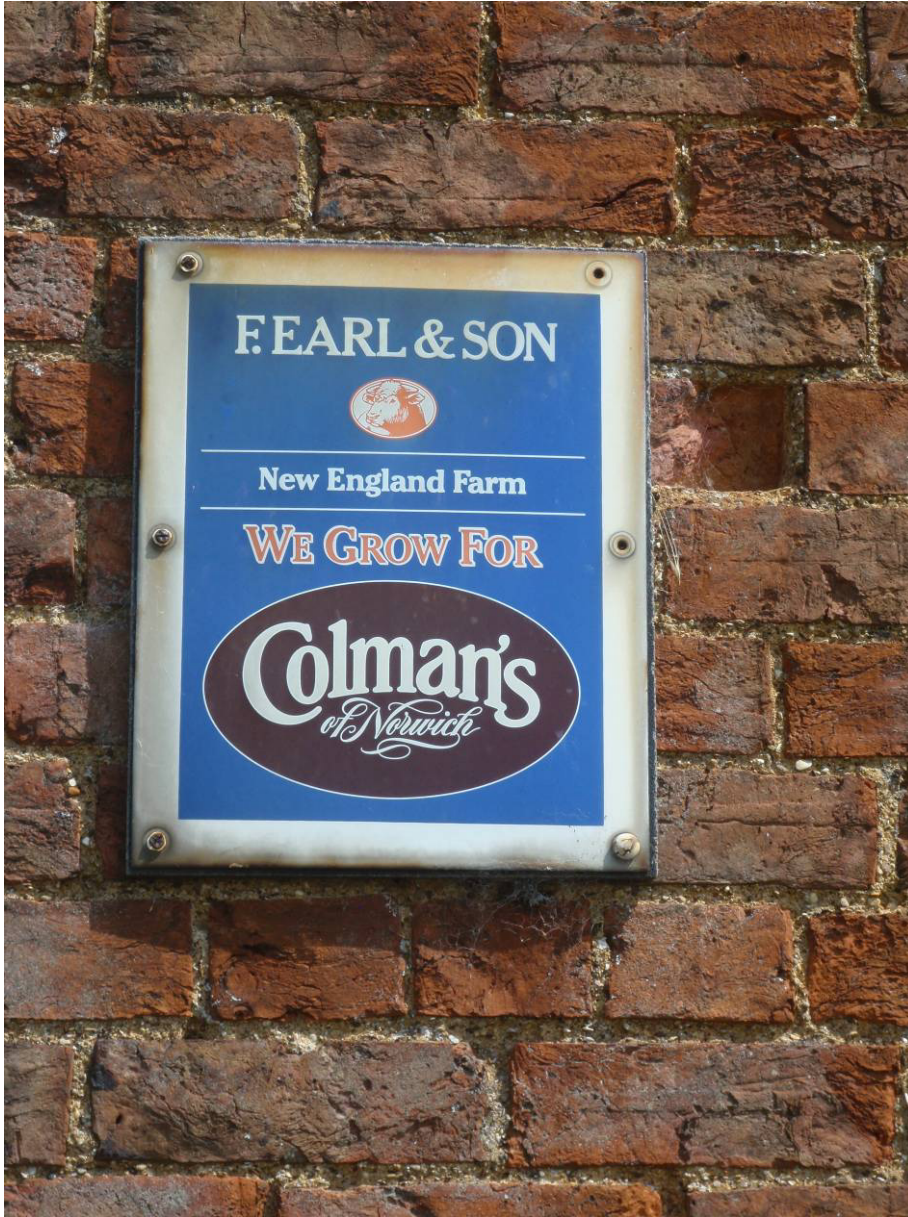
supplied Colman's of Norwich (Plate 6). Centrally located just below the eaves is a small covered opening, identical to that on the eastern elevation (see above). Otherwise, the upper part of the elevation is plain.

Plate 6. Detail of advertising panel on south elevation

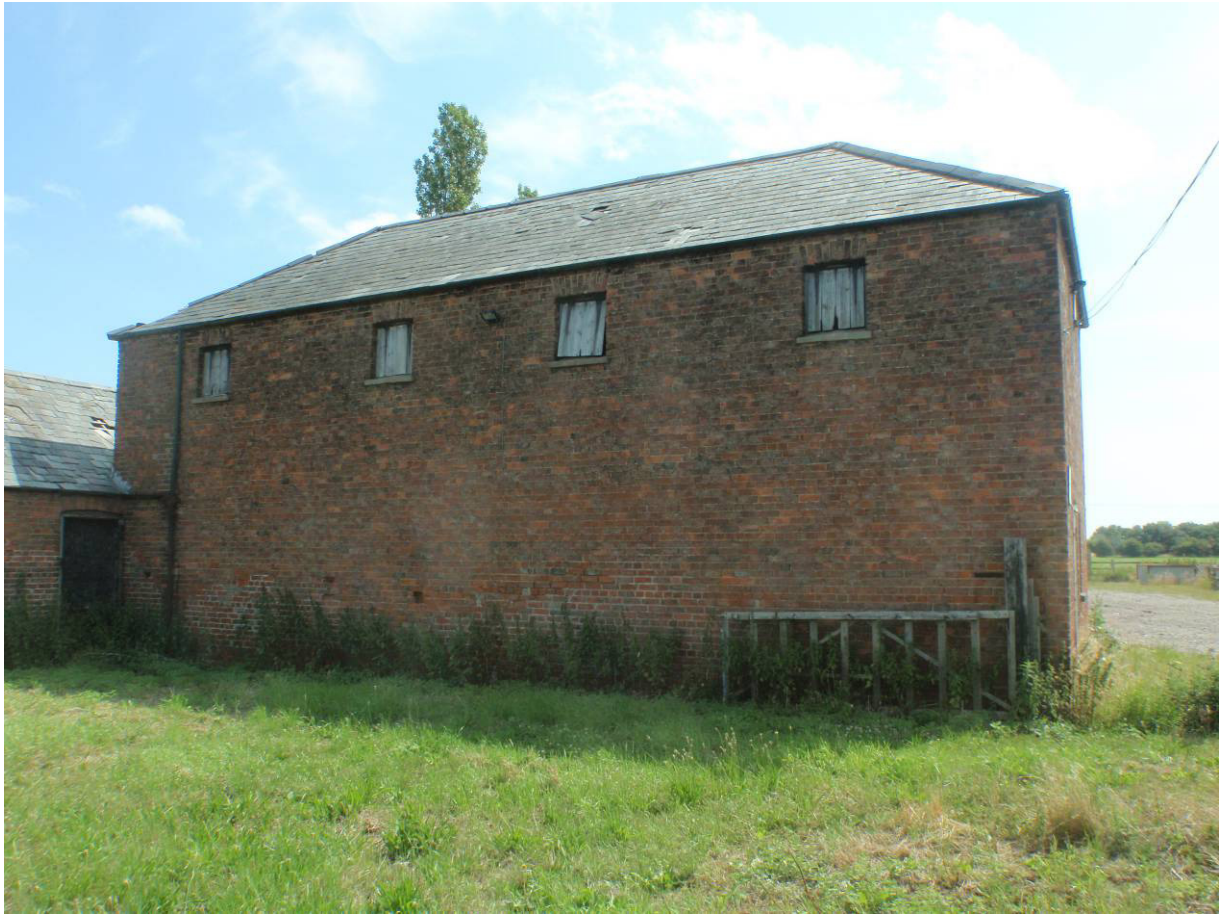
At ground floor level the western elevation is plain. On the upper storey is a series of four wooden shuttered windows, each with gauged arches of brick rubbers and cills of York stone (Plate 7). At its northern end the elevation meets the northern range.

Plate 7. Western elevation, looking northeast

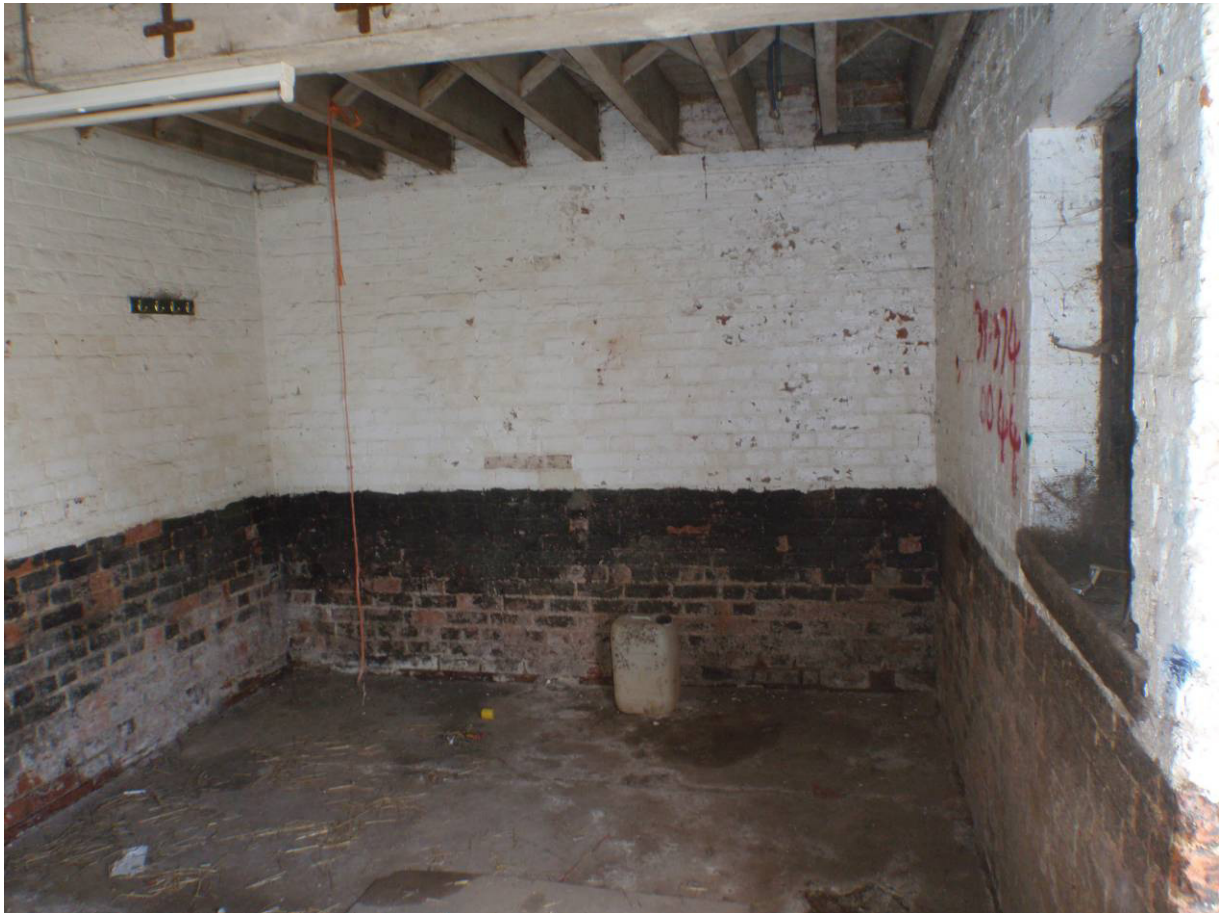
At ground floor level the eastern range has two internal compartments (Figs. 6 and 8). At the southern end, and accessed from the doorway in the southern elevation, is a plain room with a concrete floor. A beam crosses the centre of the room north-south, supporting the floor of the upper storey (Plate 8). In the south wall, alongside the doorway, the boarded-over window retains remnants of a wooden ventilator grille (Plate 9).

Plate 8. Interior of southern room, east range, looking east

The eastern range comprises two compartments. At the southern end is a single storey room. This is plain and mostly lacks any evidence of original function. However, remnants of a slatted ventilator window suggest that this may have been a loose box. Loose boxes are typically almost featureless but were generally provided with ventilation, often slatted windows as present here (cf Barnwell and Giles 1997, 54-5).

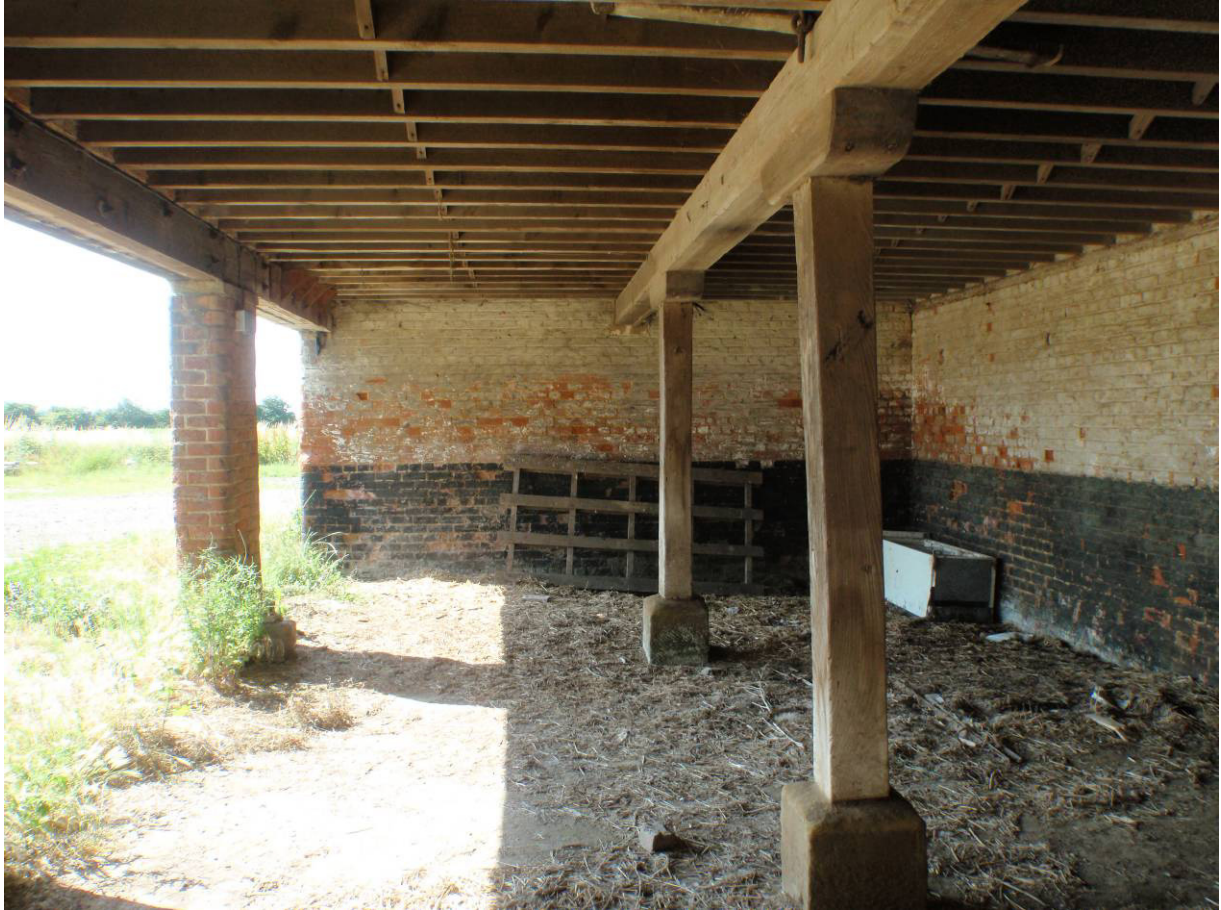
The northern compartment has an open east side, supported on brick piers. Two further stanchions, comprising of timber posts set on York stone plinths, support a north-south beam through the centre of the compartment (Plate 10). The beam is formed from two timbers, linked by a basic scarf joint above the southern stanchion (Plate 11). The paired stanchions divide the compartment into three narrow bays and the floor is of compact earth.

Plate 10. Interior of northern compartment of east range, looking south

Immediately to the north of this probable loose box is an open-fronted cartshed. This would have accommodated other large equipment, particularly horse-drawn implements such as ploughs.

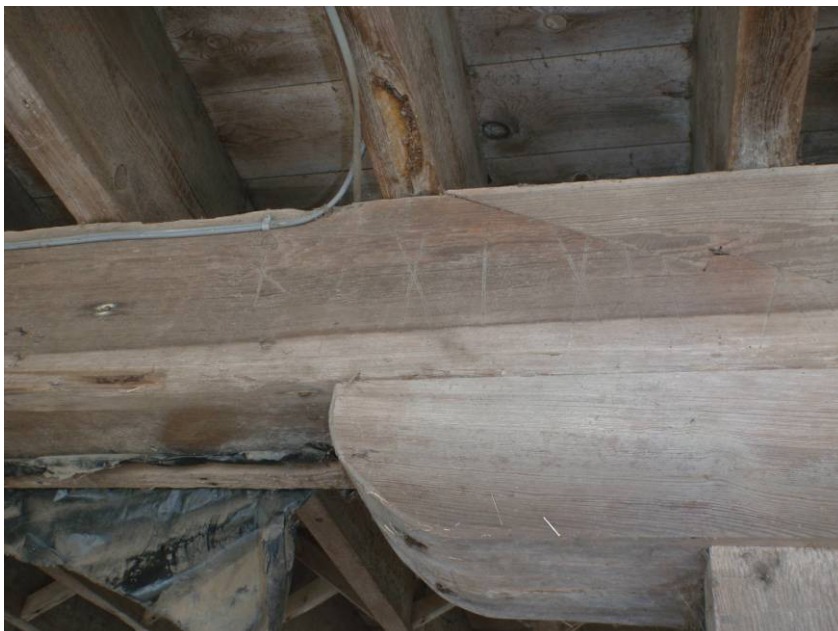
The central beam retains a variety of incised markings. Towards the southern end, and on the east face, is a series of Roman numerals, X, XI, XII, XIII (Plate 11), with the latter two partially cut across by the joint.

Plate 11. Beam showing incised Roman numerals and joint, looking west

Crossing the cartshed is a beam with several incised markings. Most of these are Roman numerals but these are not joiners' marks and they have no matching pairs, as carpenters' marks do. Additionally, there are irregular cursive incisions. These have the appearance of importers' marks, found on Baltic timber. By the mid 19th century it had been recognised that Baltic pine was straighter and of better quality than home-grown timber and it was increasingly used in agricultural buildings (Barnwell and Giles 1997, 160).

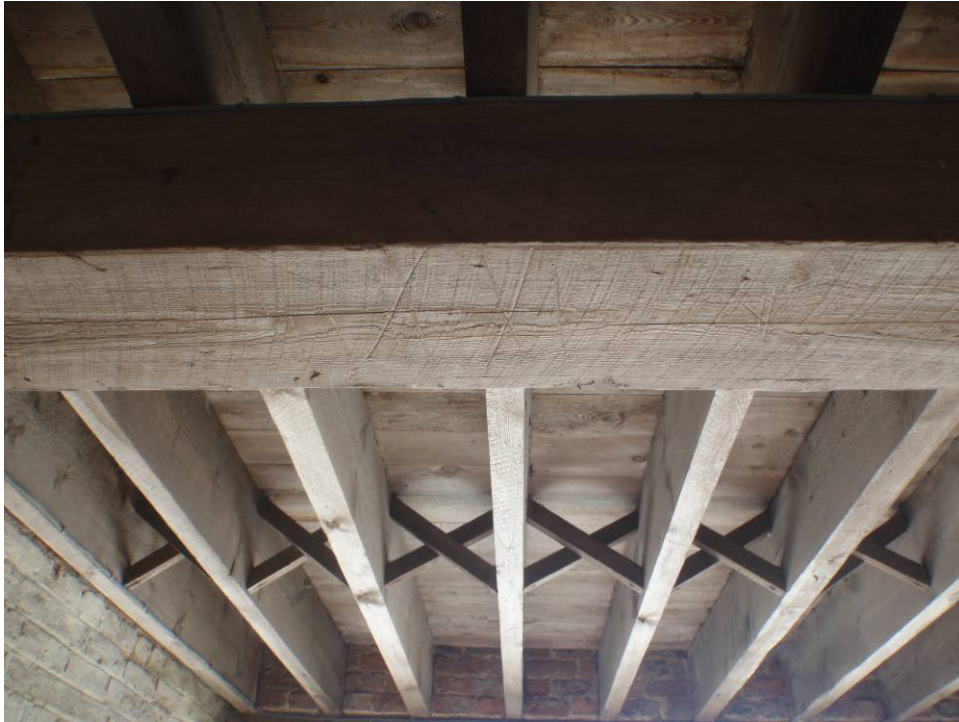
Further apparent Roman numerals are located on the underside of the beam towards the northern end, but the sequence is less distinct (Plate 12).

Plate 12.
Underside of
beam showing
incised Roman
numerals, looking
east

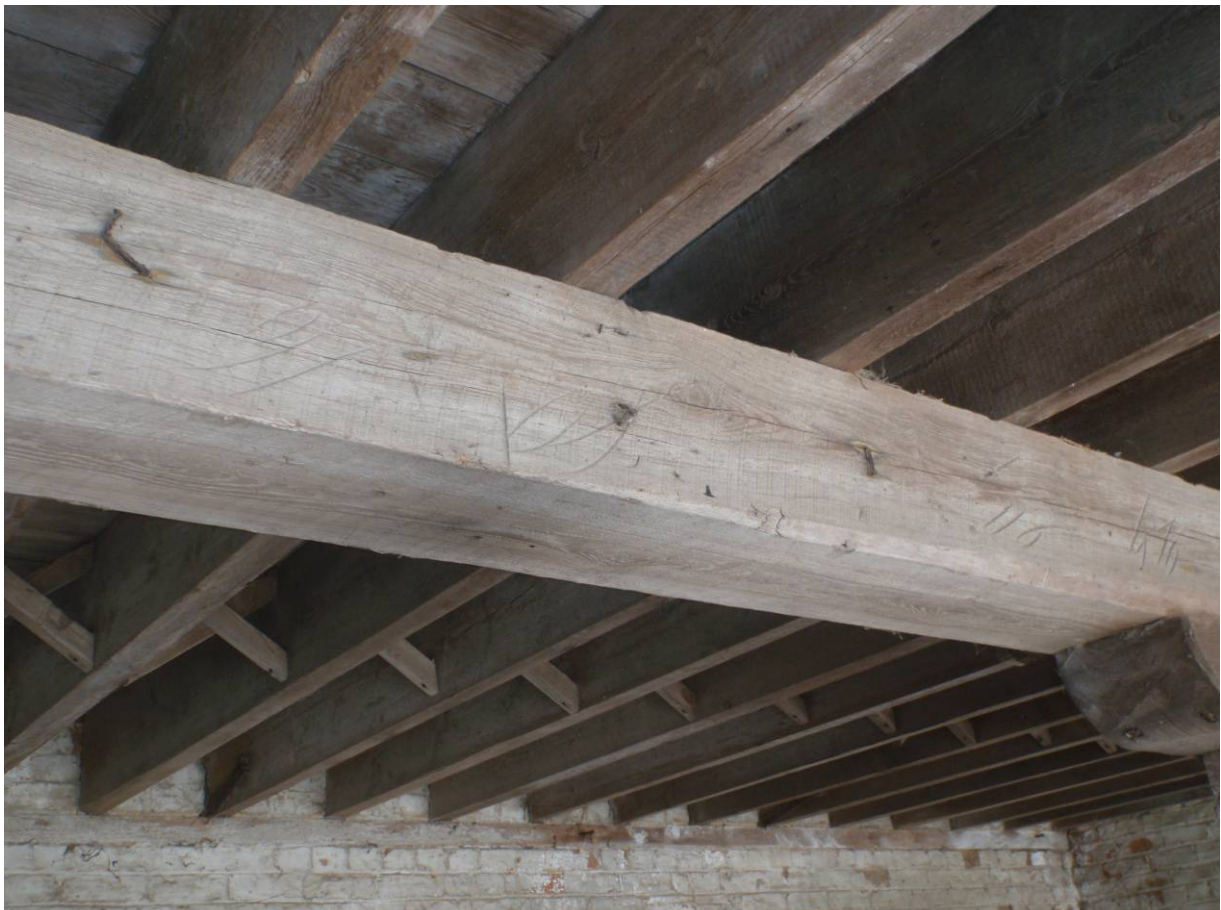
Near the centre of the beam, on its eastern face, is a further group of incised marks (Plate 13). These may be Baltic importers' marks (cf Barnwell and Giles 1997, 160).

Plate 13 Possible 'Baltic' importers' marks on beam, looking northwest

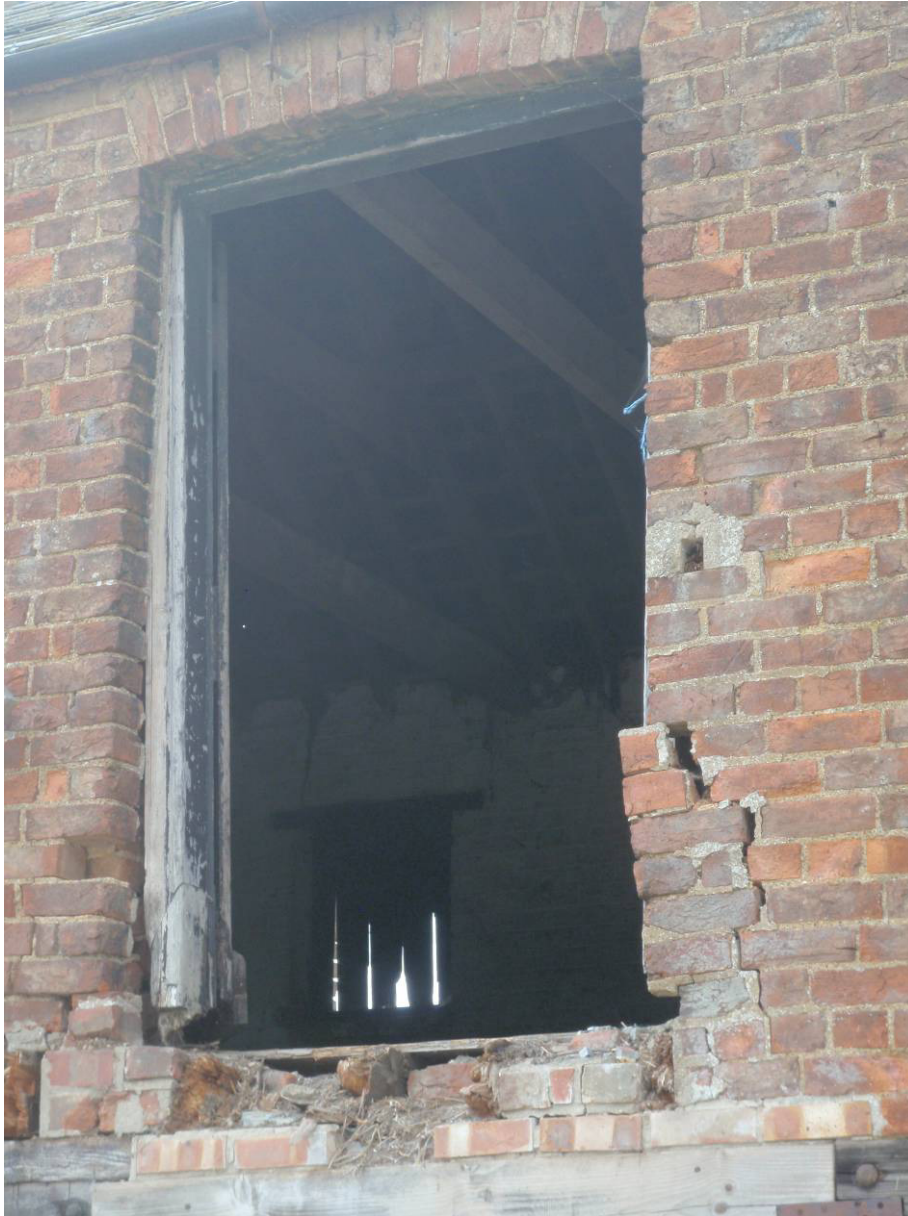
The external stairway that had previously provided access to the upper storey was no longer in place (see Plate 4), having been removed for safety reasons, and the upper storey was not accessible. Views through the open doorway suggested the upper storey (Fig. 7) was probably one large open space, covering both of the ground floor compartments. Roof trusses of tie beams and collars were evident, and wooden shuttered windows, as seen from the exterior (Plate 14).

Plate 14. View into upper storey, east range, looking southwest

A second storey was located above the cartshed and loose box. This was probably a granary. This positioning of granary over a cartshed is typical of later 19th century farmsteads of south Lincolnshire and elsewhere (Barnwell and Giles 1997, 52-3; Brunskill 1999, 90-3). In addition to this arrangement, the upper storey was accessed by an external stairway, now removed. Such external stairs are also typical of Lincolnshire and other granaries. The granary extends over the loose box at the southern end of the range. Granaries were sometimes located above stables, as horses consumed large quantities of oats, and it was convenient to have the feed close, being dropped through trapdoors in the granary floor to the stable below. A similar situation probably took place here, with grain being dropped into the loose box for the horse being sheltered there, though the ceilings of the cartshed and loose box may be later replacements and there is no surviving evidence for a trapdoor.

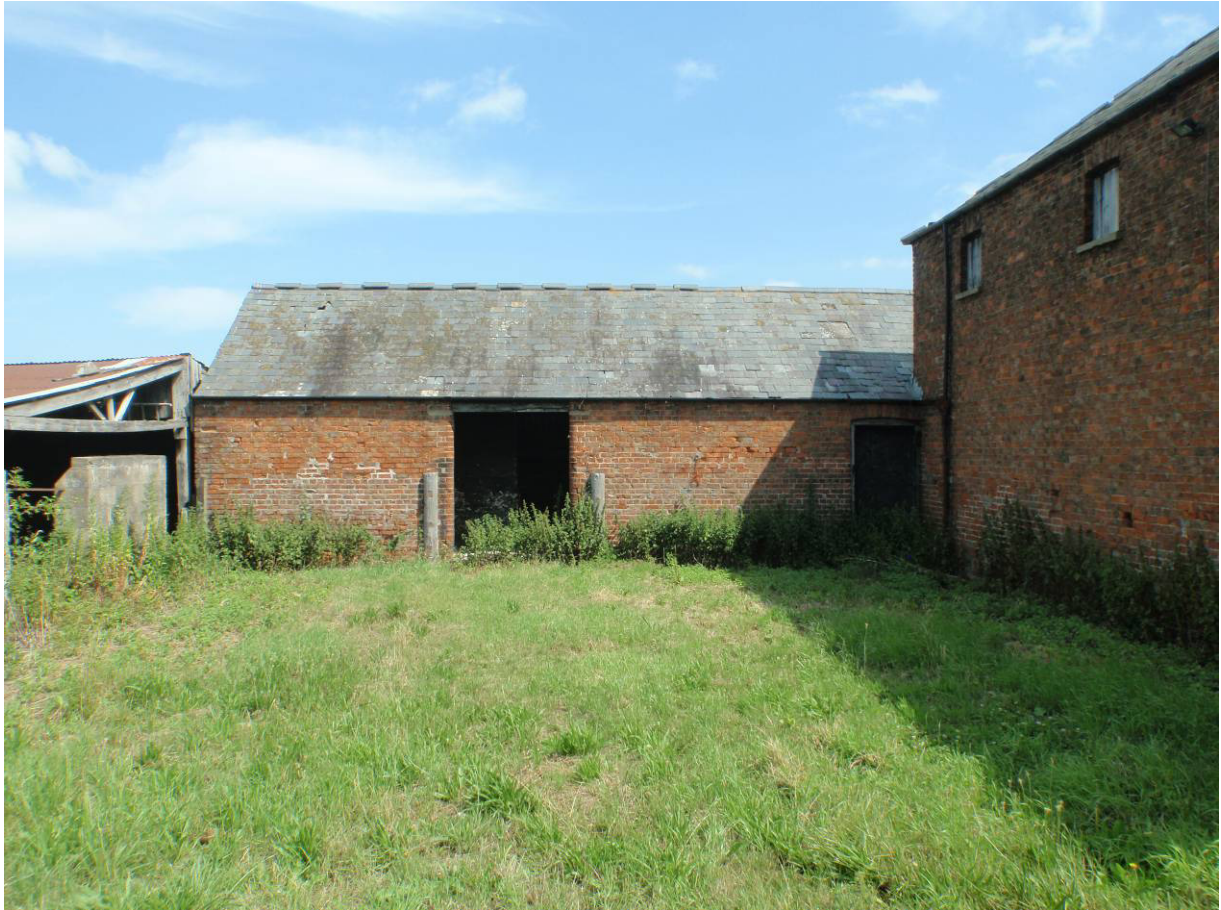
Plate 15. Northern range, south elevation, looking north

The southern elevation has two doorways. Located almost centrally is a wide opening with edgings of bullnose bricks (Plate 15). At the top of each side of the doorway, and supporting the lintel beam, are slabs of York stone. At the eastern end of the elevation, adjacent to the east range, is the second doorway. This is of standard width and has a gauged arch of brick rubbers.

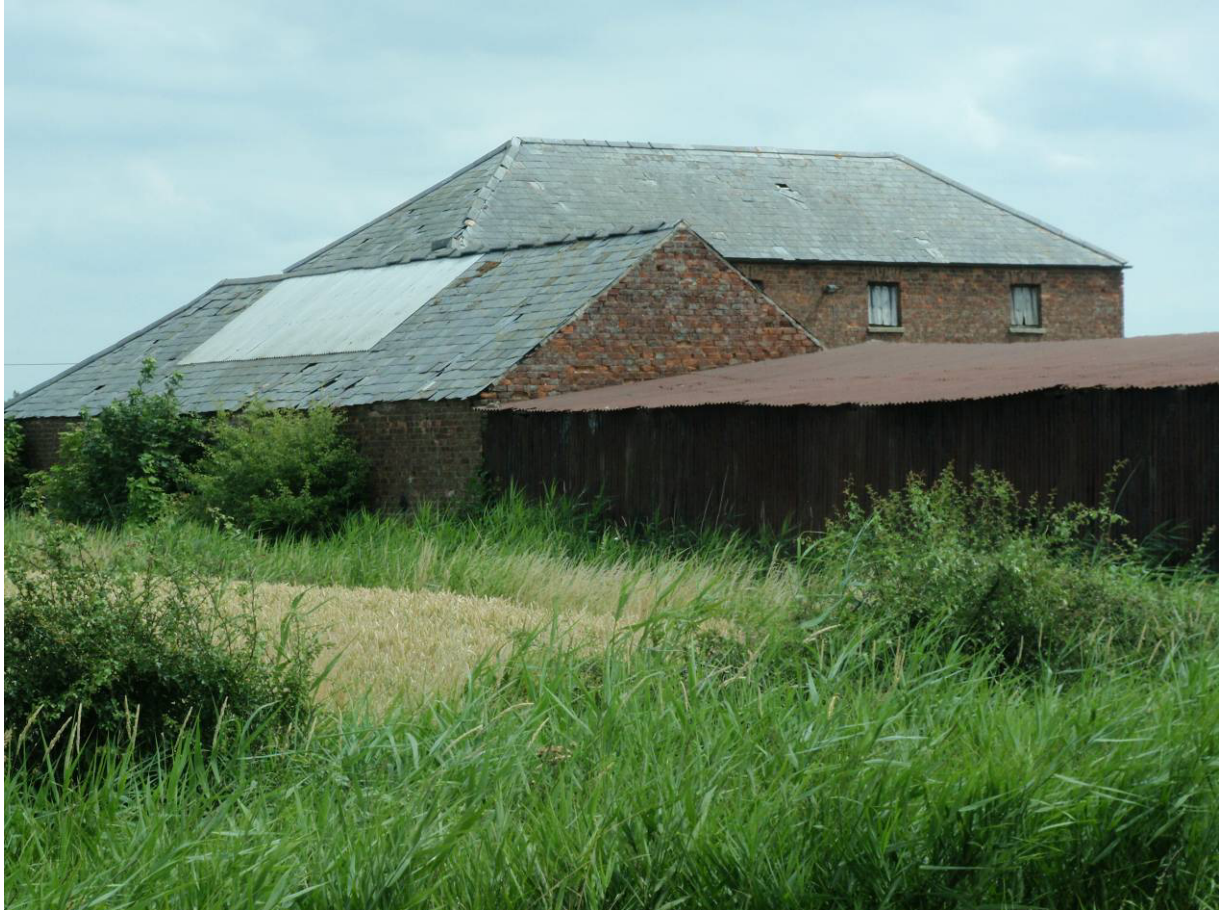
The western elevation is mostly obscured by an adjacent single storey range but above this the elevation is a plain gable (Plates 16). There was no direct access to the northern elevation but vegetation obscured much of it. From the partial, distant, view the elevation appeared to be plain, though windows were observed in the interior (see below).

Plate 16. North range, west and north elevations, looking southeast

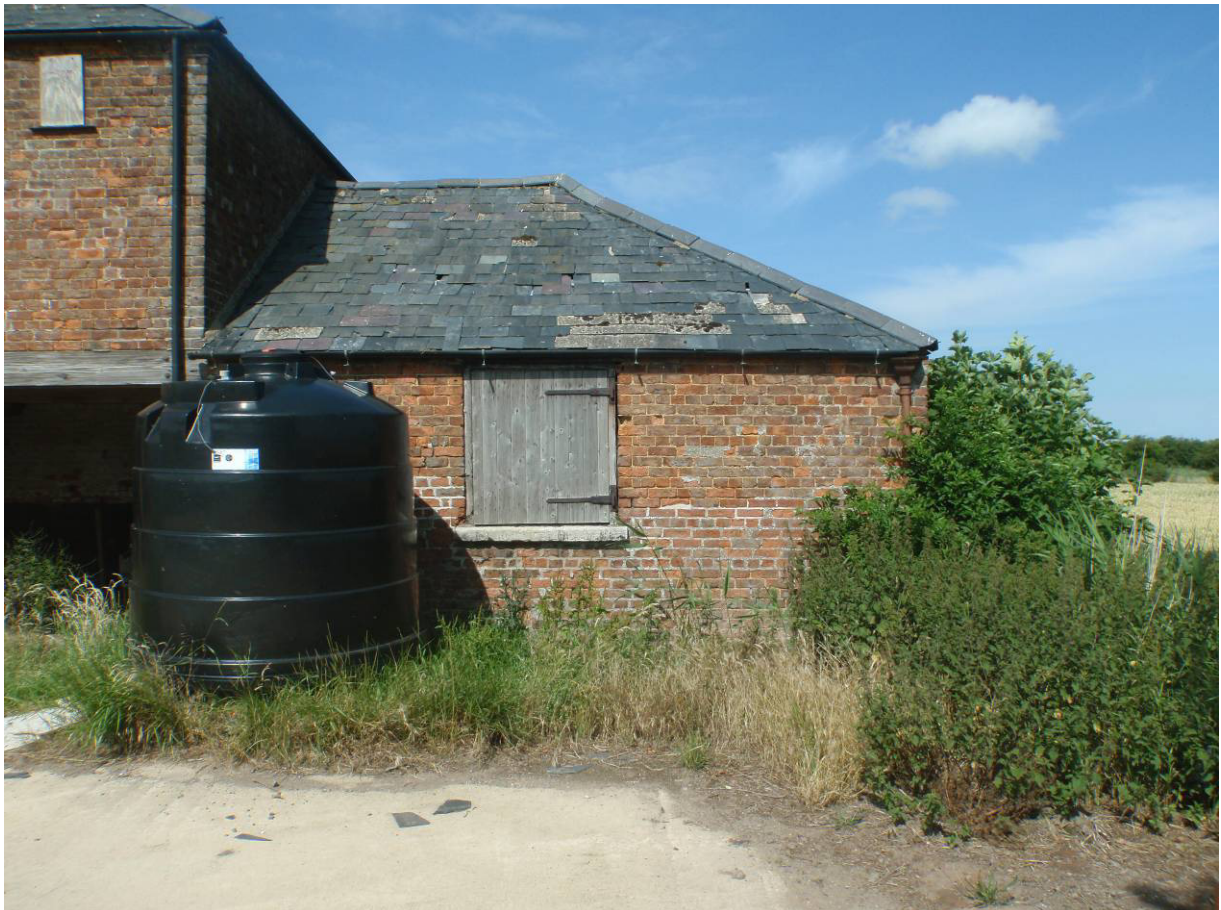
The eastern elevation contains a single centrally-located wooden shuttered window with a stone slab cill (Plate 17).

Plate 17. North range, eastern elevation, looking west

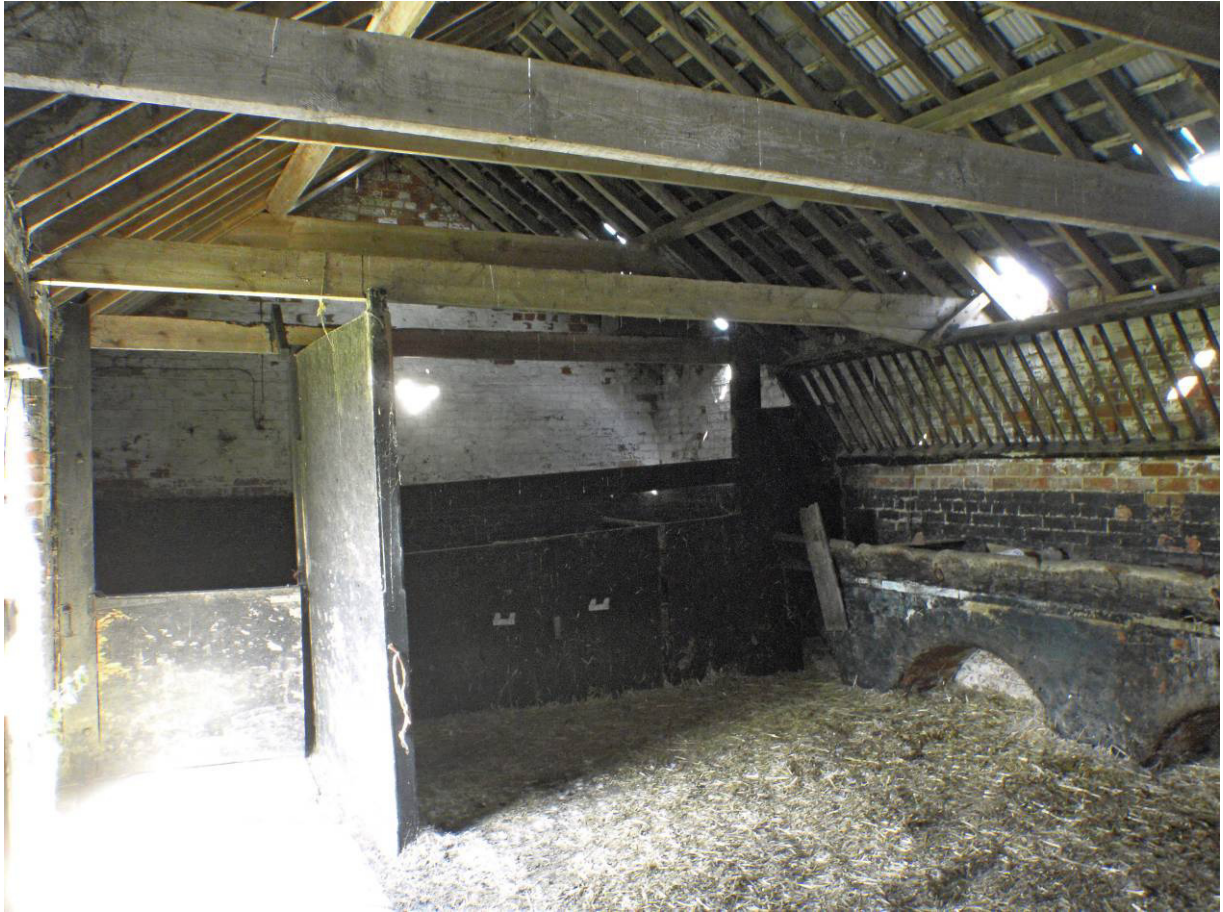
Access to the interior of the north range is through the wide southern doorway (Figs. 6 and 8). Where evident, the floor of the range is entirely of concrete. There is one internal dividing wall of brick, located centrally, and several timber partitions forming a number of compartments. Tie beam and collar trusses cross the range north-south and, together with walls, form seven bays.

Plate 18. North range, western end, looking west

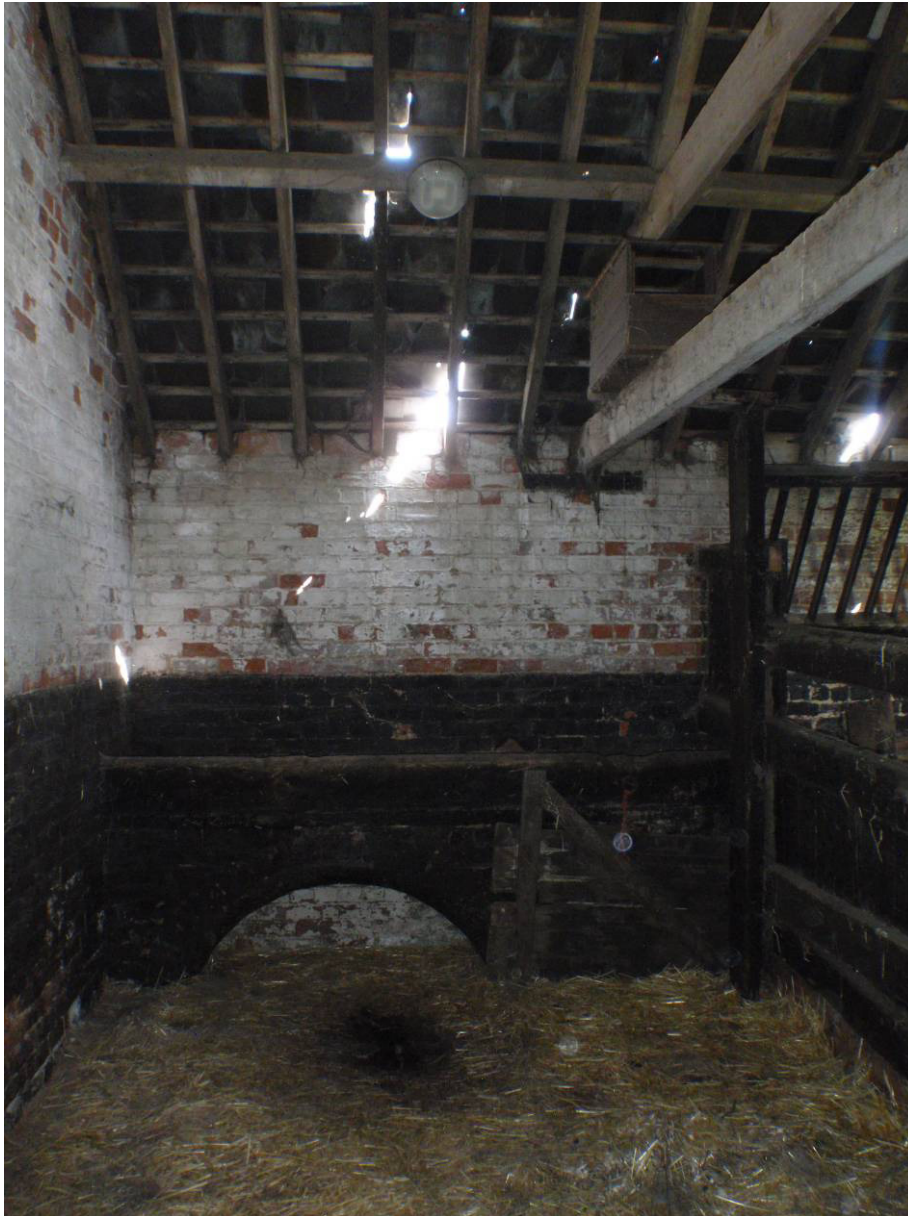
The wide doorway opens into a large room of 4 bays width, with a brick wall to the east. Partially facing the doorway is an inserted partition of chipboard. This extends a short distance to the west, to an entrance with a low door (Plate 18). From this entrance a low partition wall of planks extends northwards to form a small compartment, Room 1 (Plate 19). Along the north side of this compartment is a brick manger with archways beneath. The western archway is open but the eastern, which extends beyond the north-south partition, is covered with timber boarding.

Plate 19. North range, western compartment (Room 1), looking north

A relatively recent timber partition has been inserted in the stable area to create Rooms 1 and 2. It is likely that the small Room 1 at the western end was created as a loose box, with the remainder being retained as stables.

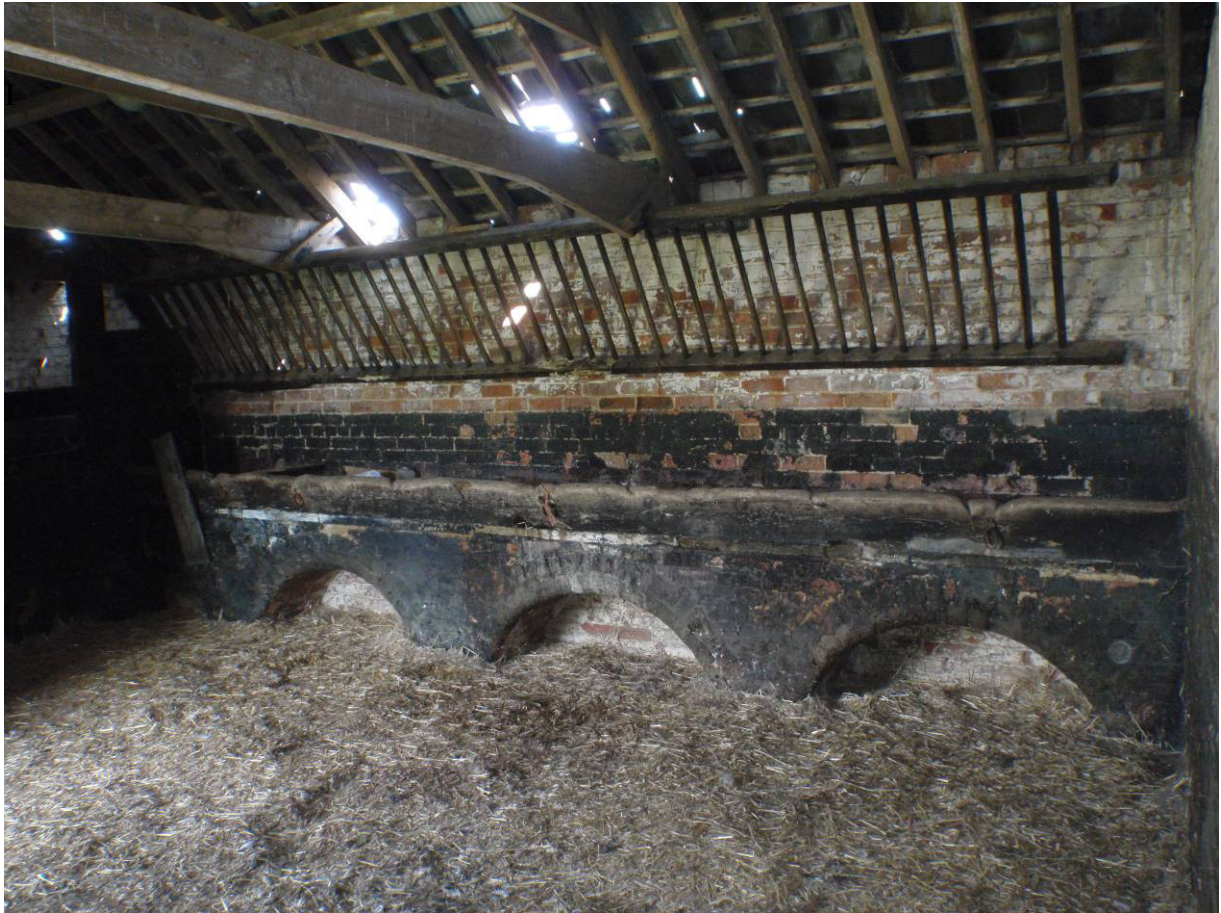
East of the small compartment is a wider room (Room 2) extending to the eastern brick wall. The brick manger, seen in the western compartment, continues along the north wall, with the western partial arch extending past the dividing wall to the west compartment, Room 1. Above the manger is a hay rack (Plate 20).

Plate 20. North range, large room (Room 2) with manger and hayrack, looking northwest

Initially, this stable range probably comprised three rooms, the main stable to the west, a tack room and a loose box to the east. The main stable area is largely defined by the manger which crosses both Rooms 1 and 2 of the range. It is likely that the hayrack, now only present in Room 2, originally continued westwards into Room 1. The manger had arches beneath which left a recess at the horses' feet for litter. Such features are fairly common in 19th century stables (Barnwell and Giles 1997, 55).

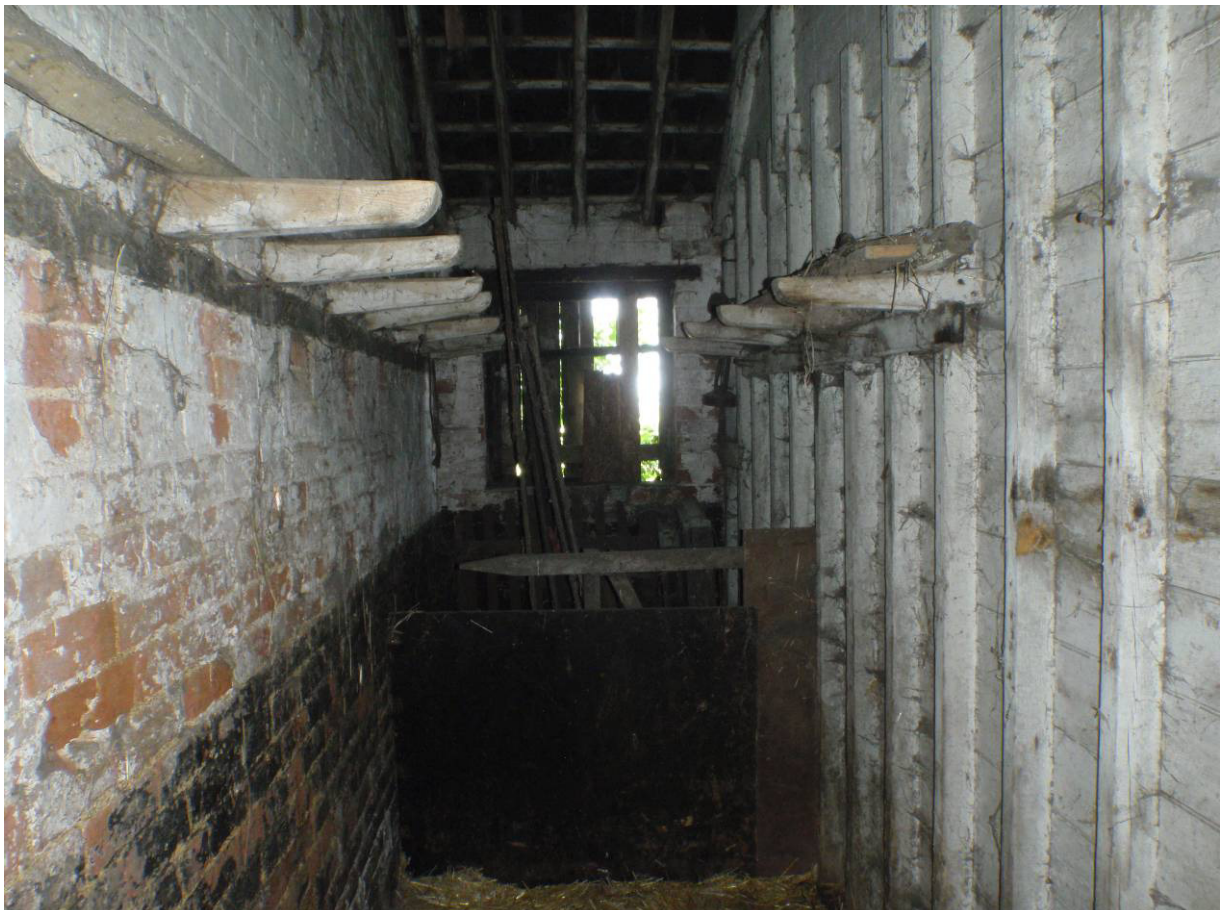
Immediately to the east, through a doorway at the south end of the brick wall, is a narrow room (Room 3). The west wall of this is of brick and the east of timber. Protruding from both walls are series of saddle or harness pegs (Plate 21). Towards the northern end of the room is a low wooden partition, with material stored beyond it. In the north wall is a window, now partially blocked with wood.

Plate 21. North range, Room 3, looking north

Immediately east of the stables was the tack room. This was narrow but the tack pegs, for the suspension of harnesses and bridles, are still present on the side walls and define the function of this small compartment.

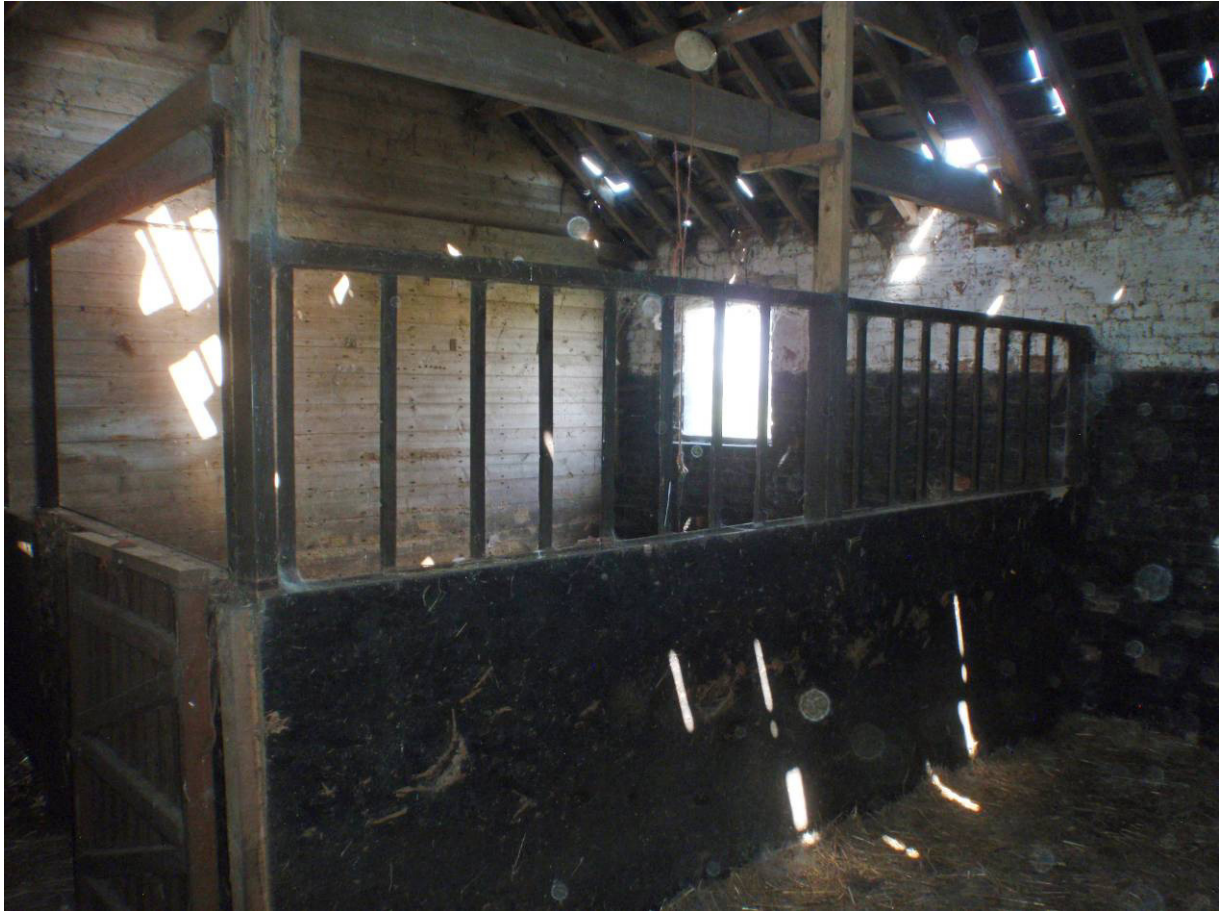
Plate 22. North range, Room 4 from Room 5, looking northwest

The walls of Room 4 are of low timber boarding, with a heightened partition of struts forming an open grille on the east side (Plate 22). Access to this compartment is through the lower leaf of a stable door in the south side. There is a window in the north wall.

To the east of the tack room was a larger compartment, Rooms 4 and 5. This may have originated as a loose box or a fodder room. However, recently inserted partitions have divided the area into two, both probably loose boxes.
