**HISTORIC BUILDING RECORDING
AT
NEW ENGLAND FARM
DELGATE BANK
WESTON HILLS
LINCOLNSHIRE
(WEDB15)**

Planning Application No: H22-0904-14
National Grid Reference: TF 2886 2276
OASIS Record No: archaeo11-218804
The Collection Accession No: LCNCC: 2015.135

A.P.S. Report No. **71/15**

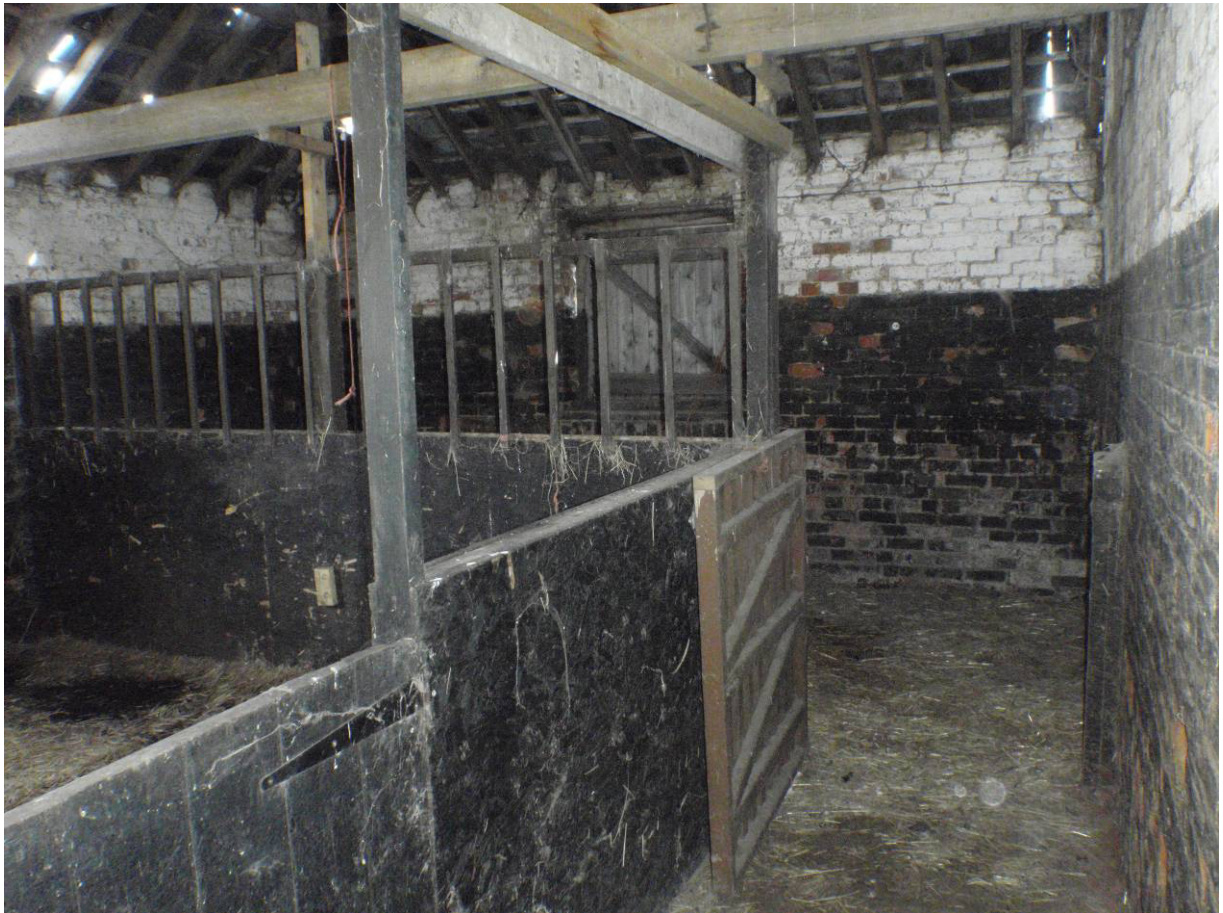
A short passageway runs along the south side of Room 4 and provides access, via the lower leaf of a stable door, to Room 5 at the eastern end of the range (Plate 23). In the middle of the east wall of Room 5 is a wooden shuttered window. Otherwise, the room is plain.

Plate 23. North range, passageway and Room 5 beyond, with Room 4 on left, looking east

To the east of the tack room was a larger compartment, Rooms 4 and 5. This may have originated as a loose box or a fodder room. However, recently inserted partitions have divided the area into two, both probably loose boxes.
