**ARCHAEOLOGICAL EVALUATION
AT ST PETER AND ST PAUL'S CHURCH,
ALGARKIRK,
LINCOLNSHIRE
(ALCH15)**

**Work Undertaken For
Walker Cunnington Architects and Algarkirk PCC**

APS Report No: 85/15

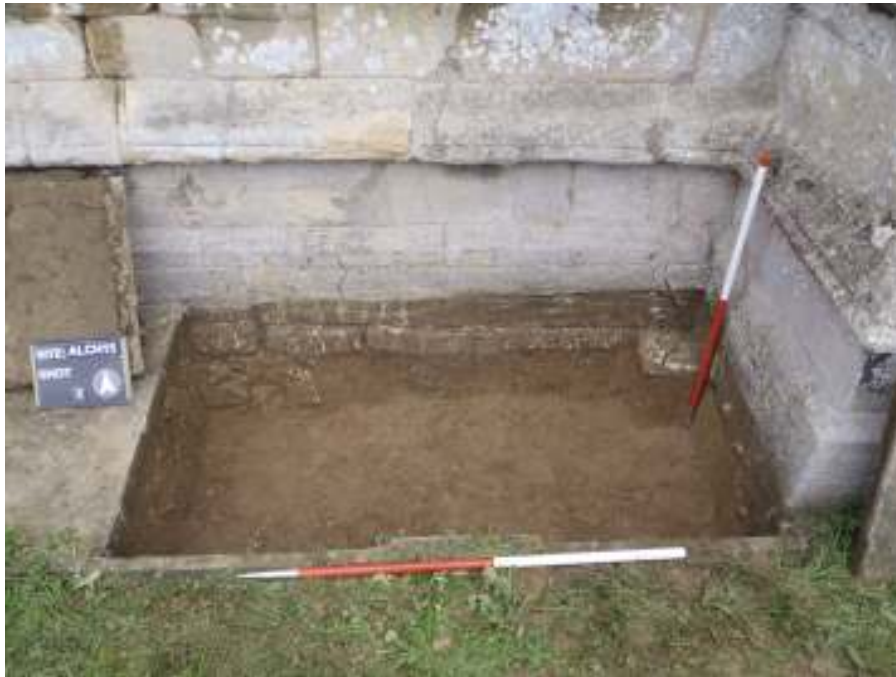
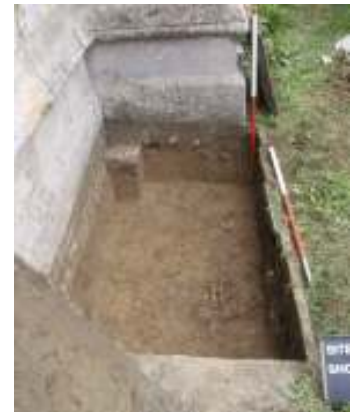
Figure 4 - Trench 1

Trench 1 abutted the south wall of the church. The lowest deposit observed was a soft mid orange brown sandy silt natural (105).

The second cut feature appeared to be a rectangular grave cut [112] aligned east-west. It was only visible in plan and was at least 1.50m long and over 0.40m wide. It was filled by a firm mid grey brown clayey silt with fragments of human bones (111).

The grave cut [112] was sealed by a topsoil, comprising a firm mid greyish brown clayey silt (104), up to 0.18m thick. The rubble filled feature [108] and the small pit [110] were overlain by a single course of rough dressed limestone blocks (103), measuring 0.09m thick which formed the foundation for the wall. A single rough dressed limestone block (102) measuring 0.20m wide and 0.06m thick, appeared to be part of, but out of

Above the foundation course, the church wall (106) was made from dressed, regular limestone blocks. The wall was keyed in, and probably contemporary with, the buttress (101) at the east end of the trench. It was noted that the buttress appeared to have been partly over the offset foundation stone (102) and directly over the topsoil (104). The flagstones (100) covering the area were butted against the wall buttress.

Trench 1 had three features that predate the church walls; a grave, a pit and rubble foundations. The rubble foundations suggest an earlier, probably medieval, wall

Over these features are the modern foundations. The existing south aisle wall had very shallow foundations, made from a single course of roughly hewn limestone. The buttress was partially built directly on to the topsoil. It is probable that the current wall is part of the extensive restoration of 1850-54. The off-set of this wall with the earlier foundations suggest the south aisle was extended eastwards during the restoration works.

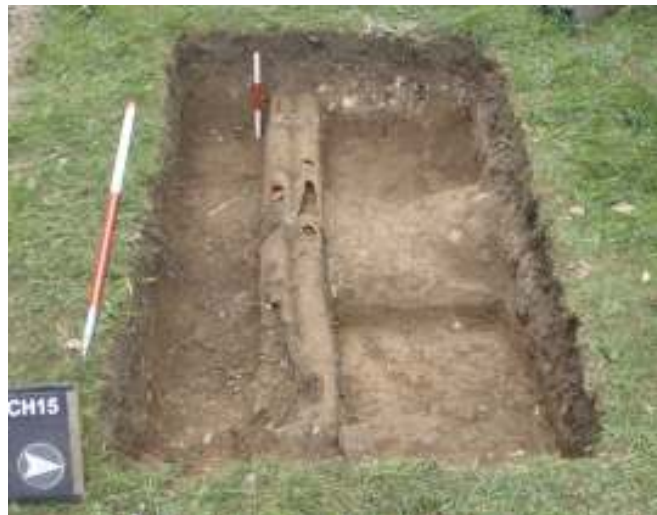
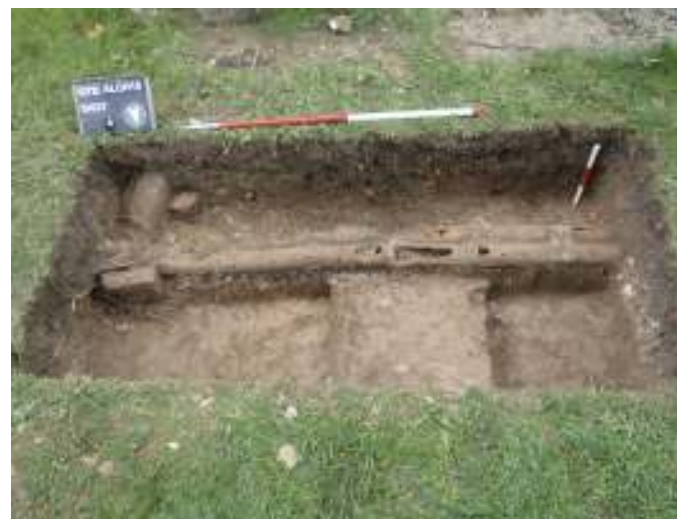
Figure 5 - Trench 2

The lowest deposit observed in this trench was a firm mid reddish brown clayey silt natural (203) at least 0.30m thick.

The natural was cut by an east-west orientated oval pit [205] measuring 0.80m long and at least 0.20m wide. It was filled with a firm mid greyish brown clayey silt with frequent gravel and stone, and fragments of modern brick (204).

A layer of firm greyish brown clayey silt with frequent gravel (202) also overlay the natural. This was 0.20m thick and skull fragments were noted in this deposit.

Sealing layer (202) and pit [205] was a firm dark greyish brown sandy clayey silt topsoil up to 0.20m thick with frequent gravel inclusions (201). A modern ceramic drainage pipe bisected the trench from east to west.

Trench 2 revealed a modern pit and an undated layer, possibly a subsoil or levelling layer. The fact this deposit contained human bones suggests it contains redeposited material from truncated graves in the vicinity. The pit is of uncertain function. However, its fill contains frequent gravel and stone, which may imply it was a soakaway.

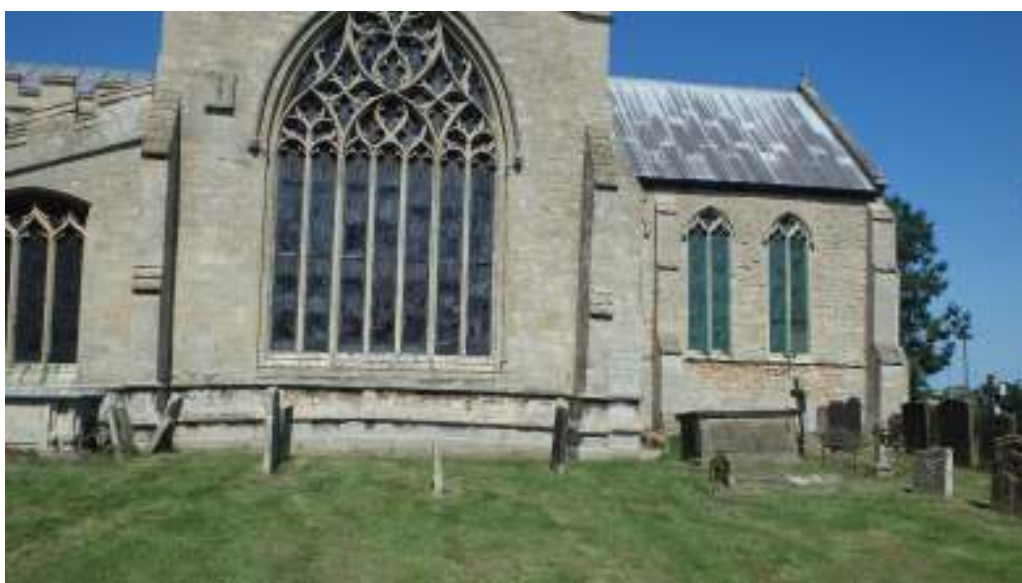
Plate 3: Subsidence, south aisle

The aims of the project were twofold. On the south side of the church the objective was to expose enough of the church foundation so that an assessment could be made as to the cause of subsidence. To the
