**ARCHAEOLOGICAL WATCHING BRIEF
AT ST. MARY'S CHURCH,
MARSTON,
LINCOLNSHIRE
(MSMC 07)**

**Work Undertaken For
Tim Benton Chartered Architect**

March 2007

APS Report No. **18/07**

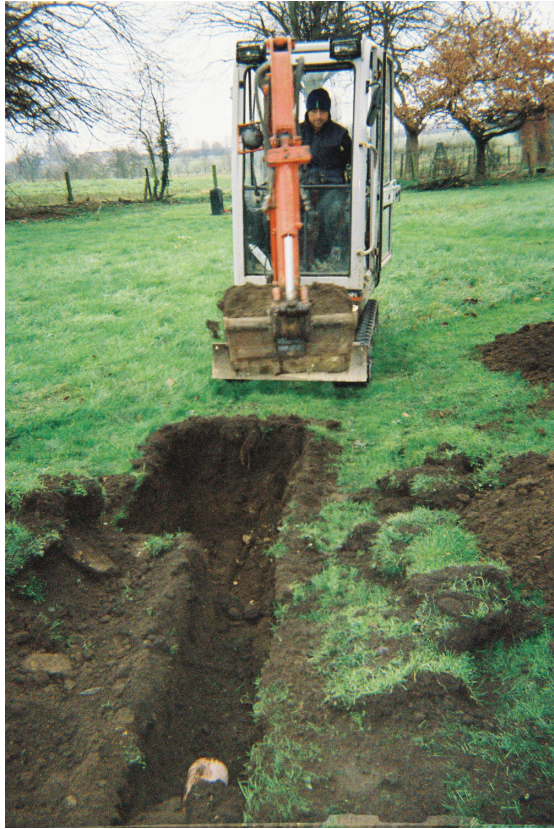
Plate 1 - View of the drainage trench during excavation, looking north

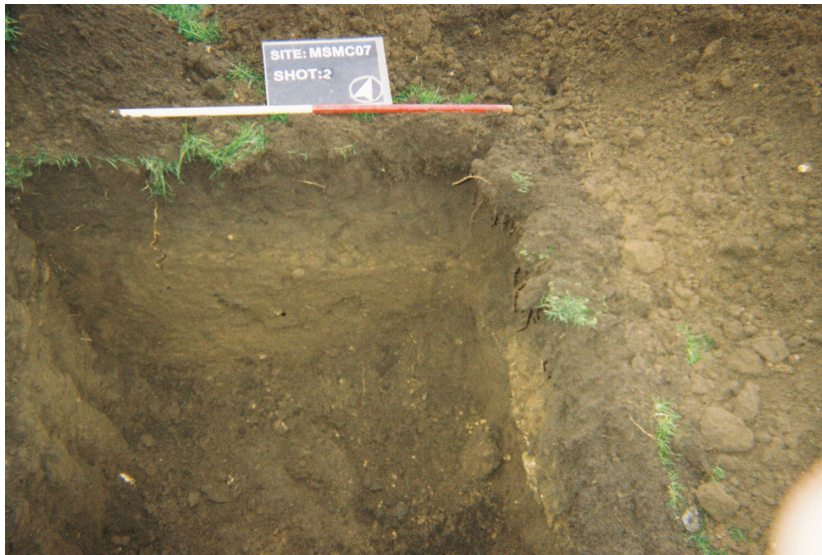
The earliest deposit encountered at the base of the soakaway trench was a layer of greyish brown sandy silt (003). Identified as a graveyard soil, this measured in excess of 0.48m thick (Fig. 4, Section 1).

Developed upon the graveyard soil was a 0.17m thick subsoil comprising greyish brown silty sand with yellowish brown sand (002). Sealing all deposits was the topsoil of greyish brown sandy silt (001) that was 0.32m thick.

Plate 2 - Section 1, looking north
