**ARCHAEOLOGICAL WATCHING BRIEF  
AT ST PAUL'S OLD CHURCHYARD,  
LOW CHURCH ROAD,  
MIDDLE RASEN,  
LINCOLNSHIRE  
(MROC 07)**

Work Undertaken For  
Graham Cook Architect

APS Report No. **21/07**

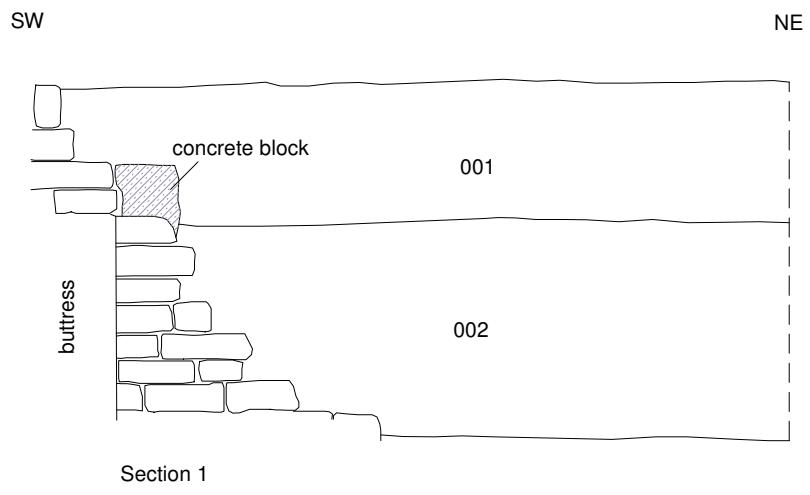
Figure 4 - Sections 1 and 2

The earliest deposit encountered during the watching brief was a layer of brown sandy silt (005) identified as a graveyard soil. This measured in excess of 0.7m thick.

Developed upon this was a subsoil layer of brownish grey sandy silt (002 and 004). This was between 0.45m and 0.57m thick.

Sealing all deposits was the current topsoil comprising a 0.35m-0.4m thick layer of grey sandy silt (001 and 003).

No.	Description	Interpretation
001	Friable dark grey sandy silt, 0.35m deep	Topsoil
002	Friable mid brownish grey sandy silt, 0.57m deep	Subsoil
003	Friable dark grey sandy silt, 0.4m thick	Topsoil
004	Friable mid brownish grey sandy silt, 0.45m deep	Subsoil
005	Friable mid brown sandy silt, >0.7m thick	Graveyard soil

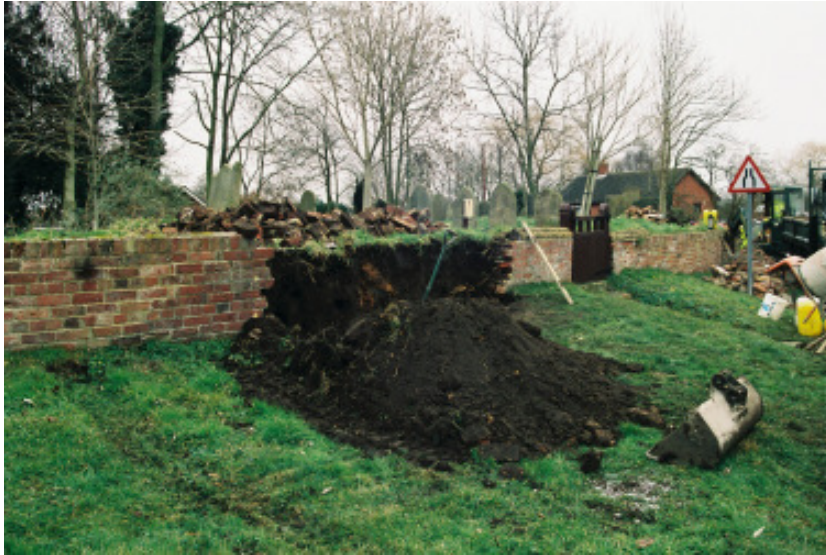
Plate 1 - View of the churchyard wall showing the repairs in progress, looking northeast

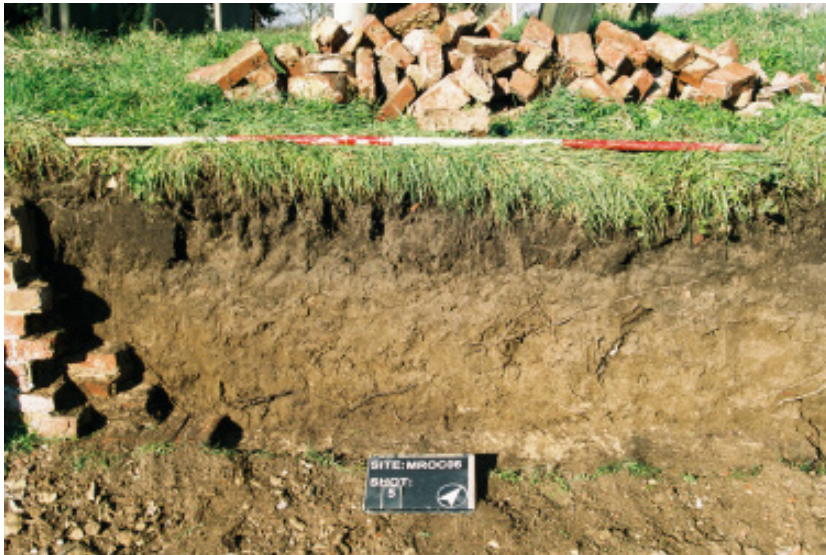
Plate 2 - Section 1, looking northwest

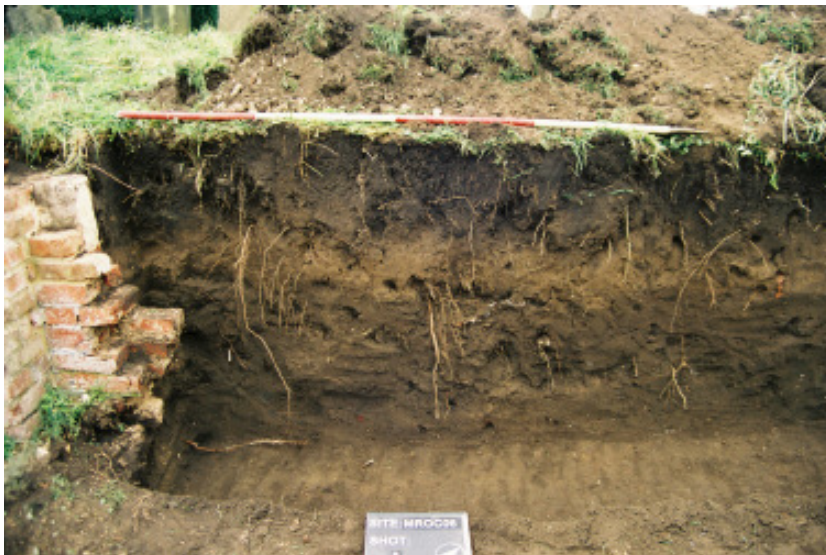
Plate 3 - Section 2, looking northwest
