**SURVEY OF BUILDINGS AT
THE RIDINGS,
MOLES LANE,
SEATON,
RUTLAND
(SEML 07)**

Planning Application No: FUL/2005/1088/NH

March 2007

A.P.S. Report No. **26/07**

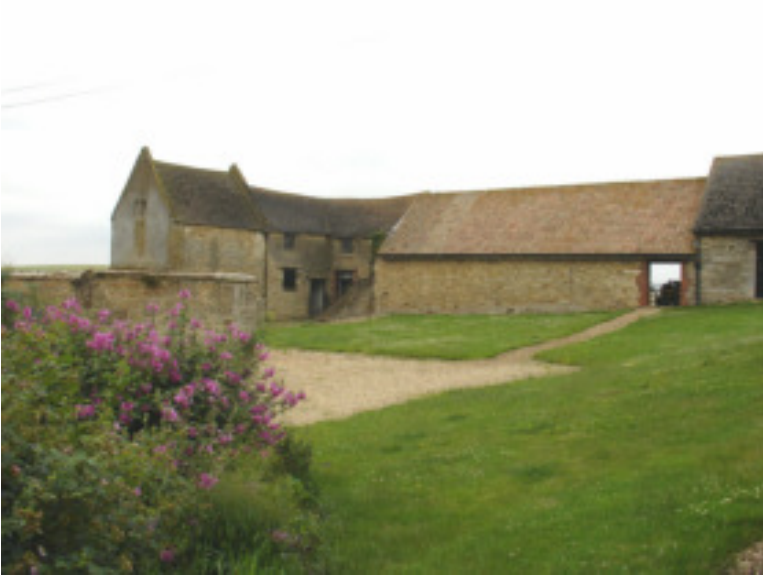
The recorded structures form an L-shaped arrangement of outbuildings located immediately to the west of the farmhouse (Figs. 3 and 4; Plate 1). This arrangement can be further divided into an L-shaped barn and a former dovecote located towards the east. These two elements will be discussed separately.

Plate 1 - View showing the range of recorded buildings, looking southwest

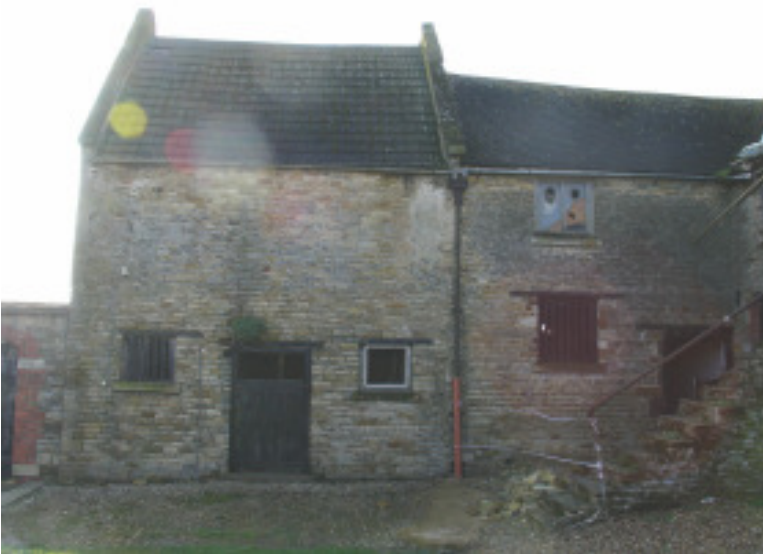
central door flanked by two windows (Plate 2). Each has a wooden lintel and a stone sill.

Plate 2 - North facing elevation of the dovecote showing gable arrangement and inserted doors and windows, looking south

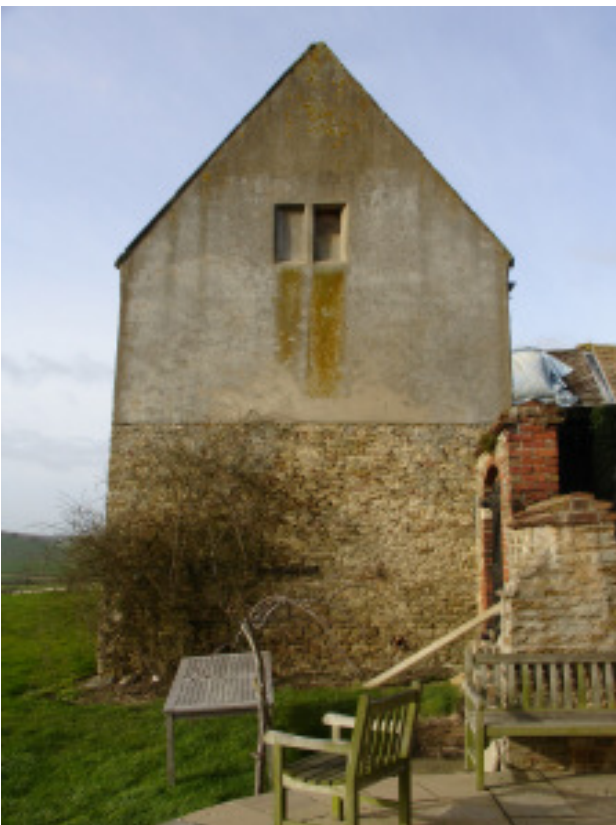
The east facing elevation (Plate 3) has a blocked door at ground level to the south (Plate 4). This is shoulder height and has a wooden lintel. Located above eaves height in the centre of the gable are two blocked windows. A more recent garden wall connects to the north side of the elevation.

Plate 3 - East facing elevation of the dovecote showing blocked windows and rendering, looking west

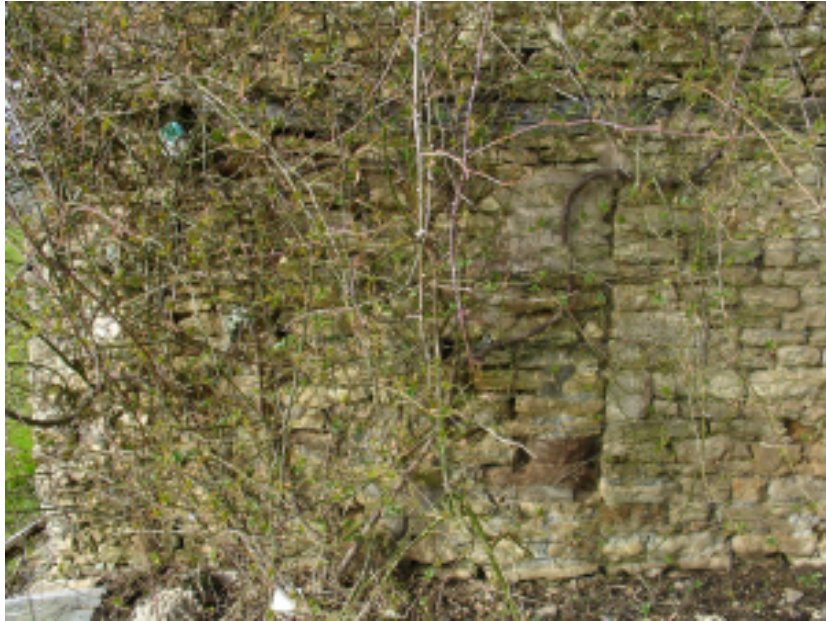
The earliest element of the recorded buildings is the dovecote. This would originally have been accessed via the now blocked smaller door in the east facing elevation. This would allow the door to be easily blocked when culling (McCann 1991, 135). The two openings in the gable would have provided access for the birds and lit the interior and the high gable ends would have allowed for perching. Alternatively, a gablet in the roof may have provided access for the birds and subsequently removed when the structure was re-roofed in the 20th century. In the interior, nothing was noted that could be associated with the building's use as a dovecote, although nesting boxes are said to exist.

Plate 4 - View showing the blocked door in the east facing elevation, looking west

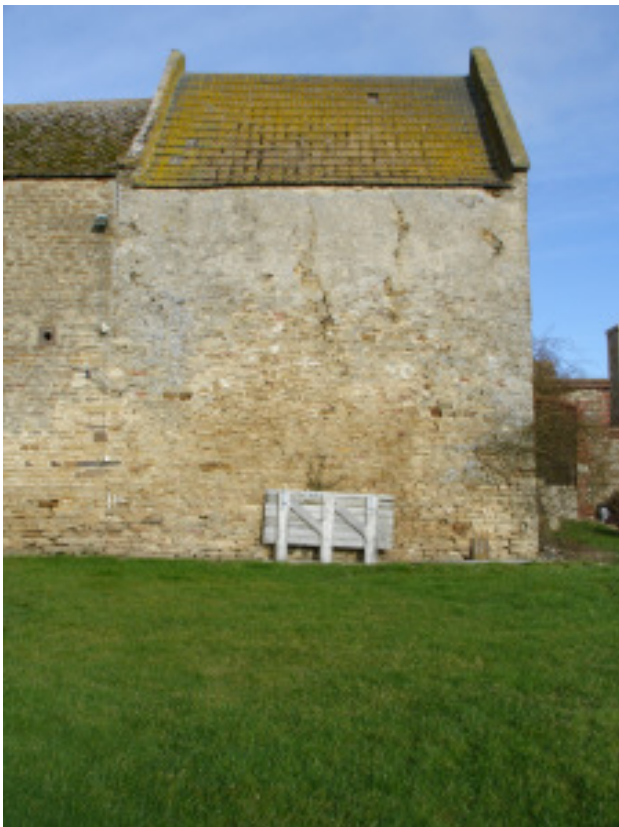
The south facing elevation is plain (Plate 5).

Plate 5 - South facing elevation of the dovecote, looking north

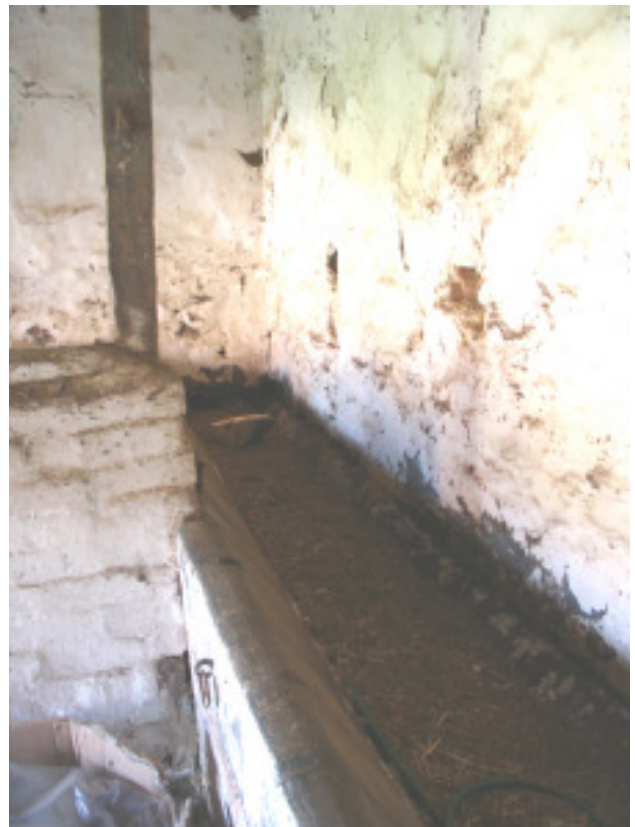
The single room on the ground floor of the dovecote has a brick partition to just above waist height. This stops just short of the south wall where a brick manger had been constructed (Plate 6). The marks of a semi-circular hay rack were present in the southwest corner of the room. The doorway is flanked by two brick supporting piers upon which is a more recent upper timber floor.

Plate 6 - Interior view of the dovecote showing brick partition and manger, looking southeast

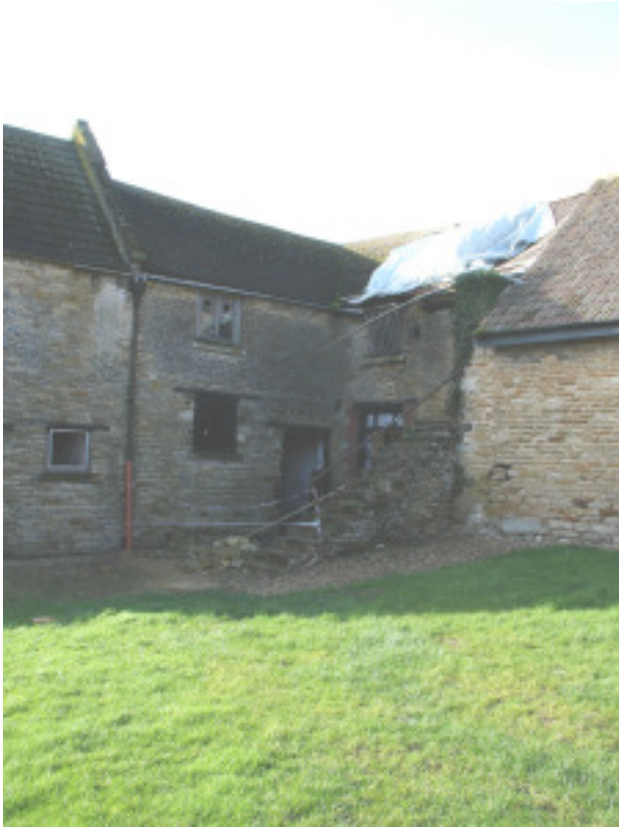
The north elevation, adjacent to the dovecote, has a single doorway located towards the corner with an adjacent but slightly higher set window (Plate 7). A window is also apparent at first floor height. The windows and door have wooden lintels and stone sills. To the east of the door are quoins of ironstone.

Plate 7 - View of the north facing elevation of the barn, looking southwest

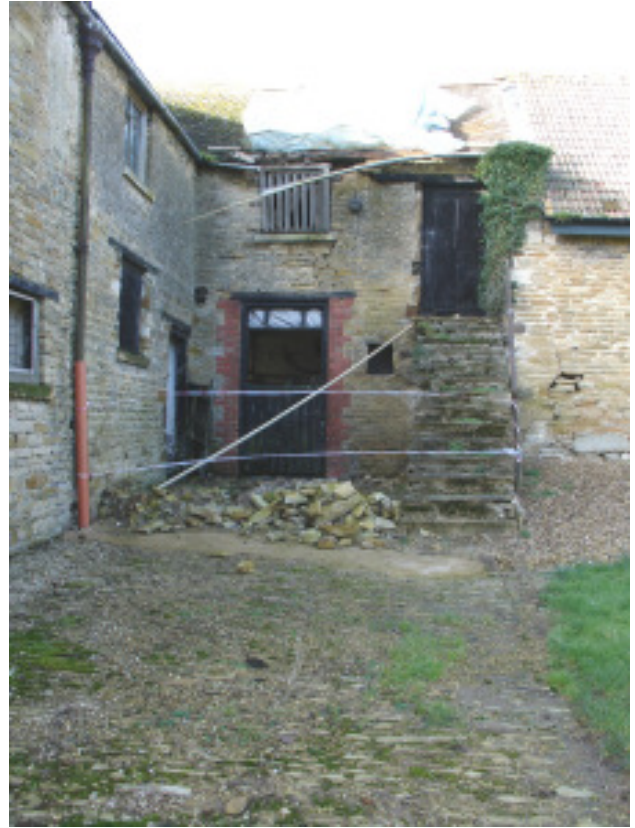
a wide and tall door which has a single opening to the north (Plate 8). The door is flanked by brickwork (using bullnose bricks), possibly a later insertion. To the north of the doorway is a flight of stairs to the first floor which goes over an arched recess or shelter to a single doorway. Above the ground floor door is a window with stone sill.

Plate 8 - East elevation of the barn with steps to first floor, looking west

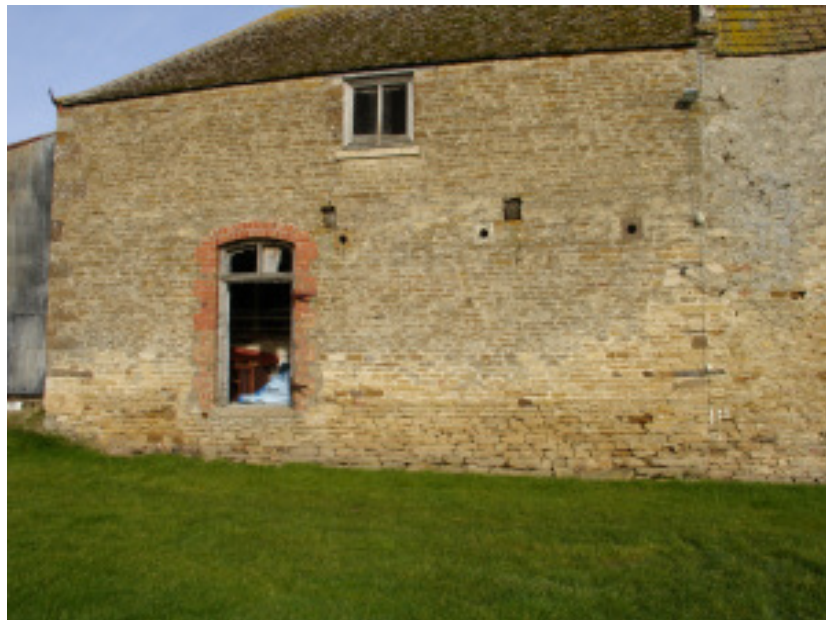
The south facing elevation is plain but has a single door at ground level flanked by a bullnose brick surround and with a segmental arch over (Plate 9). To the east are three small air vents. At first floor level is a centrally placed window with wooden frames and a stone sill. There is a straight join with the dovecote to the east and the corner has ironstone quoins.

Plate 10 - South elevation of the barn showing inserted doorway, looking north

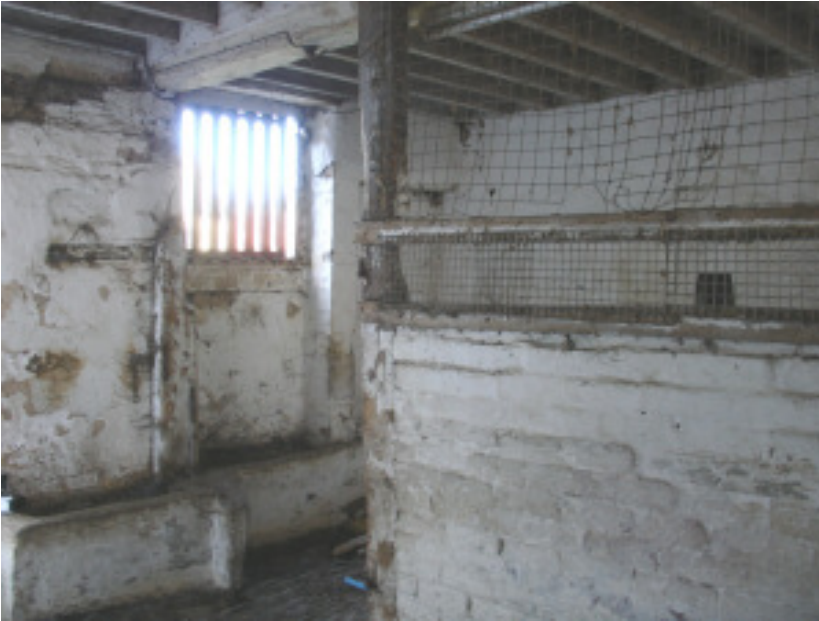
The smaller room has a central brick partition wall. Mangers have been removed from the south wall where air vents are visible. Three feed troughs of stone are located beneath the window, east of the doorway on the north side of the room (Plate 10). The western wall of the room is of brick and a later insertion. The floor is of stone cobbles with an east-west drain.

Plate 10 - Interior view of the east room of the barn showing brick partition and stone feeding troughs, looking northeast

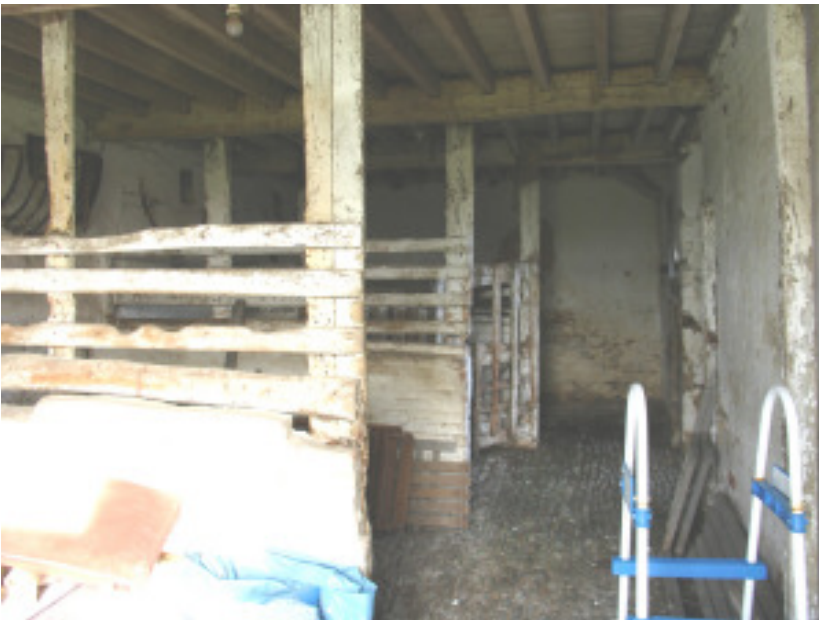
The larger room has three brick internal partitions creating four stalls (Plate 11). No mangers are present but two semi-circular hay racks survive and the position of a further three can be seen. Air vents are located above the stalls.

Plate 11 - View of the west room of the barn showing the brick stalls and hay racks, looking north
