SURVEY OF BUILDINGS AT THE COTTAGE, 35 HIGH STREET, OSBOURNBY, LINCOLNSHIRE (OHS 07)

Work Undertaken For Mr A Joy

March 2007

A.P.S. Report No: **38/07**

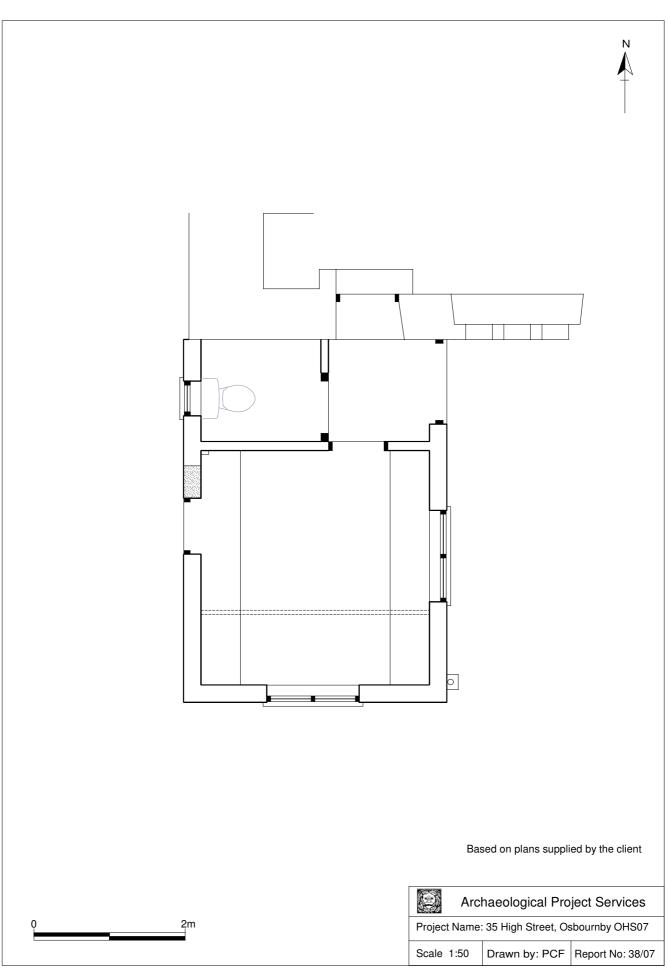
The double-door facing west enters a rectangular lobby with access into the main building and to a toilet (Plate 5; Fig. 3) and a washroom. The floor is of quarry tiles and the walls are painted white.

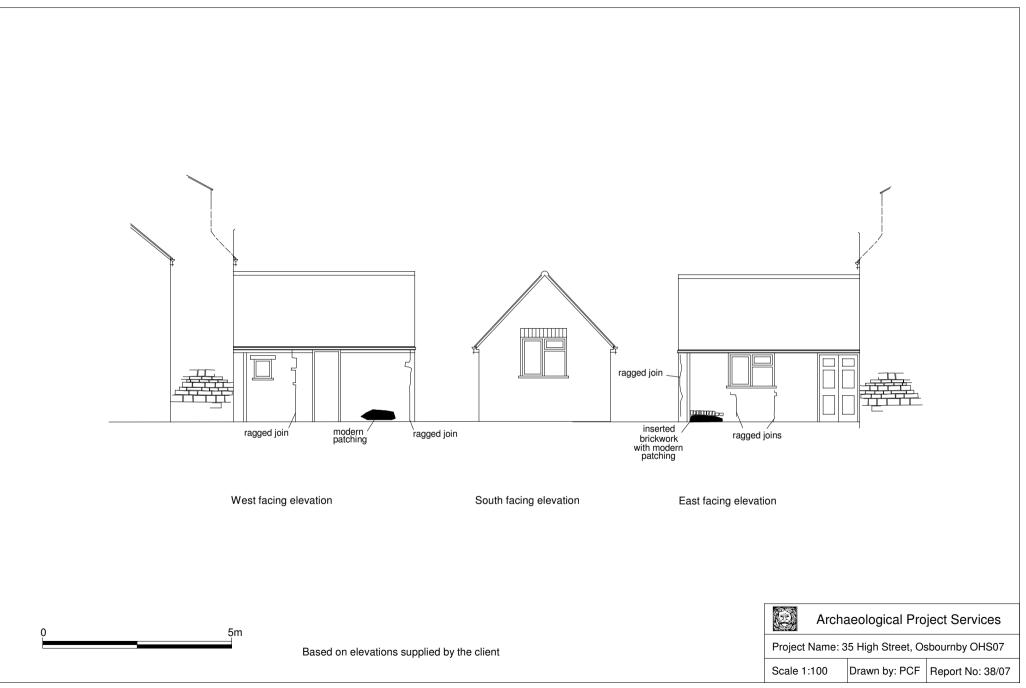
Figure 4 - Elevations of the recorded building

The west facing range has a central door which has been narrowed as evidenced by a ragged join to the north. A ragged join lies close to the southern edge of the structure and there is an area of recent patching close to ground level. North of this door is a small window with wooden lintel (Plate 2; Fig. 4).

The south facing gable end is plain and dominated by a central window which has a soldier course (upright bricks) across the lintel (Fig. 4). The bricks in this elevation are slightly larger and can be seen to tie in with the west and east facing walls. This would suggest that the gable end had been rebuilt.

The east elevation has a double-door adjacent to the older cottage with a large window to the south. Ragged joins below the window suggest the window has been replaced or that the opening was formerly a door (Plate 4). Another ragged join marks the rebuild of the south gable end. Close to the ground towards the south is a line of inserted headers above recent patching which may suggest that this feature ran through the width of the building.

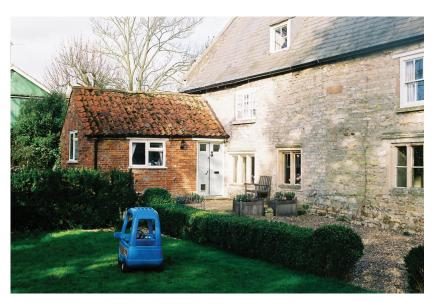
The recorded structure forms a rectangular extension to the rear (south) of the house and is located at the southwest corner (Plate 1).

Plate 1 - View showing the relationship between the extension and principal building at 35 High Street, looking northwest

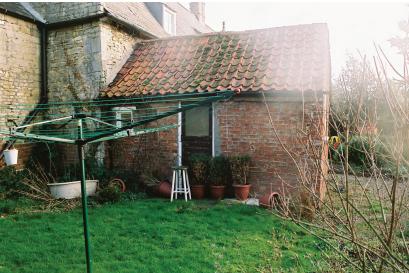
Plate 2 - The west facing elevation showing narrowed doorway, looking east

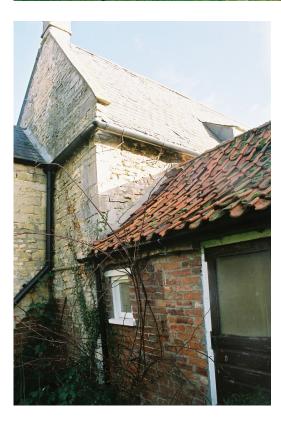
Plate 3 - Detail showing relationship between the extension and principal building, looking northeast

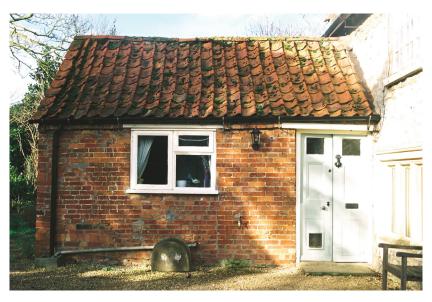
Plate 4 - The east facing elevation showing modern patching to left of picture and ragged joins below the window, looking west

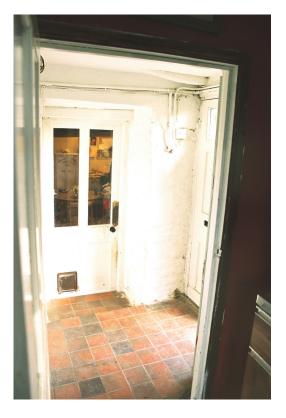
Plate 5 - View showing the lobby area, with door to main cottage in the background, looking north

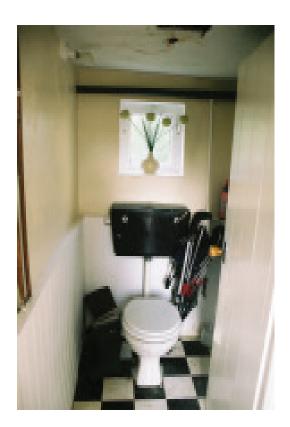
The small toilet room has wooden panelling around the lower half (Plate 6). There is a suspended plywood ceiling. The floor is of vinyl tiles.

Plate 6 - View showing the small toilet, looking west

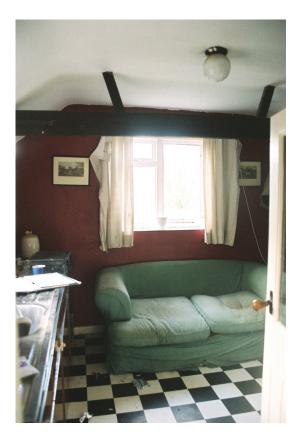
The largest room is in the southern part of the building (Plate 7). This has a similar vinyl tile floor to that in the toilet. The ceiling is higher, exposing a tie-beam with metal clasps (Plate 8) and the slope of the roof. The tie-beam supports two raking struts.

Plate 7 - View showing the larger room within the extension with exposed tie-beams and raking struts, looking south

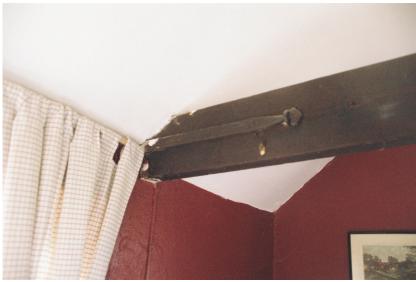
Plate 8 - Detailed view of the tiebeam showing metal clasp
