**HISTORIC STRUCTURE SURVEY AND
MONITORING AND RECORDING AT
THE VAUDEY POND
GRIMSTHORPE
LINCOLNSHIRE
(GCVF 16)**

Work Undertaken For
**Grimsthorpe and Drummond
Castle Trust Limited**

September 2016

APS Report No. **61/16**

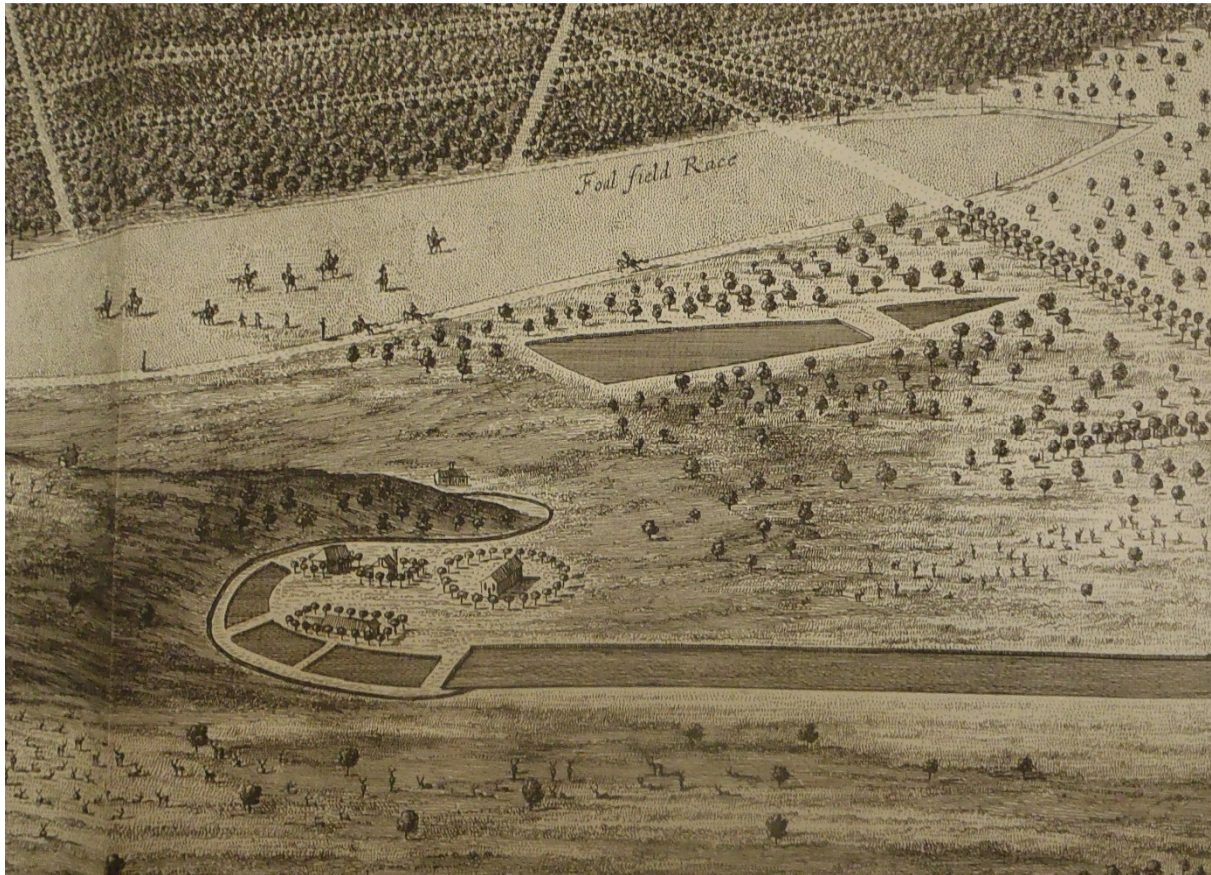
Plate 1 – Knyff and Kip's view over Grimsthorpe Park showing the Vaudey Pond

Vaudey Pond is shown as a large trapezoidal waterbody slightly downhill of a smaller triangular pond. The dam is not clearly shown and there are also no indications of any issues from the dam. In the valley below is a small building which may be the Keeper's House, mentioned by Stukeley as being the gate-house of the abbey, with the larger ornamental lakes (before later improvements) towards the bottom of the vista. Beyond the Vaudey Pond is a raceground and the wooded areas of Elsea Wood.

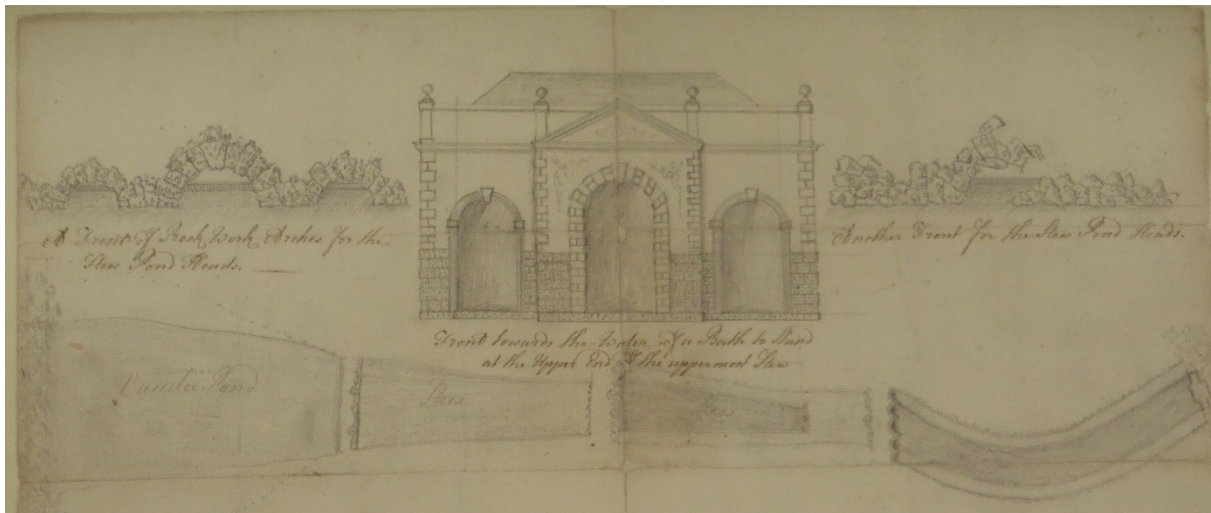
Plate 2 – John Grundy Jnr’s proposal for the Vaudey Pond, c. 1766
(*Vaudee Pond* lies on the left (east) of the picture)

One of Grundy’s proposals which did not see fruition was the construction of a bathing house along with decorative works alongside the Vaudey Pond and the adjacent smaller ponds. He proposed that the bank of the Vaudey Pond was to be raised and instead of using the outfall, water was to be channelled to the northeast to drain into the Great Pond (LAO 5ANC 5/A/10/10A). There are some earthworks to the west, north and northeast of the Vaudey Pond which may indicate that some of the scheme had been progressed.

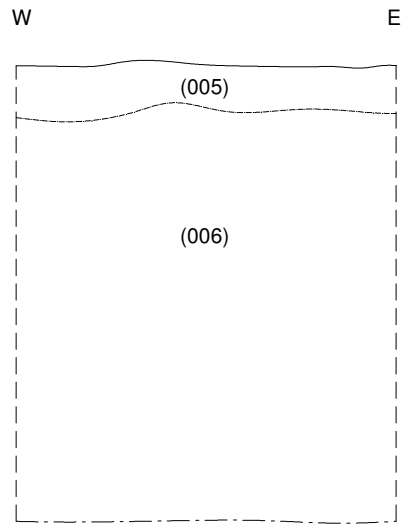
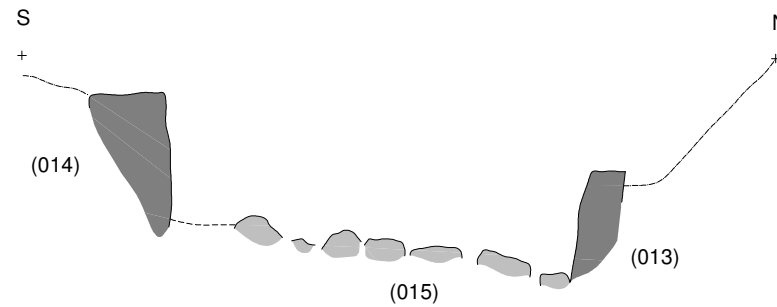
Figure 5 - Sections

The earliest deposit exposed in the breach and relating to the structure of the dam was a 0.2m thick bank of firm to stiff, mid grey clay (007) which possibly formed the inner core of the dam, or functioned as a waterproof covering for an earlier bank deposit that may exist below the current limit of excavation. This was overlain by an at least 1.1m thick deposit of firm mid brown clayey silt (006), containing frequent angular and sub-angular limestone fragments (Fig. 5, Section 1). This formed the bulk of the bank of the dam.

Section 1

Section 2
Profile across water channel

Section 3
Profile across slot [018]

This part of the spillway is separated from (003) to the east by a slot [018] which measured 0.11m deep by 0.11m wide (Fig. 5, Section 3; Plate 12). The slot is believed to represent the seating of a sluice gate. At the base of the slot, a deposit composed of firm to stiff mid brown clay (019) with occasional limestone fragments, was identified. This was either deposited in the base of the slot [018], or may underlie much of the brick head wall structure (003/004).

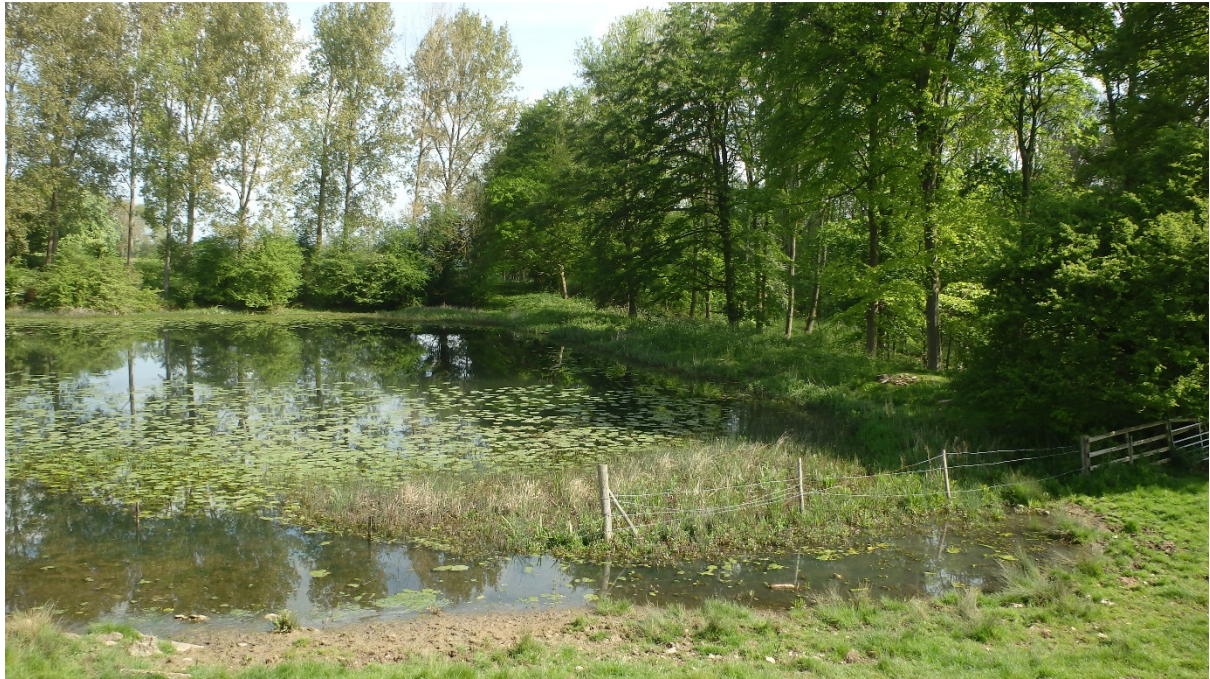
Plate 3 – View of Vaudey Pond looking north with dam on the eastern edge

The north-south dam lies at the eastern end of Vaudey Pond (Plates 3 and 4). There is a breach in the centre of the dam caused by overtopping of the pond which had weakened previous repairs to the structure (Plates 5 and 6). The material used in previous repairs was excavated to effect the repair.

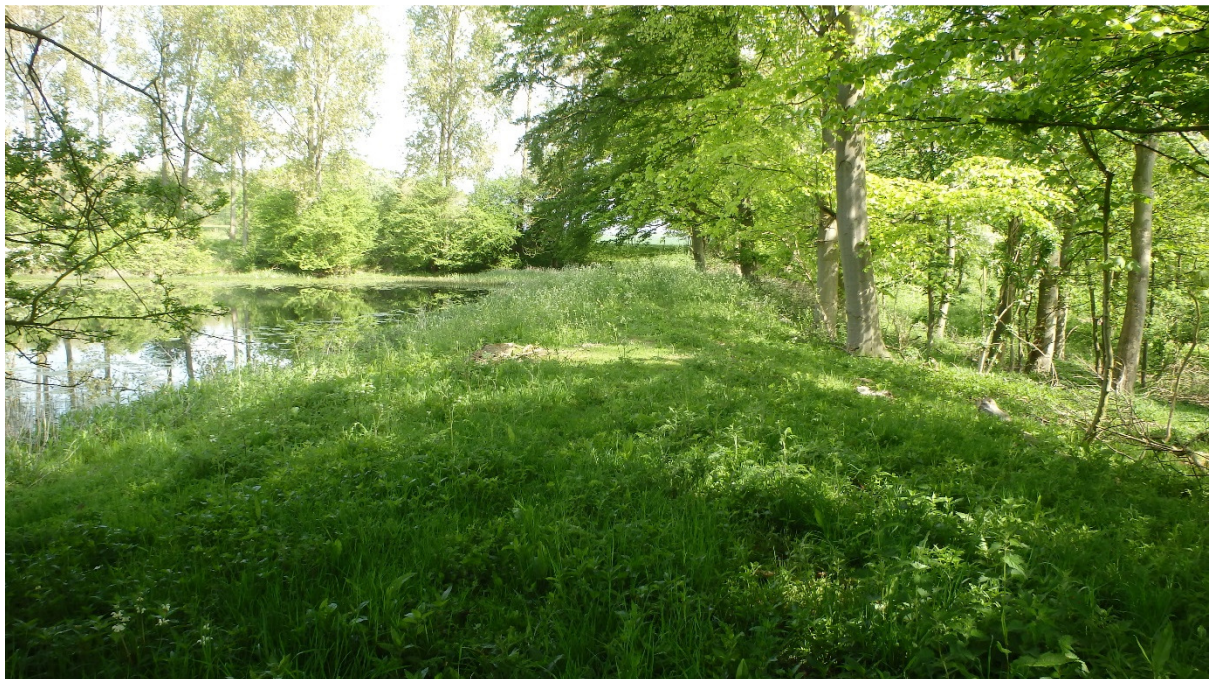
Plate 4 – View along top of dam, looking north

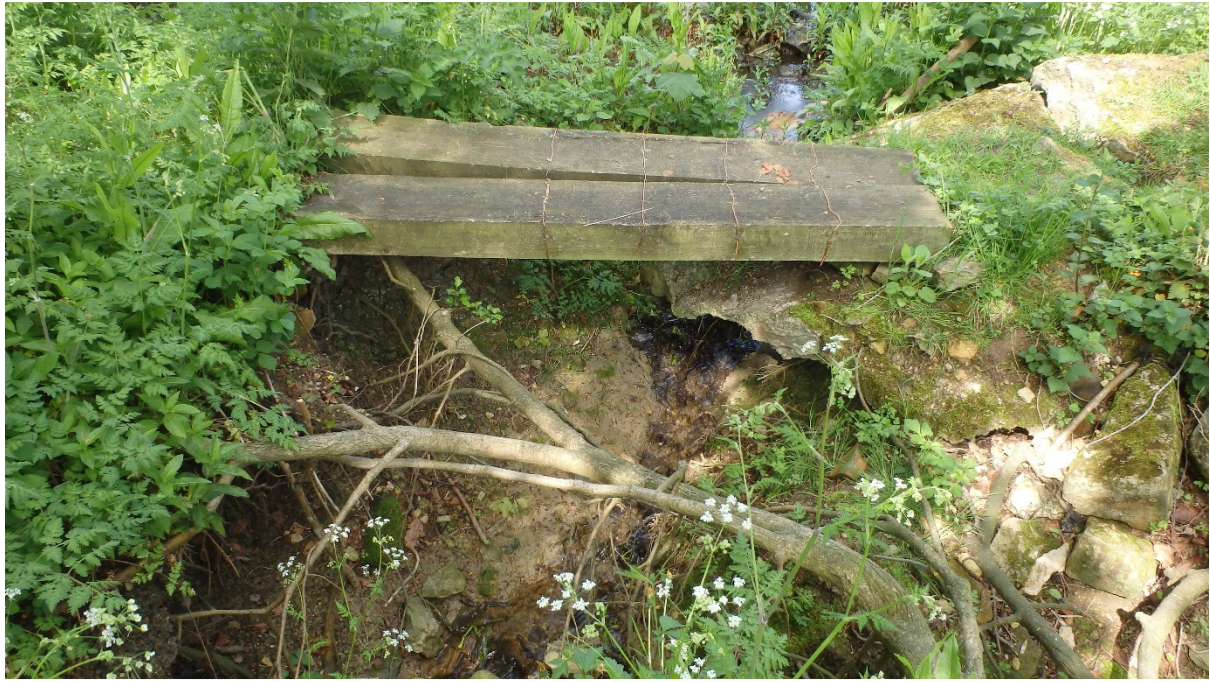
Plate 5 – Breach of dam showing former concrete repair work, looking west

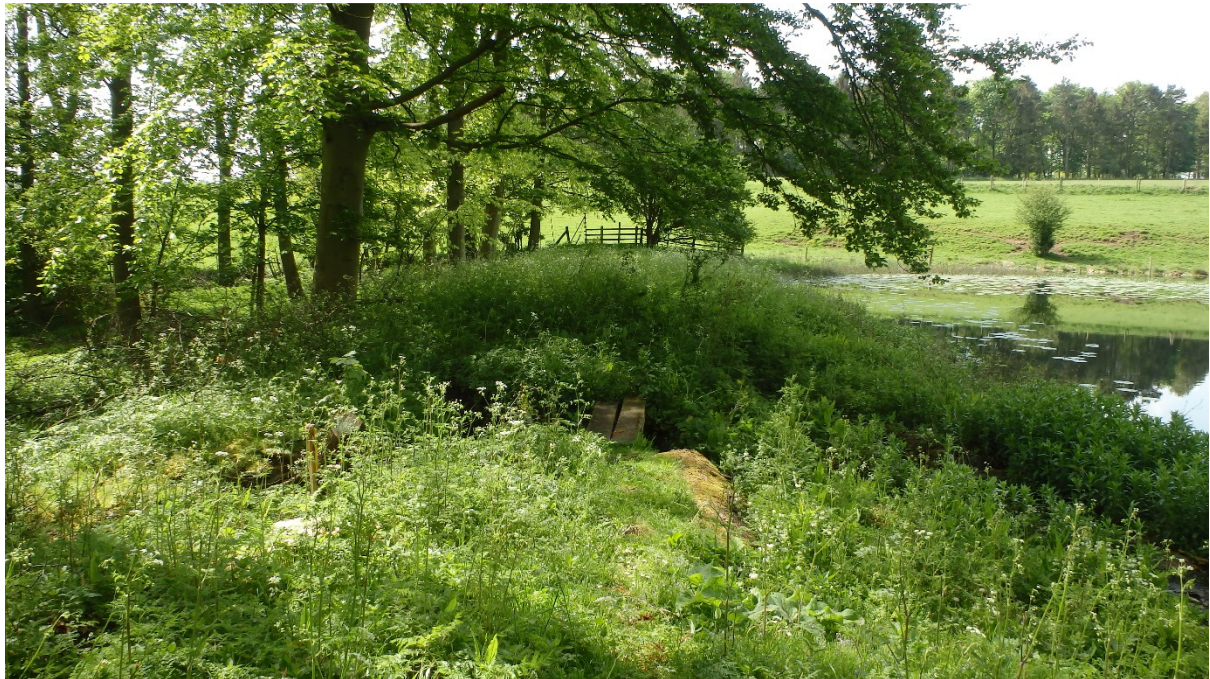
Plate 6 – View of dam, looking south, showing breach and previous concrete repair work

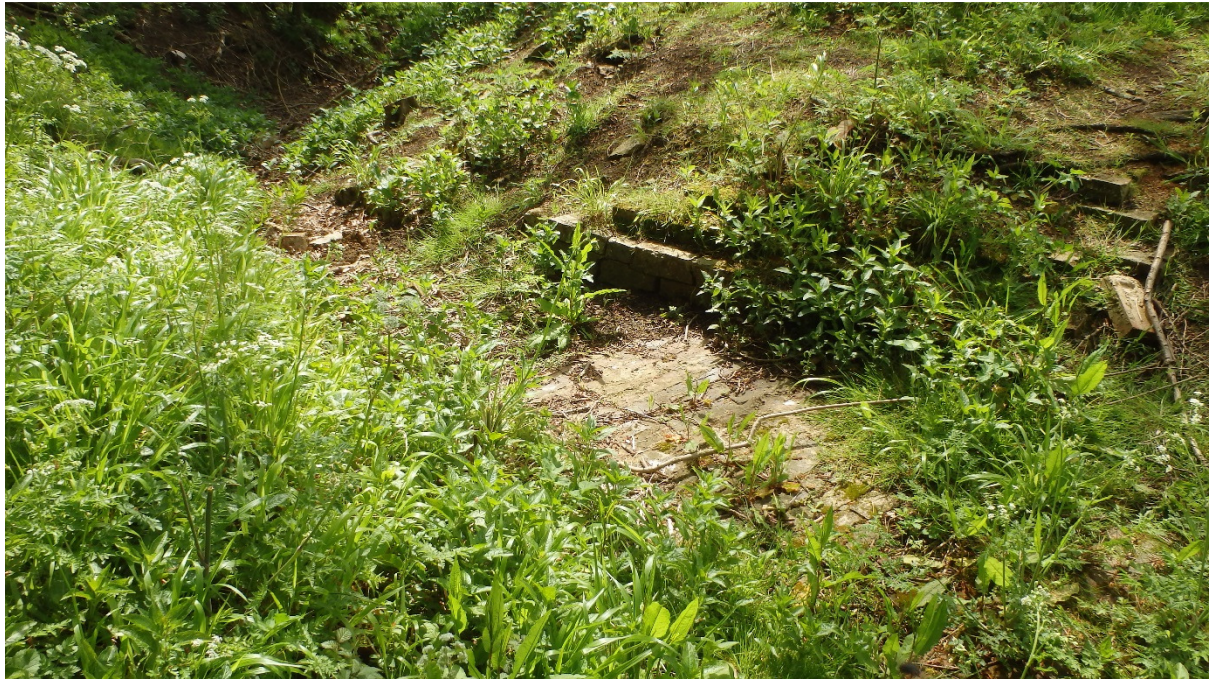
The spillway is located towards the northern end of the dam (Plate 7). It would appear to be a later addition to the dam, though may have replaced an earlier structure of which no trace now remains.

Plate 7 – Remains of spillway at north end of the dam prior to further investigation, looking southeast

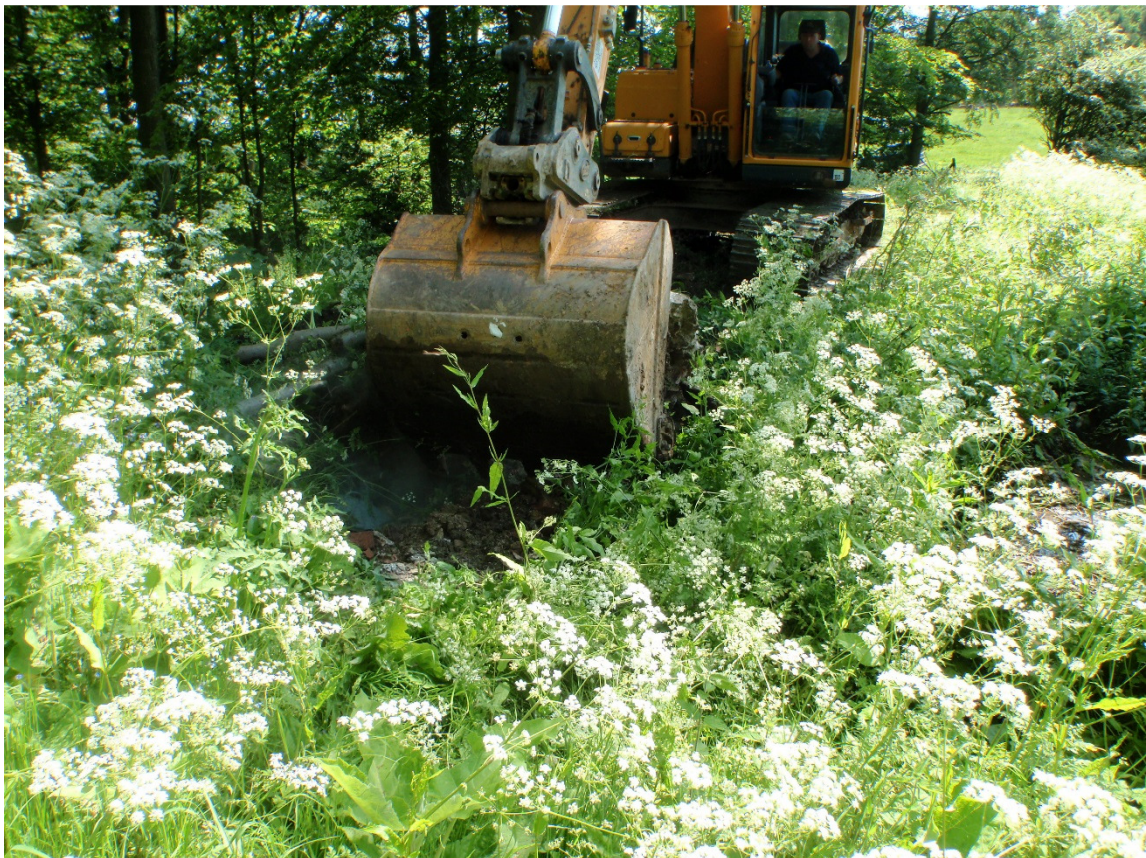
Plate 8 – Excavating the breach in the dam, looking south

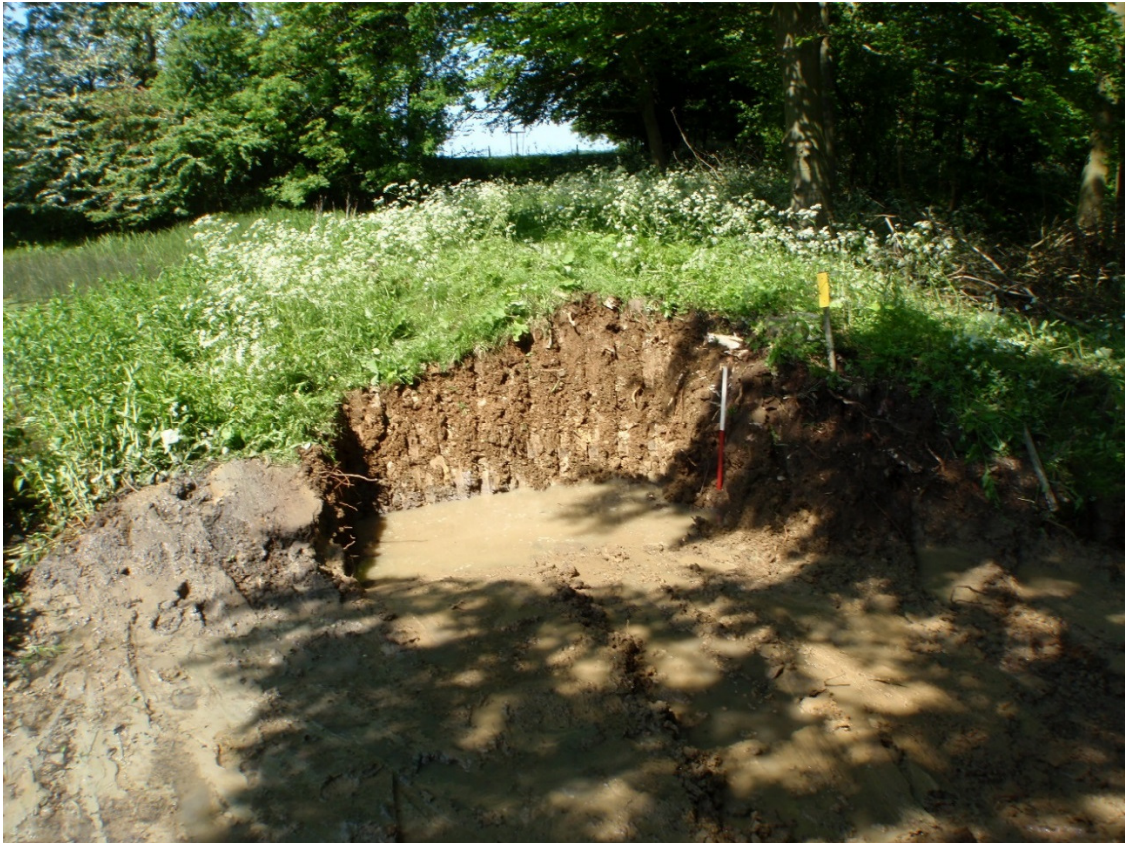
and loose rubble (010) which included limestone, ashlar and brick fragments, up to 1m thick. This later deposit probably formed part of the later repairs to the structure (Plate 9) and was sealed by soft dark brown, humic silty clay topsoil (005).

Plate 9 – Excavation of the breach in the dam, Section 1, looking north

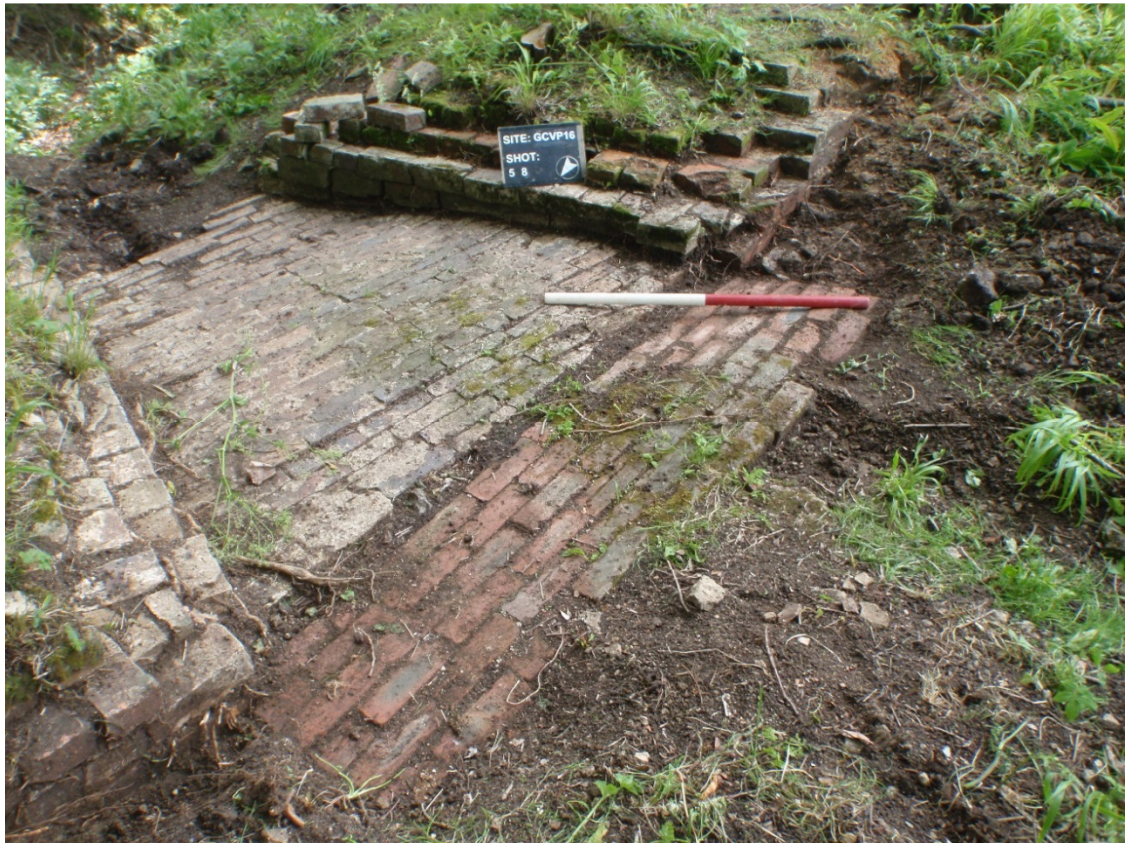
Plate 10 – Spillway entrance, looking southeast

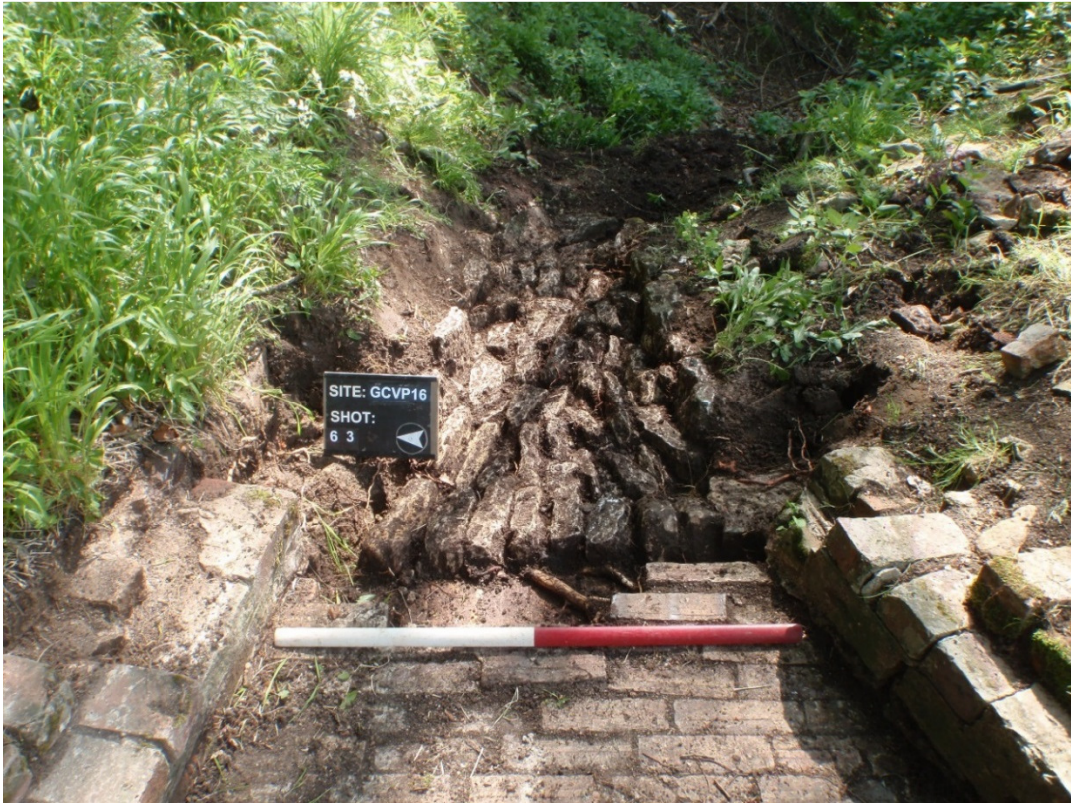
Plate 11 – Eastern end of spillway structure showing stonework (015), (013) and (014)

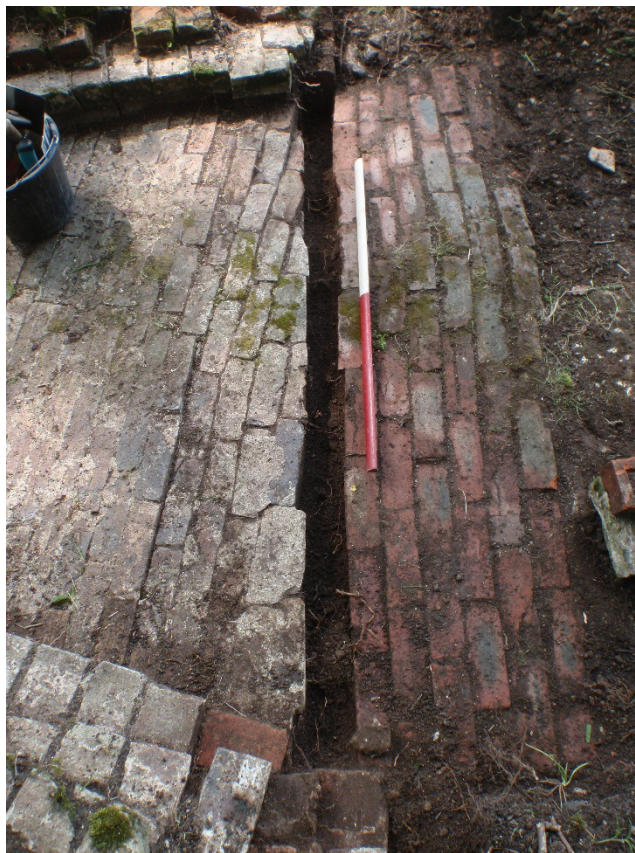
Plate 12 – Slot [018] at entrance to spillway, probably for a sluice gate

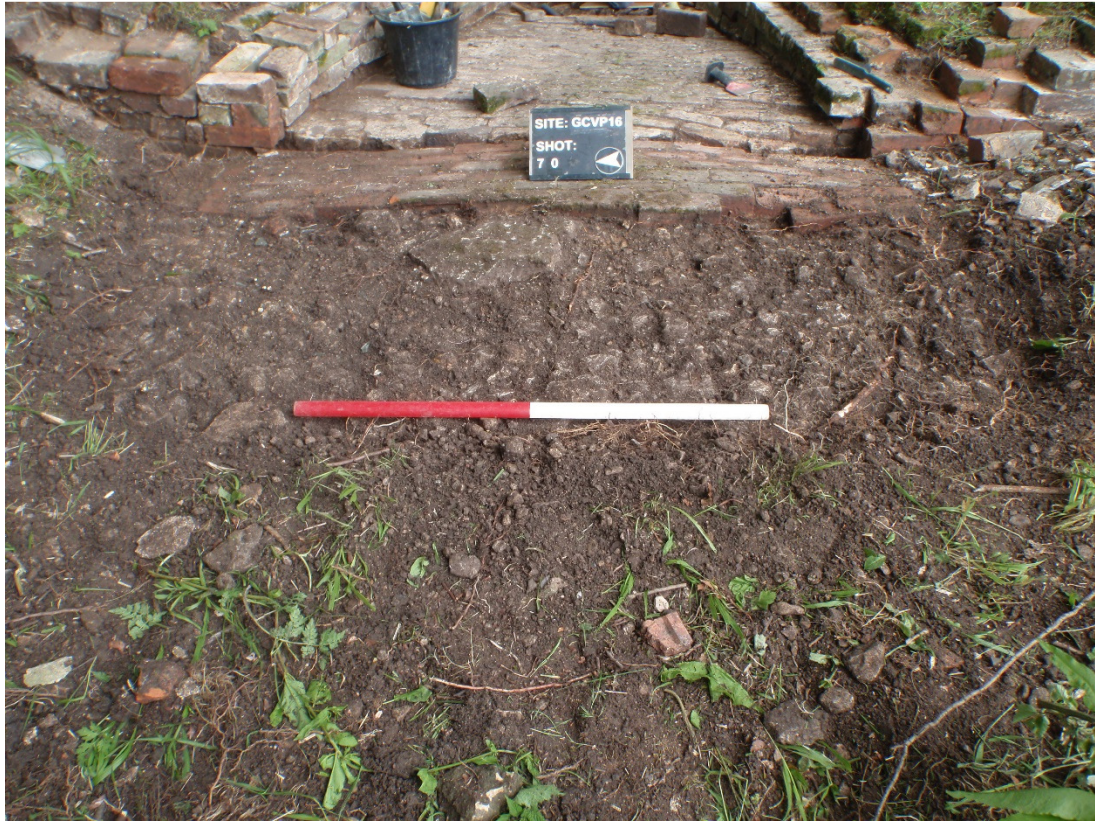
At the western side of the dam where the entrance to the spillway faces the pond, the earliest deposit relating to this structure comprised limestone fragments (016) of various size (mostly small), which formed an apron around the mouth of the spillway (Plate 14). The entrance of the spillway was constructed from brick masonry (004), with bricks measuring 77mm by 23mm by roughly 110mm, laid on their long edge forming the base of the structure and a lip facing the pond. A 20th century cartridge case was recovered from the interface of (004) and (016).

Plate 13 – Entrance to spillway showing stony deposit (016) in foreground and masonry (004) in front of slot [019]

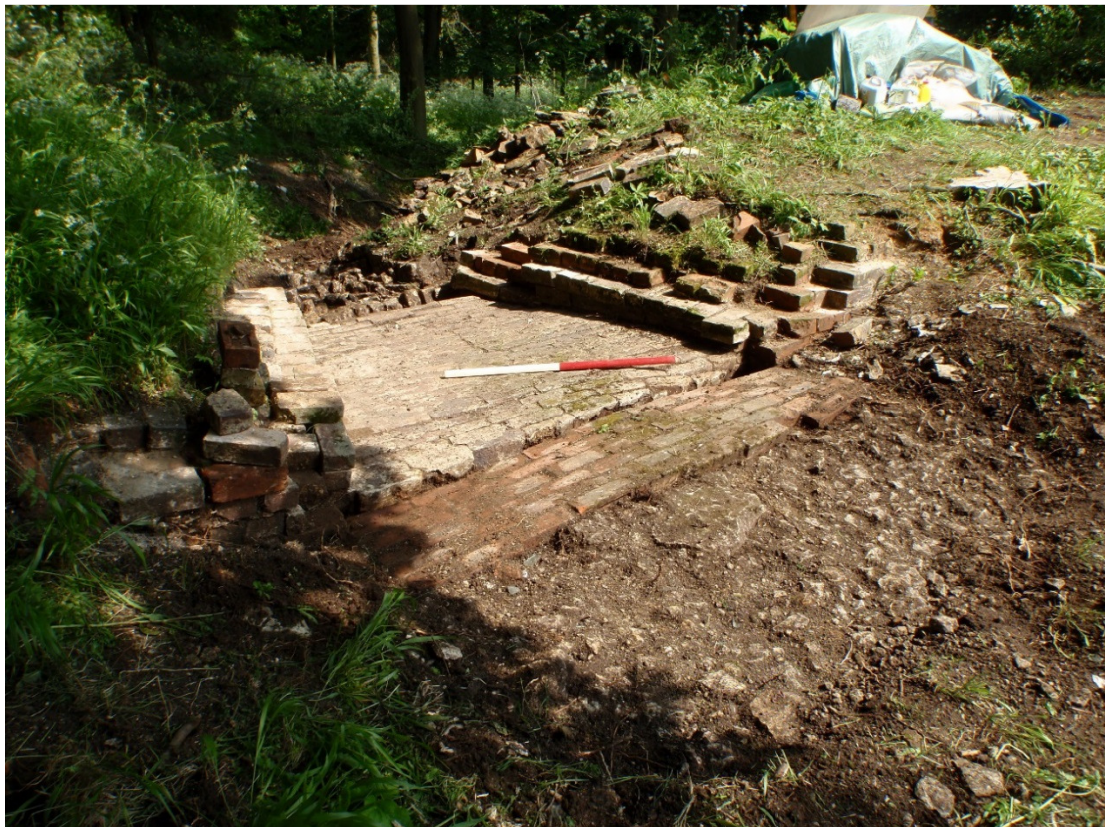
Plate 14 – View of the spillway, looking southeast
