**SURVEY OF BUILDINGS AT
THE CORN MILL,
1 LOXLEY ROAD,
MALIN BRIDGE,
SHEFFIELD,
SOUTH YORKSHIRE
(SHCM06)**

Work Undertaken For
Bagley UK Ltd

MAY 2007

A.P.S. Report No. **68/07**

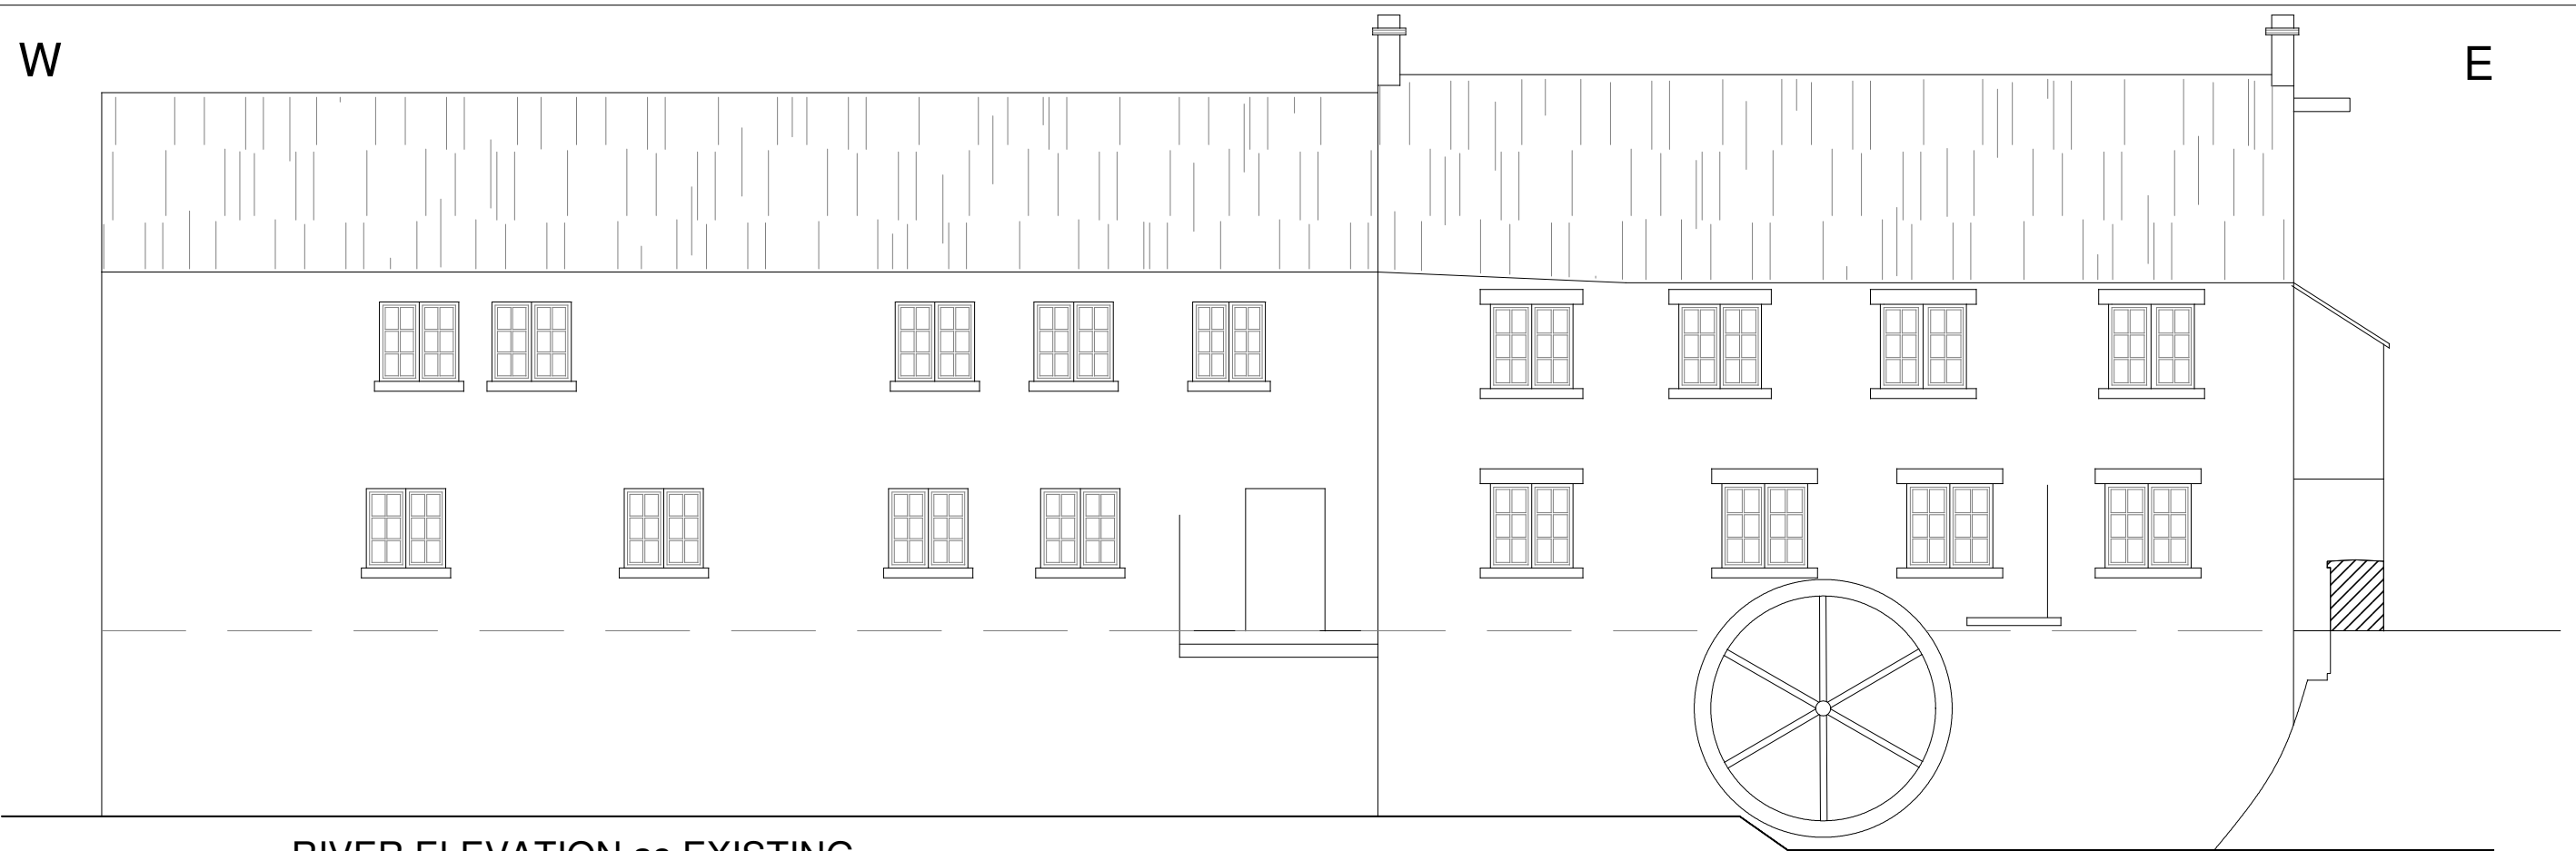
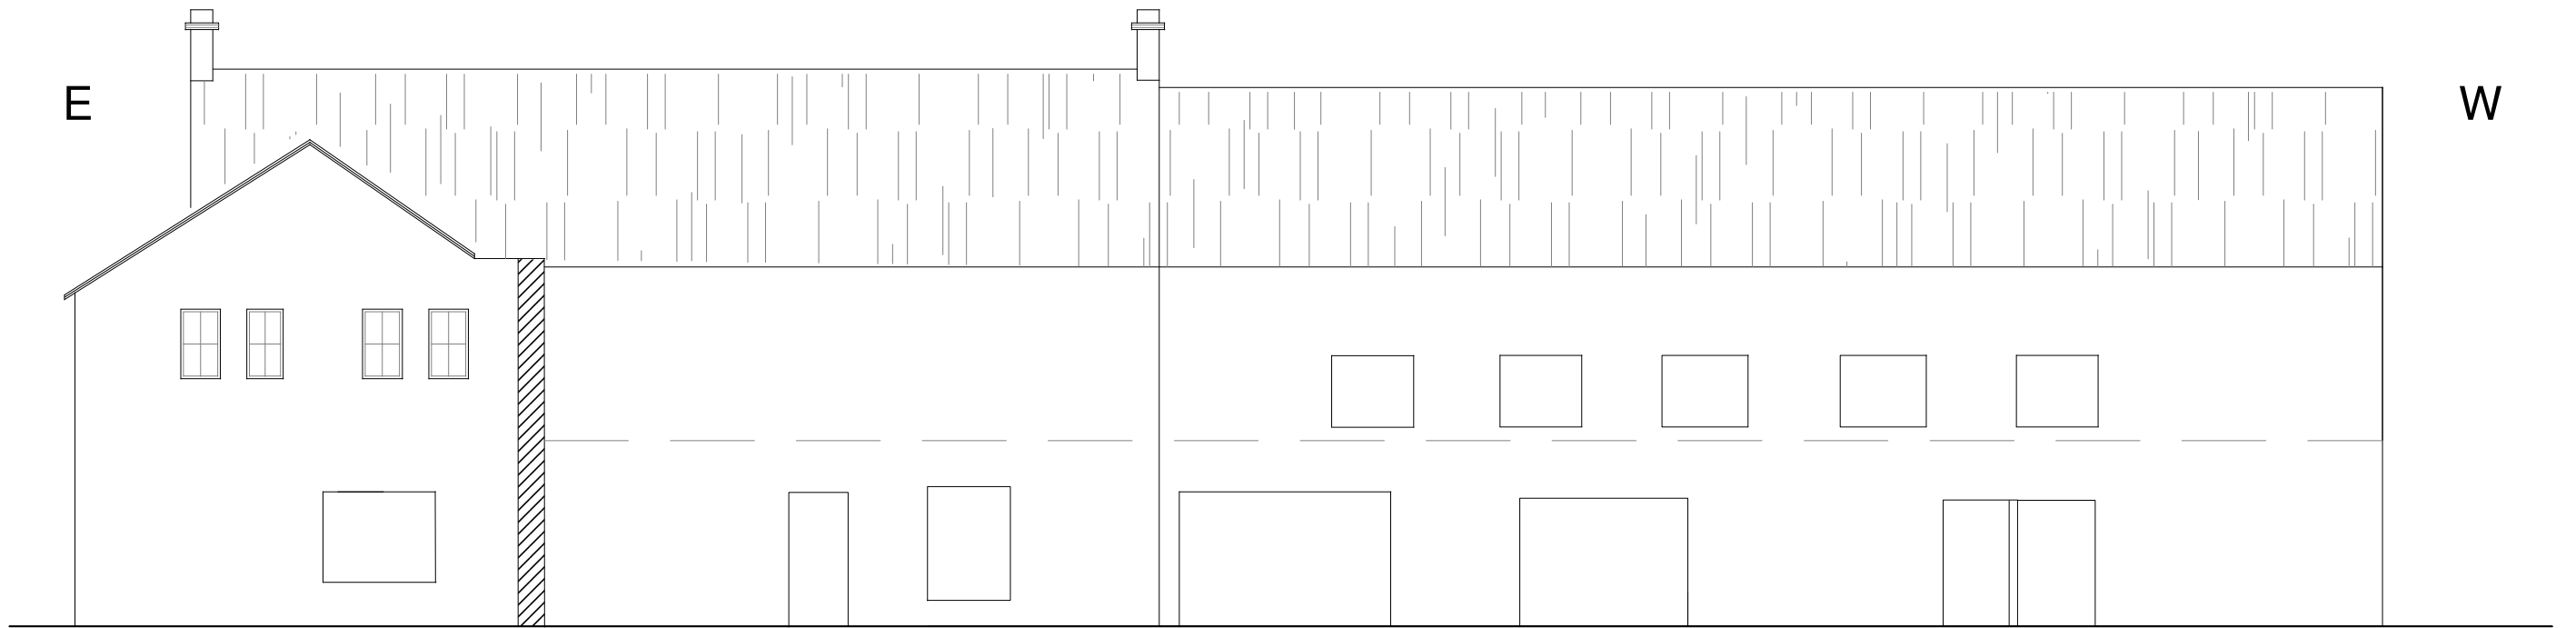
Figure 6 River and Courtyard Elevations

The northern elevation is rendered (Plate 2). At ground floor level it has two wide openings near the centre, another normal size doorway near the eastern end and a blocked doorway toward the west end. There is a row of five windows, all blocked, on the upper floor.

The southern elevation is in two parts. The western section is rendered (Plate 15) while the eastern is of exposed coursed rubble (Plate 5). The entire elevation is much taller than the others, due to it extending down alongside the mill race (Plate 16).

Within the western section of the elevation, at ground floor level, are a row of four windows and a door that leads out on to a cast iron bridge over the mill race.

Projecting from the eastern section of the elevation is the undershot waterwheel (Plate 16) with its axle passing through a hole low in the wall, below ground level, to the building interior. At ground and first floor level are two rows of four windows. Between the first and second windows from the east, right, side at ground floor level is a single straight join that is approximately 2m high (Plate 17). At the base of this is a 1.4m long stone sill that extends 0.2m east of the straight join.

RIVER ELEVATION as EXISTING

COURTYARD ELEVATION as EXISTING

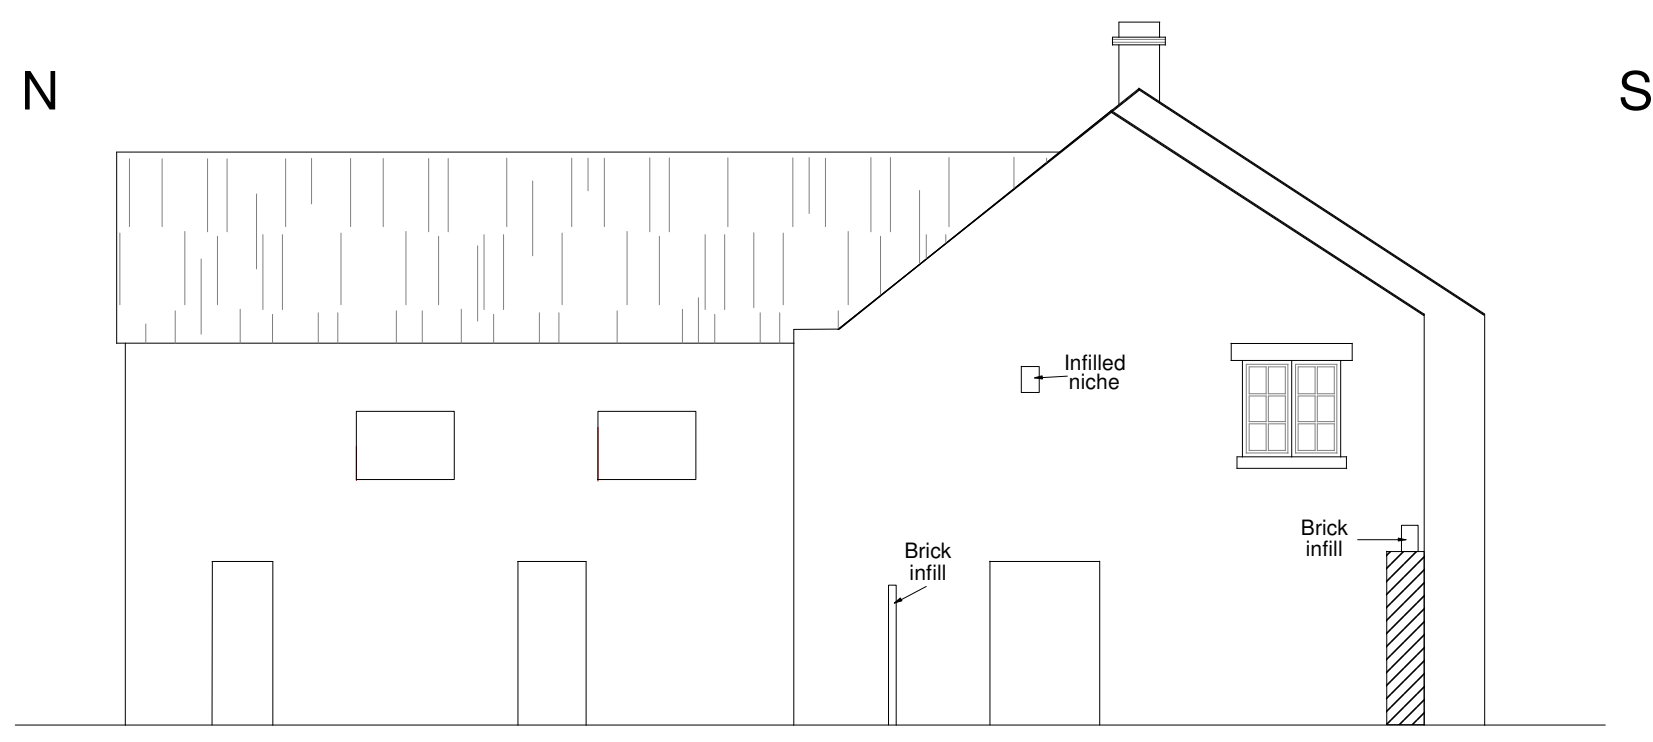
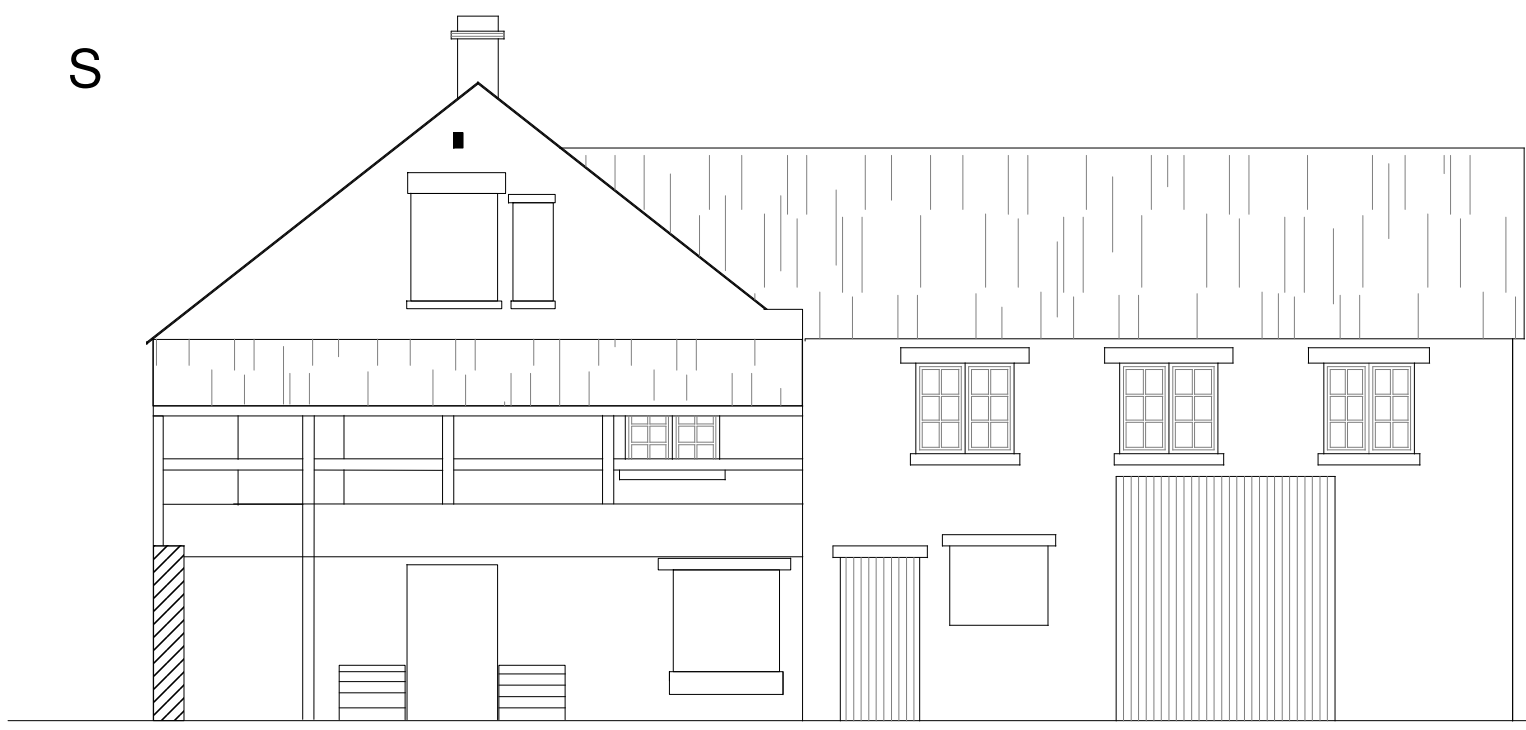
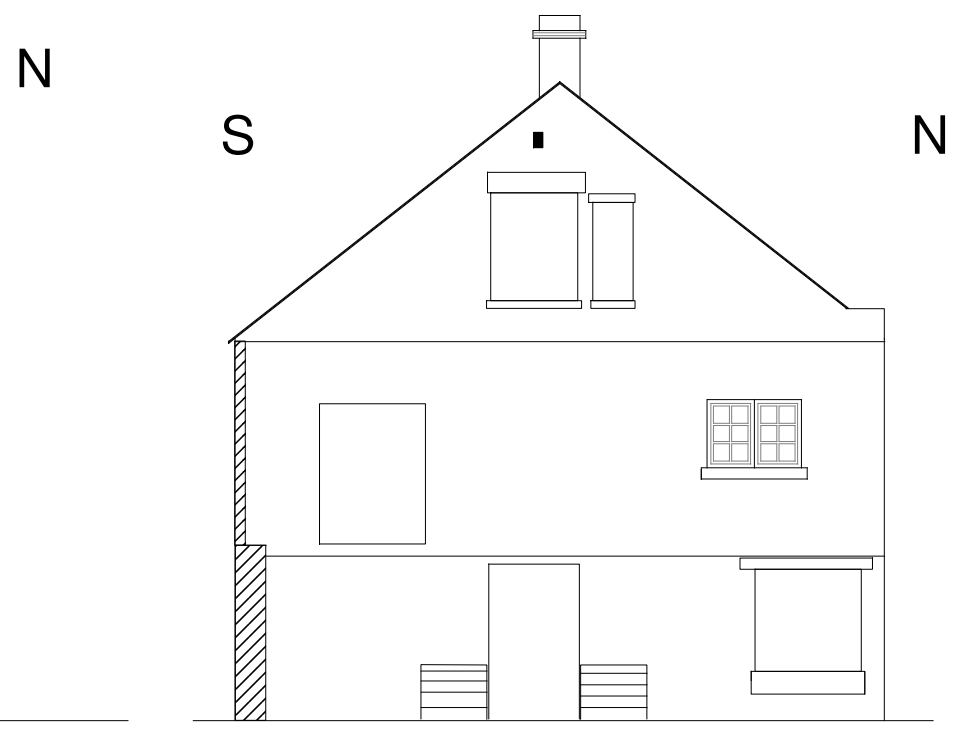
Figure 7 Western Courtyard and Stannington Road Elevations

The western elevation is rendered and has two doors on the ground and two windows on the first floor. The northern gable is exposed ashlar and has a blocked window on the ground floor and a row of four small windows in two pairs on the upper storey (Plate 4). A section of stone wall, two storeys high and from a previously attached building, extends northward from the northwest corner of the gable.

The western gable is of exposed coursed rubble and has a step at the eaves on its north side (Plate 14). There is a modern door with a concrete lintel at ground level and a window with a concrete lintel and stone sill on the first floor. North of the doorway is a vertical slot, half a brick wide and about 2m high, filled with brick. Approximately 2.5m above the door is a small (c. 0.4m x 0.25m) rectangular feature, infilled with stone. Some suggestions of straight joints to the south of the door may indicate the position of an infilled window at ground floor level.

The east gable of this range is set back slightly from the eastern elevation of the north-south block (Plate 18). In the middle of the ground floor is a doorway flanked by two sets of concrete steps. To the north is a window, boarded over. At first floor level there is a doorway toward the south end and a window to the north. In the angle of the gable is a doorway and, alongside, a fairly tall narrow window. Centrally above this door and projecting from the wall is a timber jib for a sack hoist (Plate 19). A chimney crests the gable.

WESTERN COURTYARD ELEVATION as EXISTING

STANNINGTON ROAD ELEVATION as EXISTING

STANNINGTON ROAD ELEVATION, SOUTH GABLE, WITH GALLERY REMOVED

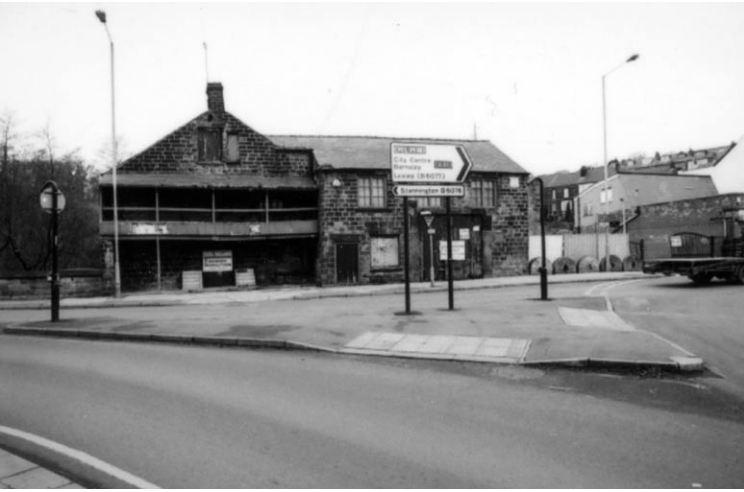
Also of ashlar, the eastern elevation contains, at ground floor level, a planked door, a blocked window and a double-height, double-width door, also blocked. In the upper storey is a row of three windows (Plate 1).

Plate 1 General Site View, showing recorded buildings, Loxley Road frontage, looking west

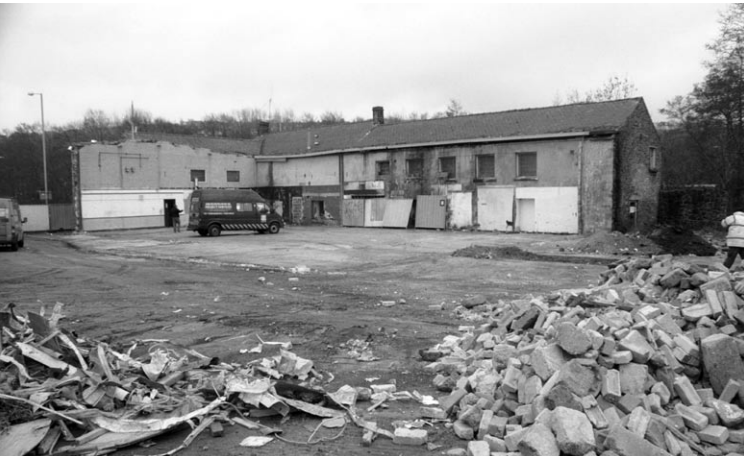
Plate 2 General Site View, showing recorded buildings, rear Courtyard area, looking southeast

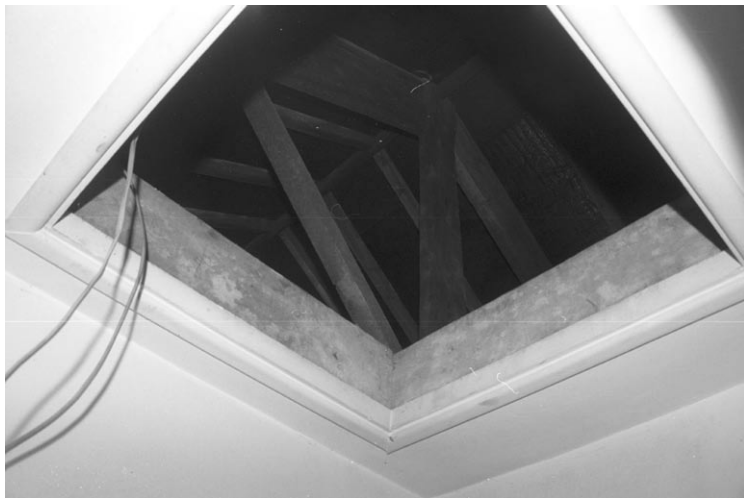
The first floor is one large room with modern internal partitions. Two tie-beams, both boxed-in plain timbers, cross the room and carry suspended king-post roof trusses (Plate 3) with inclined braces and a housed ridge plank (cf. Campbell 2000). There are four small windows, set in two pairs, in the northern wall and three larger windows equally spaced in the eastern elevation. All the glazing is 20th century.

Plate 3 King Post Roof Truss in N-S Range, looking southeast

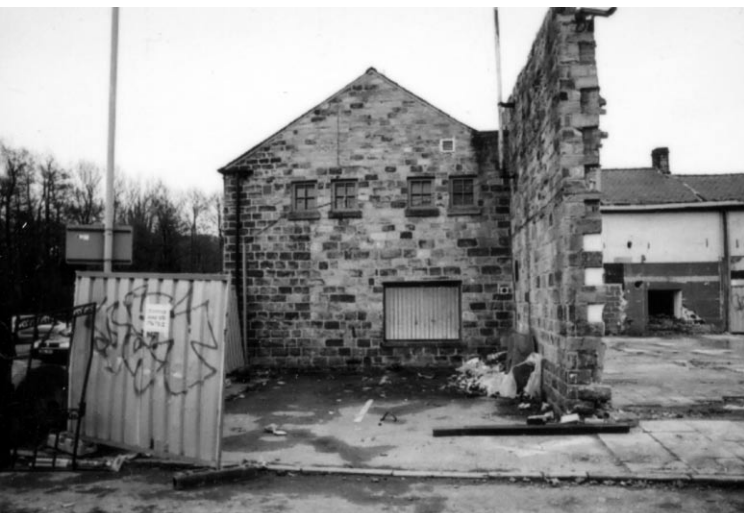
Plate 4 North Gable of N-S Range, looking south

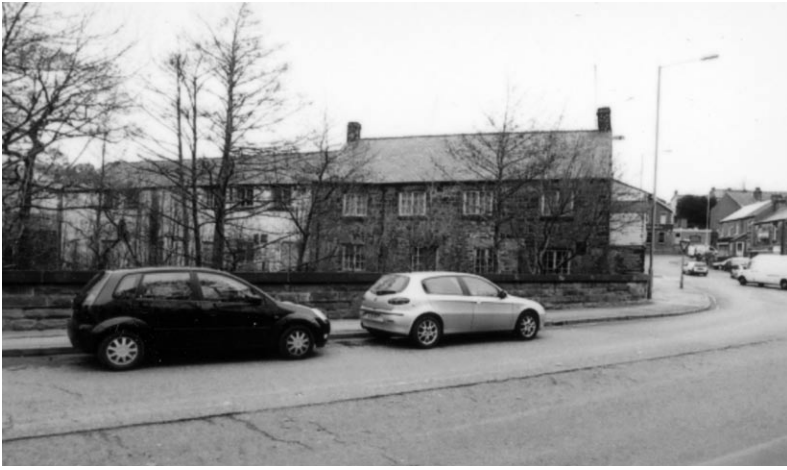
Plate 5 Southern Elevation of E-W Range, looking north

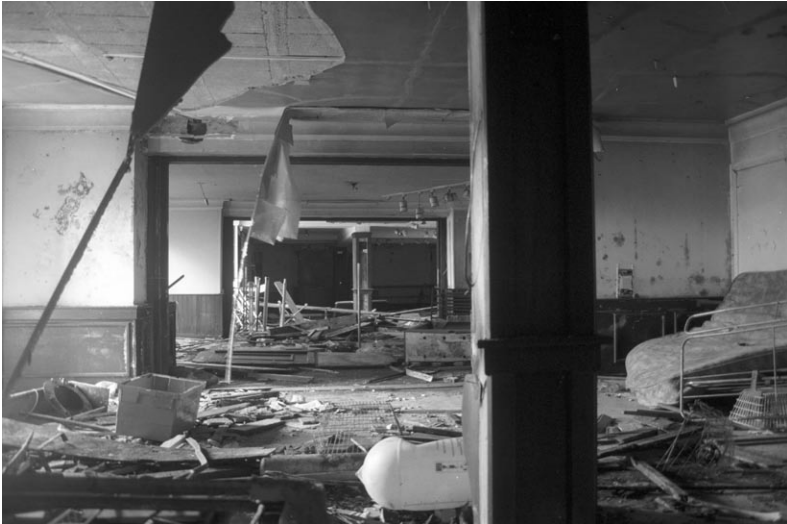
Two bridging beams cross the room and are supported on stanchions at their centre (Plate 6). These beams and stanchions are all boxed in but holes in the boxing show the beams and stanchions all to be plain square-cut timbers.

Plate 6 Ground Floor, West Room of E-W Range, looking east

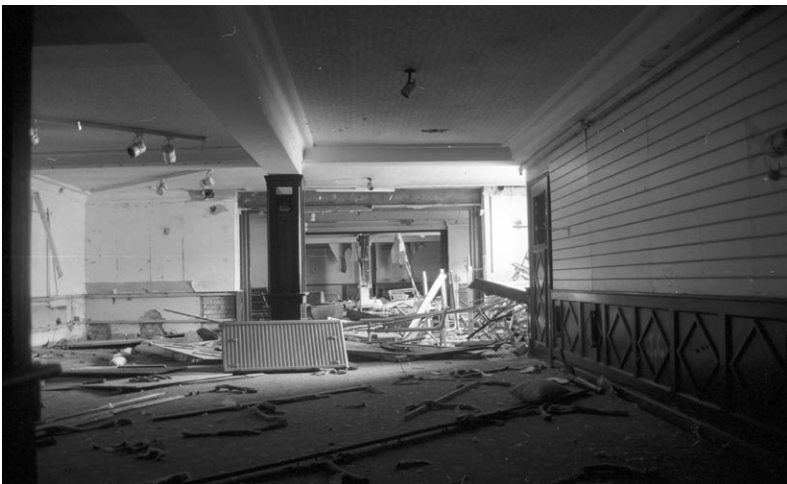
The eastern block (Plate 7) has a modern stairwell on the north side and a series of blocked windows in the south wall. Two bridging beams cross the room parallel to the angled west wall (not square with the rest of the range). These beams are supported on stanchions. Further beams

Plate 7 Ground Floor, East Room of E-W Range, looking west

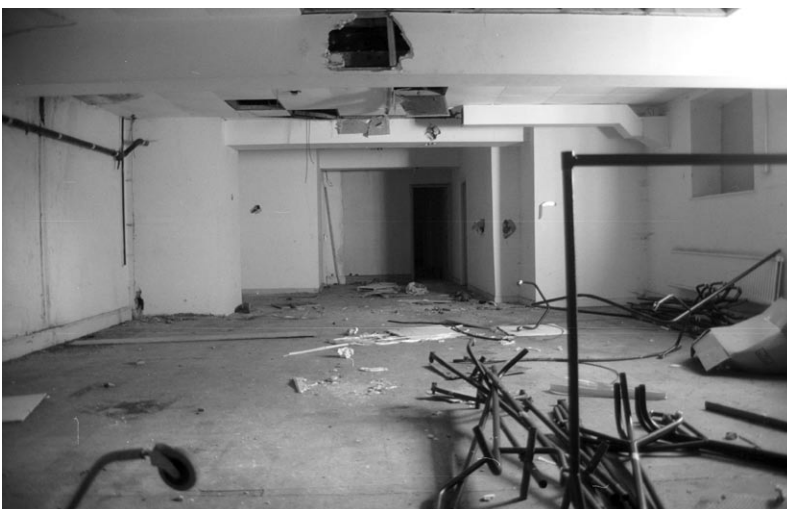
Like the ground level rooms, the first floor is basically split into two blocks, the eastern being wider than the west, with a stairwell at the western end. The western block (Plate 8) is essentially a single room with some modern plasterboard partitions. Four tie-beams, all boxed-in but of square-cut timber supported by rolled steel joists, cross the room. These tie-beams carry king post trusses, with housed ridge planks but without inclined braces and flanked by vertical struts (Plate 9). There is a series of windows in the south wall and the room has a modern suspended ceiling (Plate 10).

Plate 8 First Floor, West Room of E-W Range, looking east

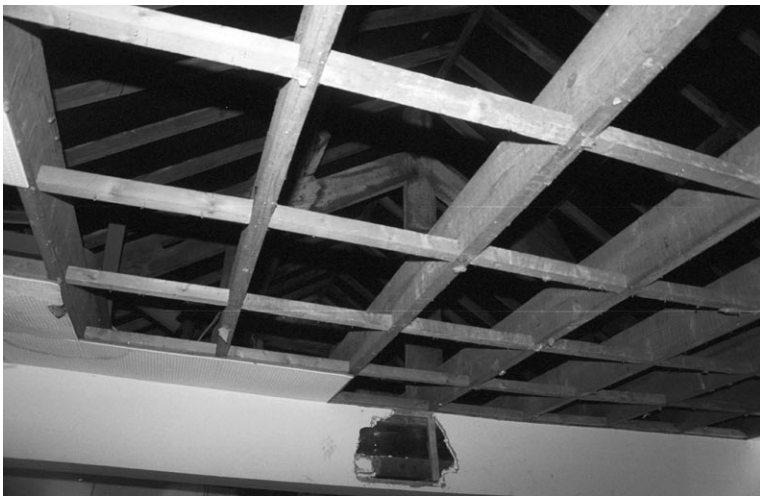
Plate 9 King Post Roof Truss in E-W Range, looking east

The east-west range alongside the river comprises two linked units, that to the east being wider and taller than the western section. In the roof space at the western end of the eastern section, that is, at the junction between the two blocks, is walling that contains a doorway. This walling is probably part of the original gable of the block and provides evidence that this eastern section is the earlier of the two cells. The doorway in this wall was probably a loading portal, comparable to that seen in the eastern gable of this same block. These loading portals indicate that the attic space of the block was used for storage.

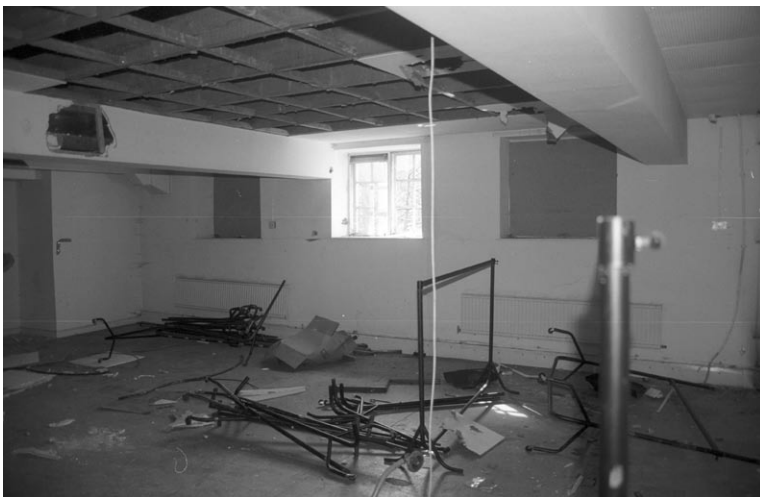
Plate 10 First Floor, West Room of E-W Range, looking southeast

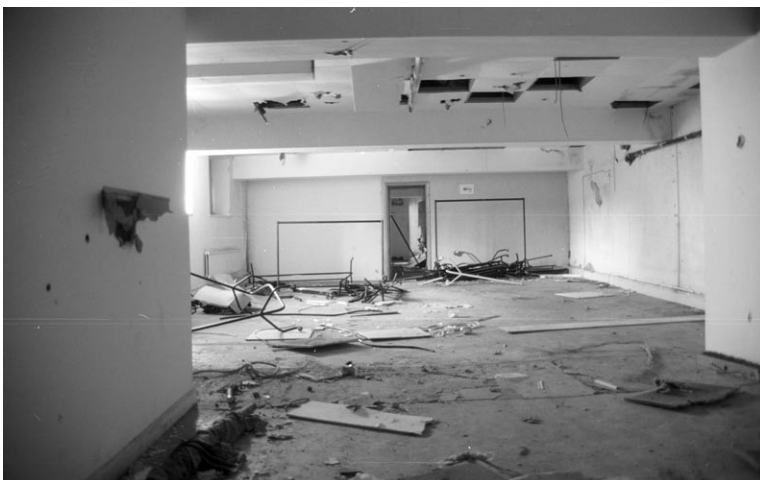
As on the ground floor, the junction between the western and eastern blocks is at a slight angle, not square to the remainder of the range. There is a 4m wide entry in this dividing wall (Plate 11), with a boxed-in rolled steel joist (RSJ) over. A series of three other boxed tie-beams, some timber, others RSJs, crosses the eastern block, again parallel to the angled dividing wall. There are four windows in the south wall and one in the east.

Plate 11 First Floor, East Room of E-W Range, looking west

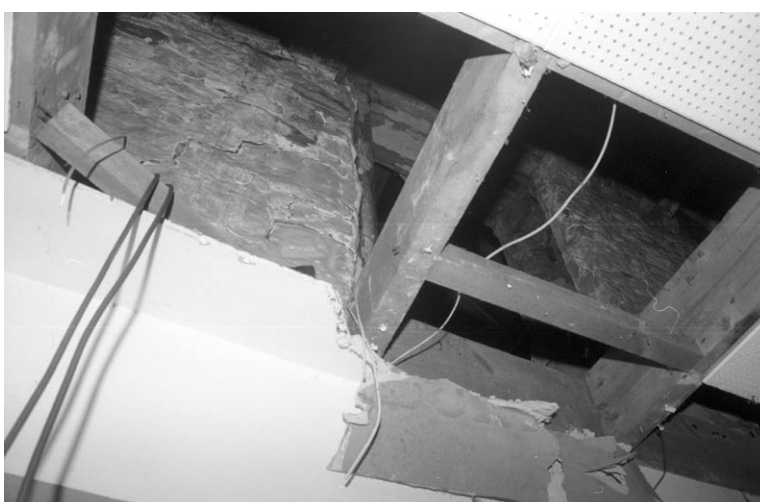
within this wall is a doorway (Plate 12). To the south of the doorway are occasional supports for a layshaft, while a hole through the wall probably accommodated a layshaft. The east gable extends into the roof space, and contains a door and a tall narrow window (Plate 13).

Plate 12 First Floor, East Room of E-W Range, showing doorway in wall in roof space, looking east

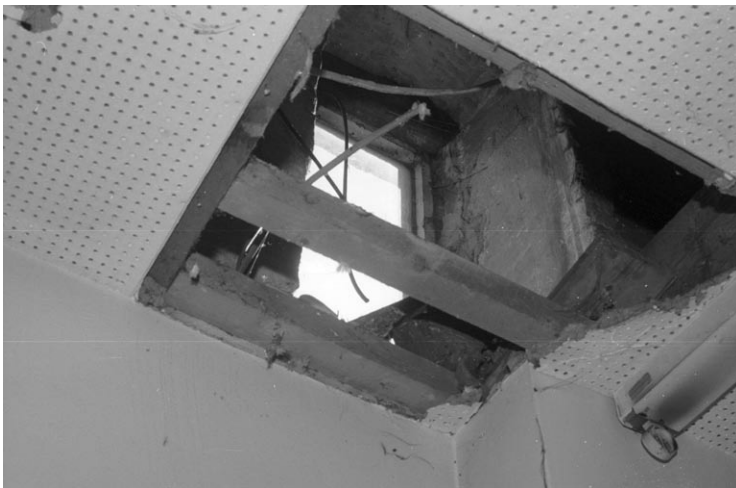
Plate 13 First Floor, East Room of E-W Range, showing window in roof space, looking east

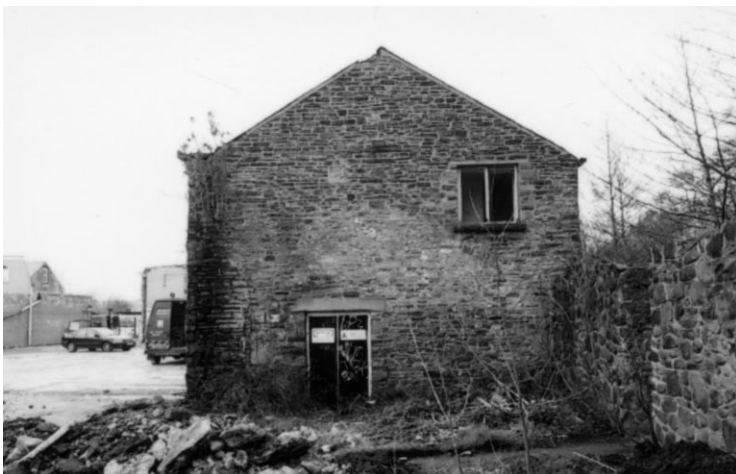
Plate 14 West Gable, E-W Range, looking east

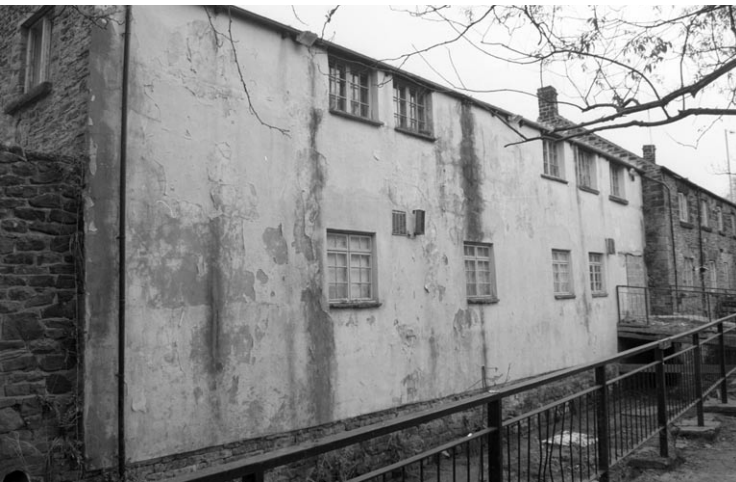
Plate 15 Southern Elevation of E-W Range, showing western end, looking northeast

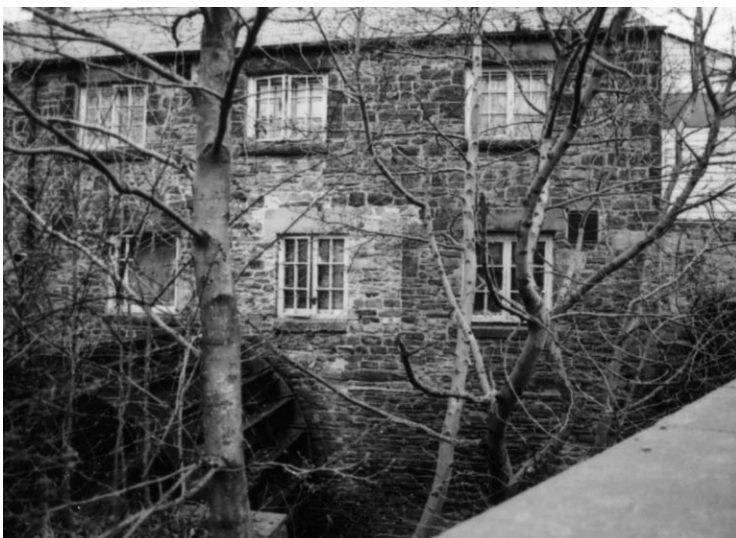
Plate 16 Southern Elevation of E-W Range, showing eastern end and waterwheel, looking north

The only parts of the waterwheel mechanism that survive, other than the waterwheel itself, are the pit wheel and common axle. All other parts of the mechanism, which might have included the wallower and vertical main shaft, great spur, crown and bevel wheels, lay (or line) shafts and pulleys (Vince 1978, 13), have been removed. Some of these sections of

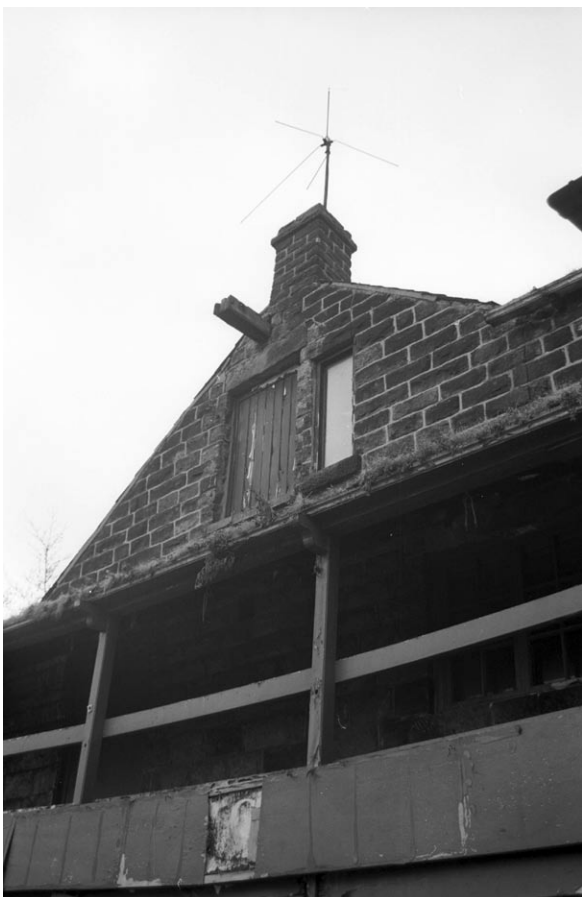
Plate 19 Eastern Gable of E-W Range, upper part showing jib over loading door, looking southwest

mechanism are only speculative, though it seems certain that there had been a wallower (to convert the power of the waterwheel vertically through the mill) and drive shaft. The loading portals in either gable also strongly suggest that the drive shaft passed up through the building and had a crown wheel that turned bevel wheels attached to lay shafts that operated sack hoists (cf Major 1975, 118). No lay shafts remain, though there are a few supports for such in the roof space. Also, the jib over the eastern loading door was almost certainly powered by lay shaft pulleys.

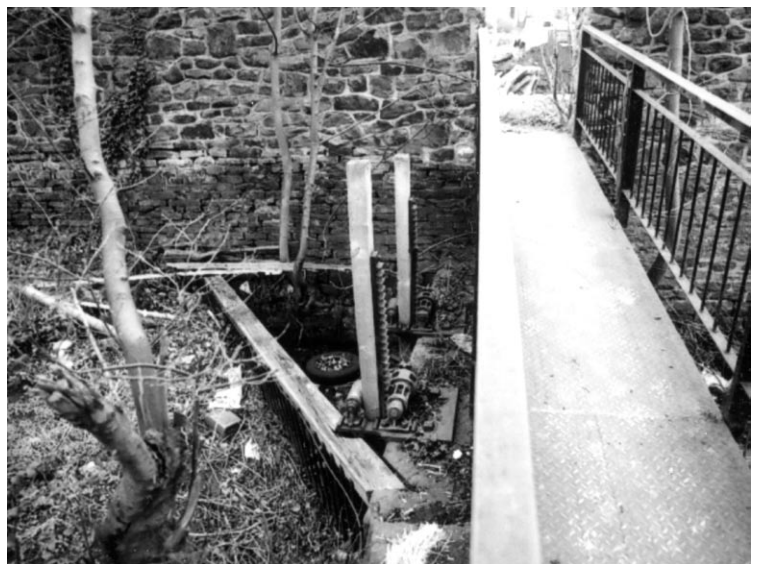
Just by the southwest corner of the building are sluice-gates to the mill race (Plate 20). The mill race west of these, branching from the river, is infilled and overgrown.

Plate 20 Sluice Gates by southwest corner of mill, looking north
