**ARCHAEOLOGICAL
EVALUATION ON LAND AT
BURTON ROAD,
NEEPSSEND,
SHEFFIELD
(SHBR07)**

Work Undertaken For
CgMs
On behalf of
Rutledge (Neepsend Triangle) Limited

July 2007

A.P.S. Report No.: **91/07**

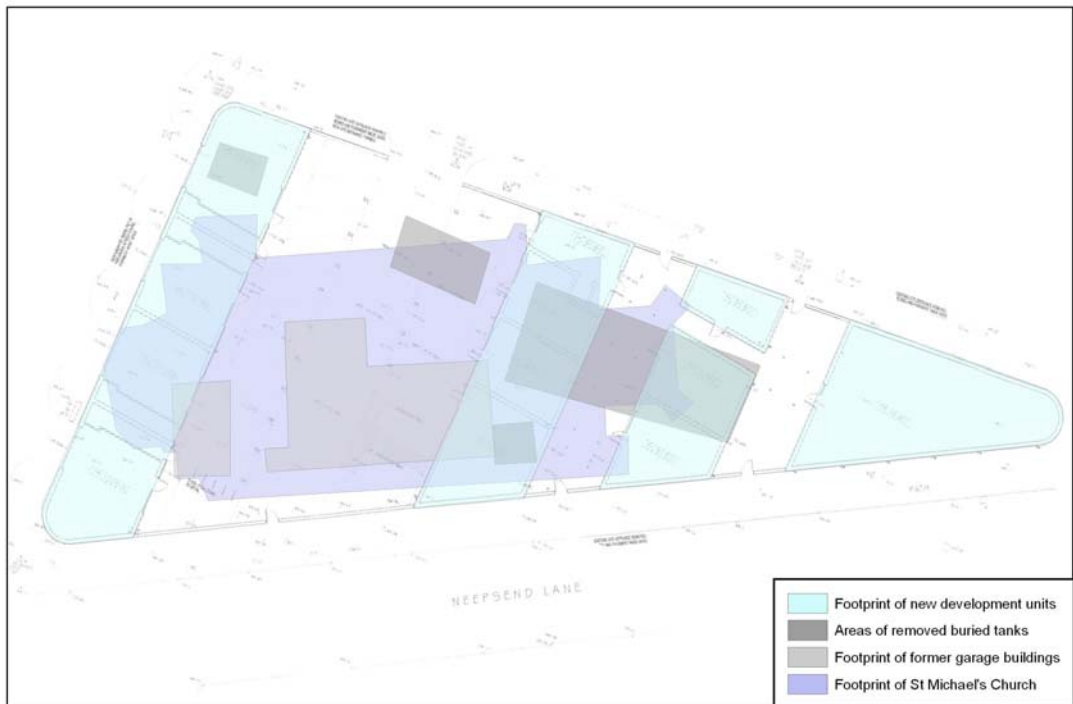
Figure 2 – Footprint of church & later development groundworks

- 1.2.3 Subsequent to the demolition of the church, the site was redeveloped to provide a petrol filling station with two brick-built structures in the southern part of the site and pump islands with buried fuel tanks and interceptors to the north.

- 1.2.5 Although all above-ground evidence for the church has been lost, and subsequent redevelopment of the site is anticipated to have caused localised destruction of any buried remains through excavation for new foundations and pits for underground petrol tanks (and their subsequent removal), the site was considered to retain some potential for the survival of buried archaeological remains of the church's foundations and/or associated remains.

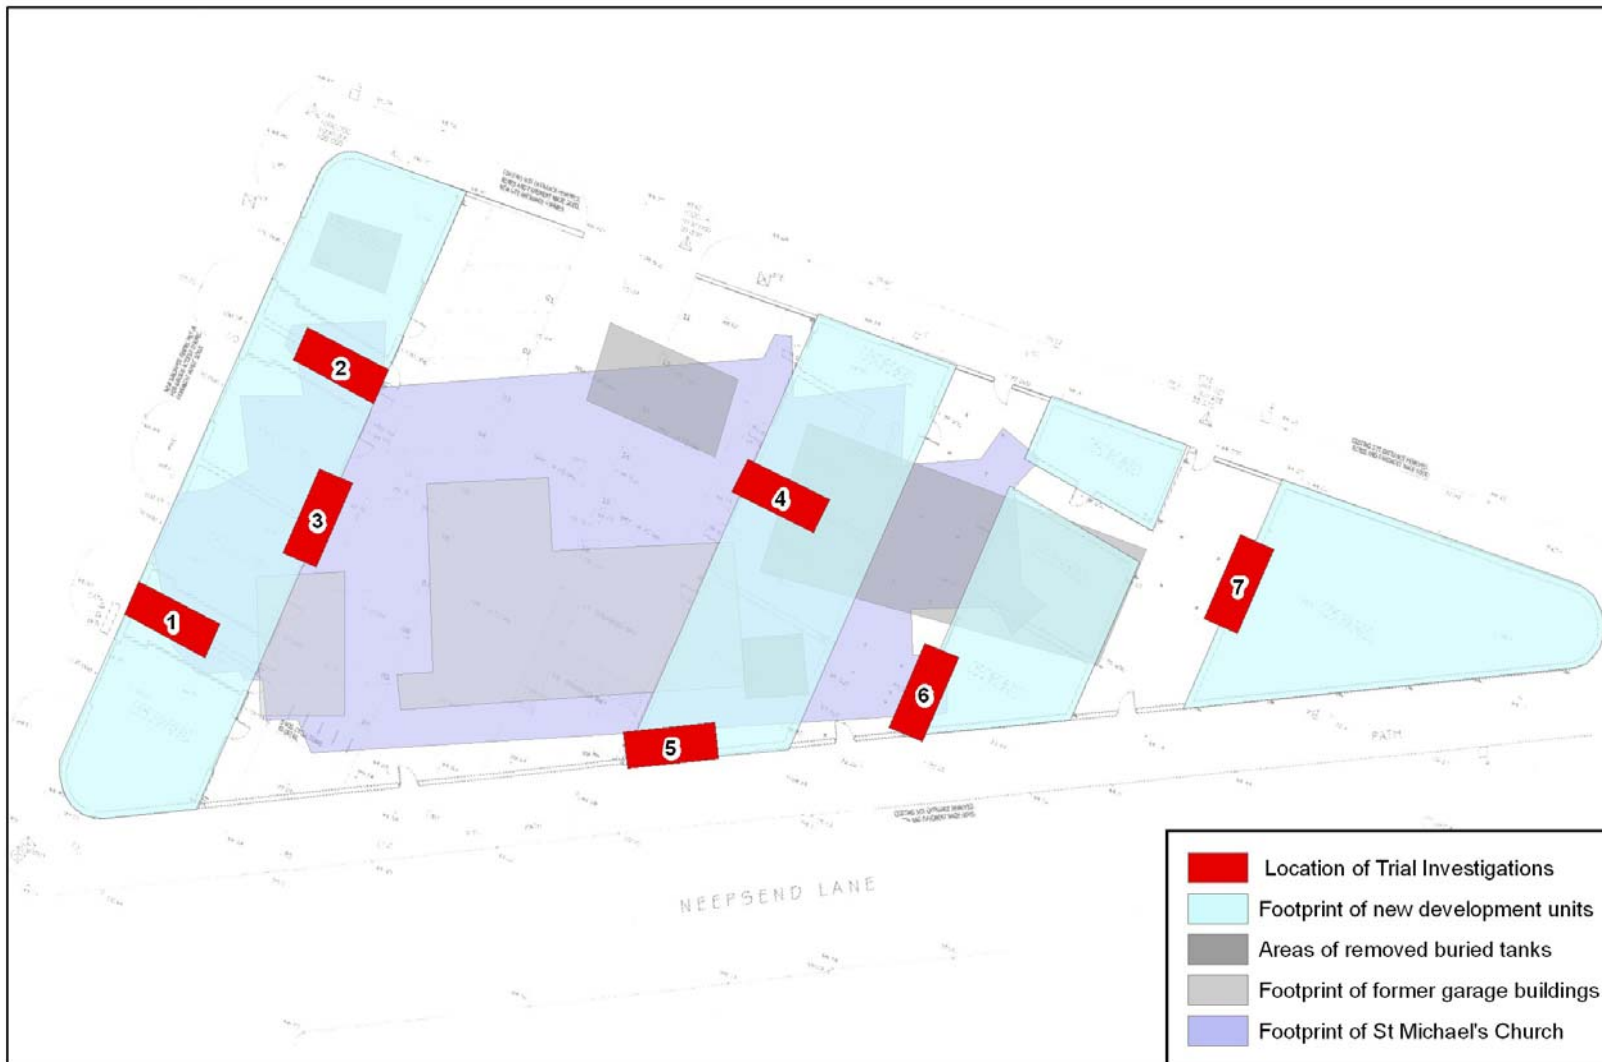
Figure 3 – Locations of archaeological trial investigations

1.3.2 It is proposed that these aims will be achieved principally by excavation, examination and recording of seven trial trenches within the development site. The trench locations proposed have been positioned to assess the survival of buried archaeological remains in areas where new development foundations will affect areas not damaged/destroyed by the previous filling station development. The proposed locations of trial investigations are shown in Figure 3, with the rationale behind their location being summarised in the table below. Every effort will be made to excavate the trial trenches to the size, and in the locations indicated, but site conditions may require slight adjustments to trench locations as might services and other obstacles.

Trial Trench	Size (m)	Rationale
1	5x2	Foundation Line intersecting location of Western end of church
2	5x2	Foundation Line intersecting position of North Porch
3	5x2	Foundation Line within western interior of church
4	5x2 (?7x2)	Foundation Line within central interior of church (<i>possible small area of survival in vicinity of removed fuel tanks and former filling station buildings; also confirming destruction within area of tanks</i>)
5	5x2	Foundation Line close to position of South Wall of church
6	5x2	Foundation Line intersection predicted southeast aisle corner
7	5x2	Foundation Line in undisturbed area east of church
