**HISTORIC BUILDING RECORDING  
MILL FARM  
MILL ROAD  
WISTOW  
CAMBRIDGESHIRE**

Prepared For  
Rose Homes (EA) Ltd

APS Report No: **59/19**

**HISTORIC BUILDING RECORDING, MILL FARM, MILL ROAD, WISTOW, CAMBRIDGESHIRE**

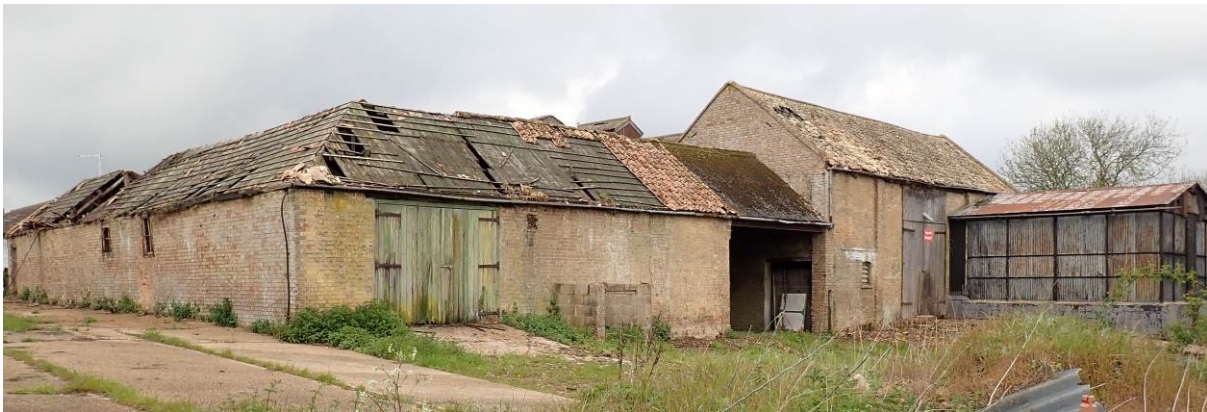
**Plate 1.** Oblique view of the buildings, looking northwest

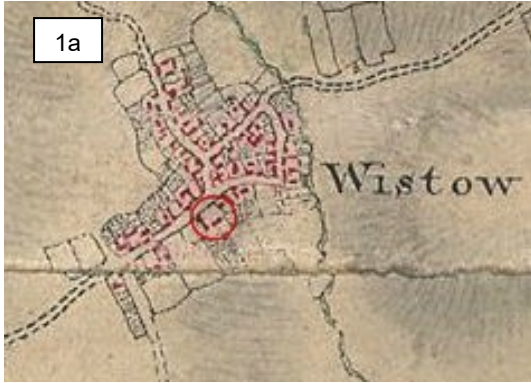
**Figure 1a.** Extract from the 1808 Ordnance Survey Drawing

In 1808, a drawing for the Ordnance Survey of the Huntingdon area by the draughtsman William Hyett shows the village of Wistow. Mill Farm is depicted with the farmhouse and a north-south range extending from it. An east-west range is also depicted at the south end of the site, although this is likely to be a building that pre-dates those that occupy the site today (Fig. 1a).

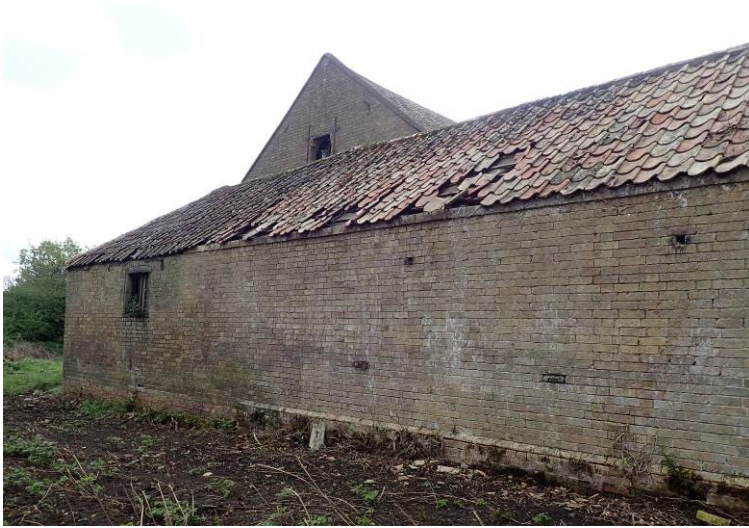
**Plate 2** (above). Vented window, north elevation of the stable

The north elevation of the cartshed has no apertures or openings. There is a plinth at the base of the wall that is not carried through into the wall of the stable. The stable at the northeast corner has a single vented window with a segmental arch<sup>3</sup> and queen closer<sup>4</sup> bricks surrounding the window aperture.

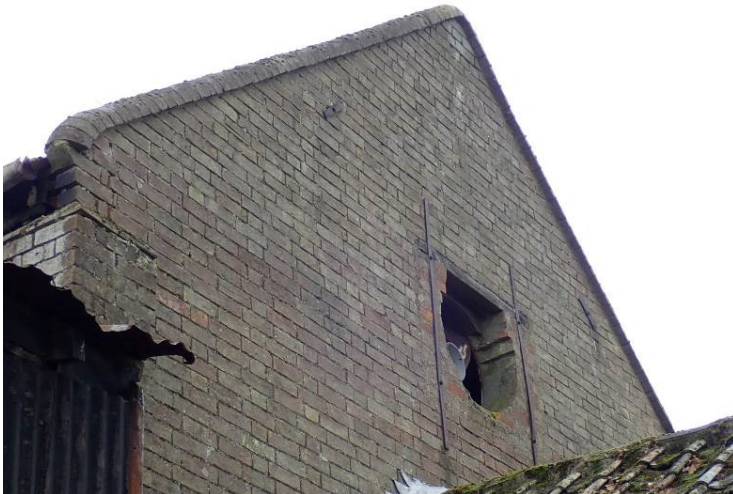
An upturned plinth header<sup>5</sup> brick forms a kneeler<sup>6</sup> at the base of the gable end of the roof, the edge of which is capped with half-round capping bricks.

Two iron ties are present in the gable and in the middle, a hole has been cut to accommodate a fan, installed with the modern machinery inside.

**Plate 4.** Northwest gable end of the threshing barn

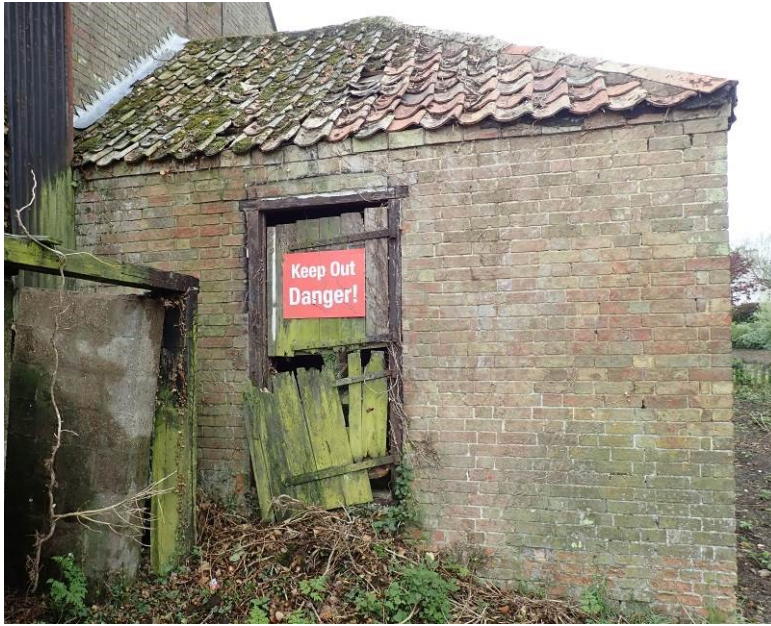
The northeast elevation of the stable has a partially blocked Dutch door<sup>7</sup>. Alterations in the outside ground level mean that the step into the building is higher than the surrounding ground surface.

Where the stable abuts the threshing barn, a modern extension covers the join as does lead flashing at the roof level.

**Plate 5.** The northeast elevation of the stable

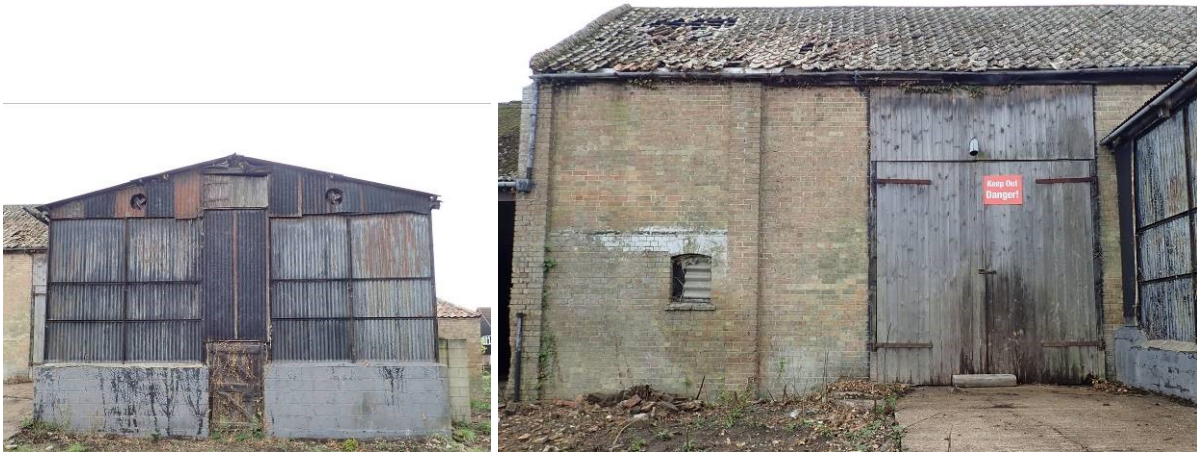
**Plate 6**

On the northeast elevation of the threshing barn, the wall to the northwest of the main threshing door is covered by a modern corrugated metal extension with a breeze block base. It was not possible to enter to view this section of the barn externally.

The modern extension to the northeast elevation of the threshing barn

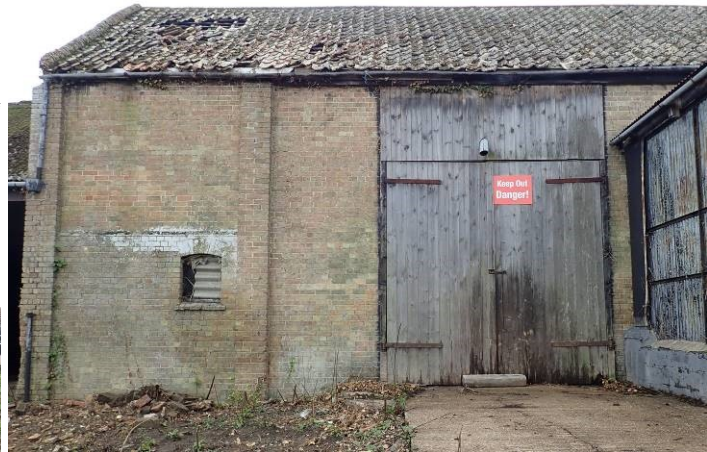
**Plate 7**

The northeast elevation of the threshing barn to the south of the modern extension

The threshing door on the northeast elevation (one of two opposing doors either side of the threshing floor) has been heightened from its original size and now reaches the eaves level. The wooden doors and shuttering above are not original. Either side of the threshing door and at the corners of the barn are brick pillars for additional structural strength. The window with the segmental arch at the southern end of the elevation is original.

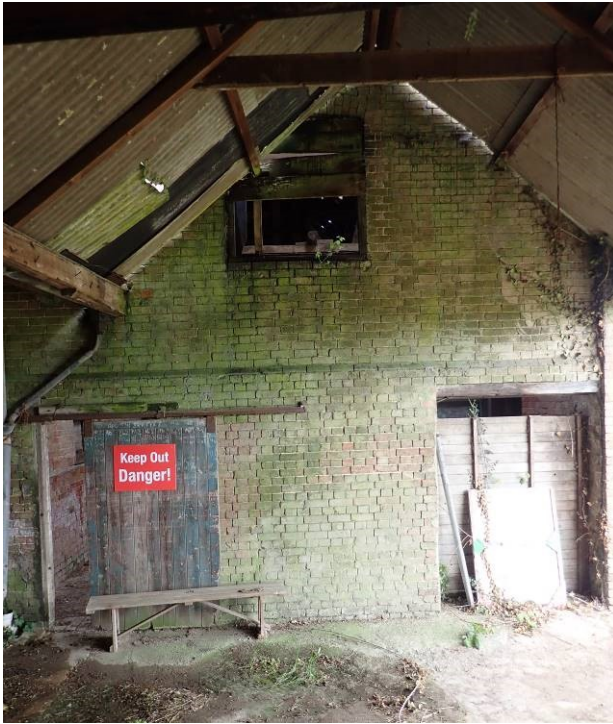
Viewed from underneath the covered entrance to what would have served as the crewyard, the southeast elevation of the threshing barn has undergone alteration. On the bottom part of the wall, the bricks are laid in English bond, stepped out to form a plinth, whereas above in the gable, they are laid in Sussex bond. Two door apertures have been added in the lower part of the wall while the pitching door with segmental arch in the upper part of the gable end is original.

**Plate 8** (above). The original gable end and pitching door in the southeast elevation of the threshing barn

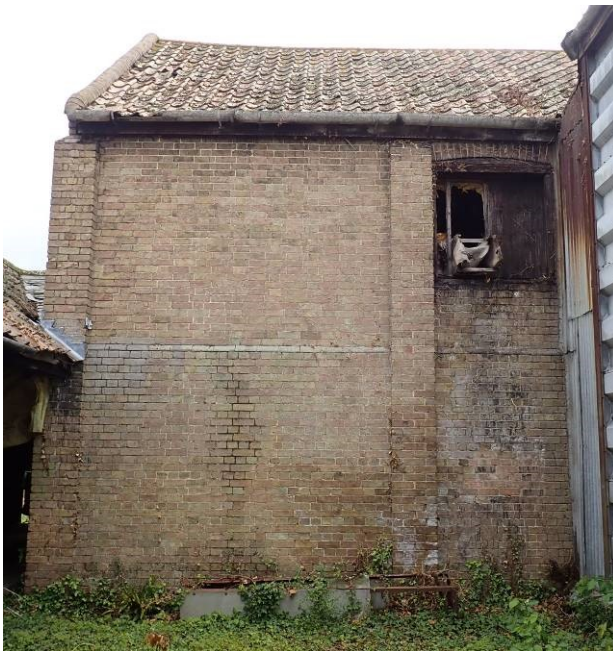
**Plate 10**

Much of the southwest elevation of the threshing barn is covered by a modern corrugated metal extension for grain storage. The northwest end is visible showing that the bricks in English bond forming a plinth continue along the bottom part of this elevation. The window at the eaves height appears to be contemporary with the original phase of the build.

The southwest elevation of the threshing barn, mostly blocked by a modern extension

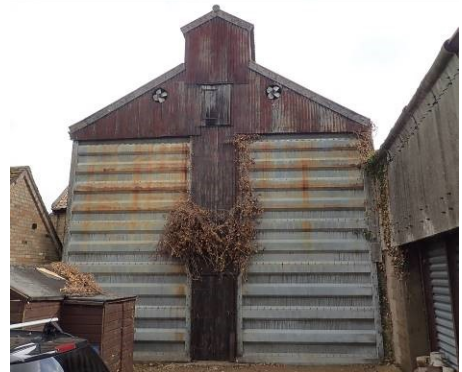
**Plate 11**

The modern grain store that blocks much of the southwest elevation of the threshing barn

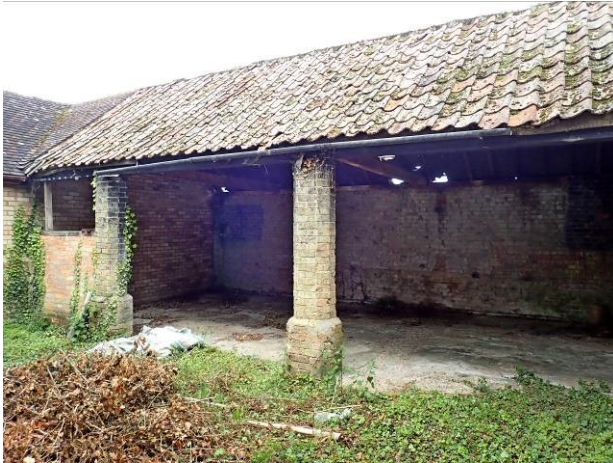
Facing southeast into the crewyard is the open fronted cartshed that extends southwest from the stable and the northwest end of the threshing barn. At the southwest end the cartshed adjoins the converted dwelling, 'The Barn', previously part of the cartshed range.

Two bays survive of what appears to have been a three bay shed. A modern concrete floor has been poured around the hexagonal pillars, which are constructed with left and right handed external angle bricks sitting on wider brick bases.

The pantile roof sits on simple timbers that for the main part appear to be original. At the northeast end there is a door through to the stable.

**Plate 12**  
The southeast elevation of the cartshed, looking northwest

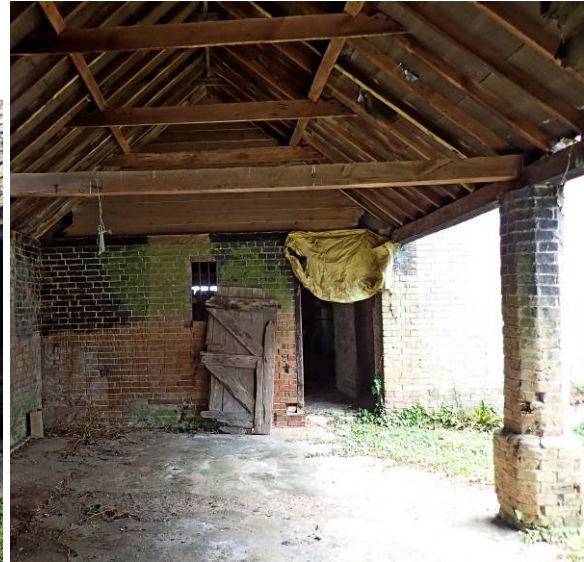
**Plate 13**  
Inside the cartshed looking northeast to the stable

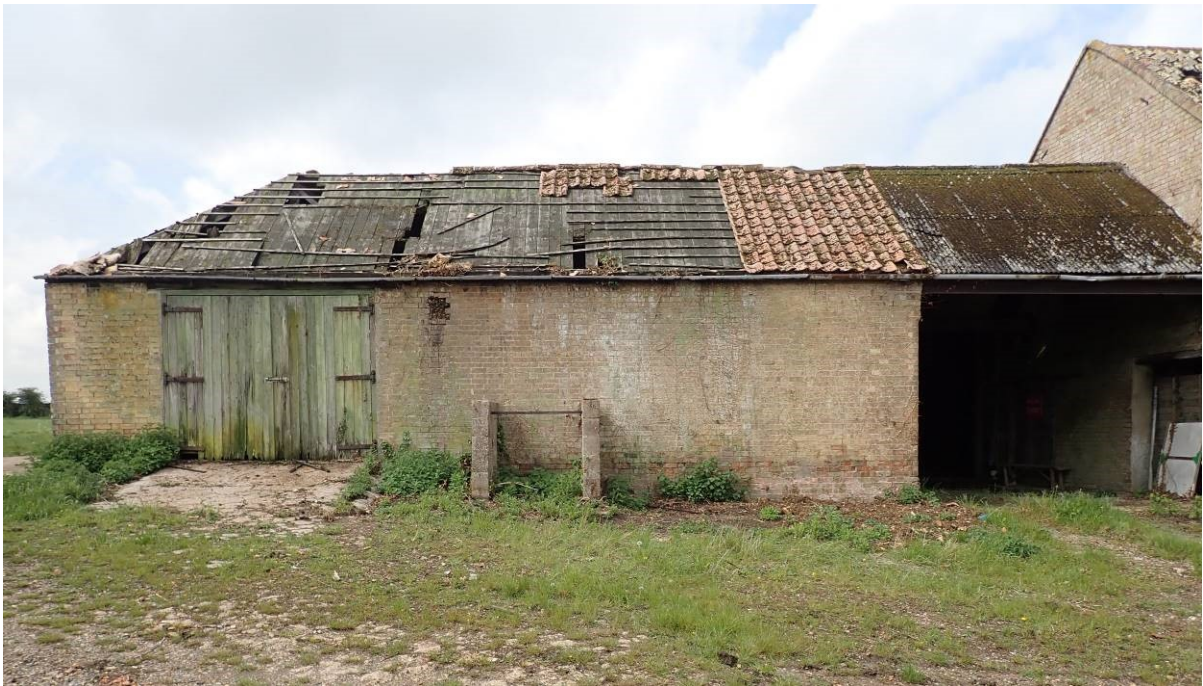
**Plate 14**  
The northeast elevation of the cattle accommodation

The cattle accommodation is also constructed in Sussex Bond. The northeast elevation is mostly featureless while at the southeast end wooden double doors are accessed from a sloping concrete ramp, a later insert for farm machinery.

Much of the pantile roof is missing and the wooden batons to which the tiles attach are stapled to boarded wooden uprights.

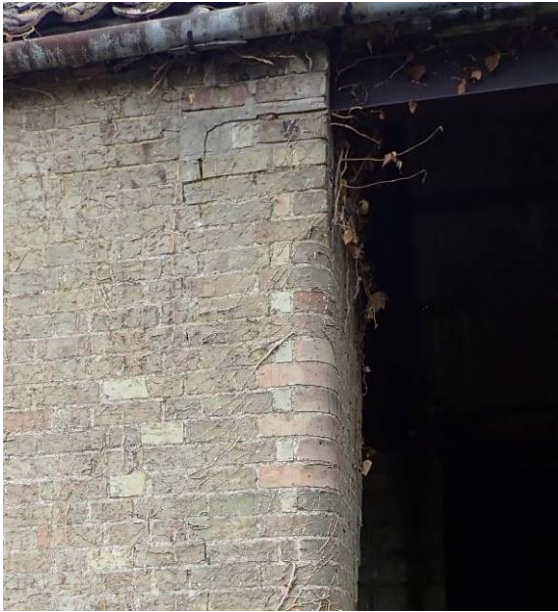
The open northwest end has 'single bullnose'<sup>8</sup> bricks creating a rounded finish to the wall edge suggesting that it was designed as an open front.

An iron supporting beam holds the roof and is seated onto the top of the rounded bullnose bricks where some have been removed and replaced with later bricks of a type other than Warboys yellows.

**Plate 15** (left). Detail of the bullnose bricks at the northern end of the cattle accommodation

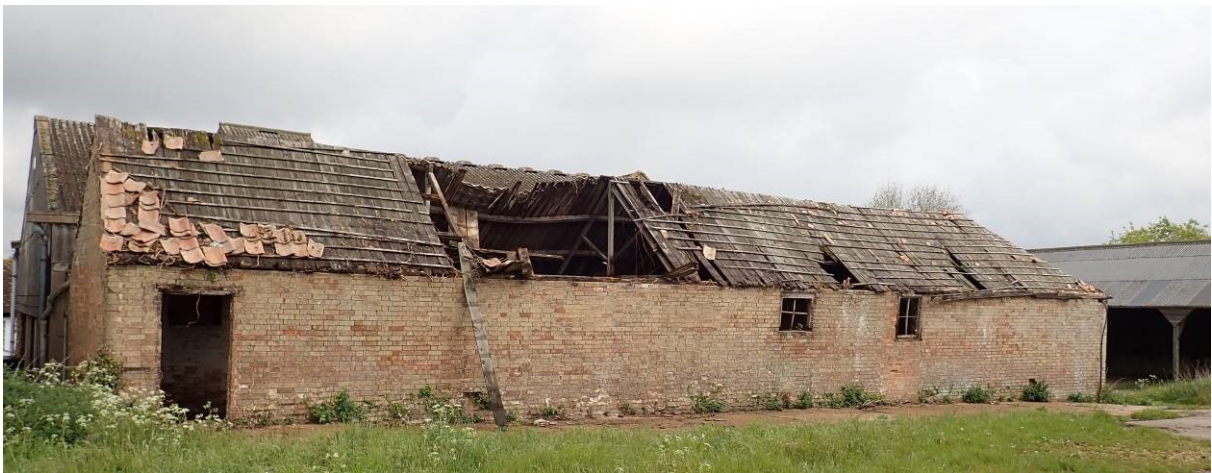
**Plate 16.** The southeast facing elevation of the cattle accommodation, looking north

The southeast elevation of the cattle shed had a door at the northeast end, blocked with plain red brick and a window left in its place. Southwest of this was an original window surrounded by queen closer bricks.

The door at the southwest end is a later addition.

The central part of the roof timbers have collapsed.

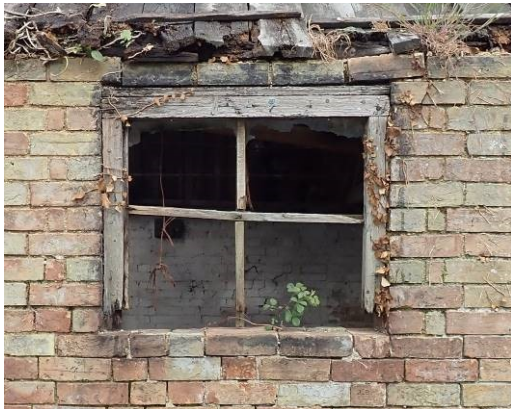
**Plate 17** (above). The original window in the southeast elevation of the cattle shed surrounded by queen closers

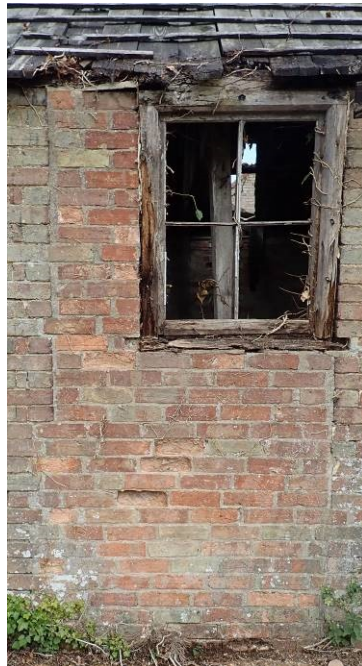
**Plate 18** (right). The blocked door, replaced with a window at the northeast end of the cattle accommodation

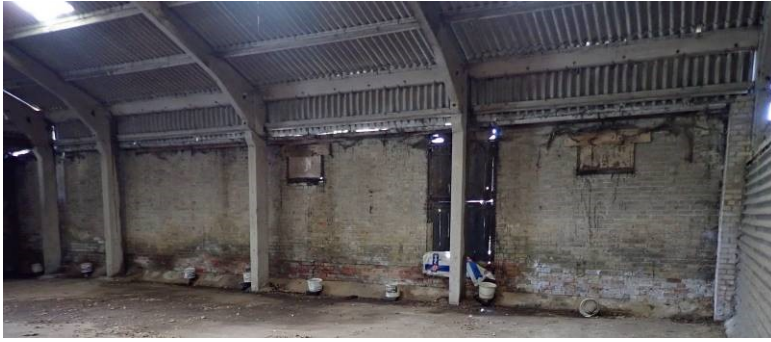
The northwest elevation of the cattle accommodation has a single door leading into the now covered crewyard. The windows either side are topped with segmental arches and are original. The level of the crewyard is now considerably lower than when the cattle shed was used by animals.

**Plate 19.** The northwest elevation of the cattle accommodation

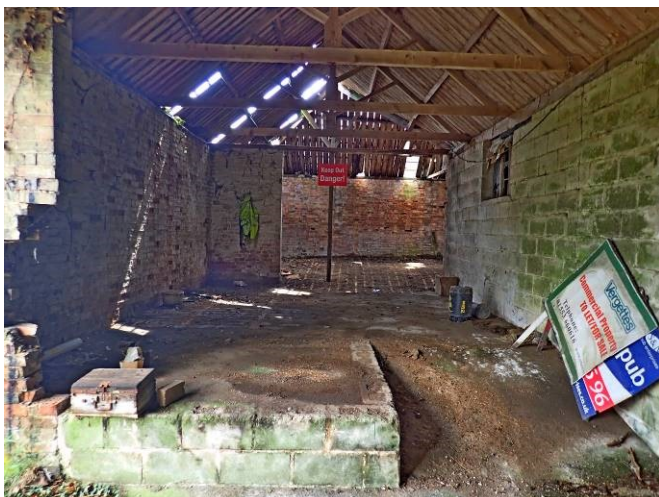
barn and the main animal accommodation. The wall on the southwest side is a modern block wall against which a sloping ramp leads to Room 5.

**Plate 26** (left). The entrance to the cattle accommodation, Room 4, looking southeast

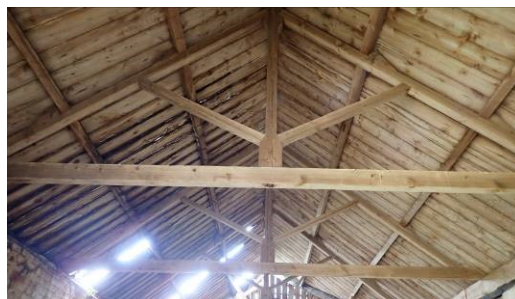
**Plate 27** (below). Detail of the king post roof trusses in Room 4

The main roof structure differs from the threshing barn being of king post construction<sup>14</sup>. The main timbers appear to be original. There are no common rafters<sup>15</sup>, instead boards have been used leaving only the principal rafters<sup>16</sup> and the ridge piece<sup>17</sup> at the top.

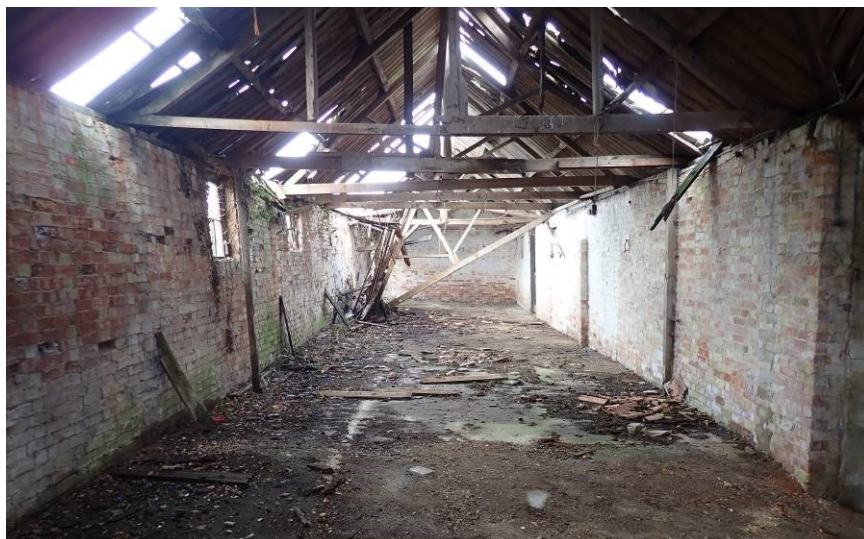
**Plate 28**. Room 5, cattle accommodation, looking southwest

Room 5 has four access points, from Room 4, from the doors in the northeast elevation, from a blocked Dutch door at the southeast end of the northwest wall leading into the crewyard, and from a more recently added door at the southwest end of the southeast wall.

The floor of the cattle shed is concreted and the walls show evidence of scarring where double stalls to hold two animals next to each other have since been removed to allow the space to be used for storing farm machinery. Any fixtures and fittings relating to its previous use have been removed.
