**HISTORIC BUILDING RECORDING
LAND TO THE EAST OF
54 & 56 HIGH CAUSEWAY
WHITTLESEY
CAMBRIDGESHIRE**

Prepared For
Rose Homes (EA) Ltd

APS Report No: **94/19**

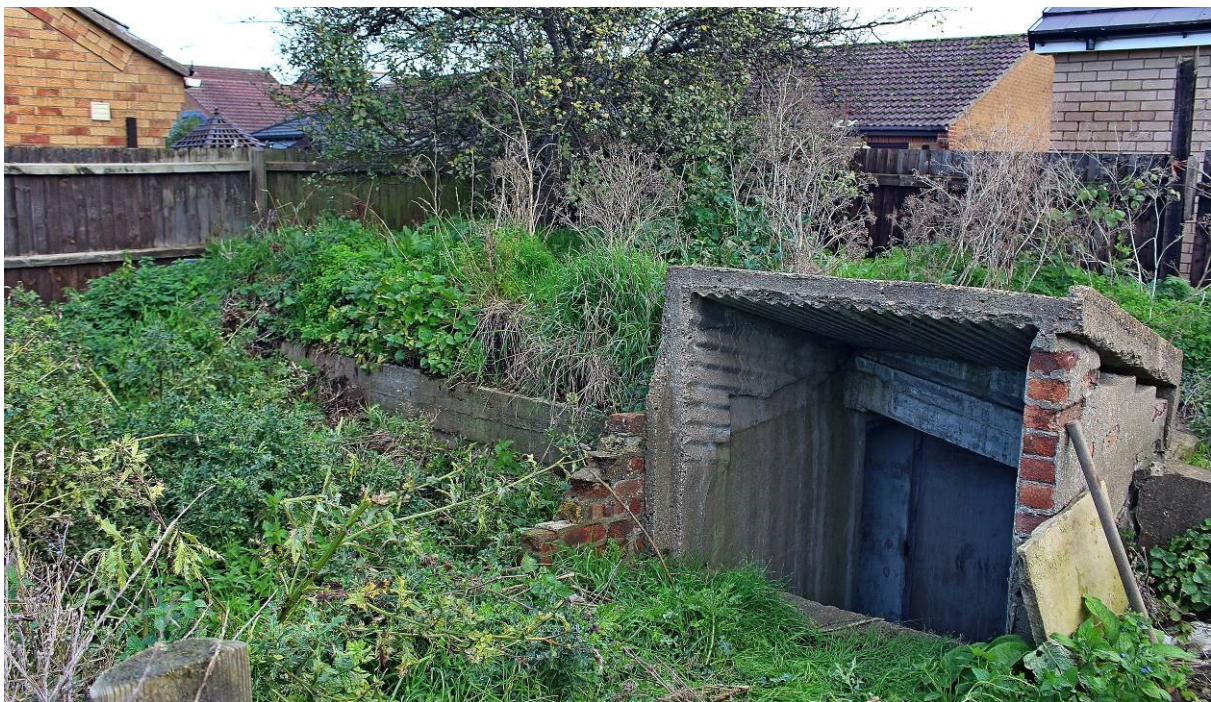
Plate 1. Oblique view of the shelter, looking northeast

The shelter is constructed mainly from concrete beams with some brick walling in the entrance structure. The structure has been constructed to a below ground level of 1.75m (approximately 6ft) and the internal dimensions will be discussed below. The spoil has been replaced over the concrete roof.

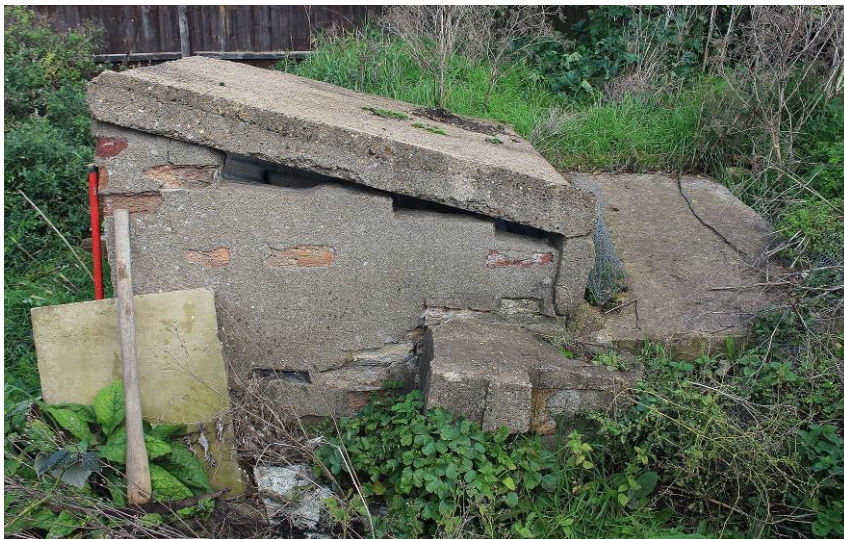
Plate 2. The south elevation of the shelter entrance

The access point for the shelter is constructed from brick and concrete slabs. The southern wall to the shelter 'porch' is constructed from brick laid in stretcher bond.² The wall is angled, the front measuring 1.3m from the top of the concrete roof slab to ground level and 0.7m at the rear. The wall has been rendered inside and out.

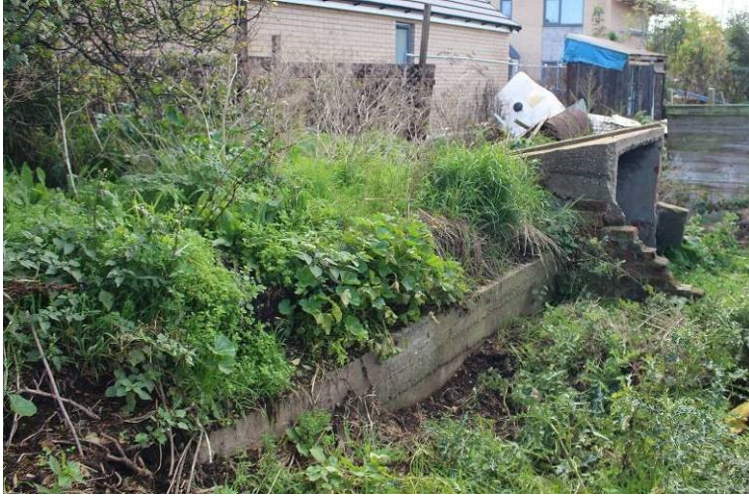
Plate 3. Oblique view of the shelter looking southeast

The sloping roof above the stair is formed from a single 1.53m x 1.53m x 0.1m (5' x 5' x 3") concrete slab. To the east is a 0.5m step down to the 1.53m x 1.22m x 0.1m (5' x 4' x 3") flat slab that covers the entry to the shelter over the base of the stairs.

The northern wall of the entrance is formed from a pre-cast concrete slab laid on its edge and cut to form the angle for the roof.

The remainder of the bunker structure is of concrete beams and is topped with earth, presumably from the excavation of the bunker.

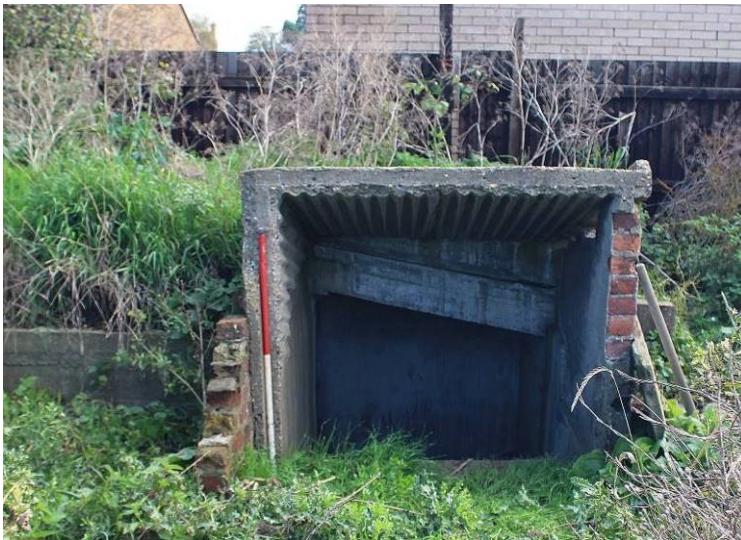
Plate 4. The entrance to the shelter, looking east

Access to the shelter is through the porched aperture of 46" (1.17m) in height. It is not clear whether or not this was originally covered with earth also. The angled brick wall extending from the north wall of the entrance suggests that more earth was banked here and that this may have served as a retaining wall for the soil.

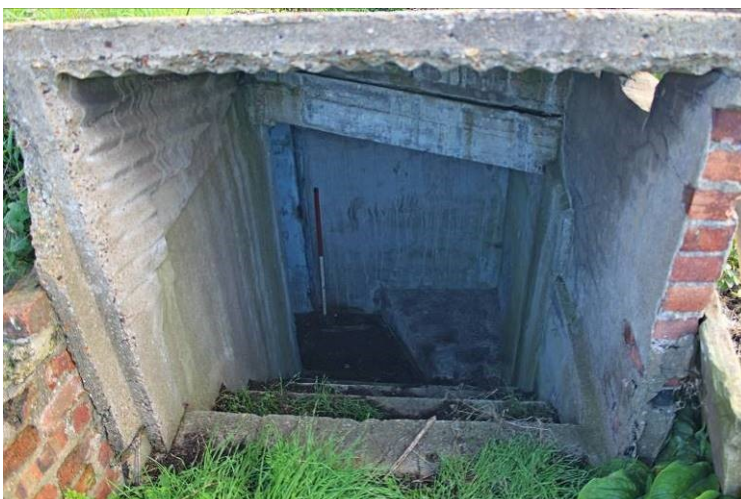
Plate 5. The stairs entering the shelter

The stairs into the shelter are constructed from precast concrete beams and are mortared one on top of the other down the excavated slope. They pass under an angled roof beam, presumably to strengthen the weaker area of the shelter. At the base there is another raised slab over a poured concrete floor.

The sloping roof over the entrance and the angled beam inside above the stairs suggests an attempt to re-inforce the weakest point of the structure. This may at one time also have been covered by some of the earth excavated during the construction of the shelter.

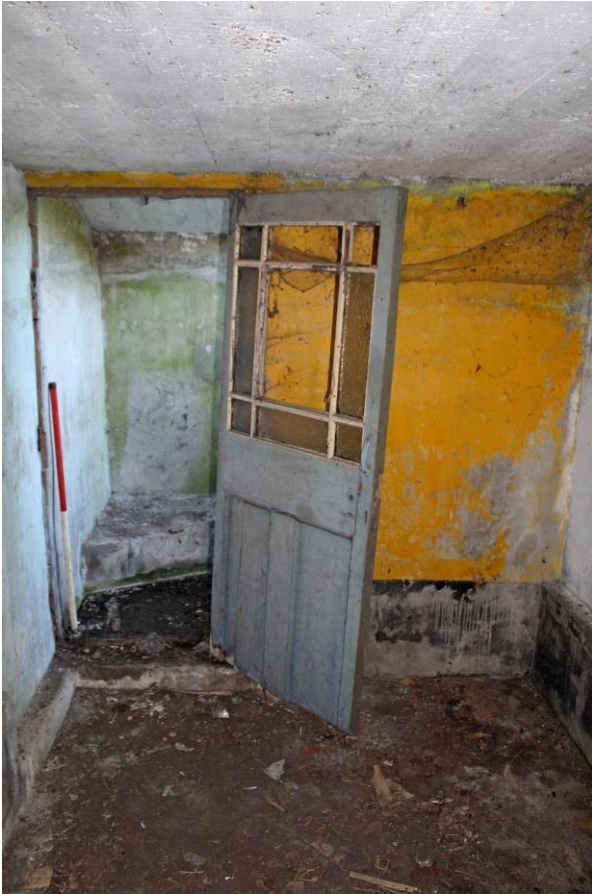
Plate 6. Internal view of the shelter, looking south

Once entered, the floor space of the shelter measures approximately 1.83m x 3.35m (11' x 6') and is 1.83m (6') in height. The entire below-ground construction is of precast concrete beams. The size of the beams could not be readily determined as much of the shelter had been roughly plastered and painted. An internal house door may be a later addition (see discussion).

An intriguing feature of the shelter is the internal door. The frame in which it sits is contemporary with the construction of the shelter. There are no different hinge marks that suggest that an earlier door was present, but the fact that a glazed door has been used is entirely inappropriate for an air raid shelter/bunker of this type. The danger caused by flying glass would have been considerable. Two explanations present themselves. The door, architecturally of the same period as the construction of the shelter, may have been a later replacement after the war when the shelter took on a different use. It is possible that it was hung using the same hinges as the previous door. Another explanation is that, as this was an early shelter, those constructing it had no experience or knowledge of bomb strikes, and were given minimal instruction by the authorities. As such, they did not think of the dangers of the glass in the door. Although nearby Peterborough was not heavily bombed, there were minor air raids between 1940 and 1941 with the heaviest night of bombing occurring on 10th August 1942 when 250 bombs were dropped by two aircraft (Peterborough War Memorial, 2019). Although air raid warnings were sounded, there is no record of Whittlesey ever having been bombed. As such, the glazed door at Whittlesey may never have become an issue that the builders thought to address.

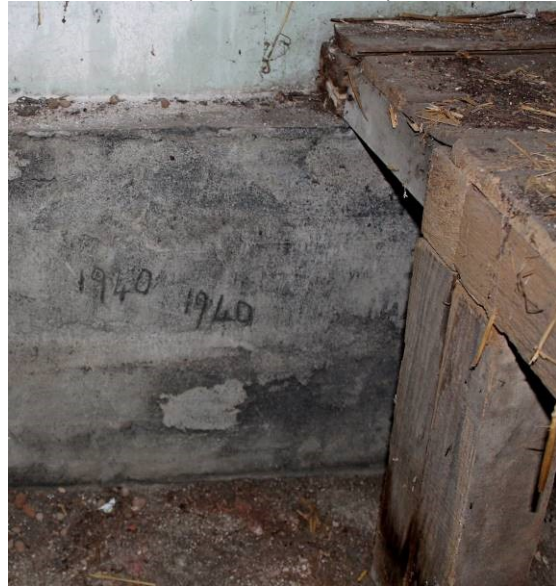
Plate 7. Detail of the date in the northwest corner

Except for immediately adjacent to the entrance, a concreted over lip of bricks, approximately five courses, runs along each of the walls in order to support bench seating. The remains of this are present along the north wall. Just below this, the date of '1940' has been written twice.

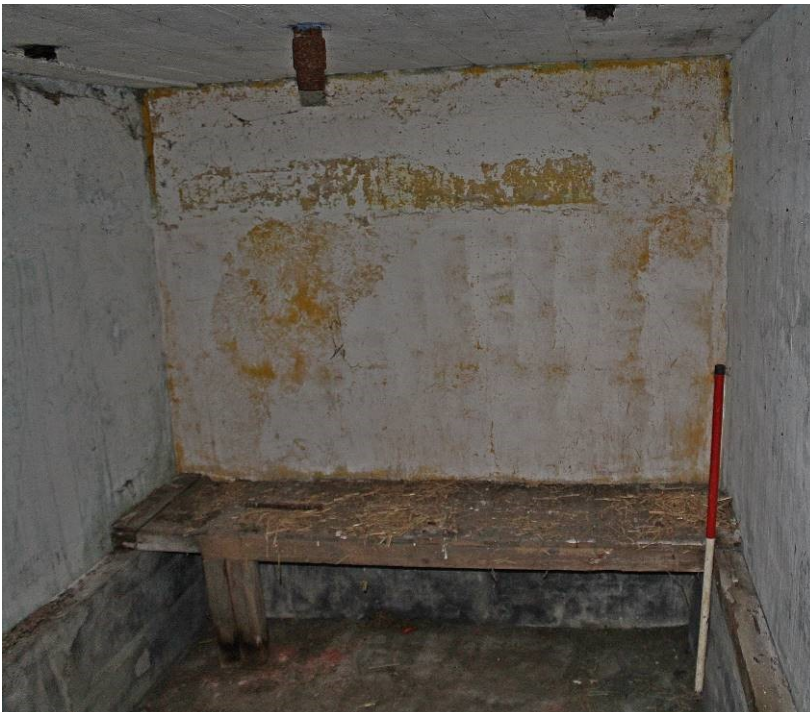
Plate 8. Internal view of the shelter, looking north

In the ceiling are three metal tubes acting as ventilation through holes drilled in the pre-cast concrete.
