**ARCHAEOLOGICAL DESK-BASED ASSESSMENT
OF THE
PROPOSED ANGLIAN WATER SUTTON TO MARCH
REZONE SCHEME
CHATTERIS TO HADDENHAM SECTION
CAMBRIDGESHIRE
(SUMR07)**

Commissioned by Grontmij
On behalf of
Anglian Water Ltd

January 2008

A.P.S. Report No. **2008/08**

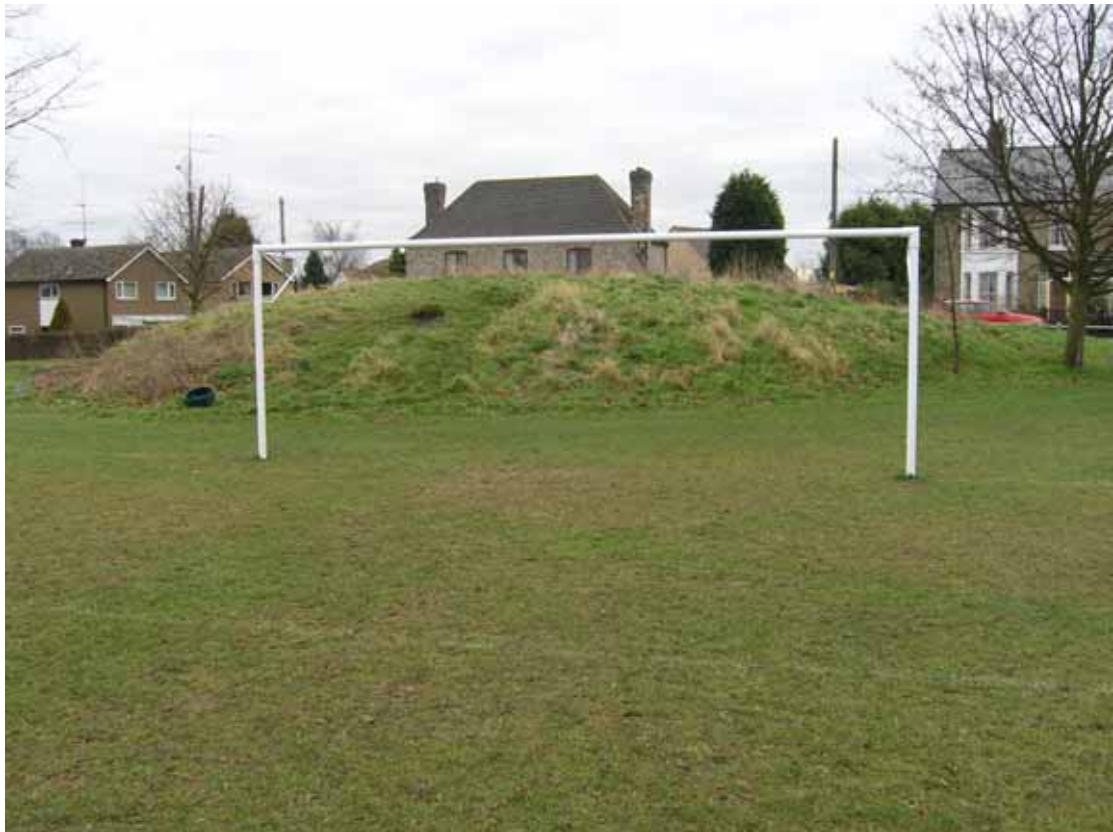
Plate 2 Extant mound on playing fields at Haddenham, looking east

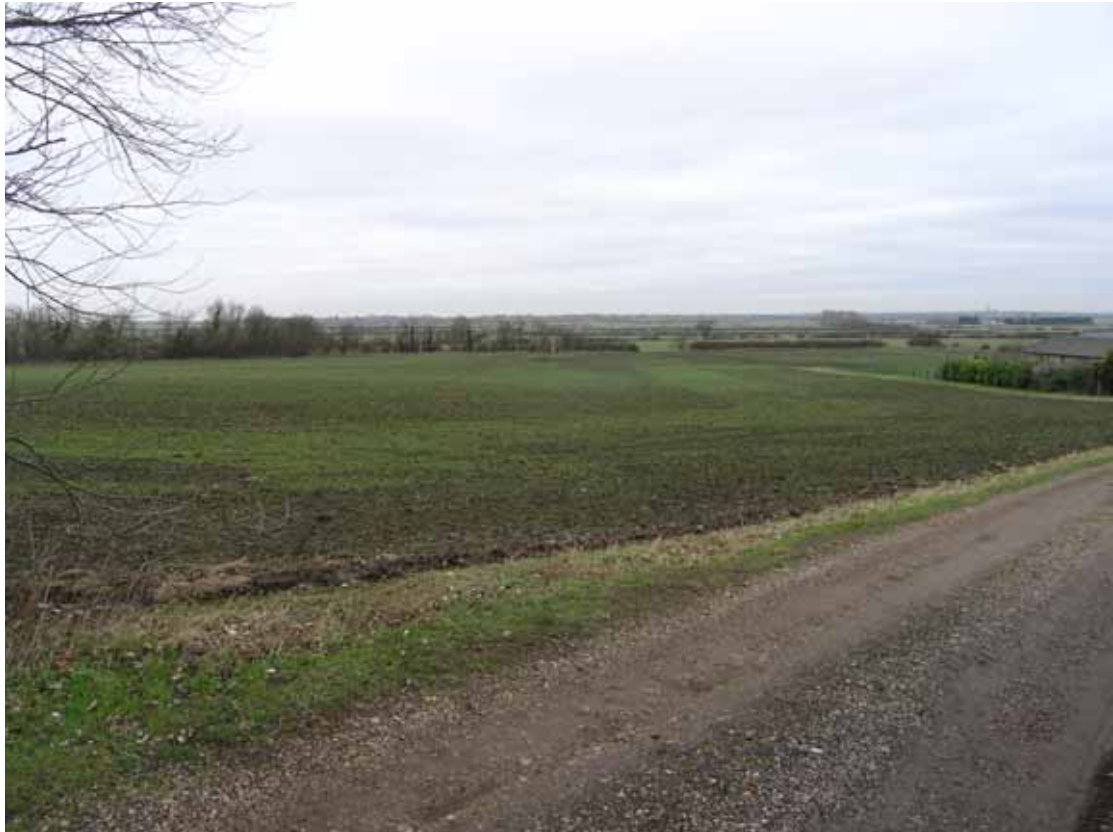
Plate 3 Earthworks leading to the original site of Hinton Hall, looking northeast

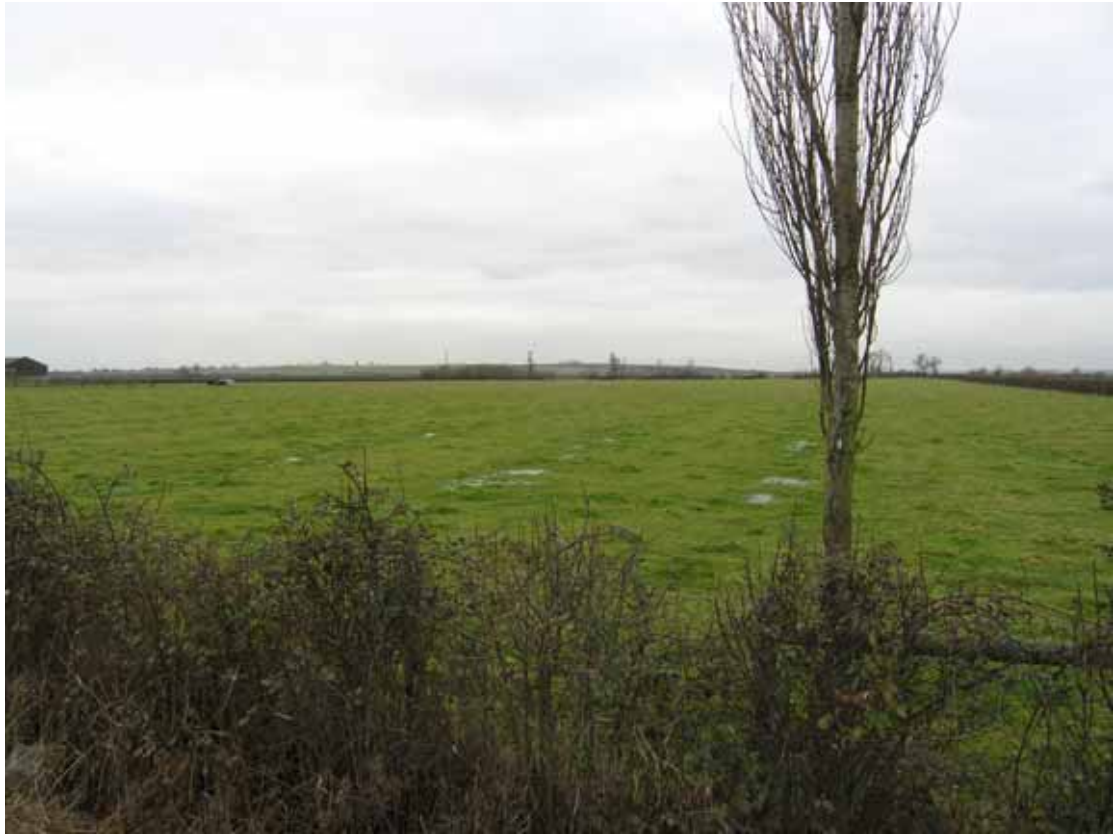
Plate 5 Extant ridge and furrow at New Farm, Haddenham, looking west

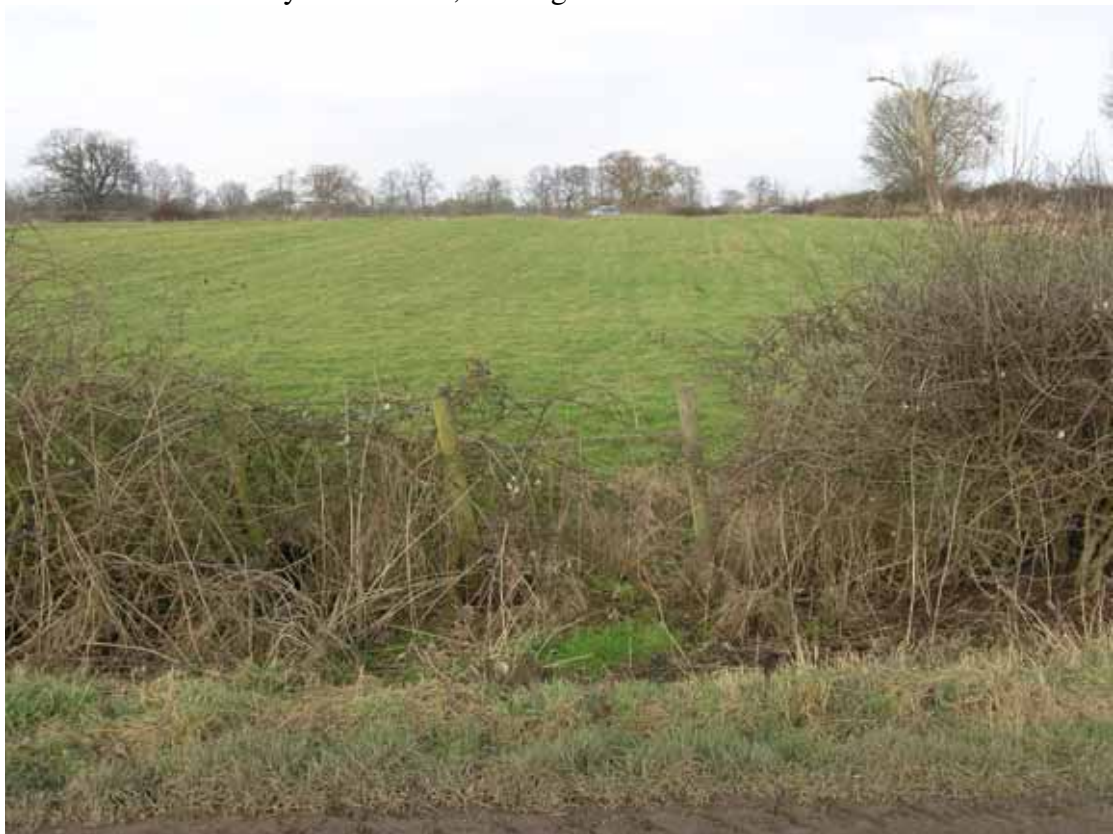
Plate 8 Extant ridge and furrow at Campole Drove, Chatteris, looking northwest

Intact ridge and furrow was noted in a fragment of pasture cut off from a larger block of land by the Chatteris bypass (Figure 7, Map Reference 57). The field is bounded by Campole Drove to the southeast and is passed by the pipeline route immediately to the northeast.
