**BUILDING RECORDING AT  
BRIDGE COTTAGE  
SHEPHERD'S WALK  
BELMESTHORPE  
STAMFORD  
RUTLAND  
(BESW08)**

Work Undertaken For  
Mr and Mrs C. H. King

April 2008

A.P.S. Report No. **47/08**

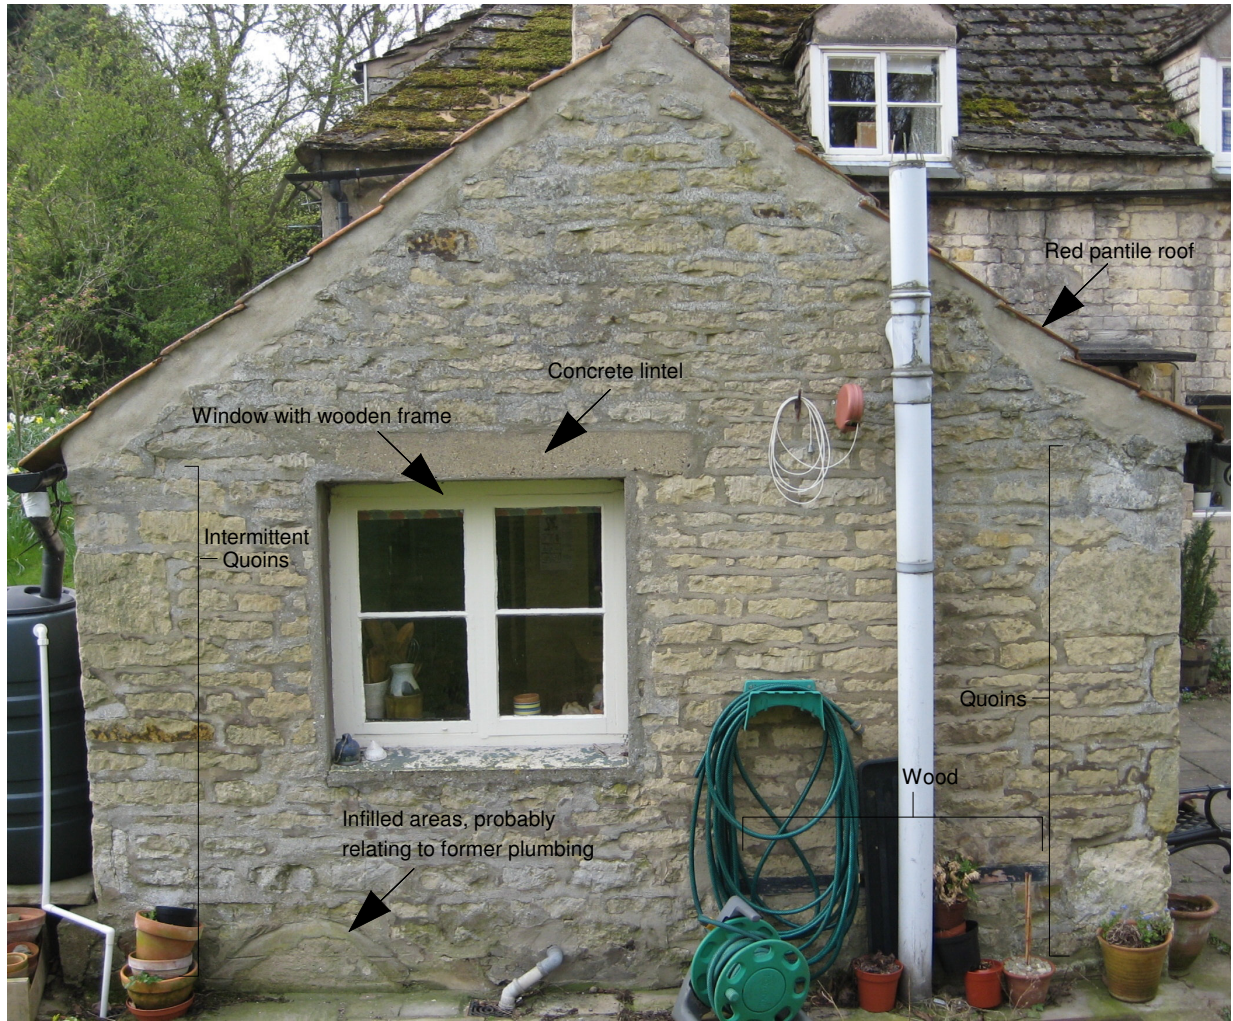
Figure 4 Plan of recorded wall and annotated external elevation

Externally, the recorded elevation comprised a single storey gable end of stone, with a pitched roof of red pantiles (Figure 4). The stones of the majority of the wall were apparently roughly squared, although the shape of individual stones was obscured by mortar. At the western edge, the wall comprised larger blocks forming quoins (angular courses of stone at the corner of a building), whilst at the eastern edge quoins were only intermittently present. The overall thickness of the wall was c.0.49m.

A single opening in the wall contained a window with a wooden frame, the surround and lintel of which were of concrete (Figure 4).

A single piece of wood was visible near the western side of the elevation, sandwiched by the stonework (Figure 4). The wood was 1.00m long and 60mm high, its base being 0.34m above the present ground level. Whilst the function of this wood is unclear, it seems probable that it relates to the previous use of the building, and is likely to represent part of a blocked opening.

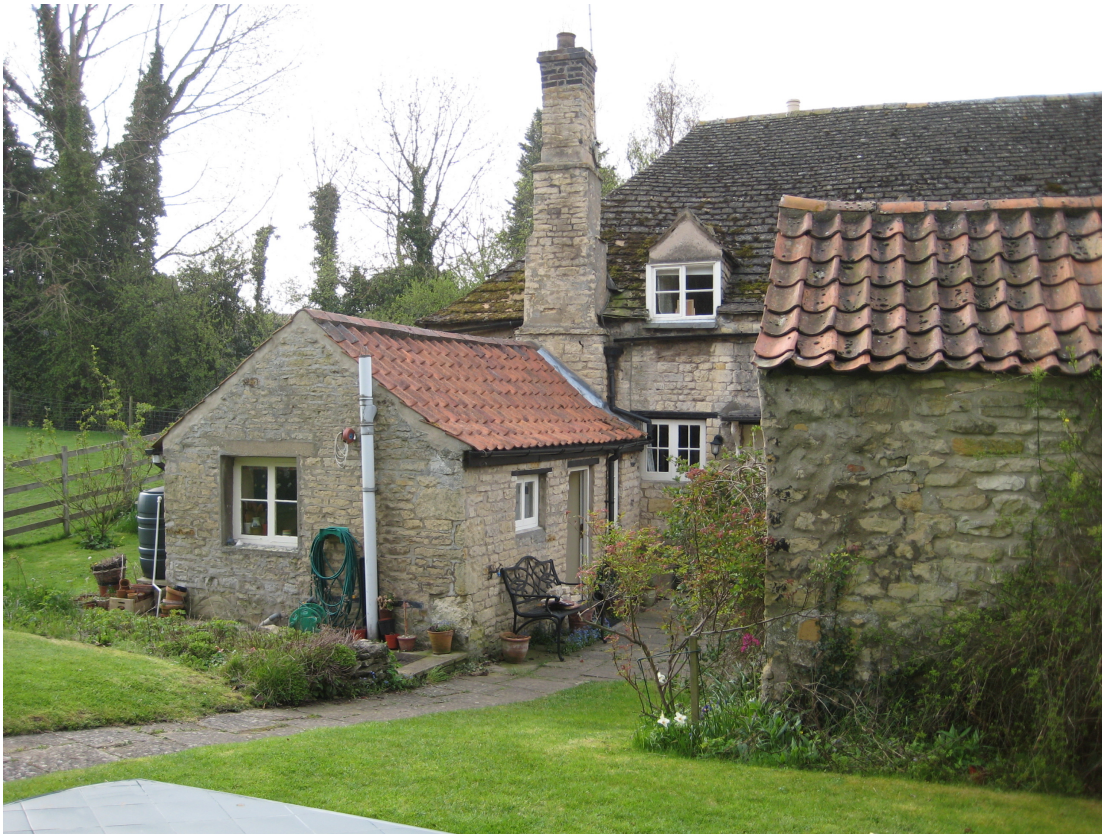
Plate 3  
View showing  
north elevation of  
kitchen wing to  
be altered by  
extension and  
main building of  
Bridge Cottage  
and outbuildings,  
looking southeast

Whilst the remainder of the northern wing was not examined in detail, it appears to butt against the main building, the eaves slightly overlapping a window of the main building (Plate 3).

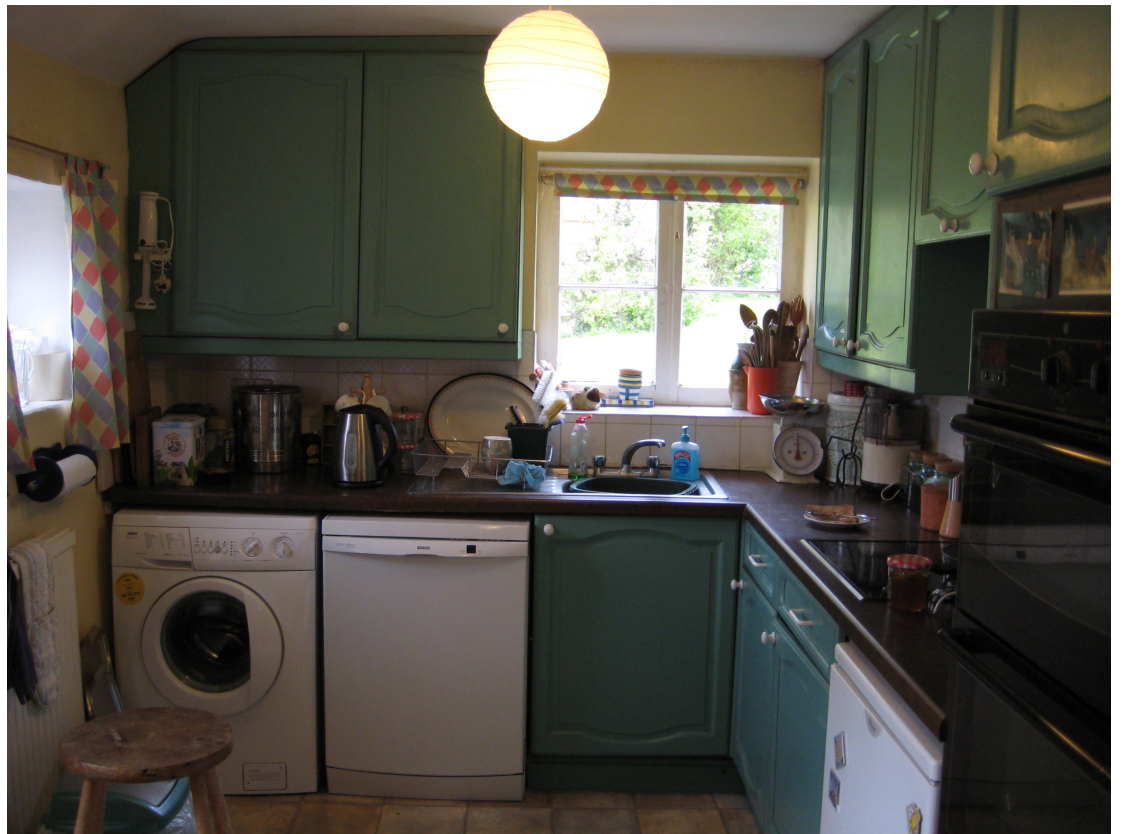
Plate 4  
Detail of south  
elevation of  
northern wall of  
kitchen wing to  
be altered by  
extension,  
looking north

Internally, the majority of the wall was obscured by fitted kitchen cupboards, sink and appliances (Plate 4). Where the internal wall was visible, this was plastered and painted and partially tiled.
