**BUILDING RECORDING AT
MARSH FARM,
BURNHAM DEEPDALE,
BRANCASTER,
NORFOLK
(51641)**

Work Undertaken For
Thomas Faire Chartered Architects

August 2008

A.P.S. Report No. **91/08**

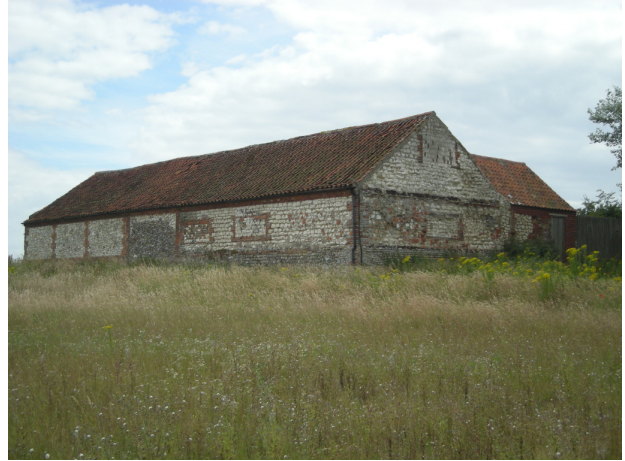
Plate 4 – The north and west elevations showing blocked openings from the northwest

Three blocked windows are apparent on the north side of the building and one each at the gable ends (Plates 3 and 4). Brick edging indicates two further openings in the gables existed close to the apex of the roof. All these openings would be too large for a threshing barn.

The overall plan is of one phase, though Building 2 is modern but may use pre-existing foundations of the former west range. Blocked doors within the barn indicate a change of function once threshing was no longer practised, perhaps by the mid 19th century. Additionally, the barn has numerous blocked windows. While these are larger than would normally be expected for a threshing barn, they may have served as ventilator windows and had a brick honeycomb or wooden lattice insert in each. The uppermost openings in the gable ends suggests that an owl hole may have also been part of the design.

These upper openings have also been truncated by the roof line. This indicates that not only were these openings taller originally but also that the building had a higher roof which has since been lowered. The roof trusses of the barn incorporate brick-built posts that support the purlins and straining beams. Such brick columns are unusual, not least in the extra weight the tie-beam has to support.

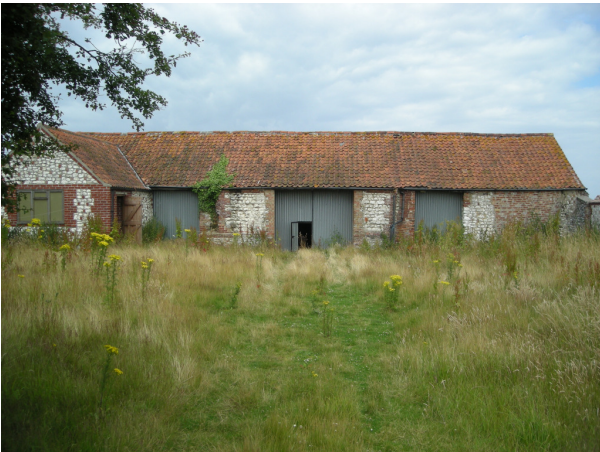
Plate 2 – The threshing barn (Building 1) from the south

Building 1 is the northern east-west aligned barn of six bays. Its external dimensions are 22.82m long by 7.77m wide. Three entrances are apparent in the south side of the building (Plate 2). Centrally positioned, the widest (3.1m) has a broadly corresponding entrance on the north side of the building which has been blocked. One of the timbers that form the top of the open entrance is re-used, with notches for floor joists. This extant entrance also has thickening of the walls on either side. Two smaller entrances lie to either side.

entrance is a large expanse of brick, which extends to the full height of the elevation. Although the joins at either side of this are ragged, they are both quite vertical. While this brickwork has the appearance of a blocked doorway, it is not evident on the interior of the building, nor is there any other internal indication of infilling or a blocked entry.

An expanse of brick in the southern wall of the barn is thought to be patching of the elevation face, as there are no internal indications that there was previously an entry here.

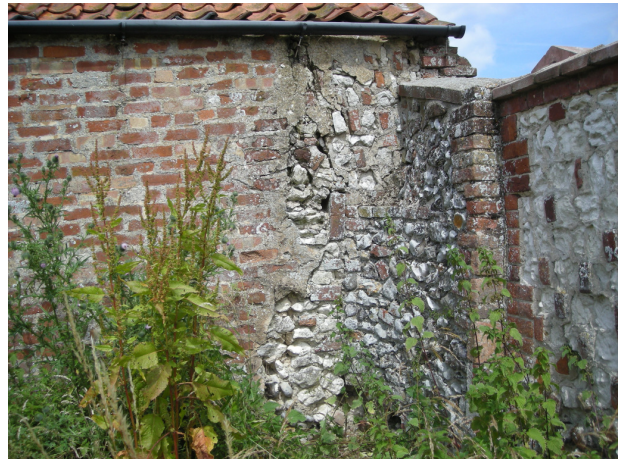
Plate 5 – Ragged join at southeast corner of the barn, looking northeast

At the very eastern end of the southern elevation is a short length of wall aligned north-south. This is of flint with brick edging at the southern end. The lower part of the wall has a concave inner (western) face that is topped by a course of bricks. Above this brick layer the wall is straight-sided.

By the late 19th century the present courtyard arrangement had been created, the eastern courtyard wall butting against the stub wall at the southeastern corner of the barn. It is possible that the stub wall marks one side of a former entrance gap between this arrangement and the eastern courtyard, this latter area perhaps functioning as a stock yard.

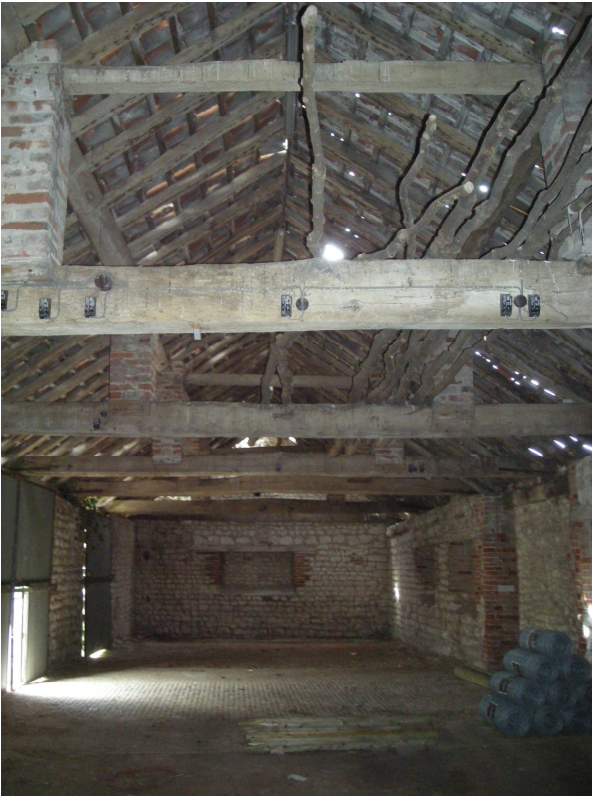
Plate 7 – Threshing barn, roof detail

The roof is supported by 7 chamfered tie-beams upon which are brick built posts supporting a straining beam in a similar fashion to a Queen post roof truss (Plates 7 and 8). Iron fittings associated with the beams were noted, and the chamfers mostly terminated in step stops, with one having a run-out stop. Most of the beams have slots in their undersides, and pegholes alongside these on either side.

Slots, flanked by pegholes, were evident in the bases of the tie-beams. These may imply the former presence of timber partitions in the barn.

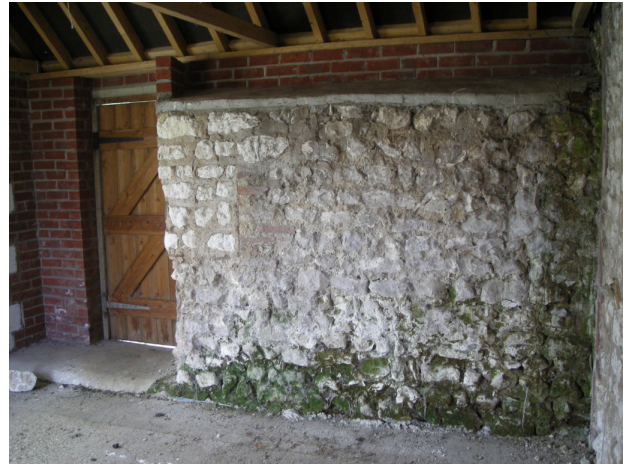
Plate 9 – Building 2, interior view showing modern door and original walling, looking southwest

brick elements (Plate 10). The west wall is of chalk rubble and has had a recent door inserted into it (Plate 9). The north wall is open above eaves level. A blocked window is indicated by hand-made brick edging on the interior and exterior of the west wall. The floor is of concrete.

The original west range is represented only by Building 3 and a short length of wall in Building 2. This latter structure is largely a modern addition, though may utilise the building footprint of the west range known from Ordnance Survey mapping. The absence of a joining wall between Buildings 2 and 3 may indicate that such a wall never existed and that this range may have been an open sided animal or cart shelter. Building 3 may have functioned as a store room.

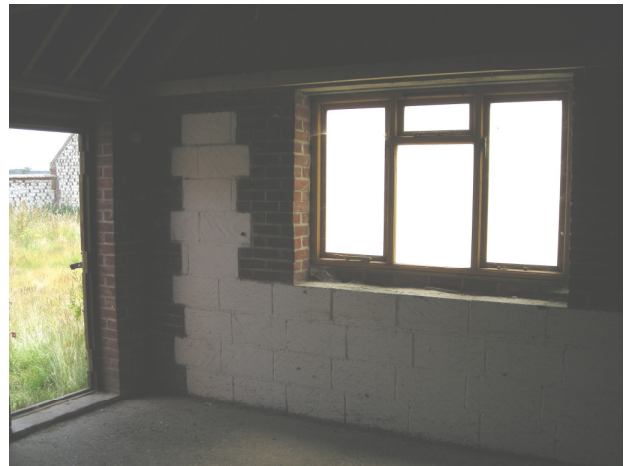
Plate 10 – Modern south wall of Building 2

This is largely a modern addition. It measures 5.14m east-west and 4.69m north-south. It has a simple ridged roof and concrete floor. The east and south walls have breeze block and machine-made

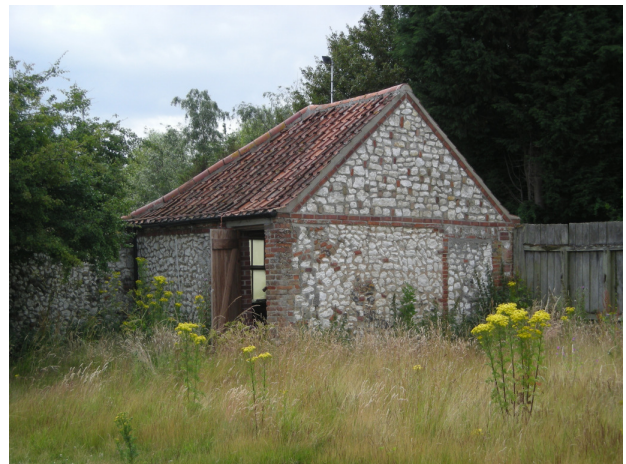
Plate 11 – Building 3 from the northeast

This building measures 5.08m wide (E-W) and 5.16m long (N-S). The north and east walls are largely original and most of the west wall. The south wall has had a more recent window and door inserted (Plate 12), necessitating a partial rebuild. There is a blocked doorway within the north wall (Plate 13). Above this, the gable is constructed of breeze blocks internally, with coursed chalk on the exterior face.

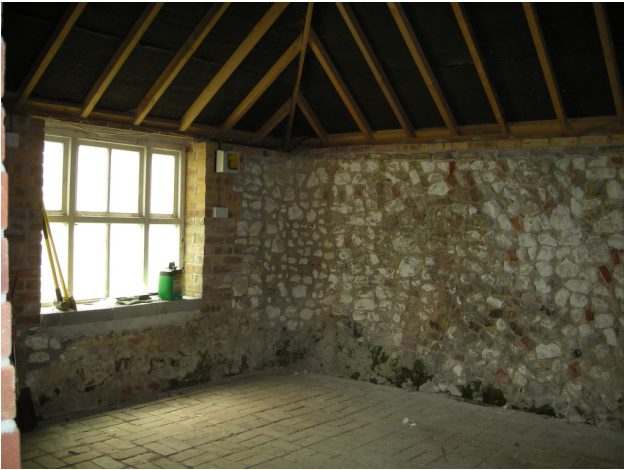
Plate 12 – Interior view of Building 3 showing brick floor

The floor is of hand-made brick laid in a paired pattern. The roof is a modern replacement and is hipped on one side (the south).

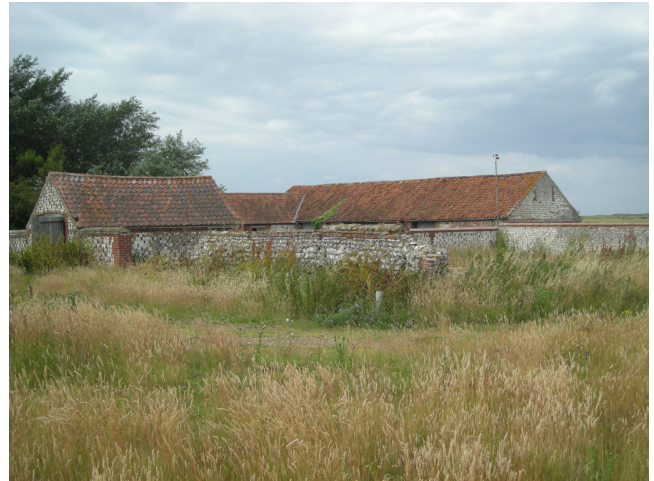
Plate 15 – View showing the remnants of the eastern courtyard, looking northwest

The eastern courtyard is in a poorer state of preservation. It comprises chalk and flint rubble walls with brick quoins and coping stones, though these are largely absent from the east and north walls (Plate 15). No evidence of any internal buildings or walls was apparent.

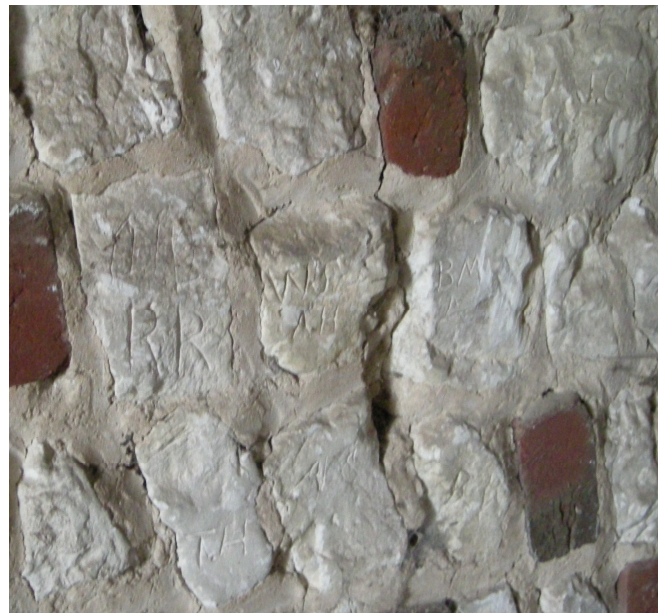
Plate 16 – Graffiti on interior west wall of Building 4

This building measures 7m long by 4.5m wide. All walls are of coursed chalk rubble with decorative brick inserts and brick quoins and door surrounds. The building is all of recent construction above the eaves level and the south facing double door is a more recent insert (Plate 14). The door on the west wall may also be an insert into an earlier door opening as the brick surround continues to the eaves level. It has an earth floor and there is much incised graffiti on the interior, particularly the west wall. This graffiti is mostly initials and dates, the earliest noted being 1947, though some of the marks may be earlier.

clear reason why this structure contains so much mid 20th century, and possibly earlier, graffiti.
