**ARCHAEOLOGICAL INVESTIGATIONS
AT
ALL SAINTS CHURCH,
EAST BARSHAM,
NORFOLK
(12243)**

**Work Undertaken For
East Barsham Parochial Church Council**

APS Report Number **75/08**

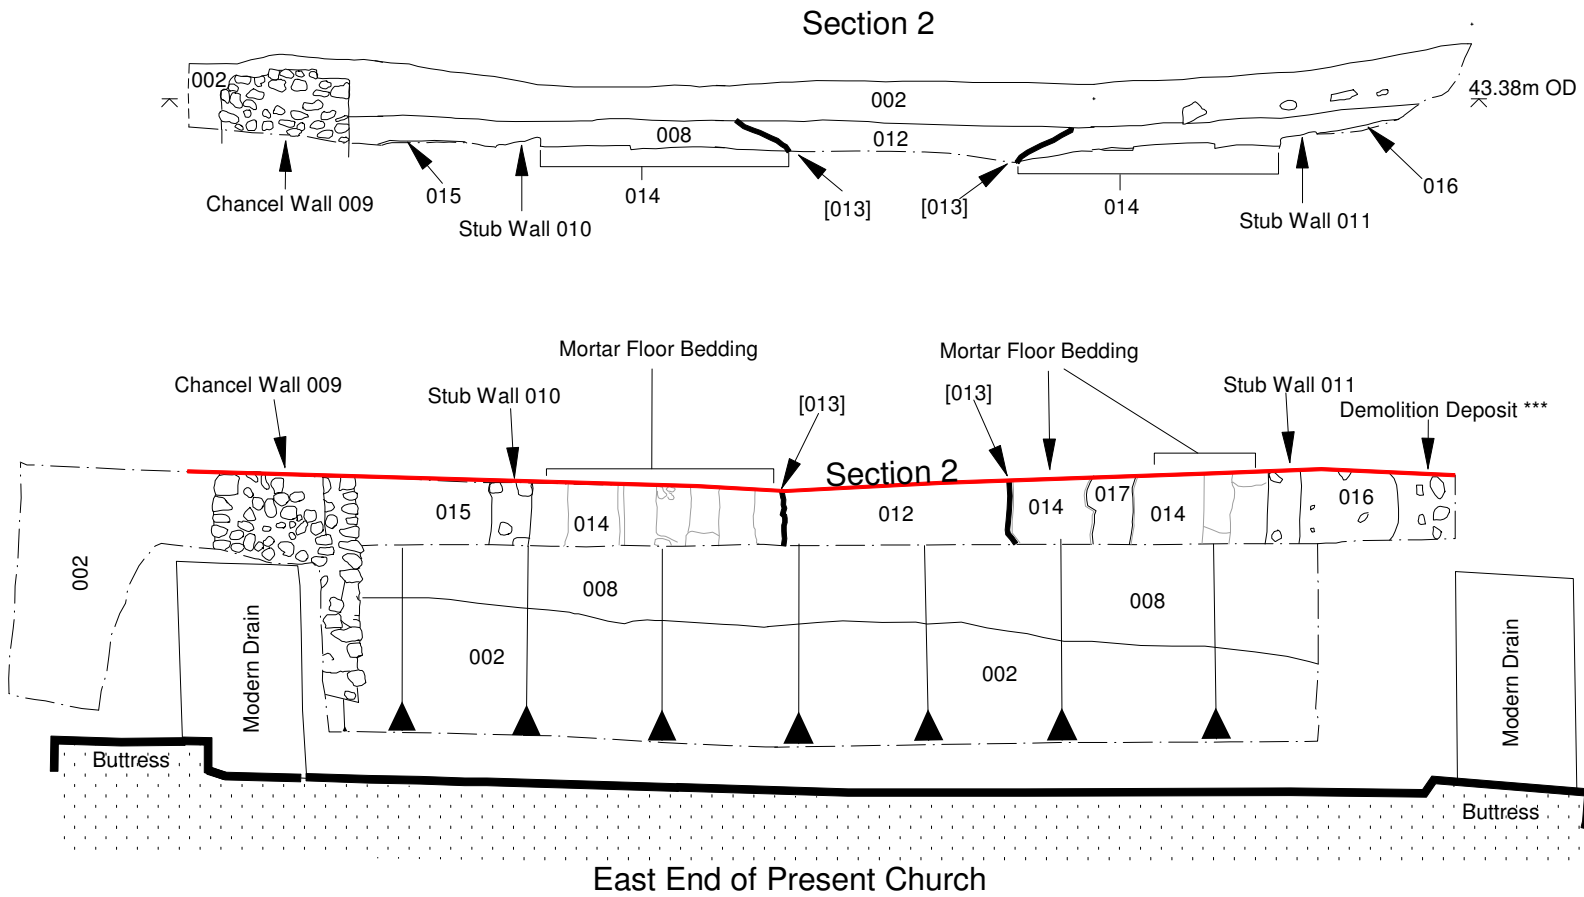
Figure 4 Chancel Excavation: Plan and Section

The earliest deposit identified was a mid-brownish slightly orangey sand (017), partially exposed beneath Phase 3 mortar bedding (014) (Fig. 4). The sand layer was undated.

At the northern end of the trench was the north wall (009) of the chancel (Fig. 4 Plates 2 and 3). Constructed of uncoursed flint rubble, set within a brownish yellow sandy lime mortar, wall (009) was 0.87m wide and was exposed to a depth of 0.55m. The wall stood above the medieval floor level (see below), indicating that it was free standing. At its highest point the wall survived to within 0.08m of the present ground surface. Further traces of this demolished wall are evident in the eastern gable wall of the surviving church.

Two east-west aligned flint and chalk stub walls (010) and (011), identified within the former chancel possibly indicate the former position of interior fittings. Although the chancel floor surface had been removed the mortar bedding for the flooring (014) survived. Impressions in the surface of this mortar indicate that the floor was constructed of tiles approximately 0.20m wide laid lengthways on an east-west alignment.

A single 9.50m long trench across the site of the former chancel was excavated (Figs. 3 and 4, Plate 2). Earthworks resulting from the mounding of deposits over buried walls meant that the extent of the buried chancel could be determined on the ground.

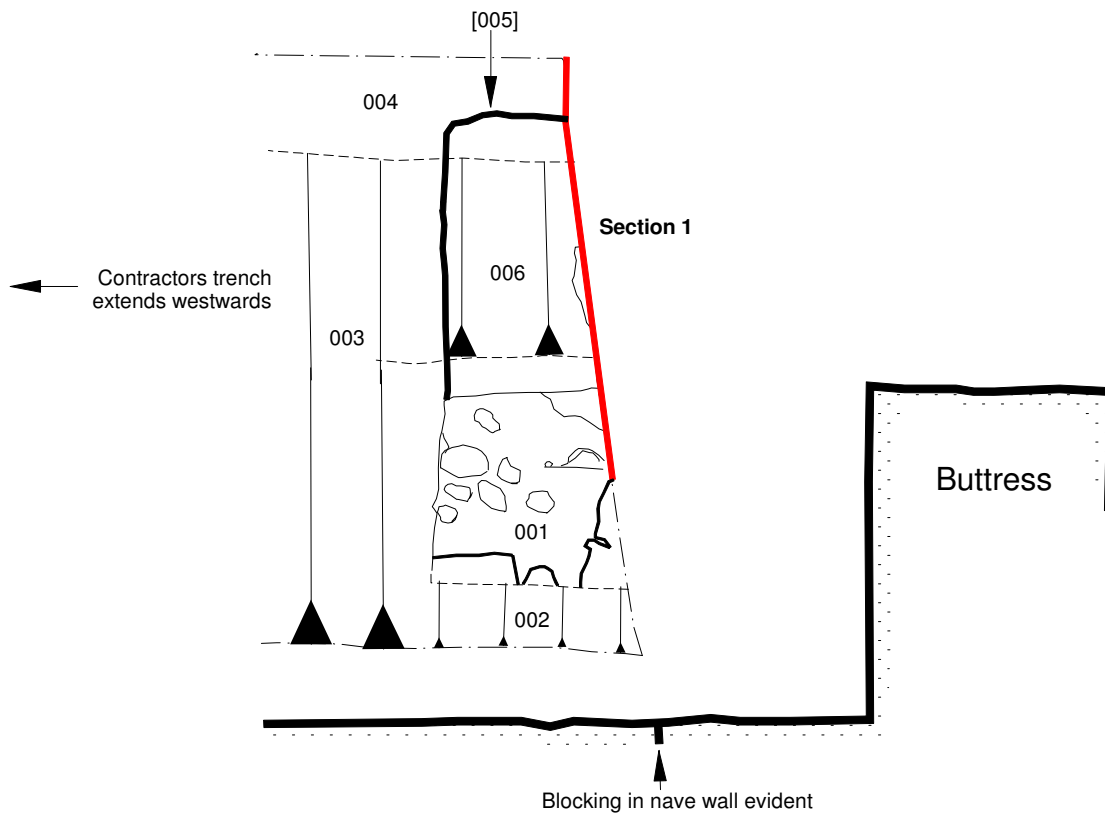
Figure 6 Plan of northeast corner of the church showing Section 1

Near the northeastern corner of the nave was a flint rubble wall footing (001)=(007). Aligned north-south, this footing survived to a length of at least 0.85m and was bonded with a loose yellowish brown mortar (Figs. 3 and 6, Plate 4). Traces of wall survive above this in the upstanding nave elevation and it is possible that (001)=(007) represents a former buttress demolished when the church was rebuilt.

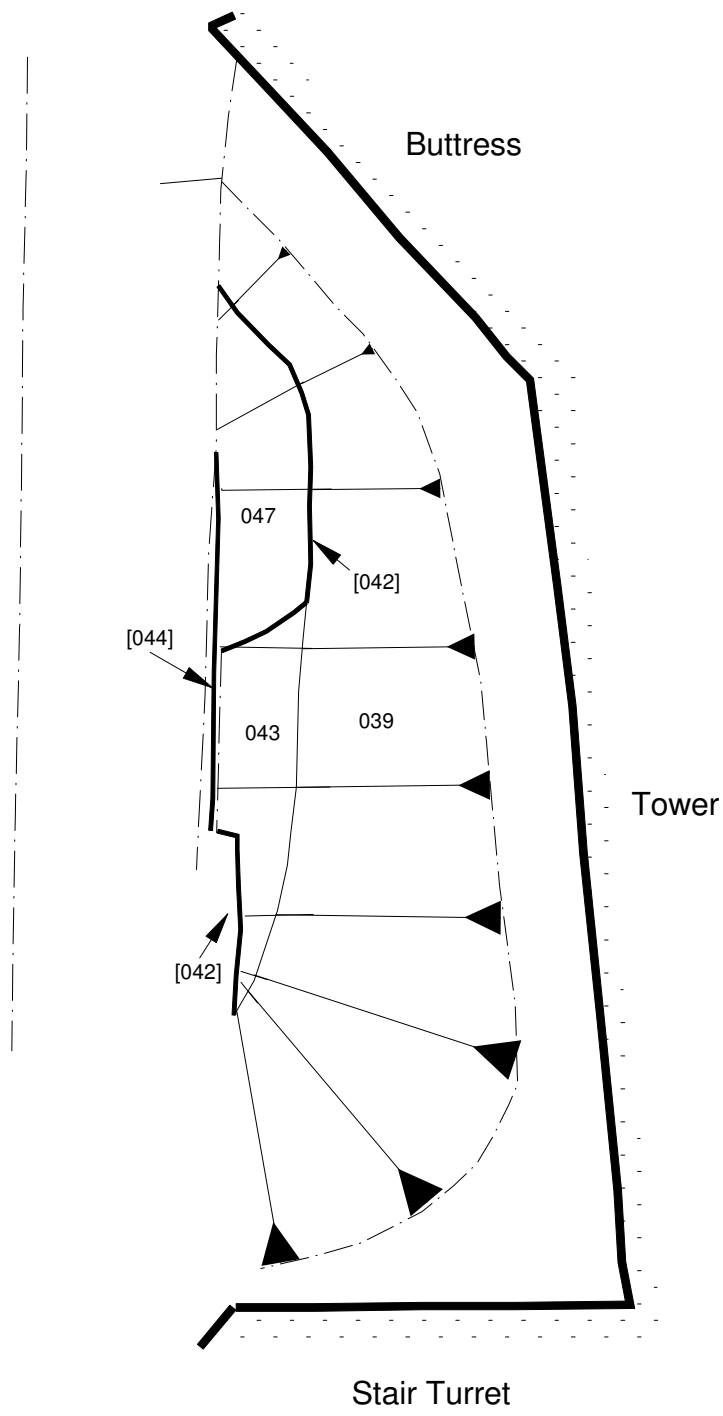
Figure 7 Plan of deposits at the northeast corner of tower

West of the tower, deposits of yellowish brown clayey sand (047) and sandy clay rubble (046) were identified as demolition debris. These were truncated by an east-west aligned cut [044], which may represent a grave as disarticulated human bone was present within its fill (043) (Fig. 7).

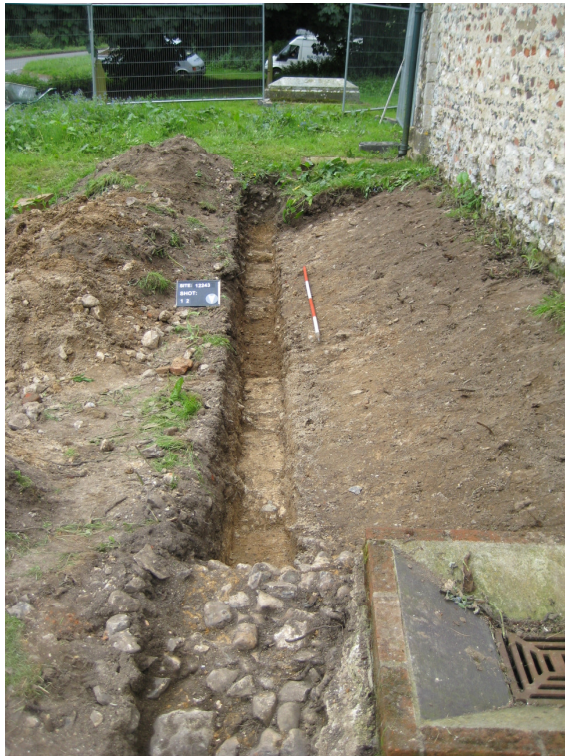
Plate 2 South facing view across Chancel excavation with wall (009) in the foreground

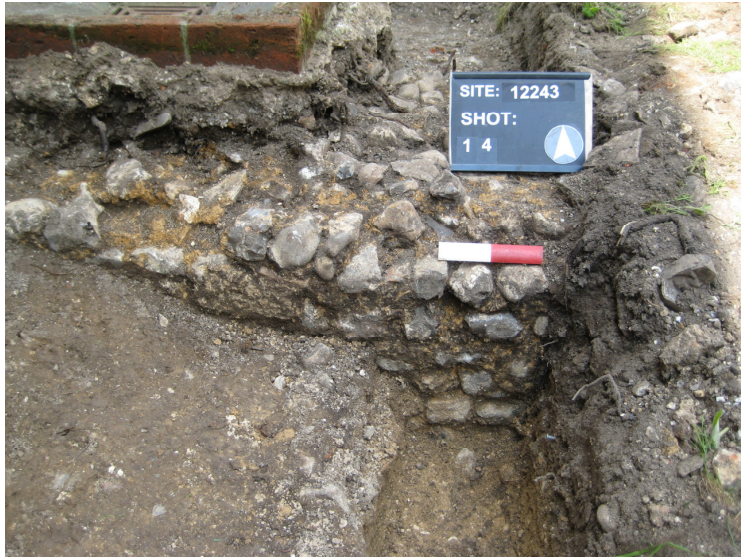
Plate 3 North facing view of wall (009) showing detail

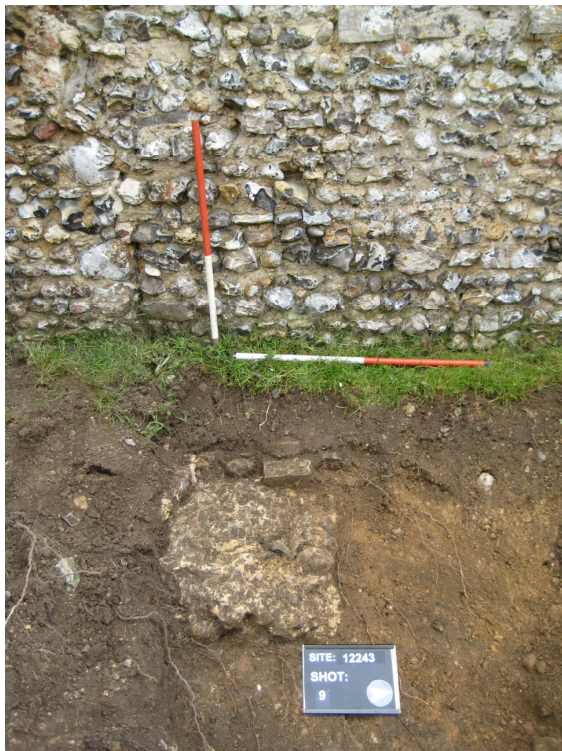
Plate 4 South facing view wall (001) showing alterations to flint work in the north nave wall

A short length of wall foundation found adjacent to the northeast corner of the nave probably represents a former buttress. Further evidence of this structure is apparent in the nave elevation above the foundation where scarring shows indications of a demolished wall. It is possible that this buttress was removed and relocated 0.8m to the east, where a buttress currently stands, when the chancel was demolished.

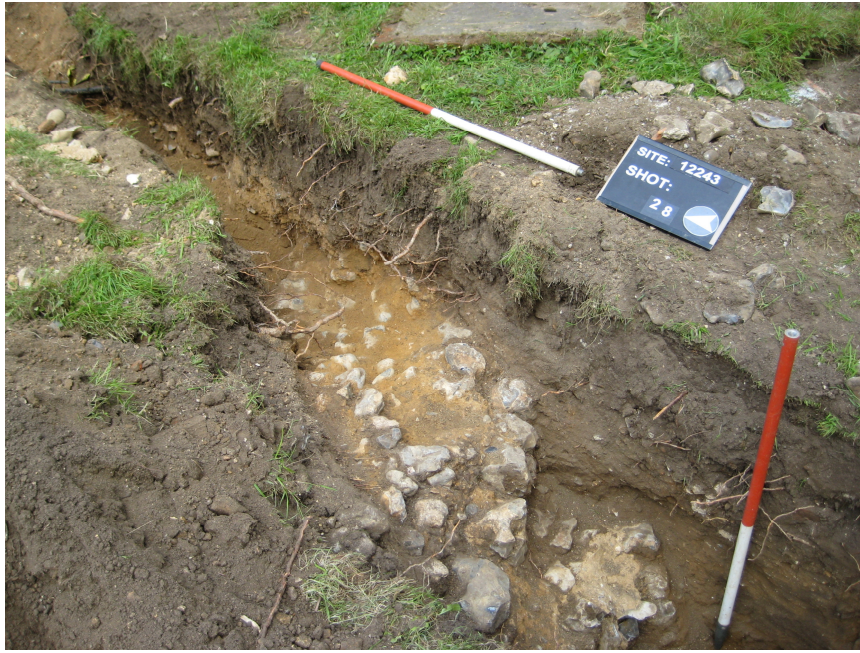
Plate 5 East facing view walls (030) and (035) (Section 6)

The earliest exposed deposit was a medium reddish yellowish brown sand (031). This was cut by an uncoursed flint rubble wall (031), measuring at least 0.45m in width. Wall (030) was on an east-southeast to west-northwest orientation which differed from the strict east-west alignments of the church walls (Figs 3 and 5, Plates 5 and 6).

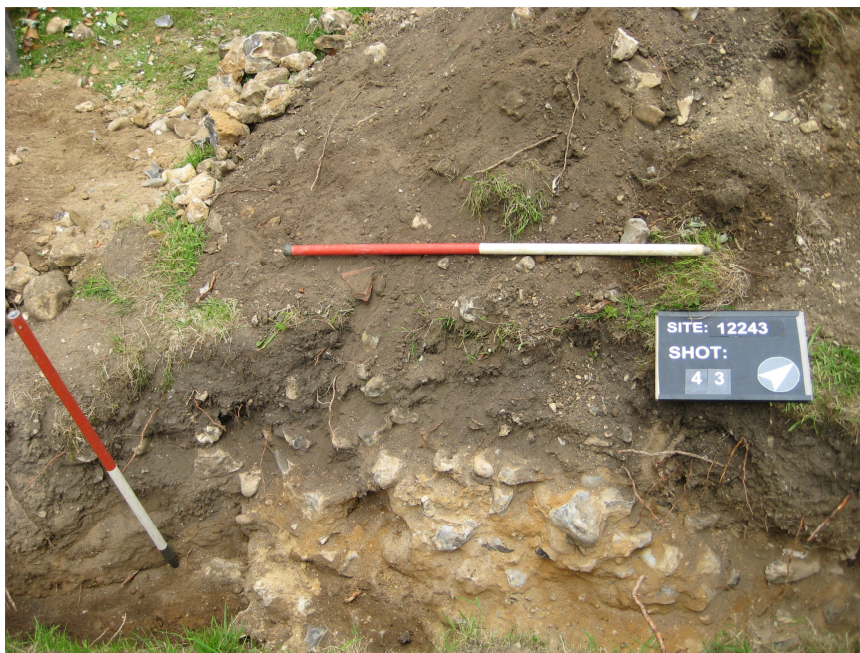
Plate 6 West facing view walls (030) and (035) after hand excavation of pipe trench (Section 8)

Although no dating evidence was recovered from any of the Phase 2 deposits, the Phase 3 wall (035) was clearly constructed upon the demolished remains of wall (030). This suggests that wall (030) predated the principal phase of church construction (Fig.5 Section 8).

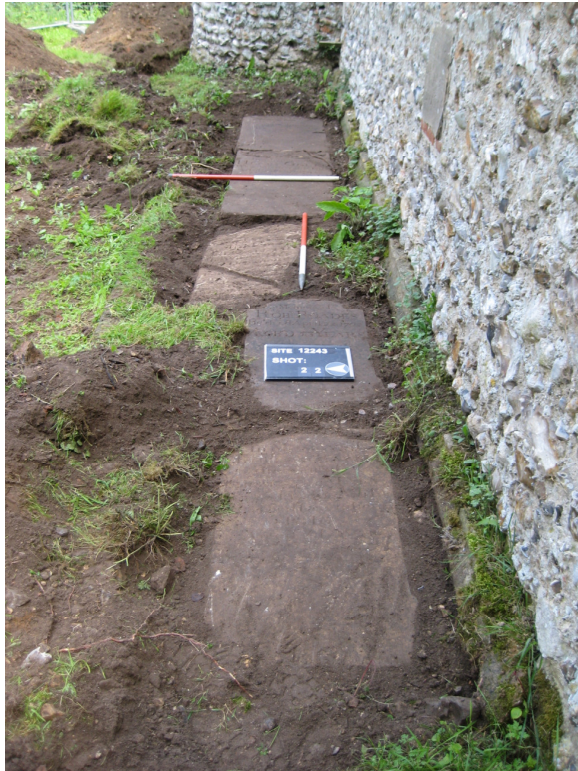
Plate 7 North facing view grave markers (051). Arrow points west.

All the deposits west of the nave were sealed by topsoil (002)=(039). Five grave markers were laid flat, facing upwards on the topsoil, in a north-south line alongside the west end of the church (Plate 7). Clearly removed from their original location, four of the grave markers could be read and commemorated: Martin Druerry, died 1790 aged 29; Henry Gould died 1792 aged 90; Robert Boades, died 1762 aged 53 and [illegible] died 1818 aged 41. The final grave marker could not be read although it was in the same style as the others.

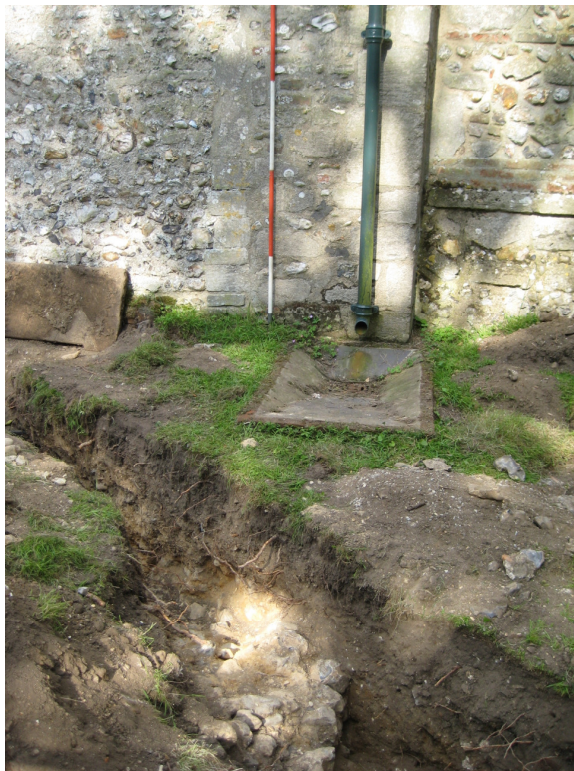
Plate 8 East facing view of wall (030) showing traces of a demolished wall in the western gable of the surviving church nave.

Traces of a demolished wall were evident in the west gable of the church adjacent to wall (035) and the wall clearly continues the line of the extant south nave wall westwards. This suggests that the present nave has been truncated and originally continued to the west.

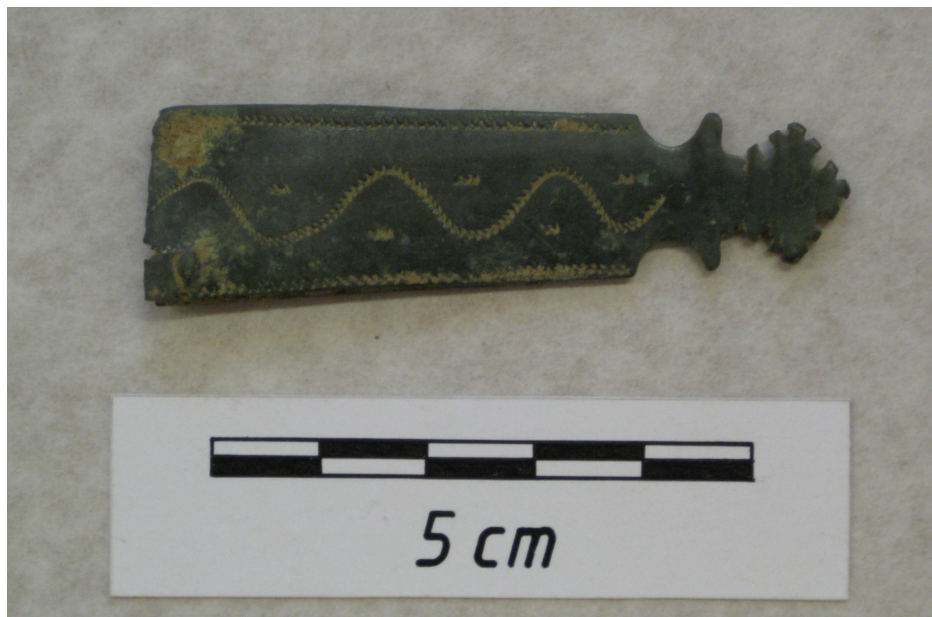
Mortar and metal items were retrieved. The mortar is of two distinctly different types and these probably relate to pointing works carried out at different times. Two metal objects were also recovered. One of these is a lead off-cut and the other is a strap end in copper alloy. This latter piece is decorated with a serpentine curve and border lines produced with an engraving tool with a U-shaped blade. There are also leaf-like patterns on three of the U-shaped cuts set in the lobes of the serpentine curve. The terminal of the strap end is lobed, in a 'floriolate cross' style. A very closely similar example, with a floriolate cross terminal but lacking the incised decoration, was recovered from Norwich from a deposit dated to 1410-75 (Margeson 1993, 35-6; fig 20, no 232).

The strap end from East Barsham church
