**HISTORIC BUILDING RECORDING
AND ARCHAEOLOGICAL
WATCHING BRIEF AT
34 WELL ST,
LANGHAM
RUTLAND
(LAWS09)**

**Work Undertaken For
Mr P Green**

APS Report No. **24/09**

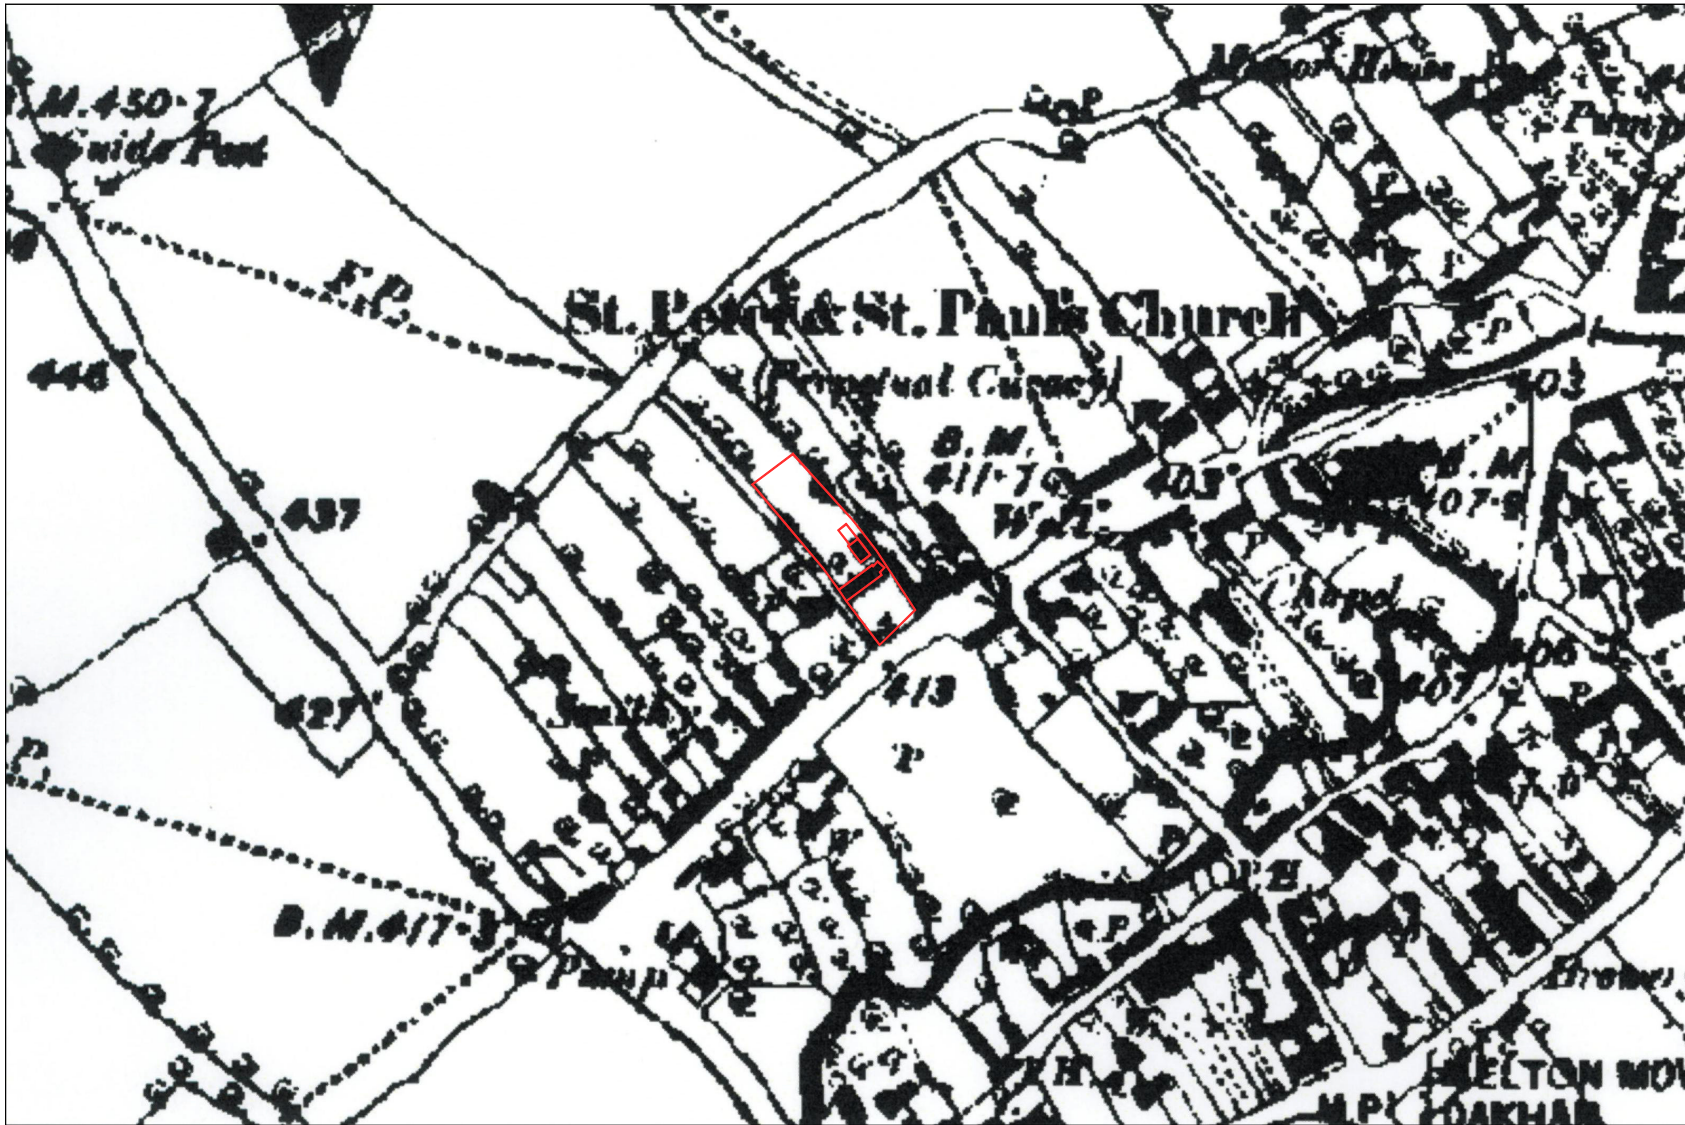
Figure 7 Extract from first edition Ordnance Survey map, 'England - Rutland: 005/SW', Ordnance Survey 1:10,560 - Epoch 1 (1887).

Examination of the first edition Ordnance Survey map, published in 1887, shows the surveyed building matches well with the location of buildings recorded at that time (Figure 7). It seems probable that the surveyed buildings are the same as those depicted on this map.

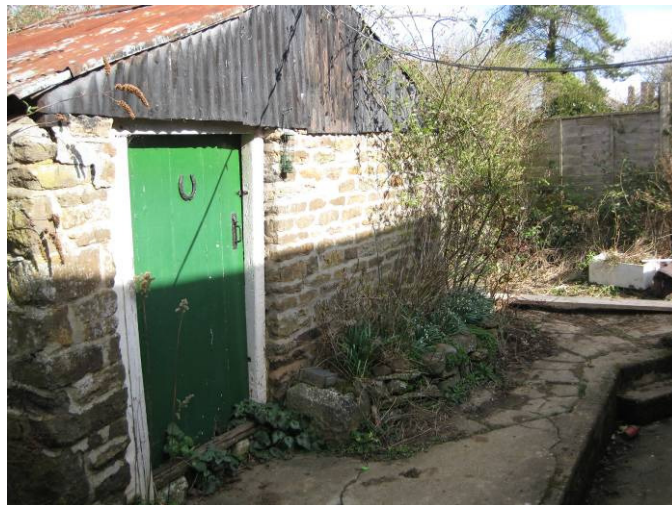
Plate 2 Southern wall of recorded building, looking northeast

Stone quoins were noted at the southeast, southwest and northeast corners of the building, although none were evident at the northwest corner (Plates 2 & 6). Occasional pebbles and fragments of tile and brick were noted within the walls.

The southern gable end was of stone up to eaves-height, and of corrugated iron above this, to the roofline (Plate 2). A small raised garden bed was built against this wall.

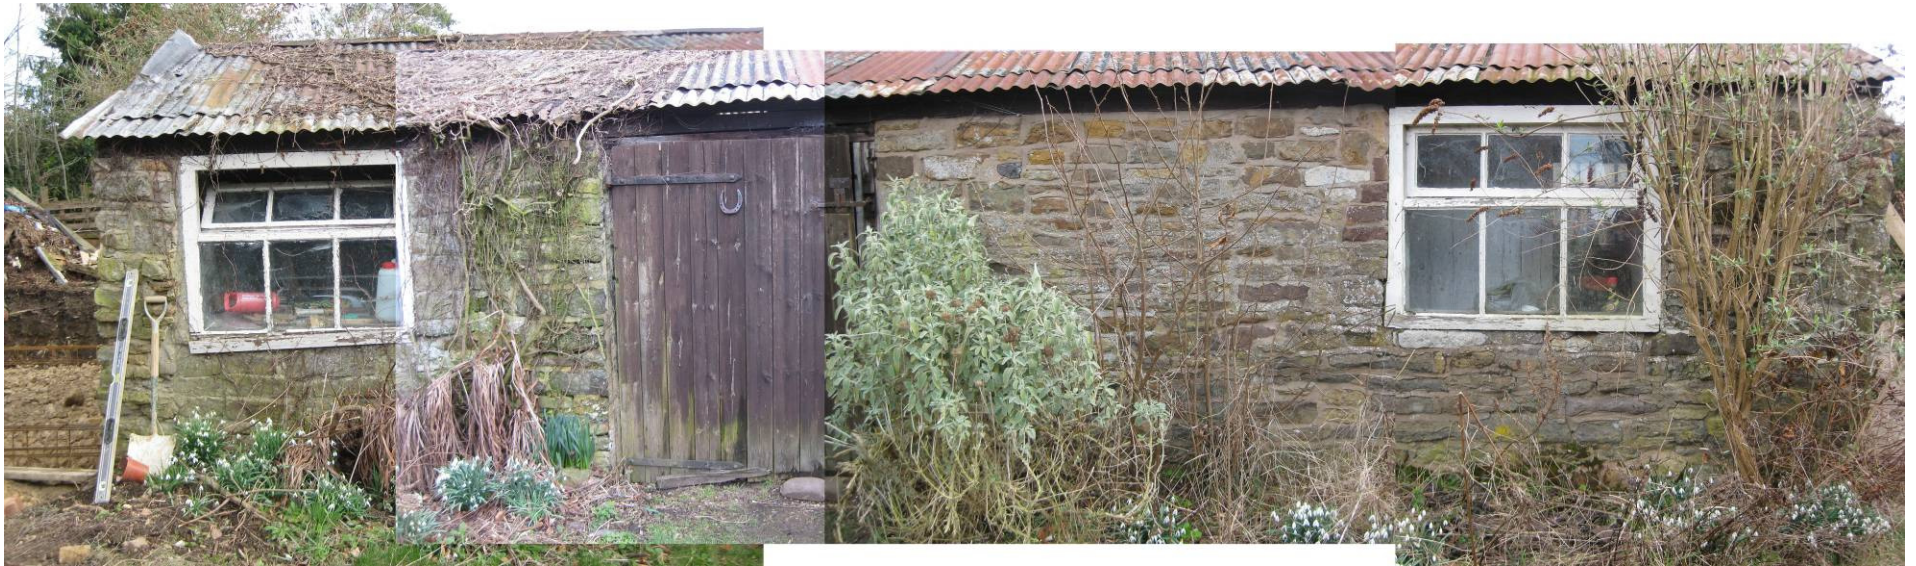
Plate 4 Detail showing western wall of recorded building, looking east

Close to this corner of the northern and western walls, the western wall projected out slightly. A similar projection was noted at the opposite side of a window here (Plate 4). It is not clear whether these variations may relate to some repair of this corner of the building, whether they may be associated with the window itself, or perhaps even a former adjacent structure. A small area between the southernmost of these projections and this window appeared to have been infilled at some time, perhaps during some alteration to the

A further window and a door were also recorded in the west wall (Plate 4). Between these a single timber was noted within the stonework of the wall, with a short straight join at its southern edge.

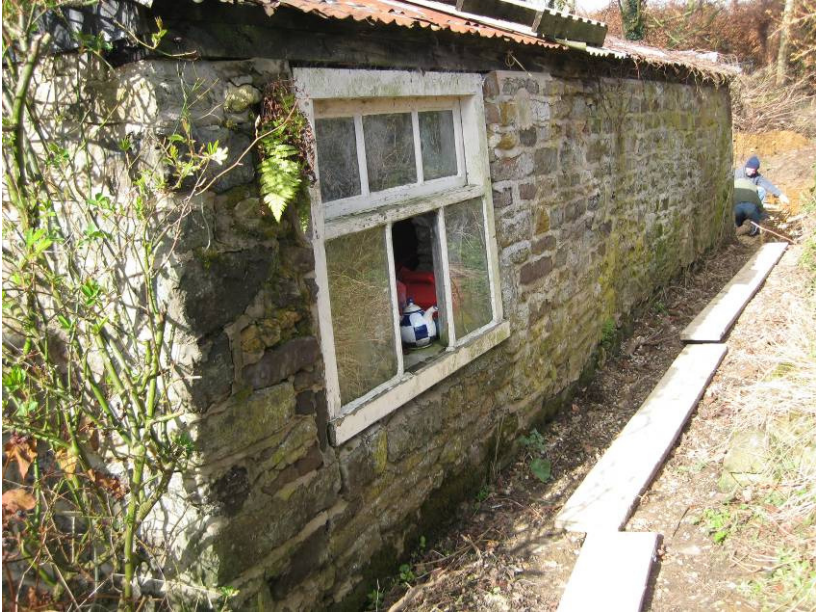
Plate 5 General view including eastern wall of recorded building, looking northwest

The east wall was topped by timber and had a single wood-framed window (Plate 4 5).

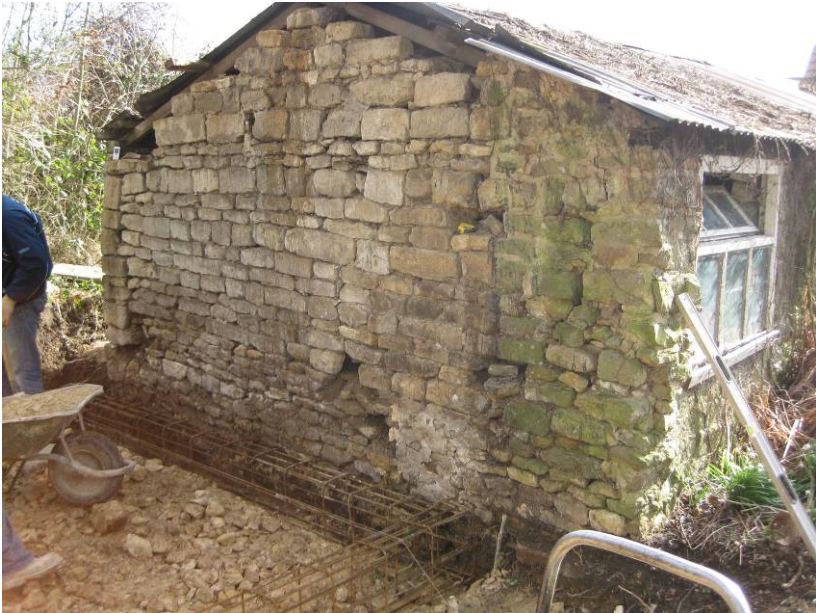
Plate 6 Northern wall of recorded building, looking southeast

The northern gable end was fully of stone, up to the roofline (Plate 6). Several stones were missing from this wall, which was generally in a somewhat poor state of repair. Weathering at the western edge of this wall marked the probable former extent of an adjacent tin shed, now demolished. The top of the eastern part of this wall had probably been rebuilt at some time.

The absence of quoins at this corner of the building is somewhat puzzling, but may be the result of repairs in this area, utilizing smaller stones which came to hand.

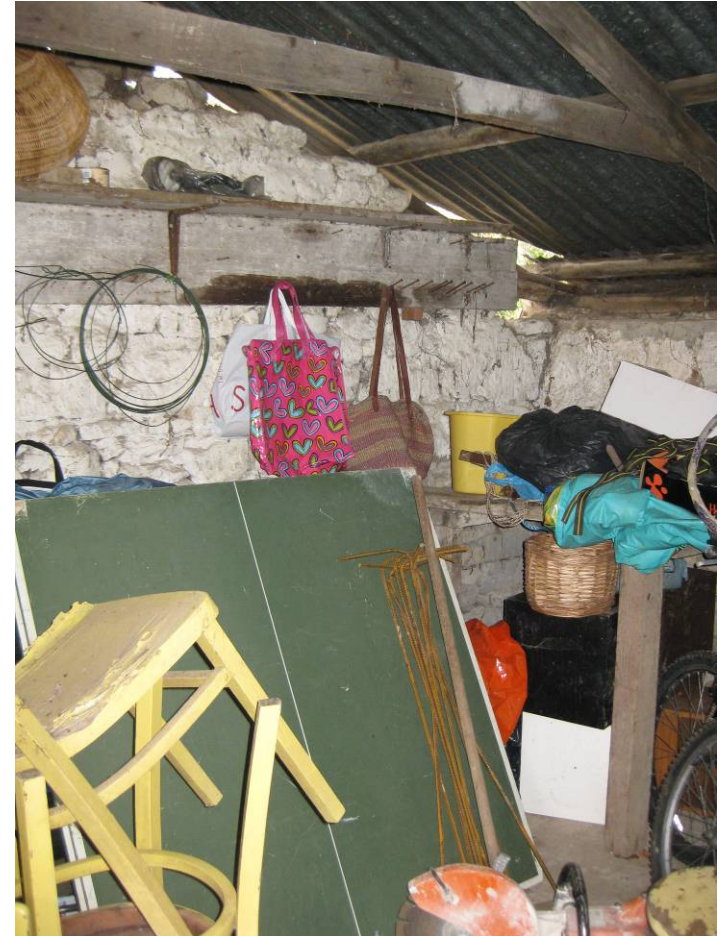
Plate 7 Interior of recorded building, showing north wall, looking northeast

Internally, the building was divided into two rooms by a timber partition to the height of the walls (Plate 8). Each of the two rooms was used for storage (Plates 7, 8 & 9).

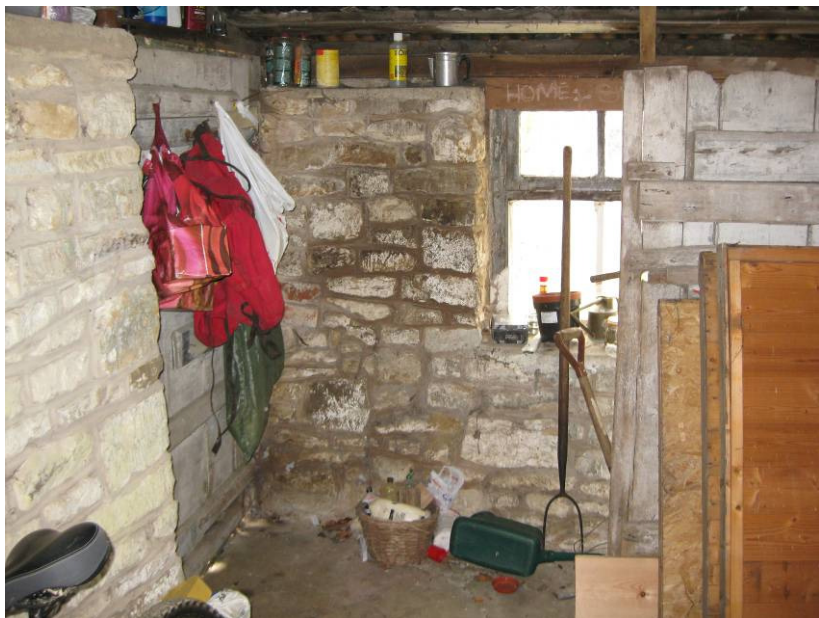
Plate 9 Interior of recorded building, showing walling, door and window at southwest corner of building, looking southwest

At the southwestern corner the west wall widened at its base, and patching was evident here (Plate 9).

Part of the southern gable end appeared to include some replacement stonework internally (Plate 9), and some of the stone had clear chisel marks.

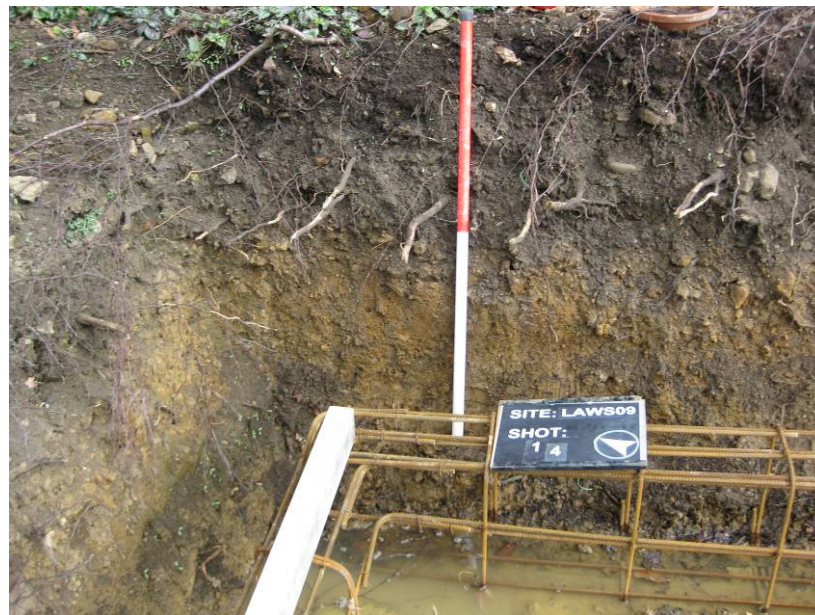
Plate 10 Representative section recorded in stripped area during watching brief, Section 1, looking east

The earliest deposit encountered at the base of the stripped area was a natural layer of soft mid orange to olive-brown silty clay (002). This measured in excess of 0.60 m thick.

Sealing the layer was a topsoil of soft dark blackish brown slightly clayey silt with frequent pebbles, up to 0.55m thick (001).
