**ARCHAEOLOGICAL WATCHING BRIEF
ON GROUNDWORKS AT
ST. GERMAIN'S CHURCH,
THURLBY NEAR LINCOLN,
LINCOLNSHIRE
(THSG 09)**

**Work Undertaken For
Tim Benton Architect
on behalf of
Thurlby P.C.C.**

Report No: 26/09

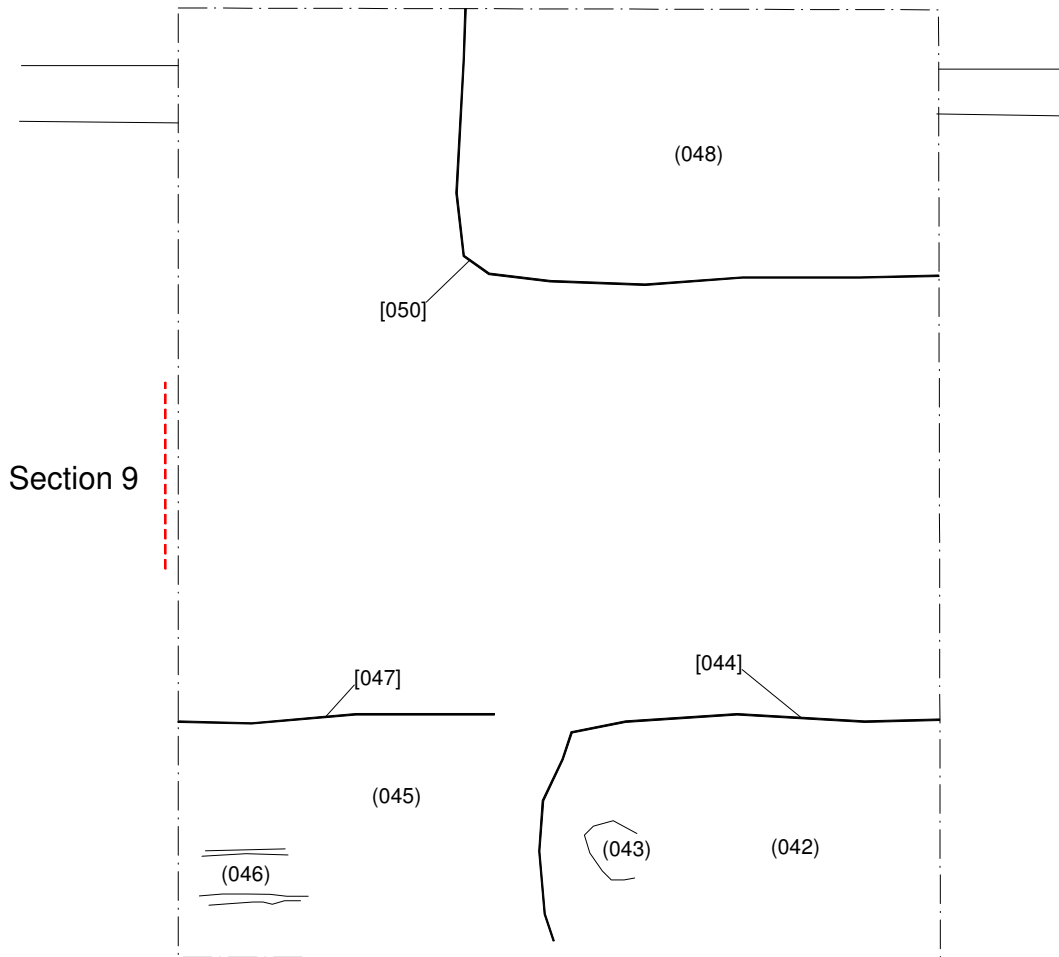
Figure 6 - Plan of soakaway to the east of the church

In the north-eastern area of the site three sub-rectangular grave cuts, [044], [047] and [050], were cut into a soft light whitish brown silty sand (041) with dark olive greyish brown patches, frequent small pebbles and fragments of human bone (Figs 6 & 8, Section 9) (Plate 10). The 3 grave cuts contained east-west oriented supine inhumations, (043), (046), and (049). Skeletons (043) and (046) were adults; skeleton (049) was only partially exposed to the tips of the shoulders and part of the skull, making it difficult to ascertain an age. All three of the grave cuts were filled with a soft dark olive greyish brown silty sand with moderate pebbles,

and were assigned context numbers (042), (045) and (048) respectively (Fig 6) (Plate 9).

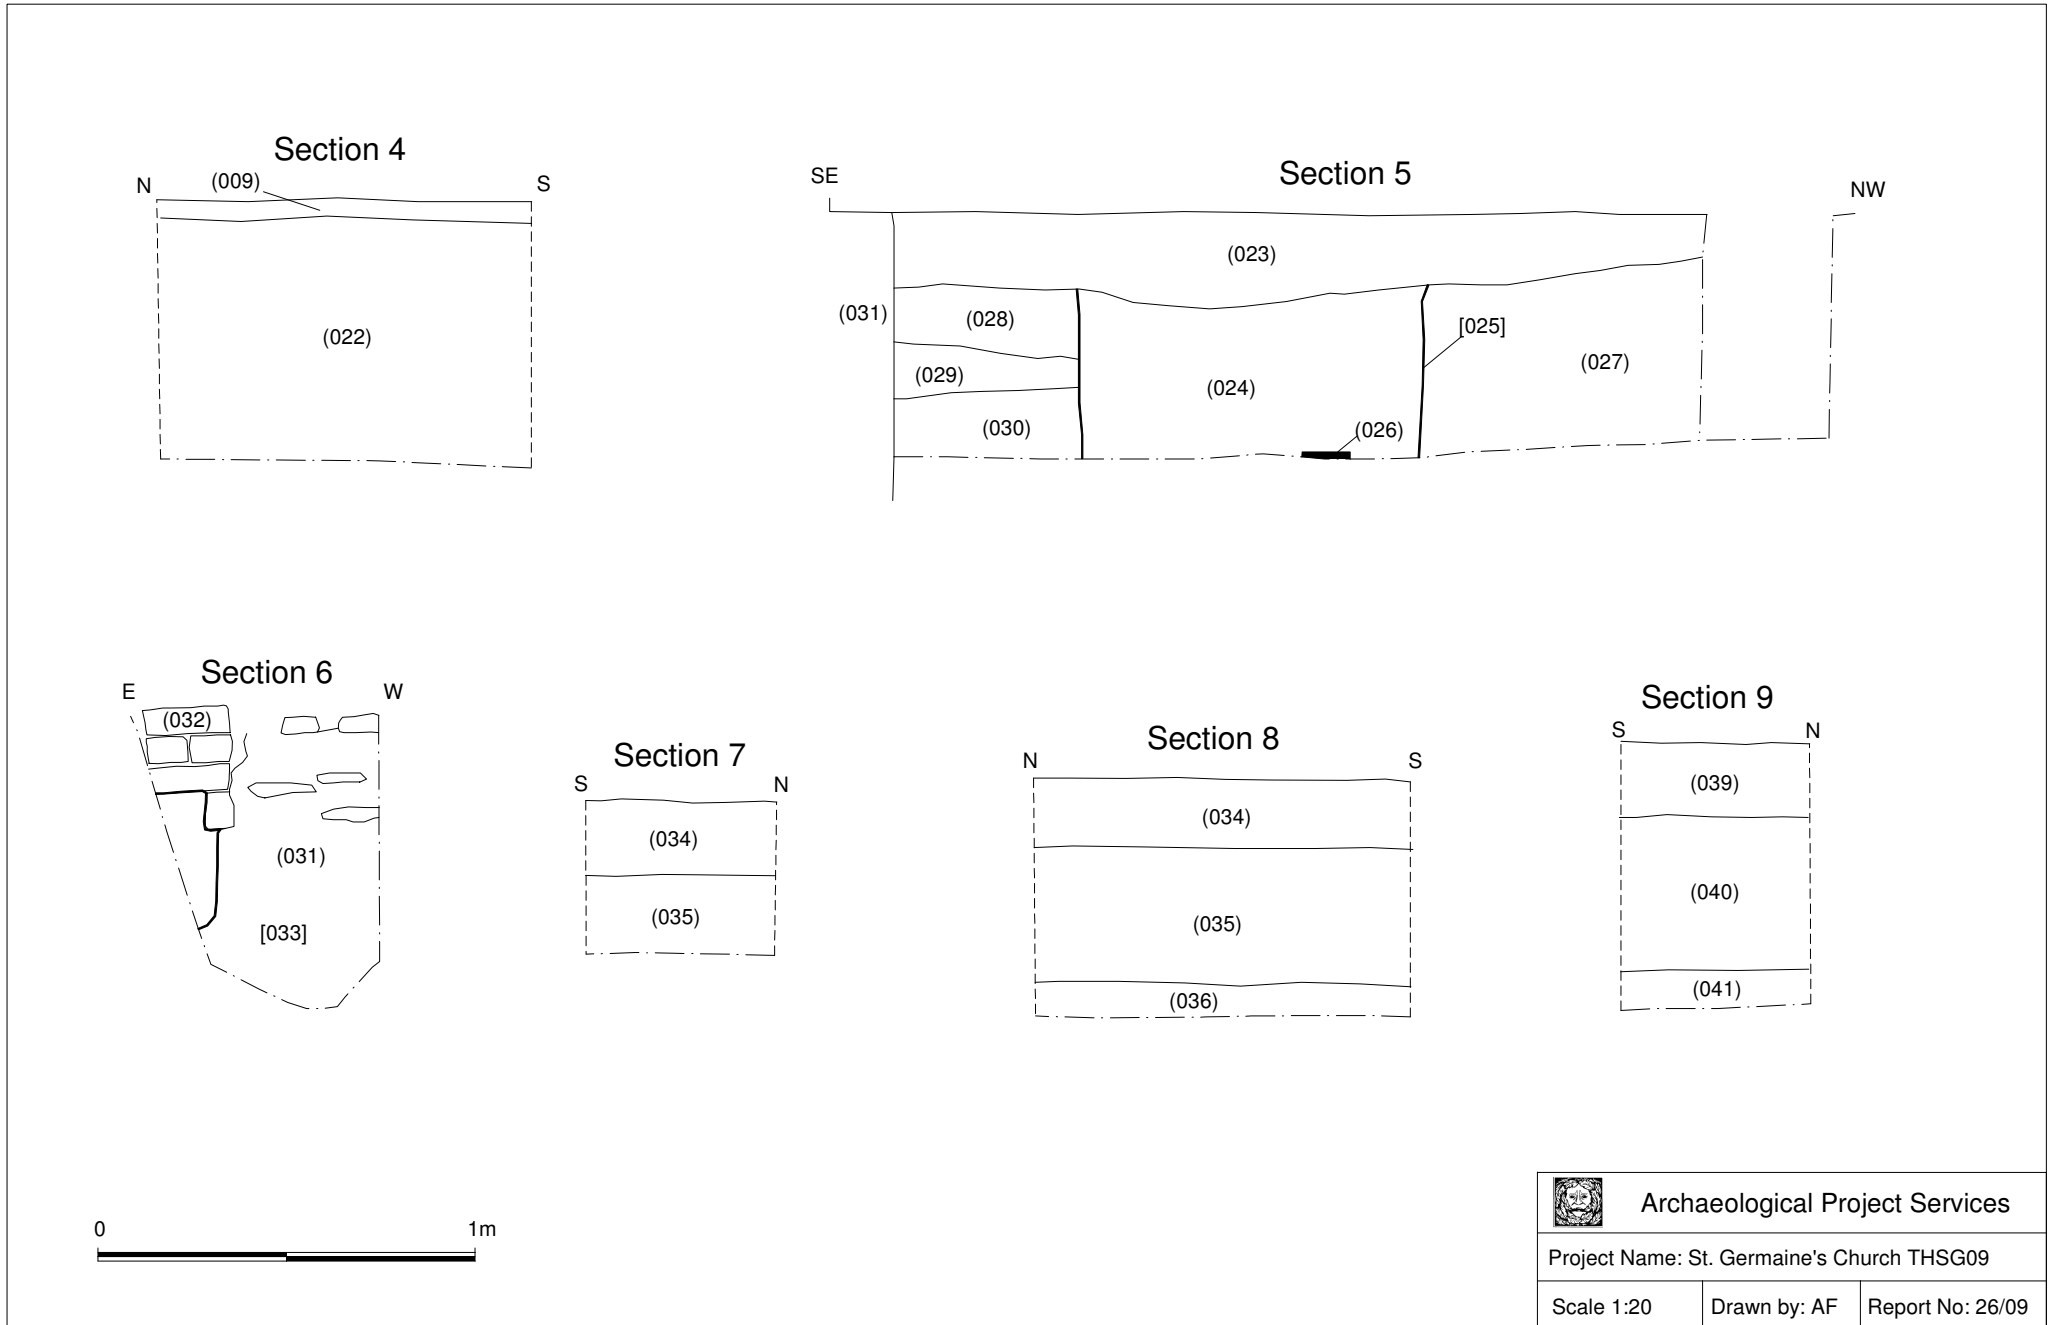
Figure 8 - Sections 4, 5, 6, 7, 8 and 9

Overlying the burials in the north-eastern corner of the site was a soft dark olivey greyish brown silty sand (040) with moderate pebbles (Fig 8, Section 9) (Plate 10). This same deposit occurred in Sections 5, 7 and 8 (Fig 8) to the north of the church tower (Fig 5) (Plate 7) and was recorded as (035) in Sections 7 and 8 (Fig 8) (Plate 8) and as (027) in Section 5 (Fig 8). A representative section recorded south of the church near burial [038] (Fig 3) also revealed the same deposit which was assigned the context number (022). A total of 5 sherds of Early to Middle Saxon pottery was recovered from this deposit.

The base of the medieval church tower had a square and vertical-sided hole cut through it measuring 0.30m high x 0.16m wide (Figs 5 & 8, Section 6) (Plate 6). This was lined with bricks (032) measuring 225mm x 108mm x 72mm and bonded with white lime mortar.

Abutting the medieval church tower base (031) was a series of three deposits recorded in Section 5 (Figs 5 & 8) (Plate 4). The first of these was a 0.27m thick soft mid grey silty sand (030) with a moderate amount of small pebbles and occasional charcoal flecks. This was overlain by a moderately firm light whitish yellow deposit (029) of powdery lime mortar and sub-angular fragments of lime mortar. The mortar deposit was sealed by a firm dark greyish brown clayey sandy silt (028) with occasional fragments of ceramic building material.

Cut through deposit (028) was a sub-rectangular cut [025] with vertical sides, 1.20m long x 1.0m wide x at least 0.45m deep (Figs 5 & 8, Section 5) (Plate 4). At the base of this cut lay the remains of a brick structure in the form of a wall

foundation (026) made of bricks measuring 225mm x 108mm x 72mm bonded with white lime mortar. The brick structure was overlain by a 0.45m thick loose deposit of brick rubble with slate and lime mortar fragments (024) (Fig 5 & 8, Section 5) (Plates 4 & 5).

Deposit (024) was overlain by a 0.25m thick firm dark brown clayey silt (023) with patches of light brown clay and a moderate amount of pebbles (Fig 8, Section 5).

North of the church tower, sealing graveyard soil deposit (035) was a soft dark brownish humic silty sand topsoil (034), 0.20m thick, with occasional pebbles (Fig 8, Sections 7-8) (Plate 8). The same deposit was recorded in Section 9 (Fig 8) (Plate 10) as (039) with a thickness of 0.20m.

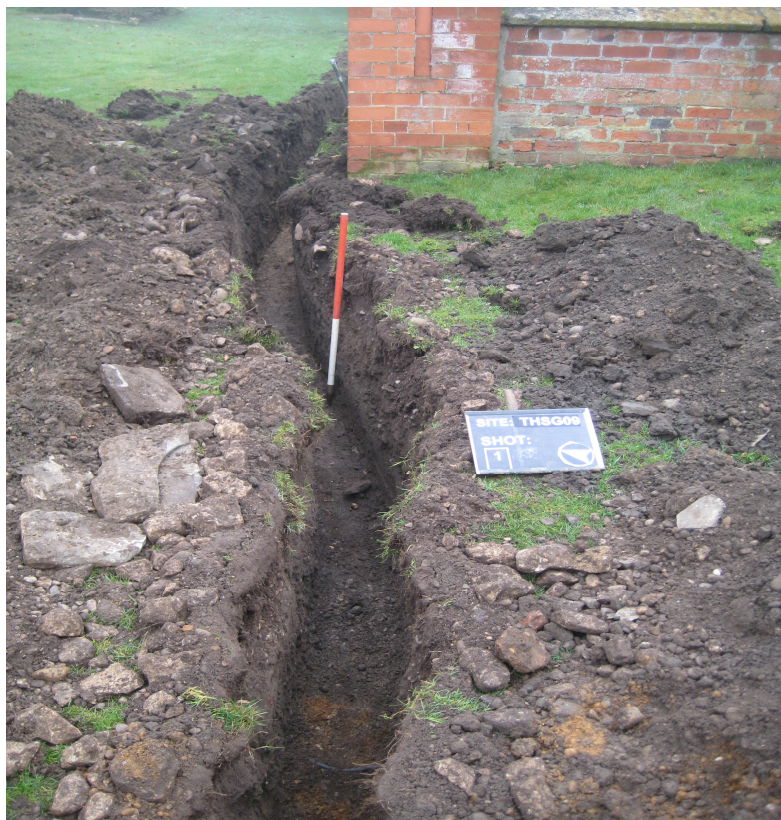
Cut through the natural gravel in the south-western corner of the site was a steep-sided, 3.60m wide, north-south aligned linear cut [001] (Figs 4 & 7, Section 1) (Plate 2). The depth of this feature remains unknown, however the cut was observed in section rising 0.28m from the base of the

trench and three fills were identified. The eastern side of the feature was filled with a soft mid to dark greyish brown silty sand (017) with frequent pebbles. The western side of the cut contained a soft light greyish white sandy gravel (016) with patches of dark grey sand. Overlying both of these deposits and forming the uppermost fill of [001] was a soft dark grey silty sand (002) with moderate pebbles and occasional charcoal flecks. This deposit contained two large mammal bones and two sherds of Early to Middle Saxon pottery dating from the mid 6th to 8th century.

Plate 2 – Ditch [001]

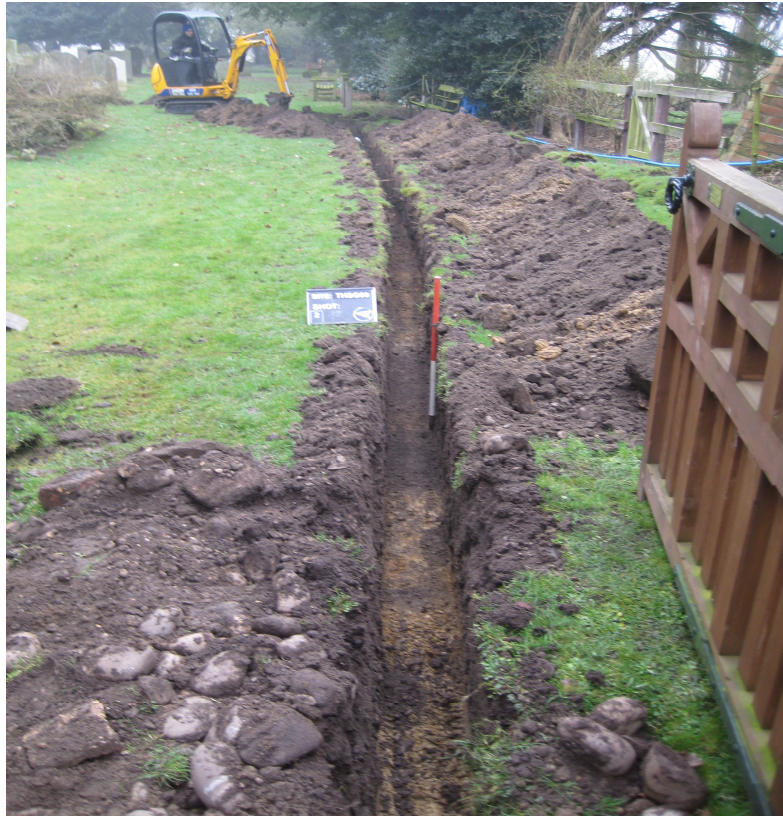
undated features were recorded cut into natural deposit (018). The most westerly of these was [007], a linear cut with a rounded terminal end and vertical sides at least 0.18m in length x 0.16m wide, with a depth of 0.20m (Figs 4 & 7, Sections 2-3) (Plate 3) This was filled with a 0.20m thick, soft mid to dark greyish brown silty sand (008) with light orange and brown mottle, frequent pebbles and occasional charcoal flecks.

Approximately 0.20m east of [007] was a vertical sub-circular cut, 0.30m in diameter x 0.20m deep [003] (Figs 4 & 7, Section 2) (Plate 3). This possible post-hole was filled with a soft dark grey silty sand (004) with moderate pebbles and occasional charcoal flecks.

The third undated feature in this area lay to the west of [005] and consisted of a possibly sub-rectangular or linear cut [021] with steep sides, 0.80m long x 0.30m wide x at least 0.20m deep (Figs 4 & 7, Section 2) (Plate 3). A soft dark grey silty sand (020) with frequent pebbles filled this feature.

Plate 3 – View of features [007], [003], [005] and [021]

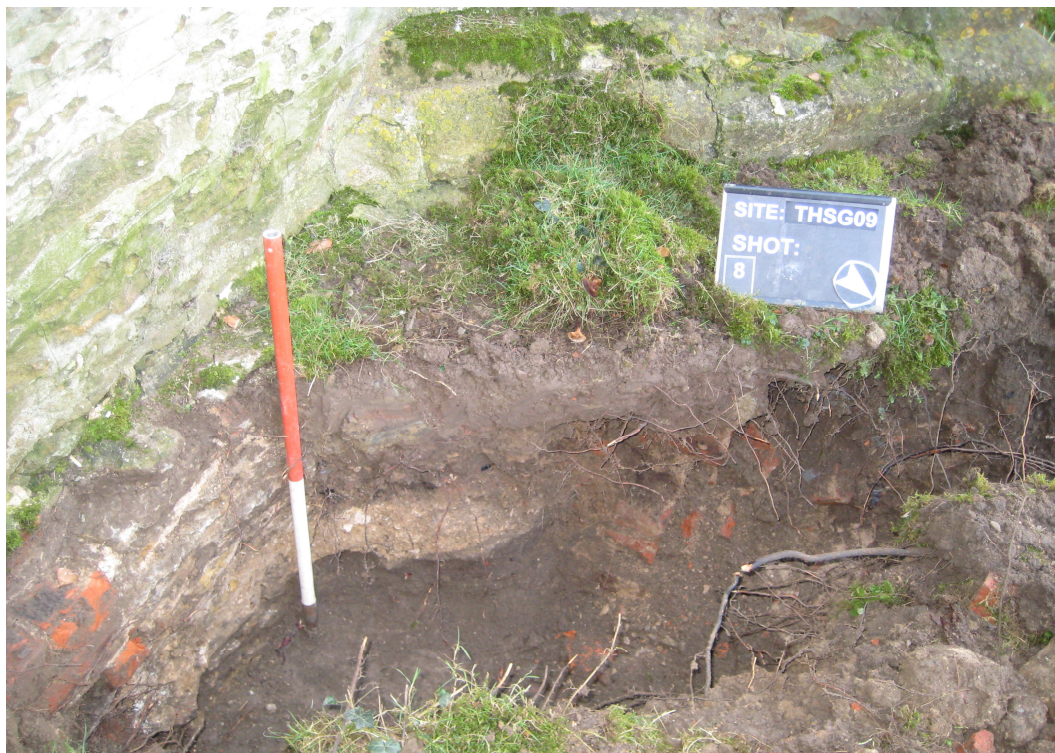
Plate 4 – Deposits abutting church tower, seen in Section 5

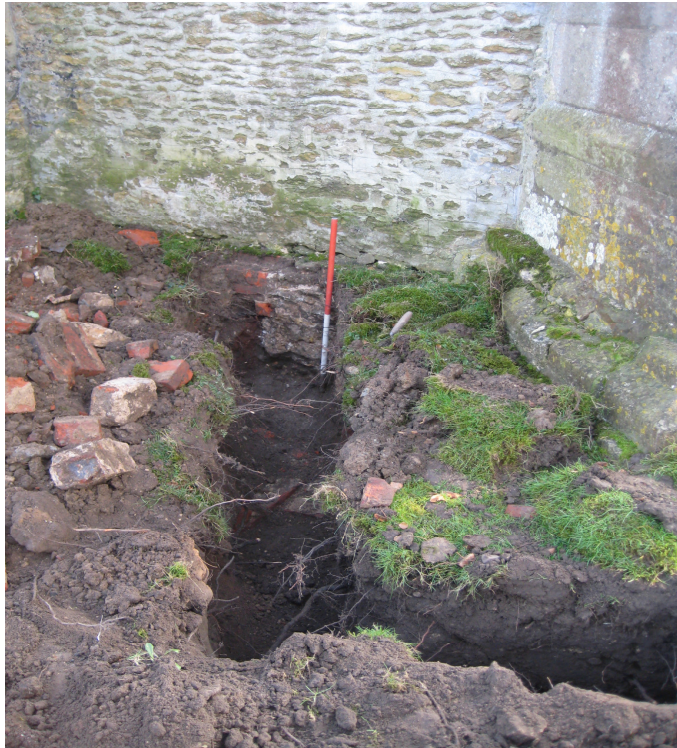
The most recent of these dumped deposits abutting the tower was cut by a sub-rectangular feature which contained the remains of a brick structure, overlain with its own demolition debris. In living memory this demolished structure was used as a coal shed, but may have had a prior use. It seems more than likely that this structure is associated with the small square brick lined cut occurring below ground surface in the base of the nearby church tower. It seems probable that this was perhaps a vent connected to the brick structure which may have performed a heating function. This feature cut into the tower was re-used for laying the current drainage pipe.

Plate 5 – Remains of brick structure (026) in base of pipe trench

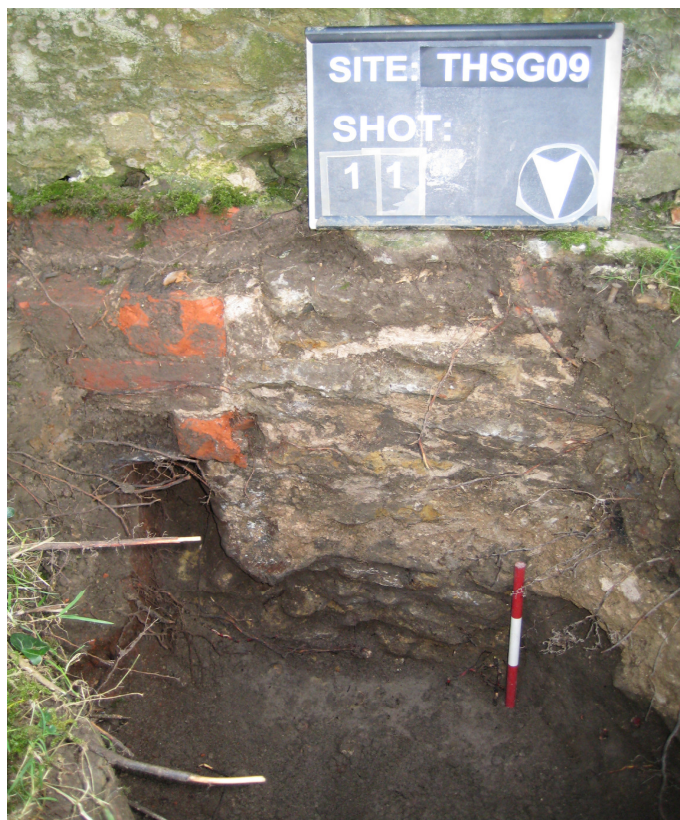
Also of note was the exposed base of the medieval church tower which was found to be cut through by a possible vent associated with a nearby demolished brick structure that had been used as a coal shed

in living memory. It is probable that this shed had a prior use and may have performed a heating function for the church with the vent connecting the two structures. The hole in the tower was re-used to fit the current drainage pipe.

Plate 6 – Brick lined cut [033] in tower base

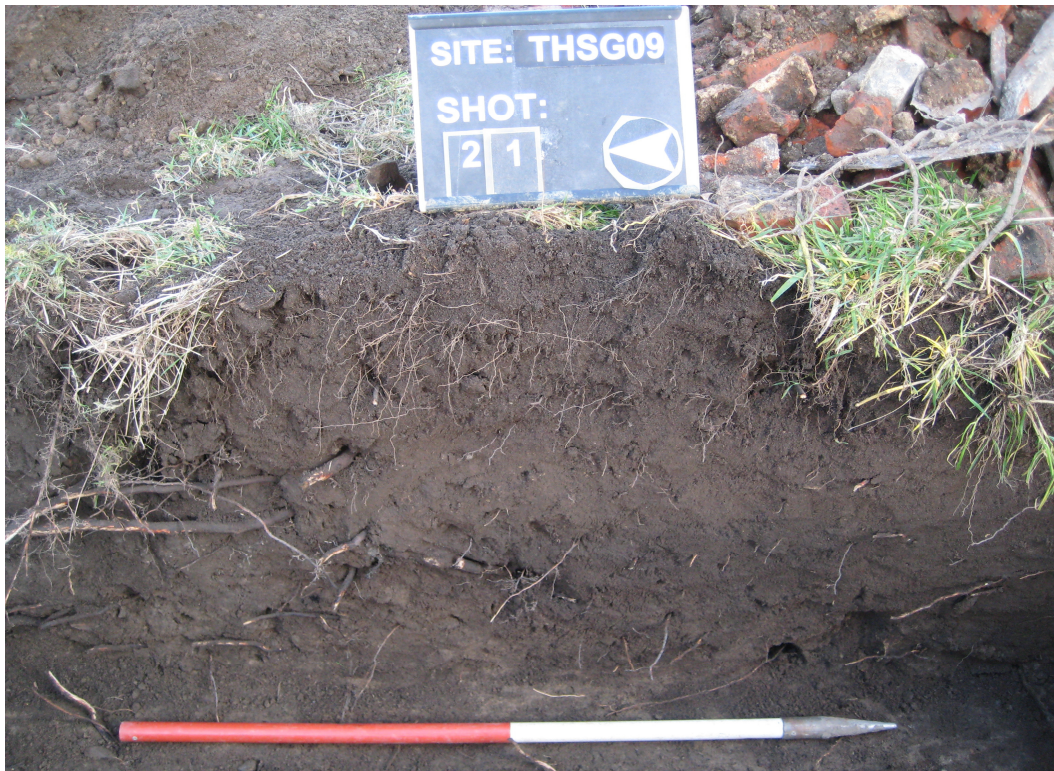
Plate 7 – Soakaway to the north of church tower

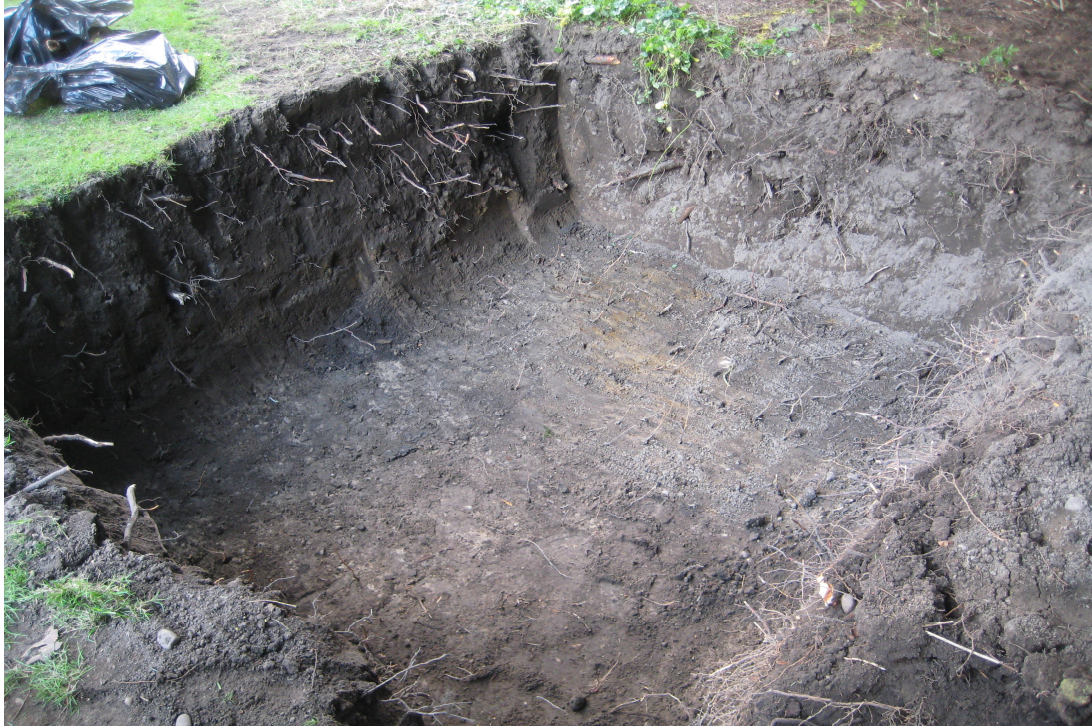
Plate 9 – Soakaway to the east of the church, containing grave cuts [042], [047] and [048]

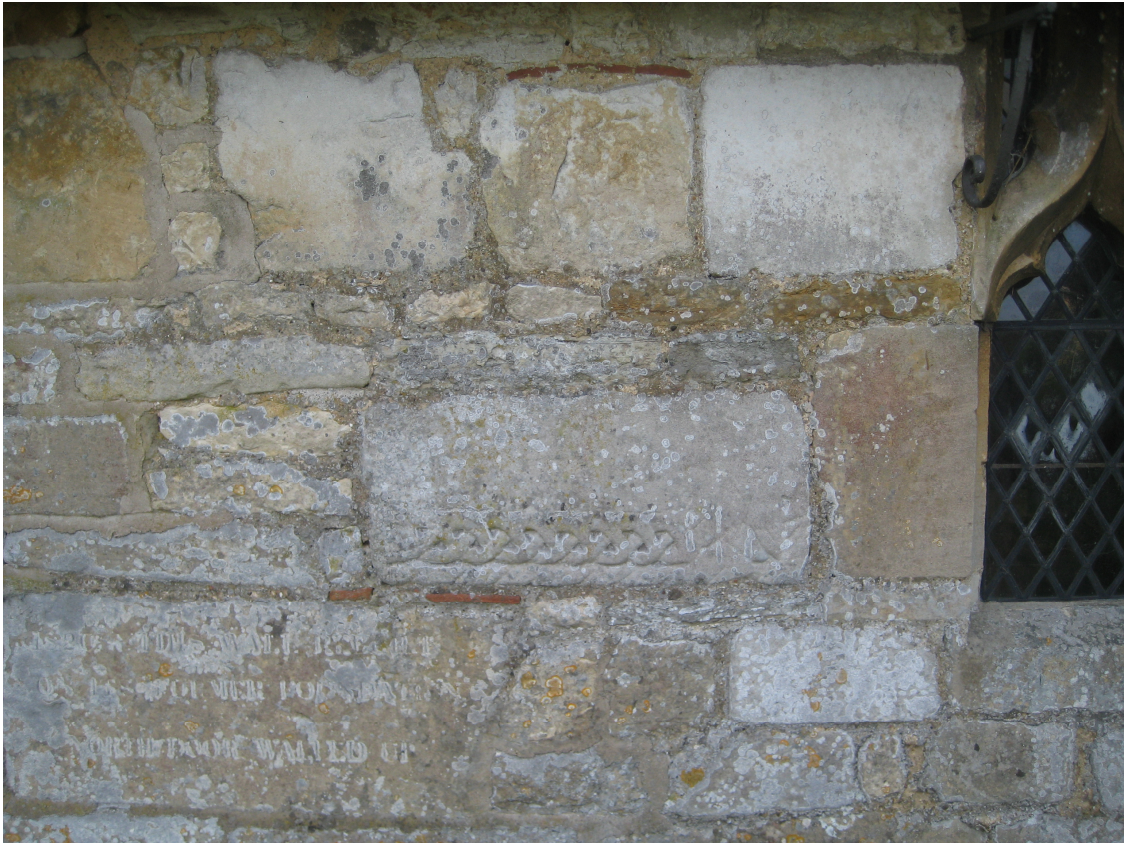
The Early to Mid Saxon features and pottery along with the incorporation of a Late Saxon grave cover into the construction of the medieval church raises the possibility that the site may have seen an earlier ecclesiastical presence.

Plate 11 – Late Saxon grave cover built into church wall
